# STRUCTURAL ENGINEER'S REPORT

**Site Address:** Ratcliffe House Farm, Ratcliffe House Lane, Ratcliffe Culey, Atherstone,  
CV9 3LZ

**Project No:** 231008

**Date of Inspection:** 7<sup>th</sup> November 2023

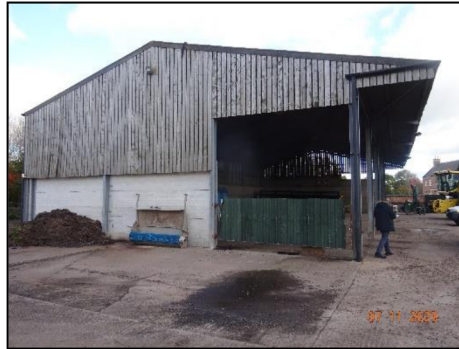
25. Fig 1 is a general view of the front and side of the building.
26. The building is a steel framed agricultural building, the building is open on the front and partially open on 1No. side, there are no internal partition walls.

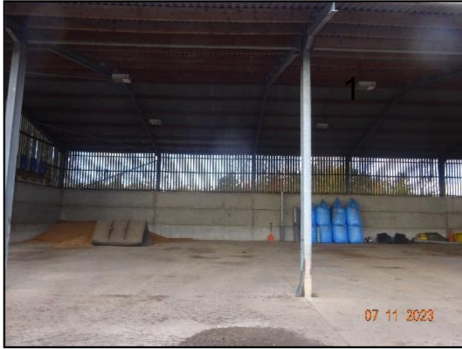
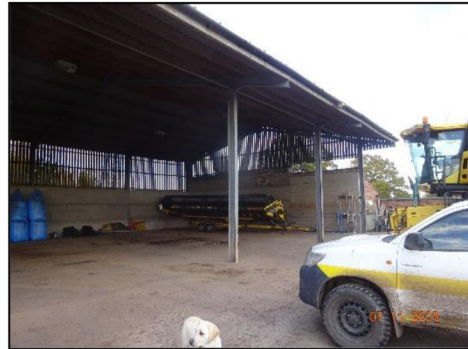
46. Fig FE1 and Fig FE2 are general views of the front elevation.

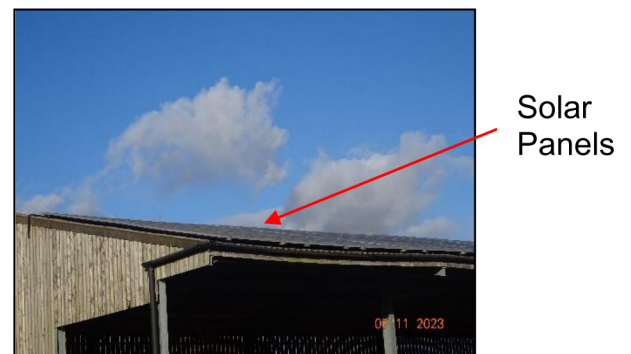
48. Fig FE7 shows the buckled flange on the column by side elevation S2 (East Elevation).
49. Fig FE8 shows the solar panels on the roof.

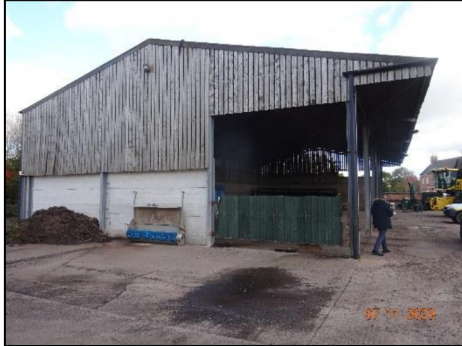
51. Fig SE1.1 is a general view of side elevation S1 (West).
52. Fig SE1.2 to Fig SE1.4 show the precast concrete 3m high panels on the side elevation. They are bolted to the structural steelwork columns.

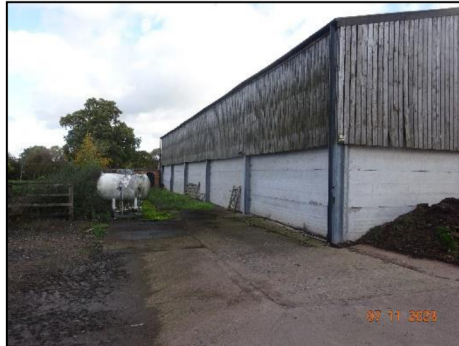
54. Fig RE1 is a general view of the rear elevation.

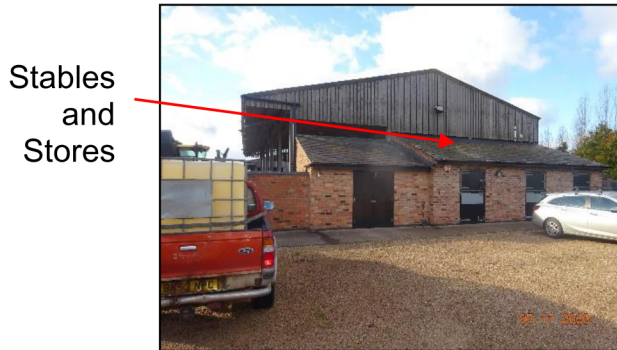
56. Fig SE2.1 is a general view of side elevation 2 (S2).
57. Fig SE2.2 shows the gutter downpipe at the rear corner.
58. Fig SE2.3 and Fig SE2.4 show the boundary wall.

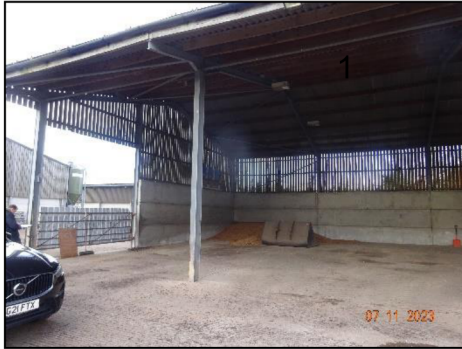
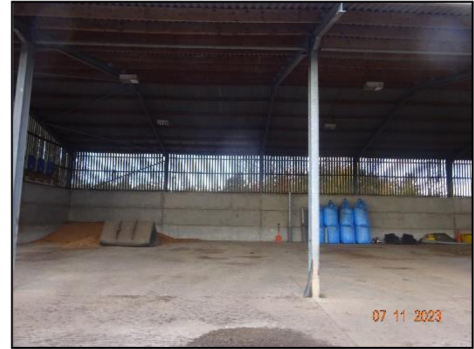
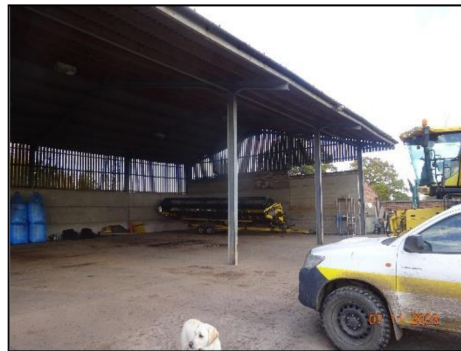
60. Fig GF1 to Fig GF3 are general internal views of the side and rear walls.

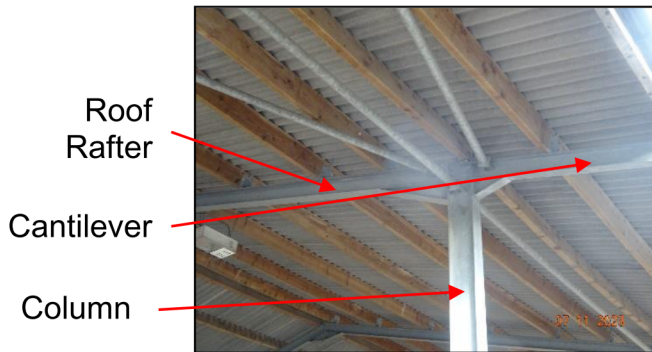
62. Fig J1 shows a typical structural steelwork column beam joint on the front elevation.
63. Fig J2 shows a typical structural steelwork column beam joint on the rear elevation.
64. Fig J3 shows a typical structural steelwork beam to beam ridge joint.
65. Fig J4 shows the timber side cladding rail to column joint.

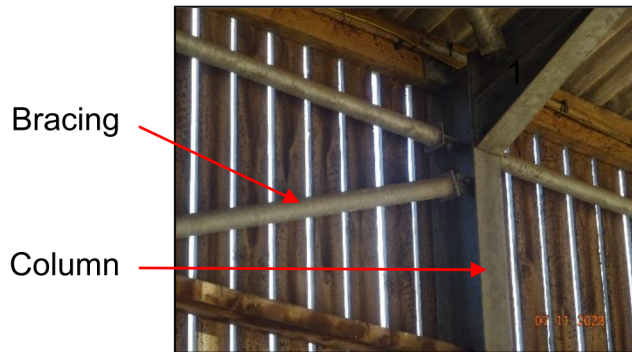
67. Fig WB1 shows the wall bracing to column joint in the rear wall in the first bay adjacent to the side elevation 1 (S1: West Elevation).
68. Fig WB2 shows the wall bracing to the rear corner column bolted joint.

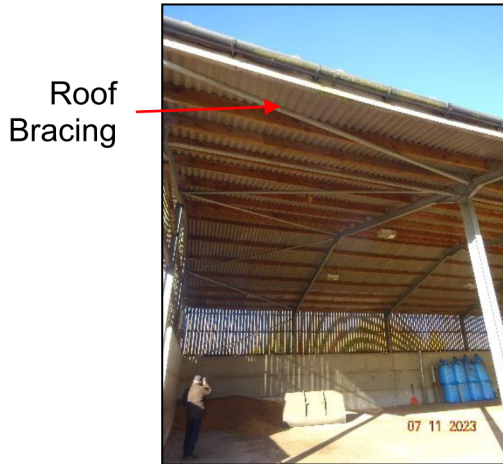
70. Fig RB1 is a general view of the roof bracing by side elevation S1 (West Elevation)
71. Fig RB2 shows the roof bracing to cantilevered roof rafter joint.
72. Fig RB3 shows the CHS eaves beam to column joint.
73. Fig RB4 to Fig RB6 show the bracing to roof rafter joints.

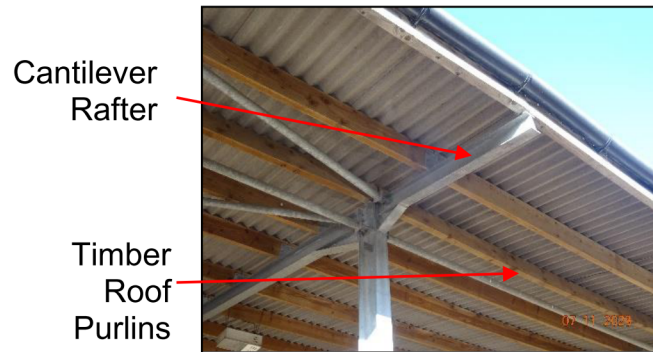
75. Fig CR1 is a view of the cantilevered roof rafter and the timber roof purlins.

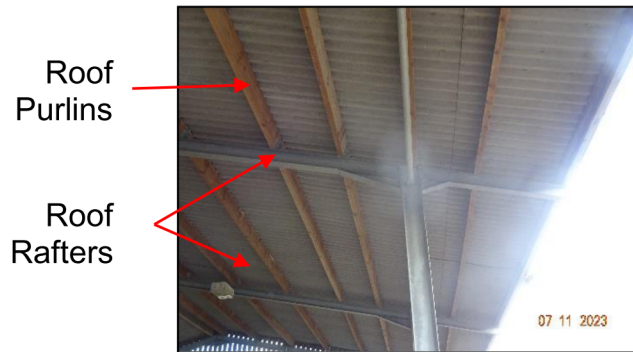
77. Fig RP1 shows the timber roof purlins supported by the structural steelwork roof rafters.
78. Fig RP2 shows the bolted roof purlin to roof rafter joint.
