**A Historic Building Photographic Survey at**

**102 Main Street,**

**Nailstone,**

**Leicestershire**

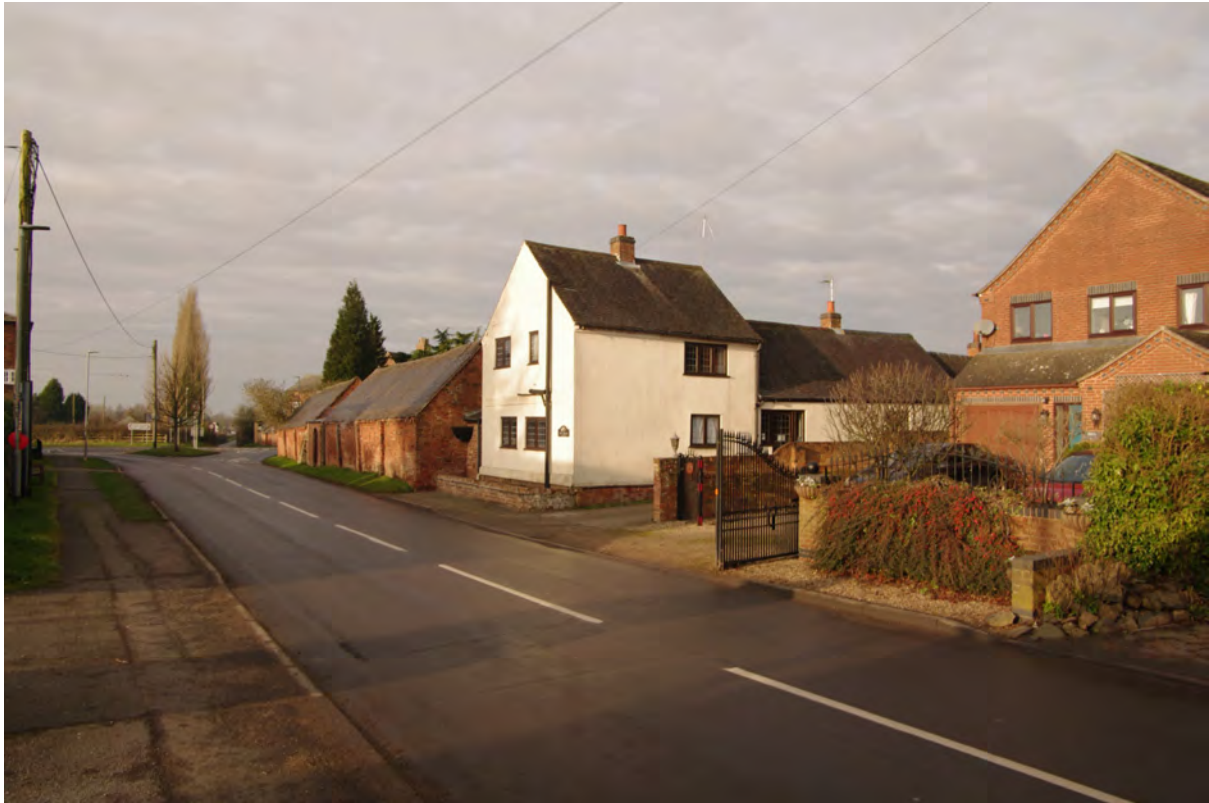
Figure 15: The site seen from Main Street  
*Looking east. The white building is the cottage belonging to the site. Ibstock Rd junction to the far left*

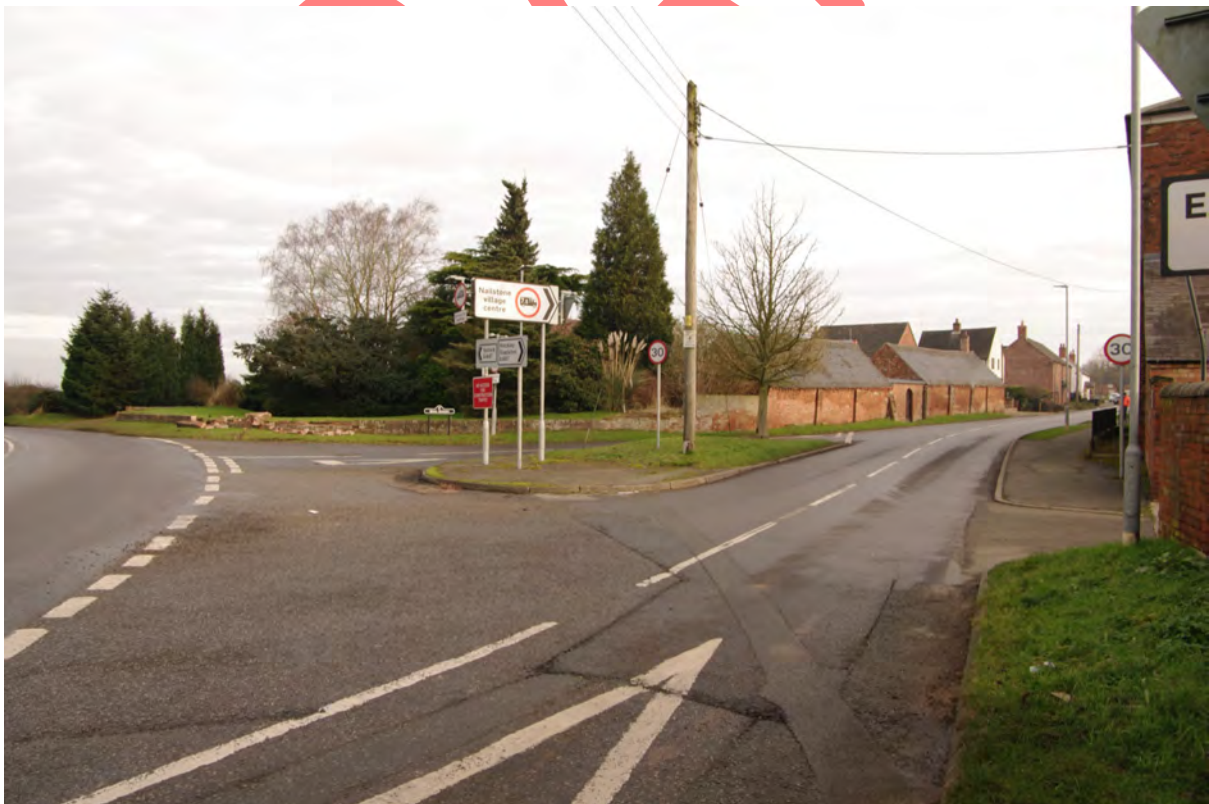
Figure 16: The site seen from the junction of Main Street and Ibstock Road  
*Looking north-east. A small area of possible earthworks is located within the trees and bushes in the centre of this picture*

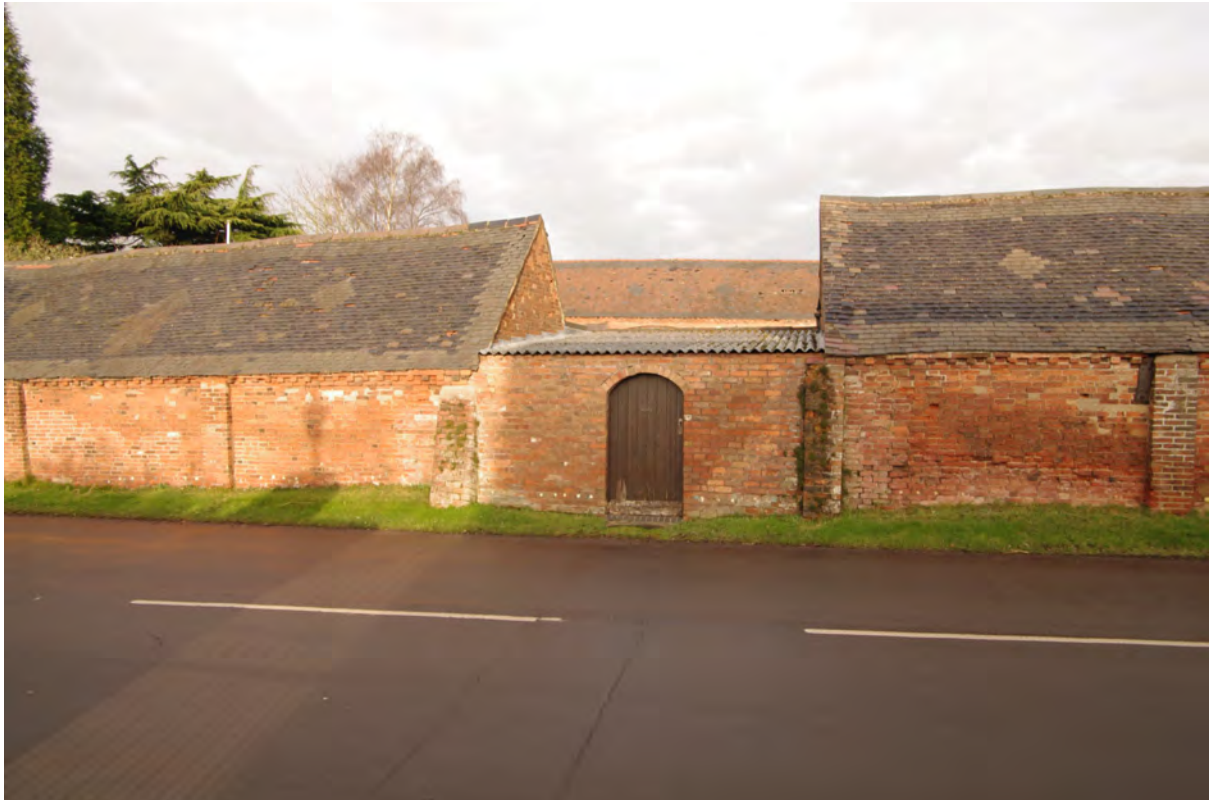
Figure 17: Area of roof to be raised between the barns on Main Street  
*Looking north-west*

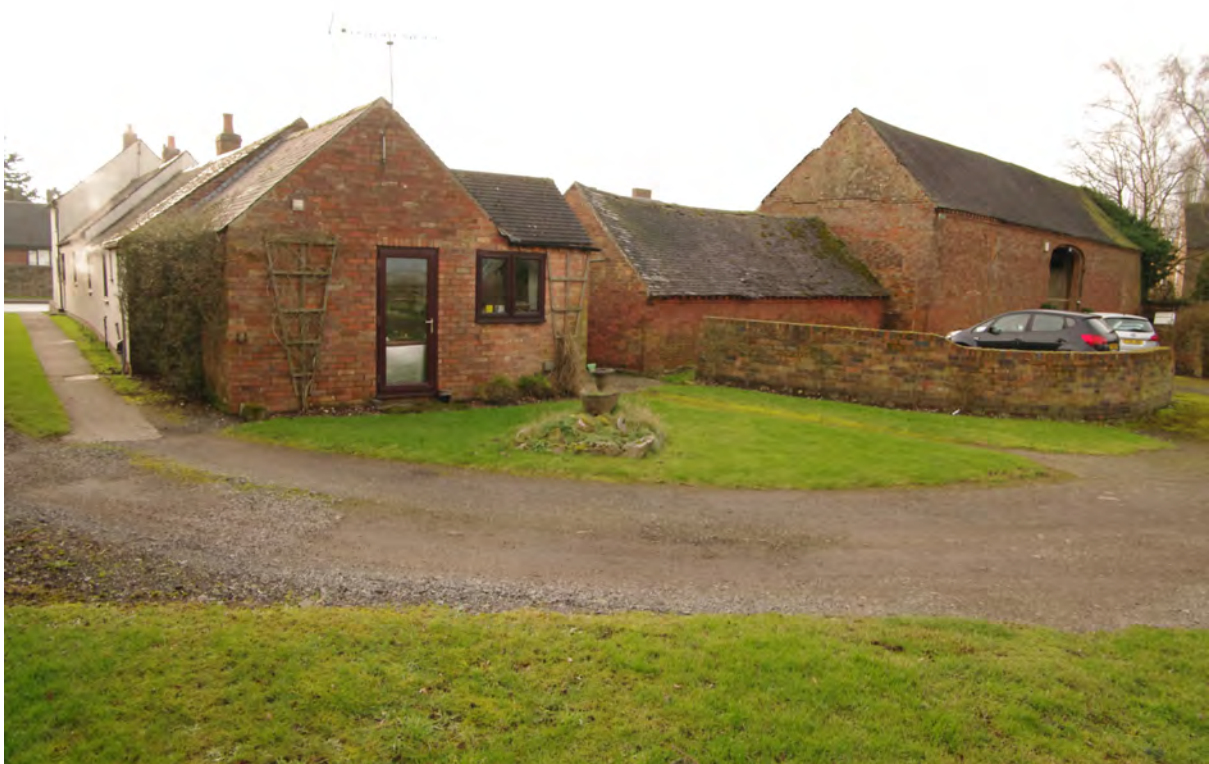
The north of the site forms the main vehicle access into the yard via the former double doorway of the threshing barn (Figure 18). To the north are two modern wooden stables which will be replaced by a new dwelling (Figure 19). North-east of the site is a new development which is first shown in the latest Google Earth image and which is still being built.

Figure 18: Northern side of the site  
*Looking south. The threshing barn and stable are on the right. The office annex is in the foreground on the left. Main Street can be seen on the far left down the track*

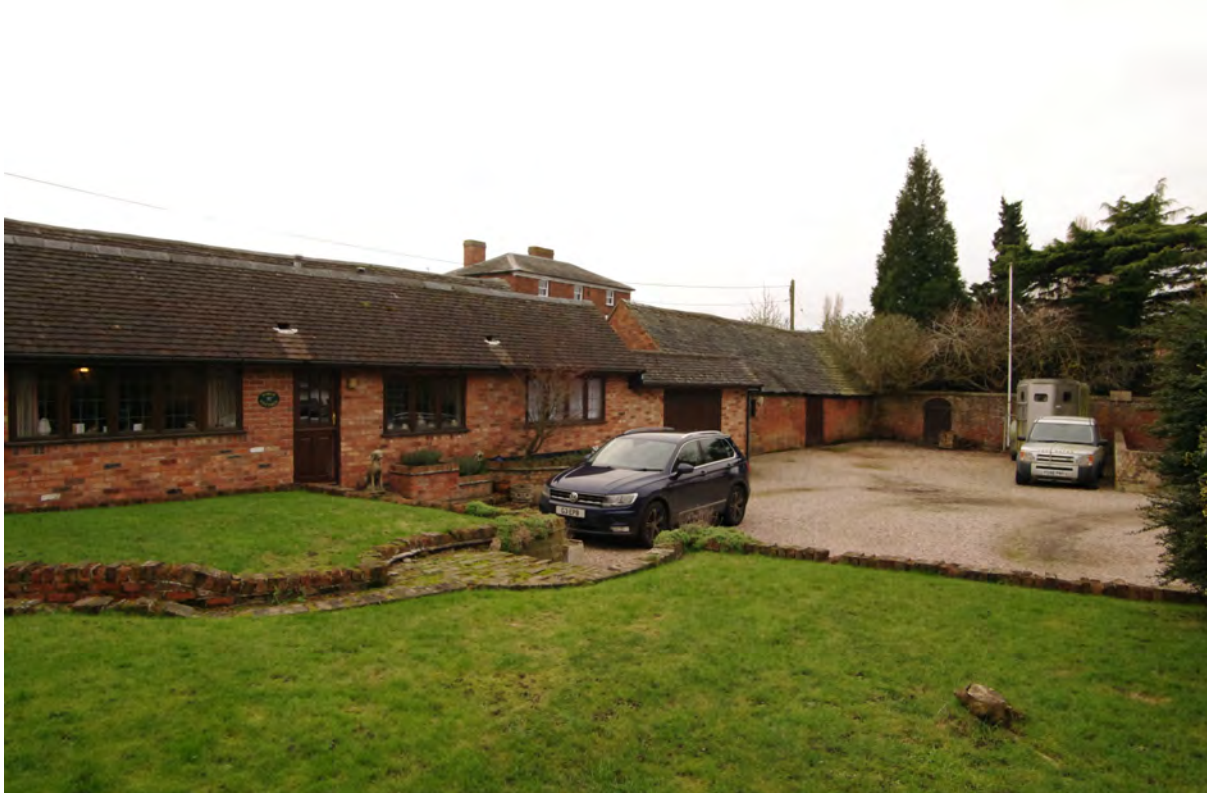
Figure 22: View of the yard looking south-west  
*Note the low roofline above the black car which will be raised. Main Street runs behind these buildings*

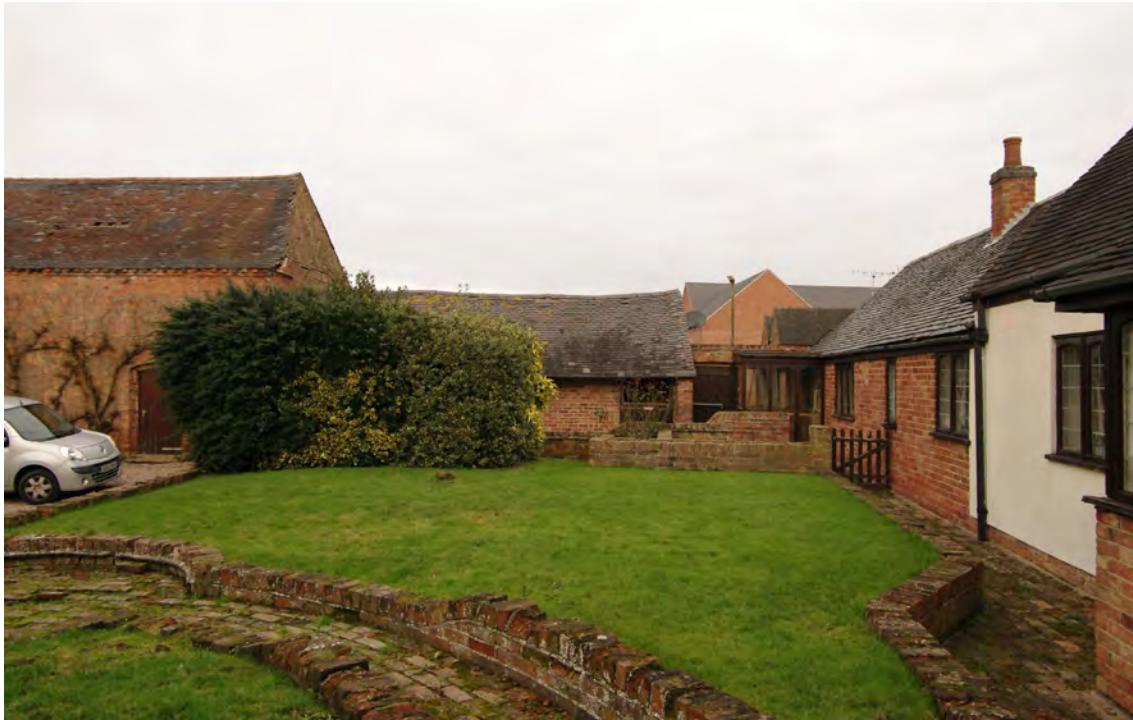
Figure 23: View of the yard looking NNE

*Threshing barn on the left with attached stable in the centre. The porch mid-right will be removed and the gabled roofline of the office annex behind this will be altered*

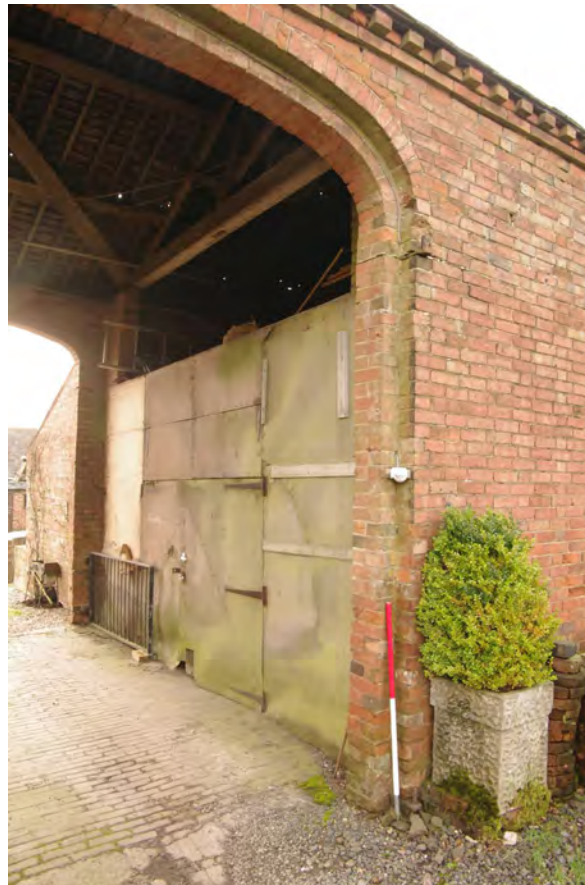
Figure 29: Threshing barn. North-west facing elevation doorway detail  
*Note the door pintles. 1m scale*

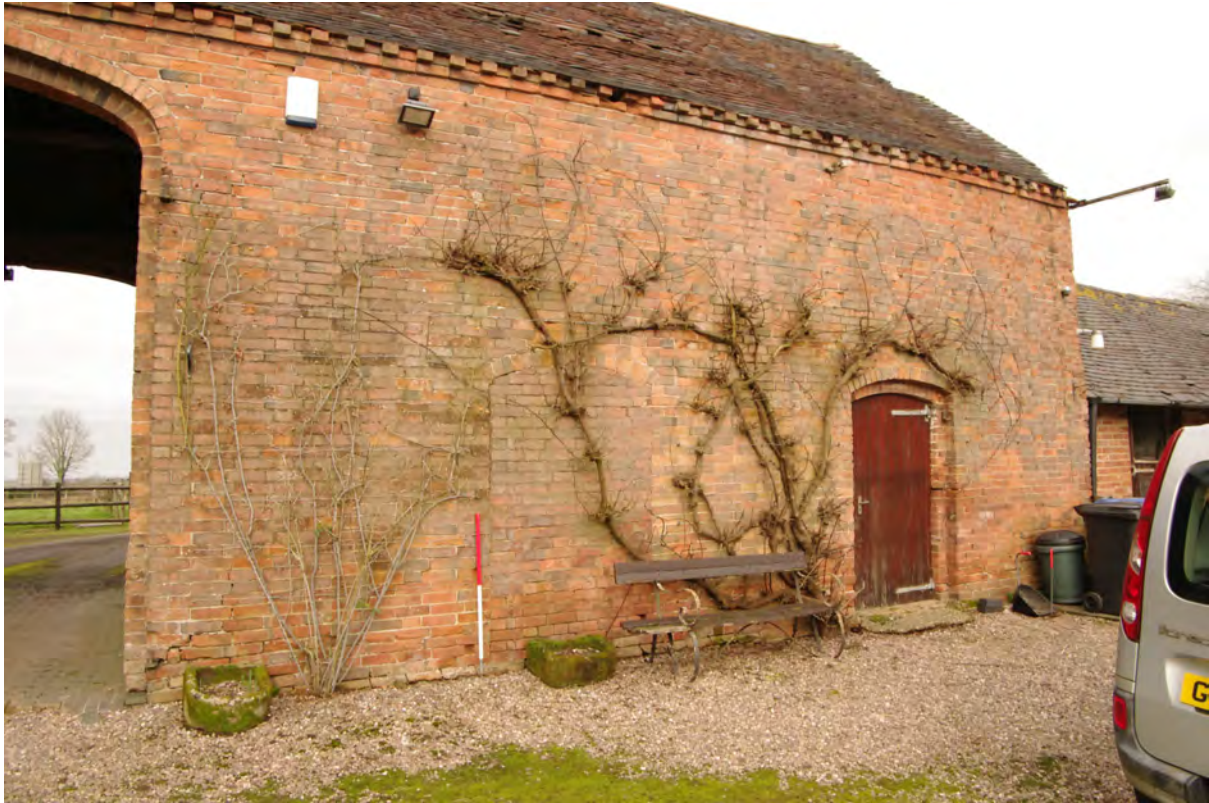
Figure 33: Threshing barn. Eastern end of the south-east facing elevation  
Looking north. 1m scale to the right of a blocked doorway

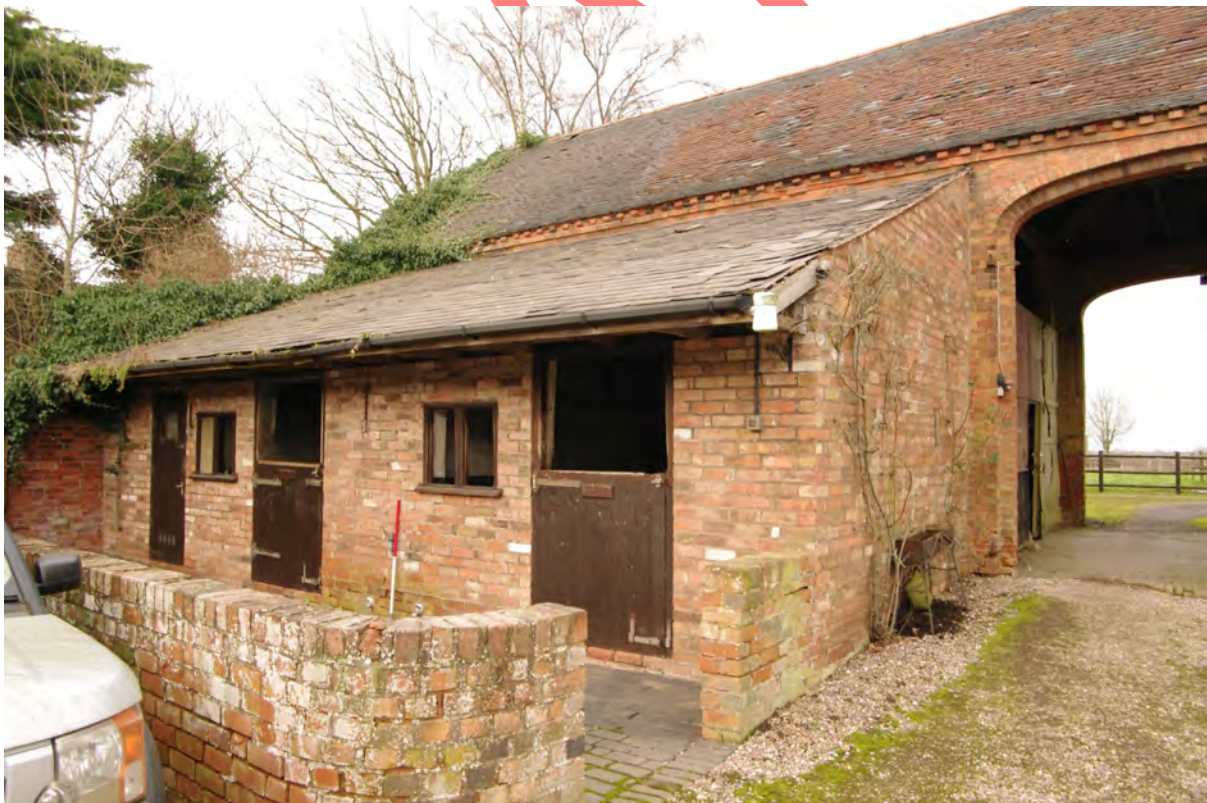
This stable forms a lean-to type structure built against the south-east facing elevation of the threshing barn (Figure 38). A small brick-paved and walled yard has been built in front of the stable (Figure 39). This is not shown on any maps so is likely to be fairly recent in date. The north-east facing elevation of the stable has no openings, blocked or otherwise (Figure 40). The south-west facing elevation is obscured by vegetation. The building contains two loose boxes and a small store room at the western end. The store room has brick dividing walls (Figure 41). Both loose boxes have the same layout and the posts supporting the purlin lean-

Figure 38: Stable built against the south-east facing elevation of the threshing barn  
*Looking north-west. 1m scale*

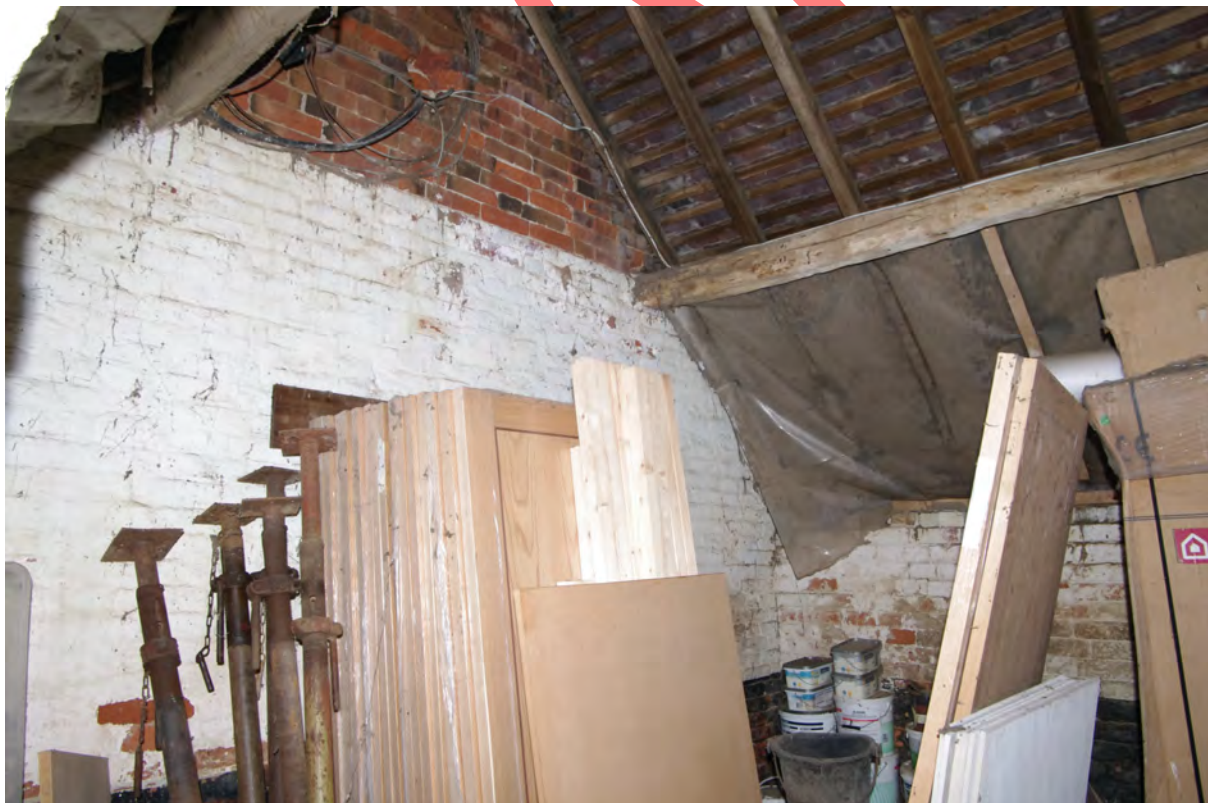
Internally, the north-eastern stable building has been divided into three similarly sized loose boxes which have concrete breeze-block dividing walls but no skinning blockwork on the outer walls (Figure 48). The roof is supported by a king post with the purlins resting on the backs of the common rafters and is typical of agricultural buildings from the second half of the 19th century in this region (Figure 49).

Figure 48: North-eastern stable, end wall with the threshing barn  
Looking north-west

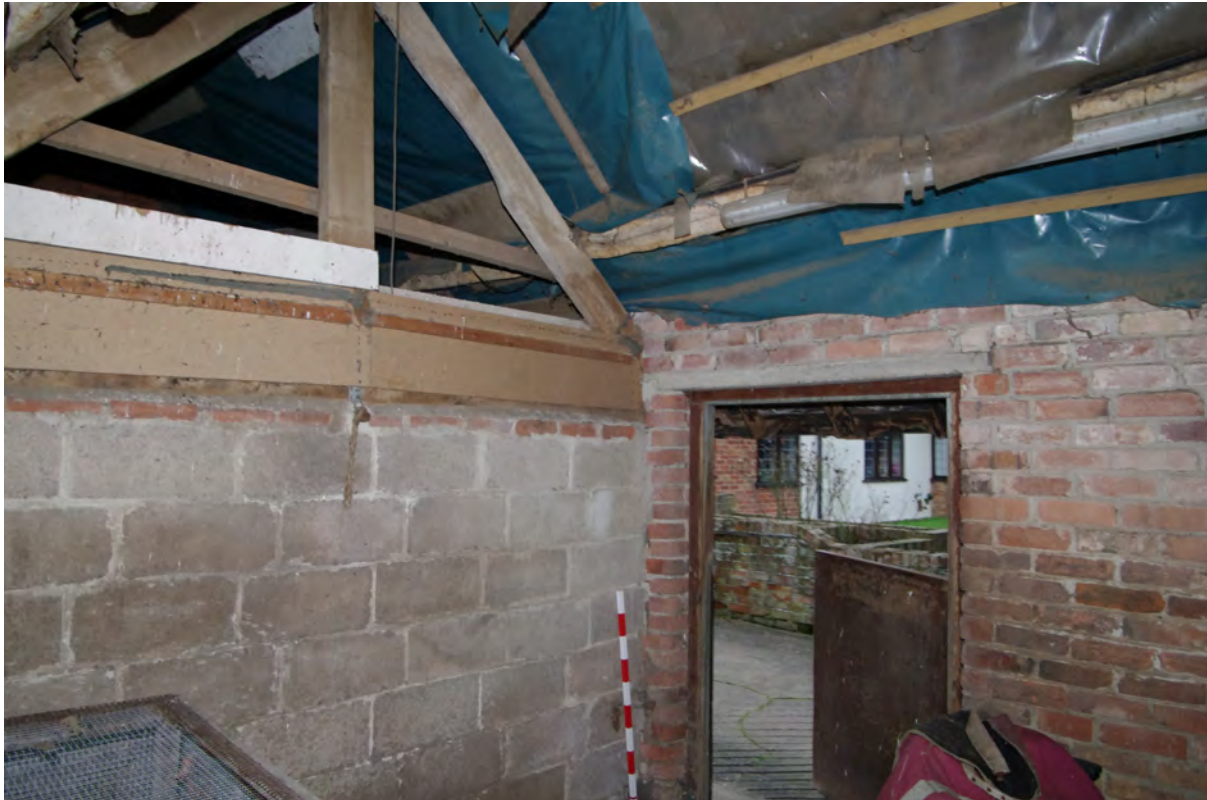
Figure 49: North-eastern stable, dividing wall and roof structure  
*Looking east. 1m scale*

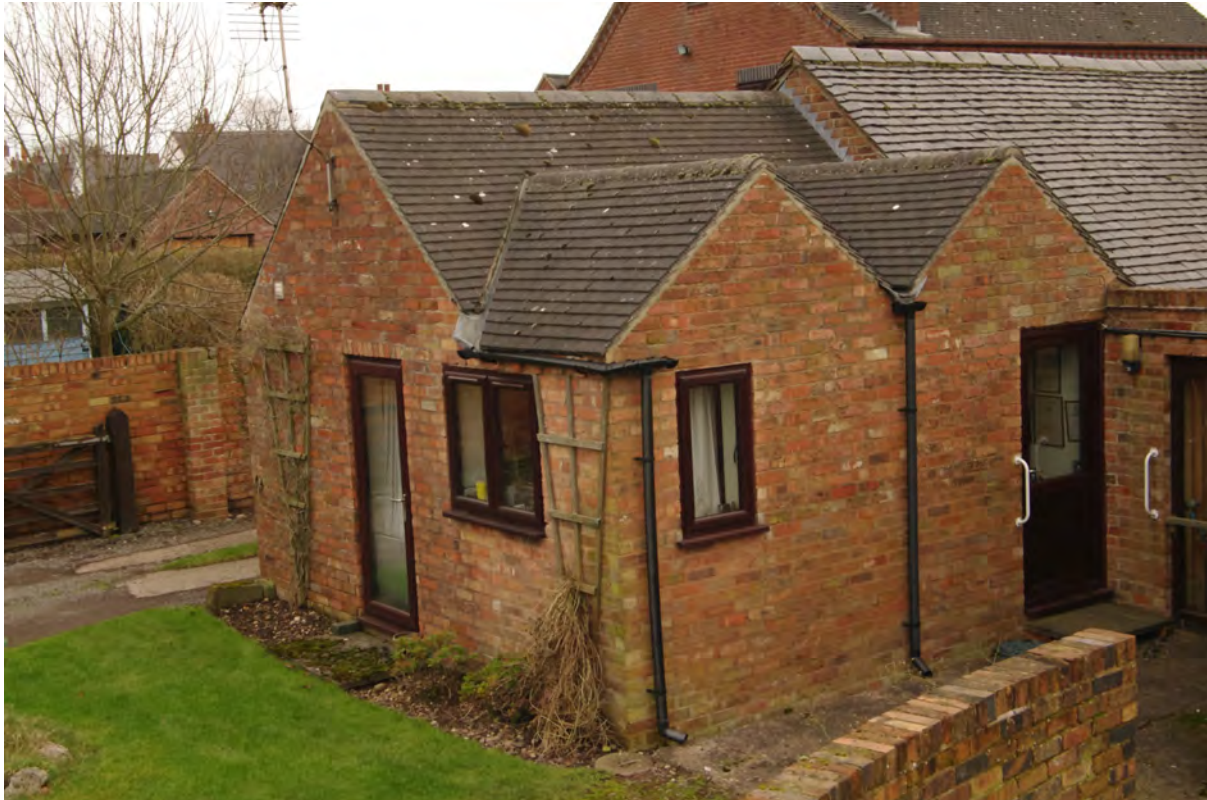
The office annex has been built against the north-western end of the range of buildings running up the entrance trackway from Main Street (see Figure 18 and Figure 50). The proposals are to modify the internal layout and roofline of this building which is currently connected to the dwelling to the south-east. The building is brick-built and has a tiled roof with two small gables projecting to the south-west. The roof of the office on the north-eastern side has a slate covering. All of the window and doors are modern.

Figure 50: The office annex  
*Looking south-east*

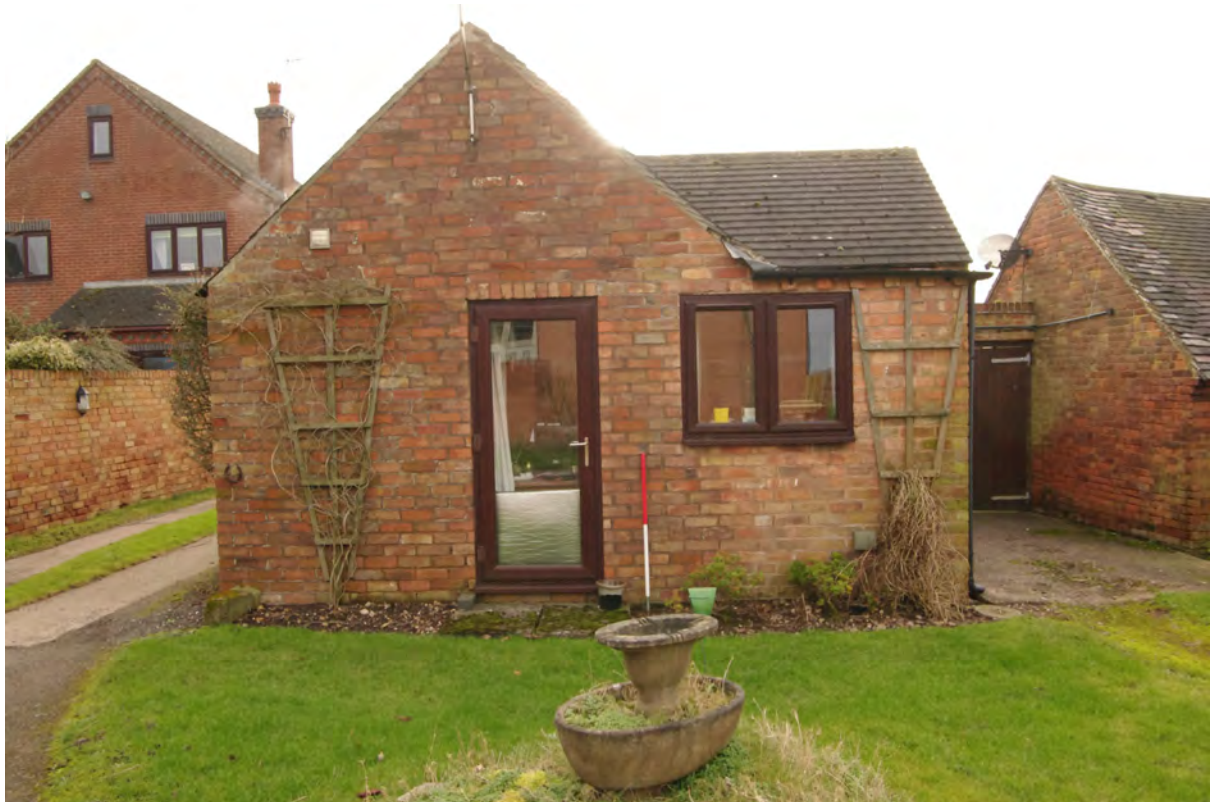
The north-east facing elevation is covered with thick vegetation but it is possible to see a single-width doorway and window (Figure 51). The window lights a small toilet and shower room. The north-west facing elevation has a small window and doorway (Figure 52). Another window and door are located on the south-west facing elevation (Figure 53). Attached to the south-west corner of the office annex is a modern timber and glass porch which will be removed during the proposed works (Figure 54).

Figure 52: North-west facing elevation of the office annex  
Looking south-east. 1m scale. The north-eastern stable building is on the right

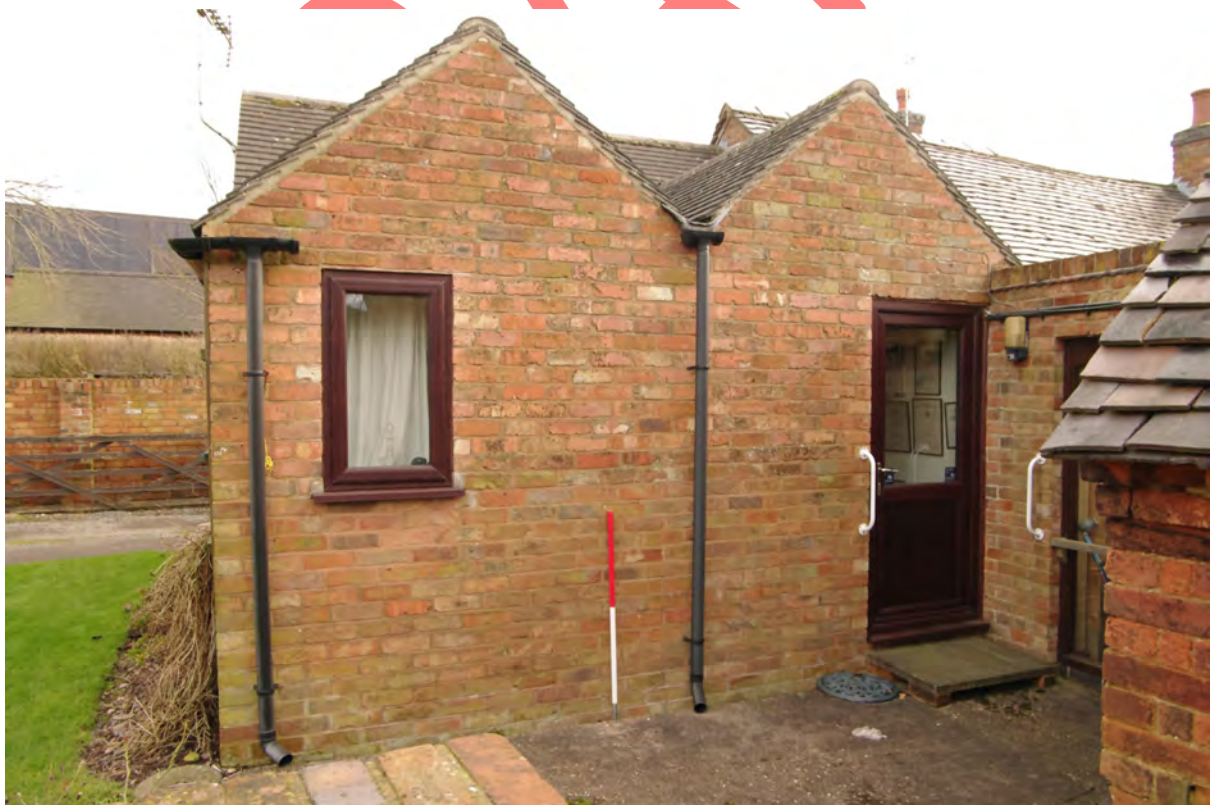
Figure 53: South-west facing elevation of the office annex  
Looking north-east. 1m scale

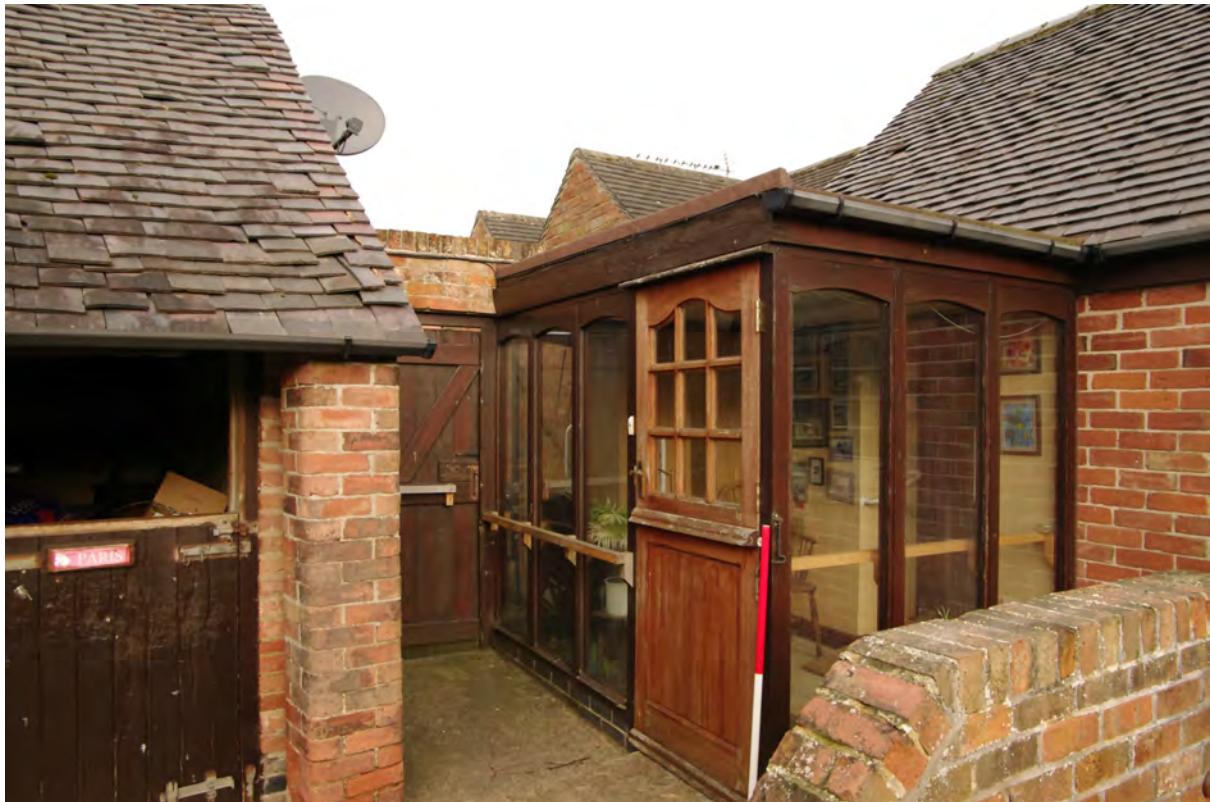
Figure 54: Porch attached to the south-west corner of the office annex  
Looking north-east. 1m scale. The small gables of the office can be seen above the porch. The corner of the north east stable is on the left

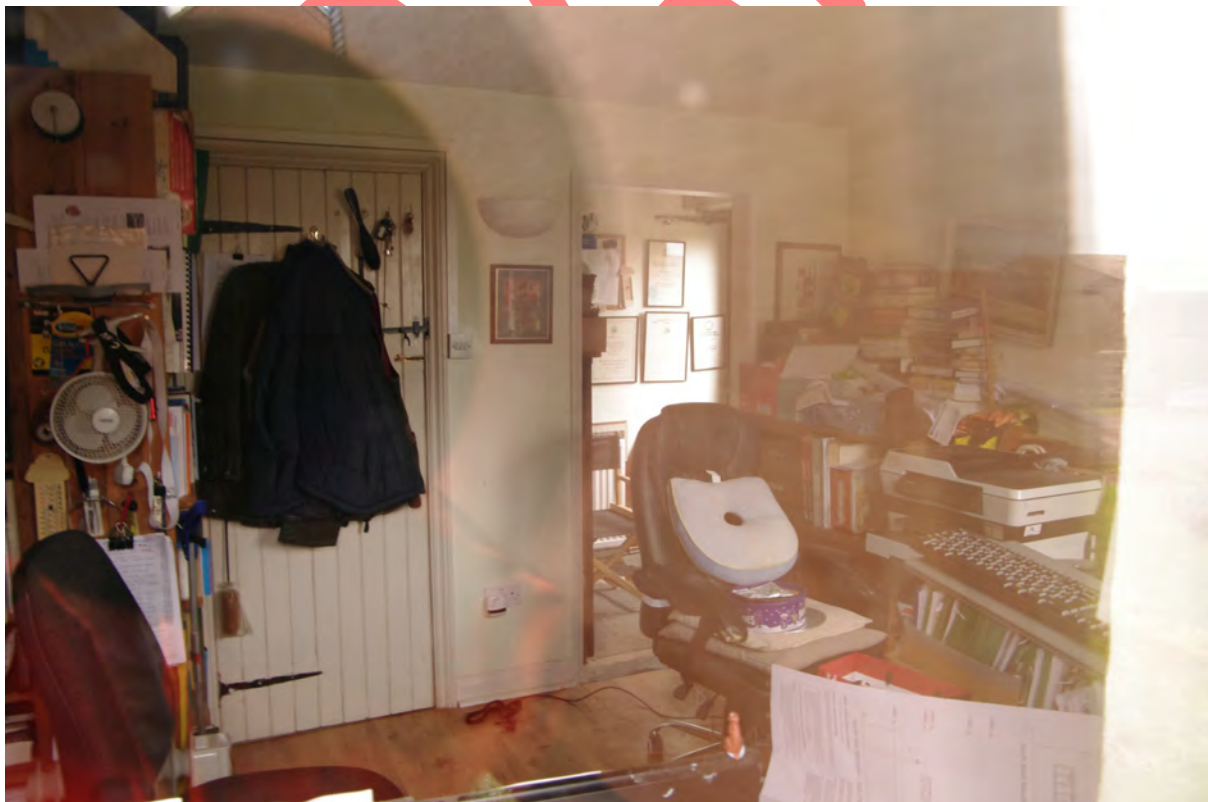
Internally, the office annex is modern with plastered walls and ceiling forming a small office and bathroom (Figure 55). At the time of the survey this was in use as part of the dwelling to the south-east and was only inspected through the windows. No brickwork or structural components were visible.

Figure 55: Inside the office annex  
Looking south-east. The doorway on the left leads to the small bathroom and the dwelling beyond
