## Barn Survey Document

**Folly Farm**

**Kirkby Mallory, LE9 7QL**

**Date:** 24<sup>th</sup> November 2025

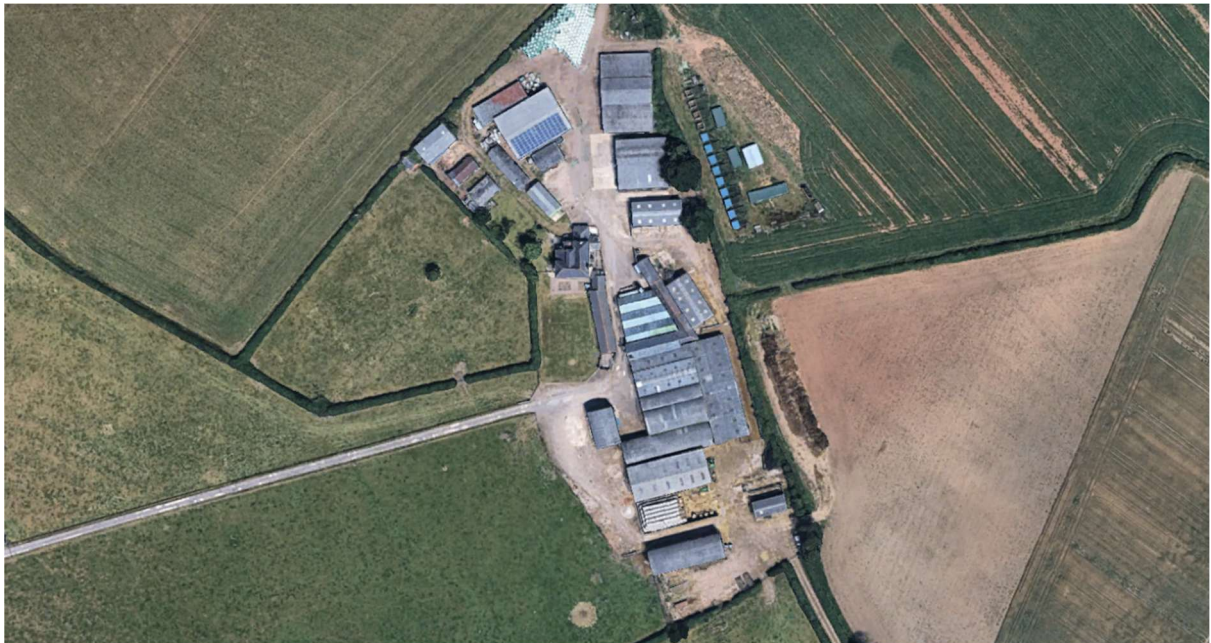
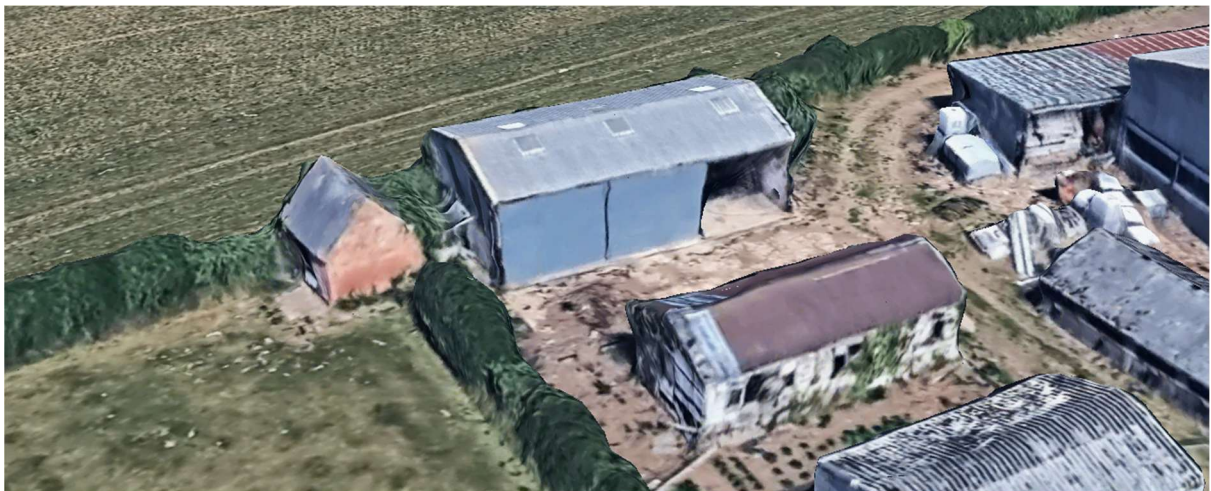
- 2.1 The barn is verified as a steel frame structure, located at Folly Farm on a relatively level plot with yard levels corresponding to floor levels. The barn faces east.

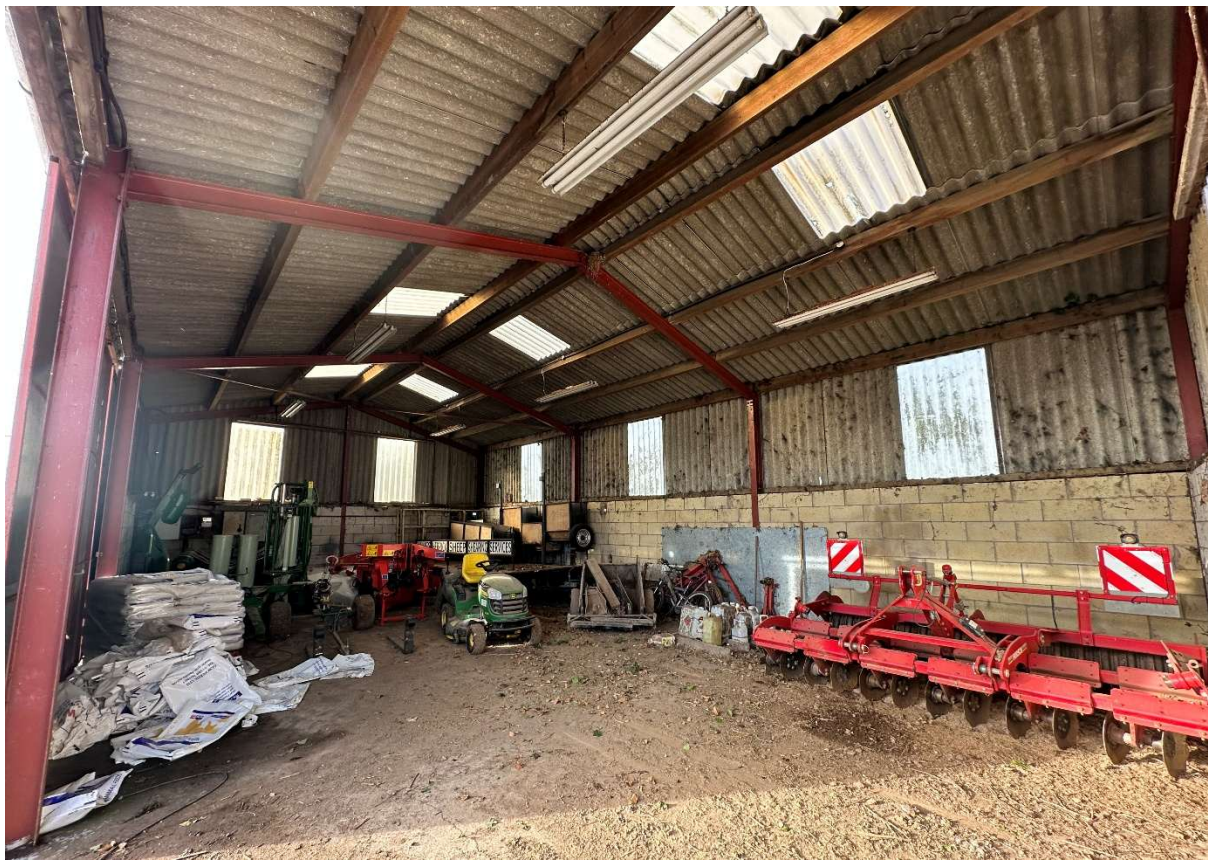
- 3.9 The roof comprises of 75x200mm purlins of which are 4 each side of the roof to which the corrugated cement fibre sheets are attached to the steel frames. The span of the purlin is 4.542m and the spacing of the purlins appears to be 2.23m.
