## **BUILDING CONDITION SURVEY**

**FORMER PUBLIC HOUSE**

**HIGHAM ON THE HILL**

**AUGUST 2019**

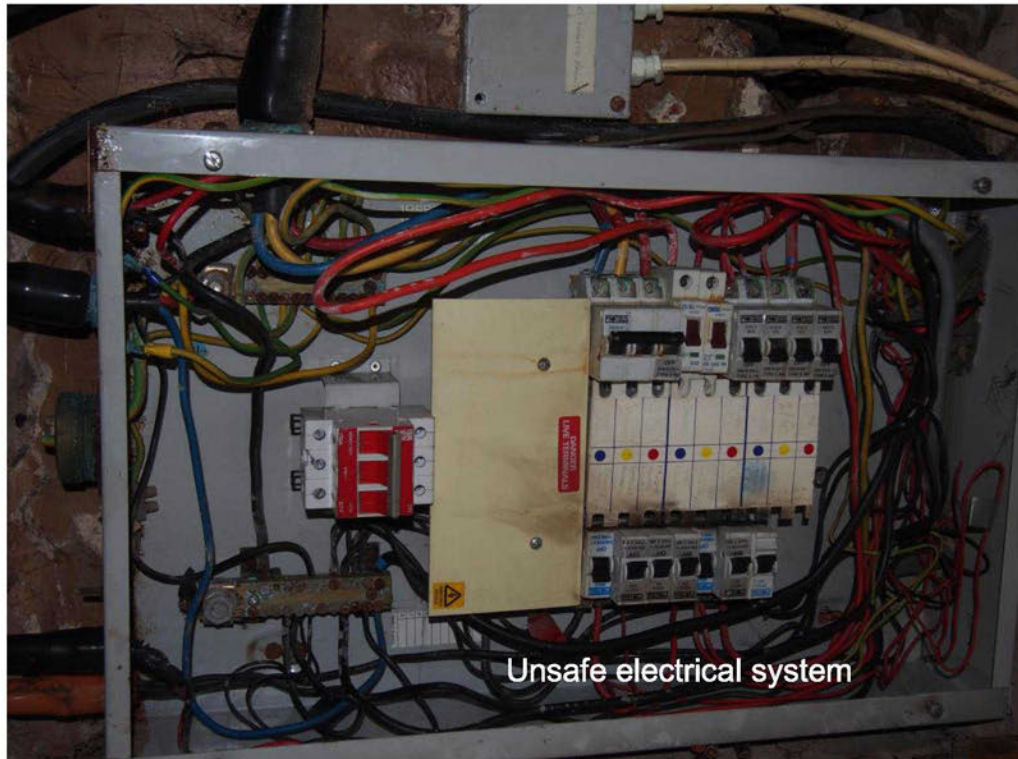
I saw no evidence of any recent electrical test certificate and it is advised that due to the additional works required a complete rewire of the property is required.
