## **PHASE 1 BAT & NESTING BIRD SURVEY**

**Poplars Farm, Sutton Lane, Dadlington,  
Nuneaton, Warwickshire, CV13 6JA**

20<sup>th</sup> October 2025

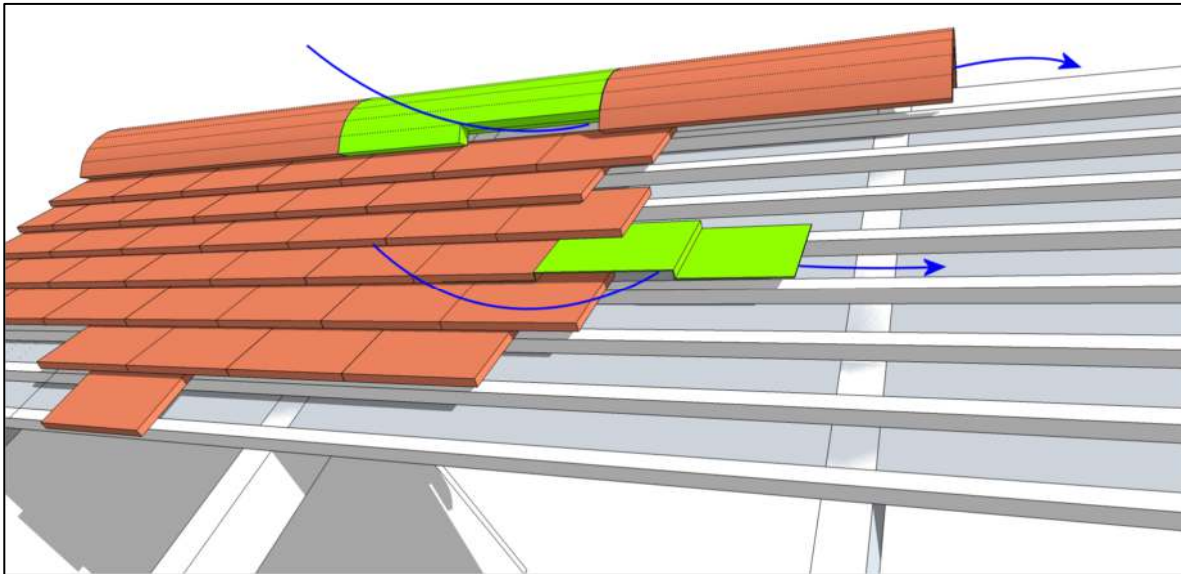
Figure 3. Access to the tile/lining cavity via a modified ridge tile and a lead saddle

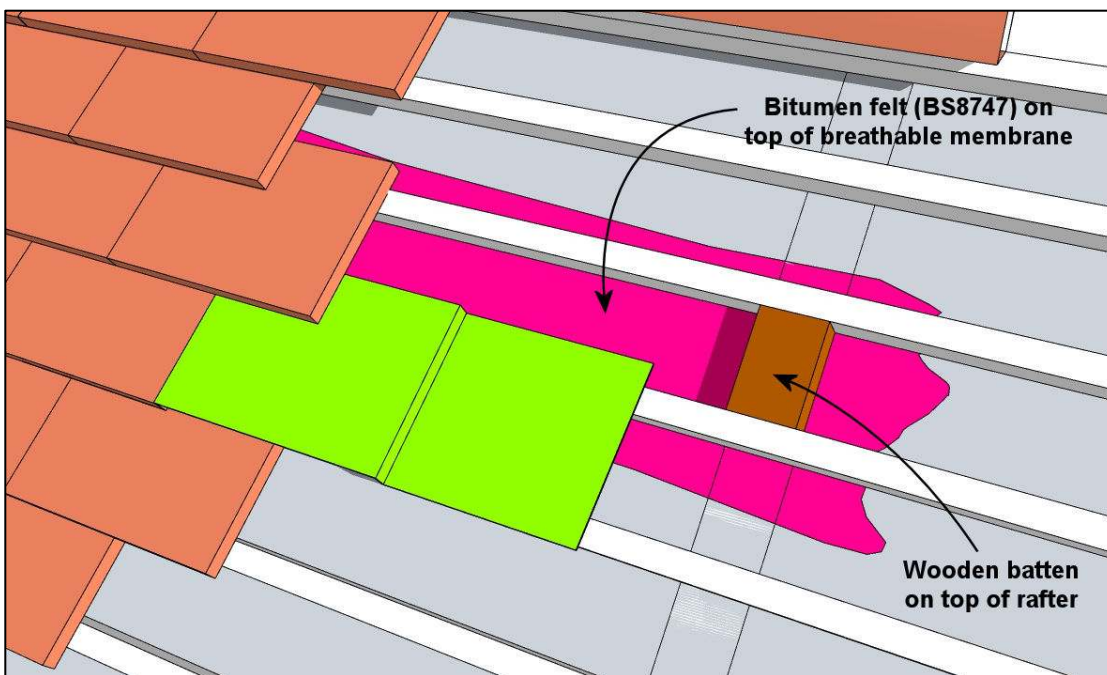
Figure 4. Access to the tile/lining cavity showing bitumen felt and wooden batten to prevent bats moving along the roof

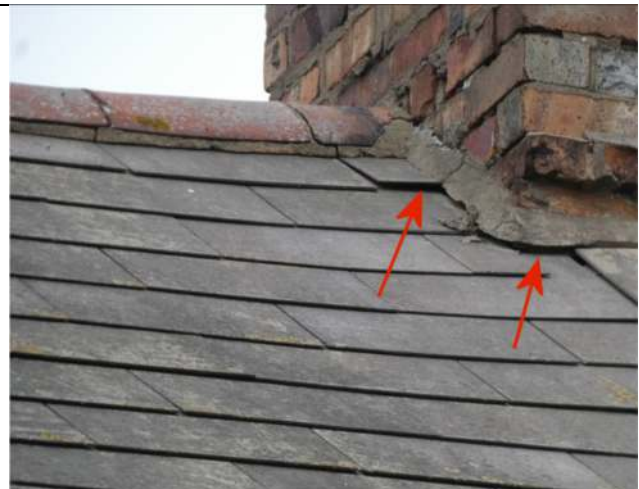
- Some openings under a slate and mortar at the base of the chimney at the south-east end of the main part of the building (Photograph 12).
- A slipped slate at the north-west edge of the two-storey extension to the north-west (Photograph 13).
- Possible openings under two ridge tiles on the north-east facing roof pitch of the main part of the building (Photographs 14 and 15). However, there may be mortar further back under the tiles, preventing access.

Photograph 12. Example of the sealed lead flashing at the base of the chimney on the Farmhouse

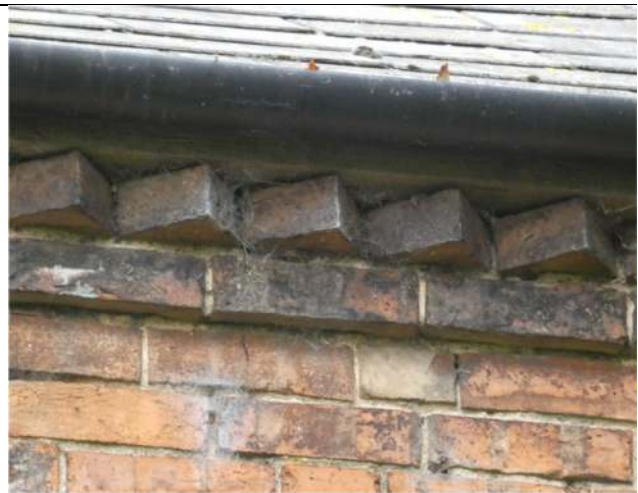
Most of the area around the corbelling at the top of the walls is sealed (e.g. Photograph 16) except for an opening at the south-east end on the south-west side of the Farmhouse (Photograph 17) and an opening on the two-storey section at the north-west end of the building (Photograph 18).

Photograph 16. Example of the corbelling on the Farmhouse

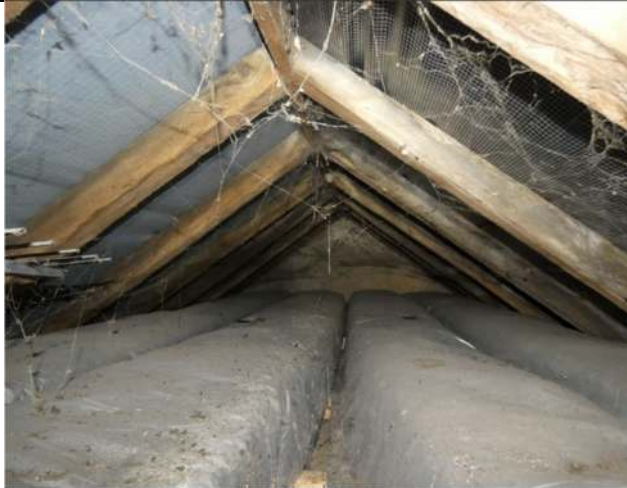
In the north-west half of the main part of the Farmhouse is a section of enclosed roof void of approximately 1 m in height (Photograph 19). There was no evidence of bats within this roof void and dense cobwebs, which in places hang down to the insulation on the floor, indicates that bats

Photograph 19. The section of enclosed roof void in the north-west half of the main part of the Farmhouse (view to north-west)

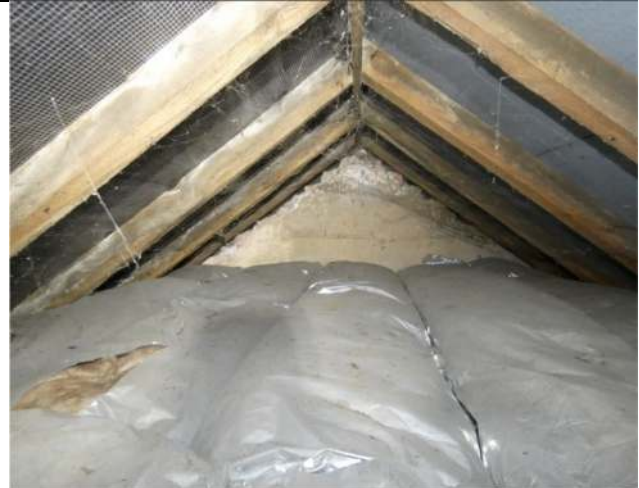
have not been present for some time, if at all. In the south-west half of the main part of the Farmhouse, there is a similar, but smaller, section of enclosed roof void (Photograph 20), which leads into the section of roof void in the attic room, as the ceiling has been removed (Photographs 21 and 22). At the edge of the enclosed section of roof void, where it opens into the room, there were approximately 8 very old, medium-sized bat droppings amongst cobwebs and dust (Photograph 23).

Photograph 20. The section enclosed roof void in the south-east half of the main part of the Farmhouse (view to north-west)

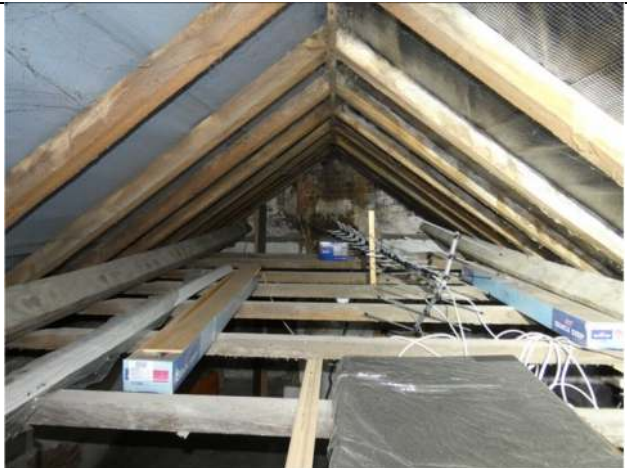
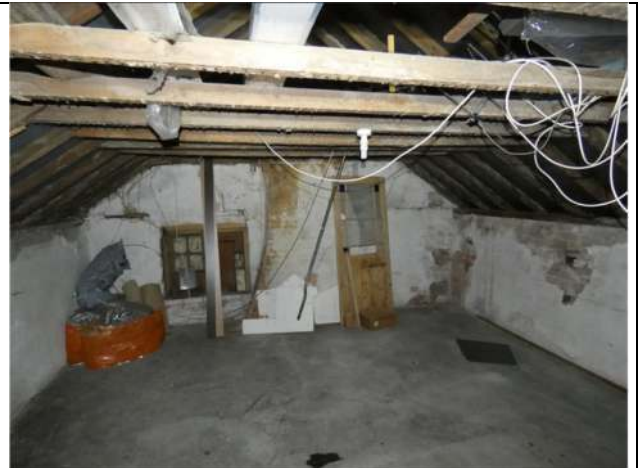
Photograph 21. The roof void in the south-east half of the main part of the Farmhouse (view to south-east)

Photograph 22. The attic room in the south-east half of the main part of the Farmhouse (view to south-east)

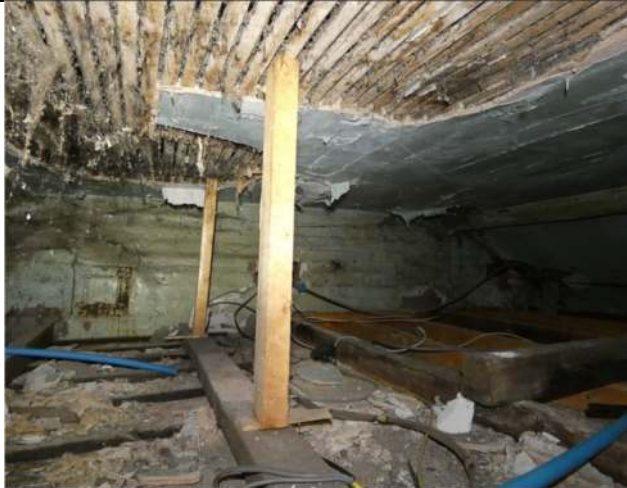
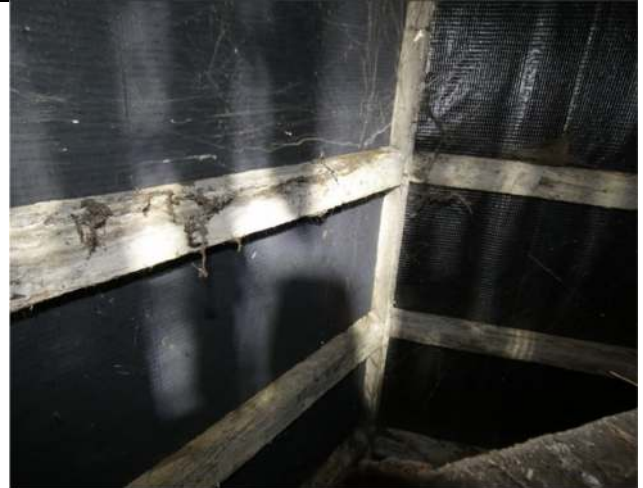
There is a section of enclosed roof void in the single-storey extension at the north-west end of the Farmhouse, which is divided by the old lath ceiling (Photographs 25 and 26). There was no evidence of bats within this part of the building.

Photograph 25. The section of enclosed roof void within the single-storey section at the north-west end of the Farmhouse (below the laths)

Photograph 26. The section of enclosed roof void within the single-storey section at the north-west end of the Farmhouse (above the laths)

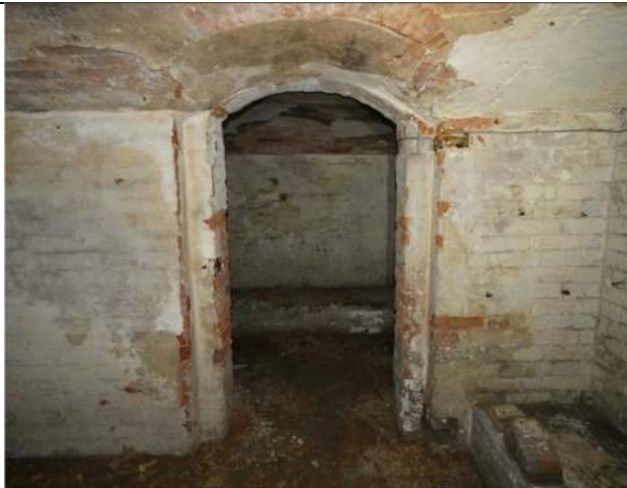
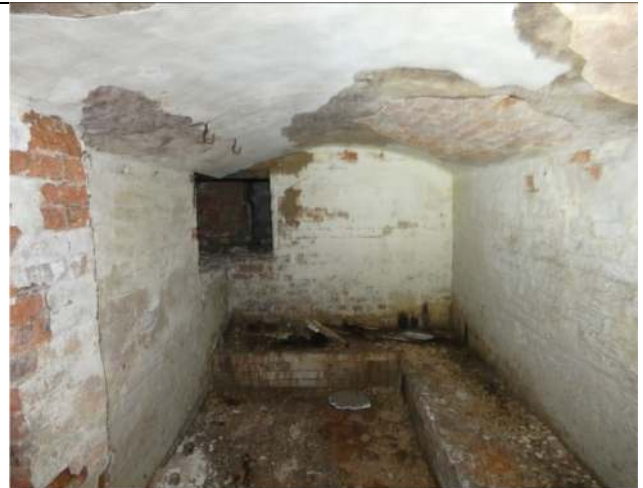
There is a relatively large cellar within the main part of the Farmhouse, which would be ideal for hibernation (Photographs 27 and 28). However, there is no suitable access for bats to this part of the building.

Photograph 27. Example of part of the cellar within the Farmhouse

Photograph 28. Further example of part of the cellar within the Farmhouse

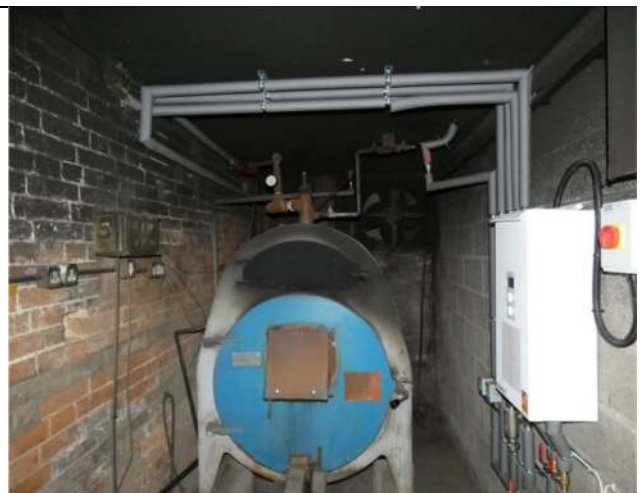
There was no evidence of bats in the boiler room (Photograph 40).

Photograph 40. The interior of the boiler room within The Granary

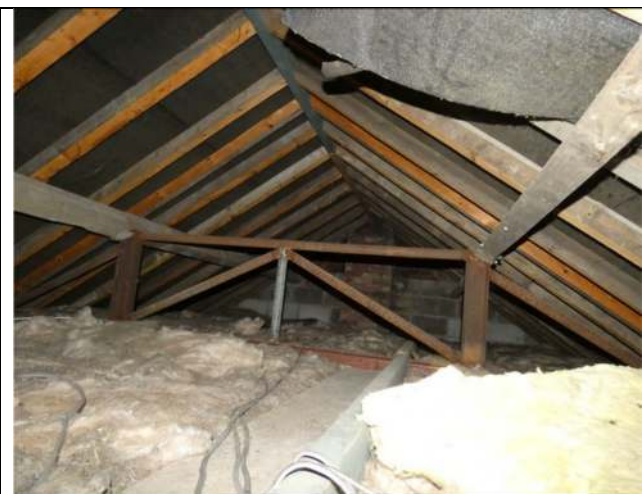
Within the single-storey extension to the side, there is a section of enclosed roof void (Photograph 41). Such roof voids are suitable for those species of bat that require a large flying area, such as brown long-eared bats. From the loft hatch there did not appear to be any evidence of bats. However, it was not possible to fully inspect the roof void as there was an active wasp's nest near an opening in the roof (Photograph 42).

Photograph 41. The enclosed roof void within the single-storey section at the north-east end of The Granary

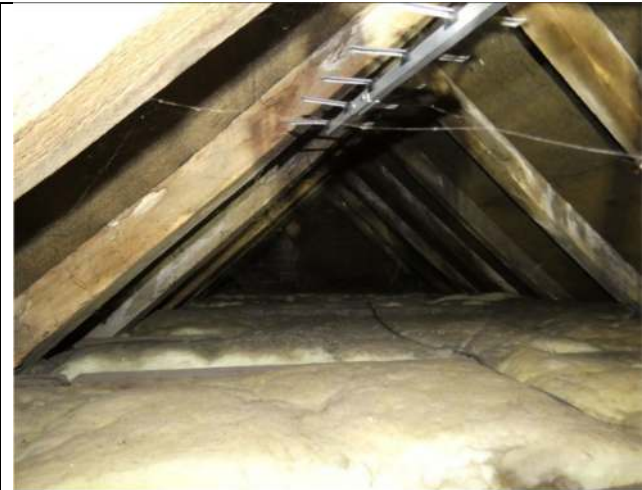
an access hatch in the wall of the bathroom, and this did not contain any evidence of use by bats (Photograph 43). However, it was not possible to gain access to the other two sections of enclosed roof void (e.g. Photograph 44).

Photograph 43. Part of the enclosed roof void within the main part of The Granary

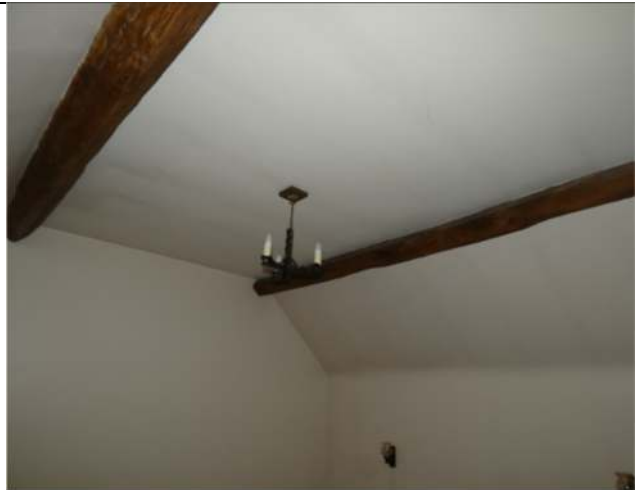
Photograph 44. The part raked ceiling within The Granary

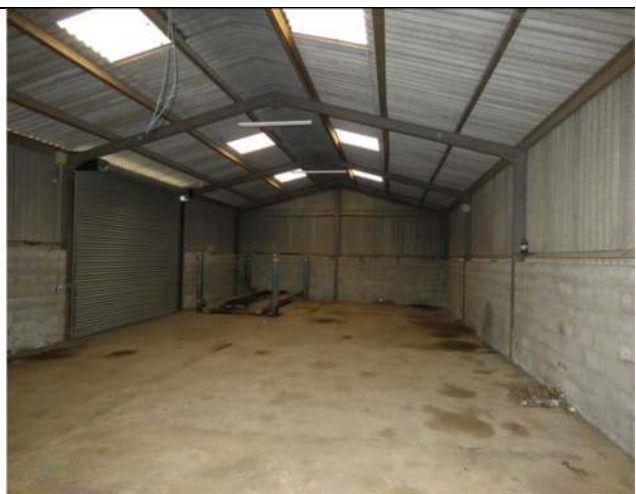
Bats could possibly perch on the metal frame of the roof, although there was no evidence of this (Photograph 48). The interior of the barn is well lit during the day, which is likely to deter bats from using it during this period.

Photograph 48. The interior of Barn 3

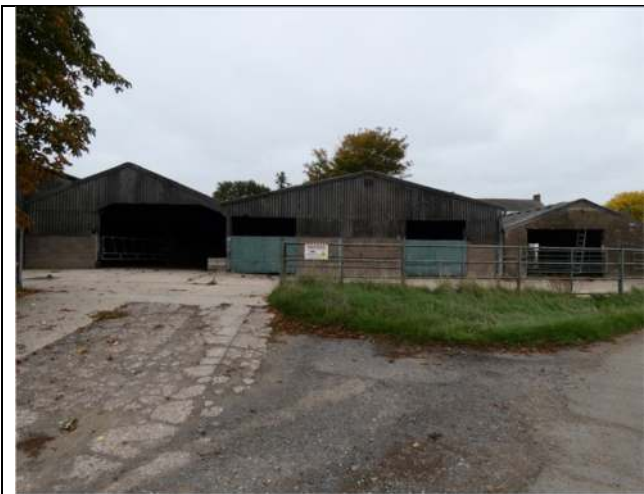
Photograph 51. The south-west elevations of Barns 5-7

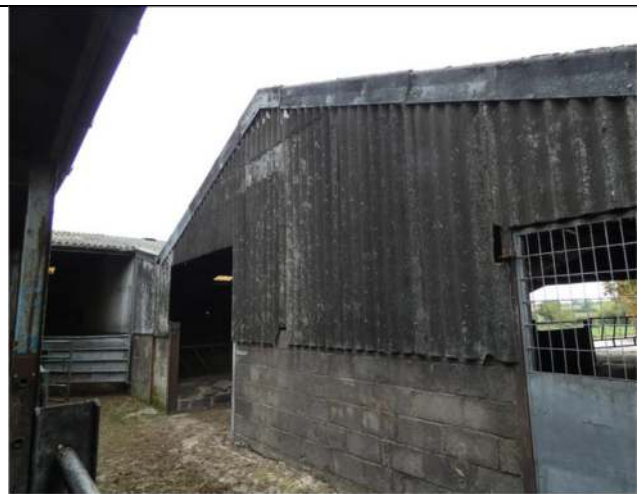
Photograph 52. The north-east elevation of Barn 6 and Barn 7

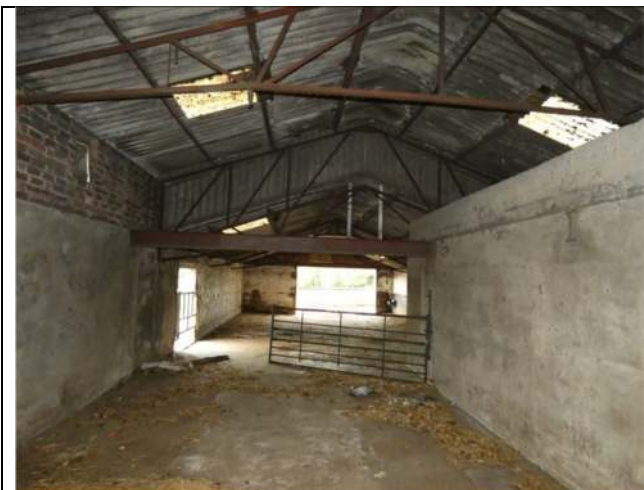
Photograph 53. The interior of Barn 5 (view to south-west)

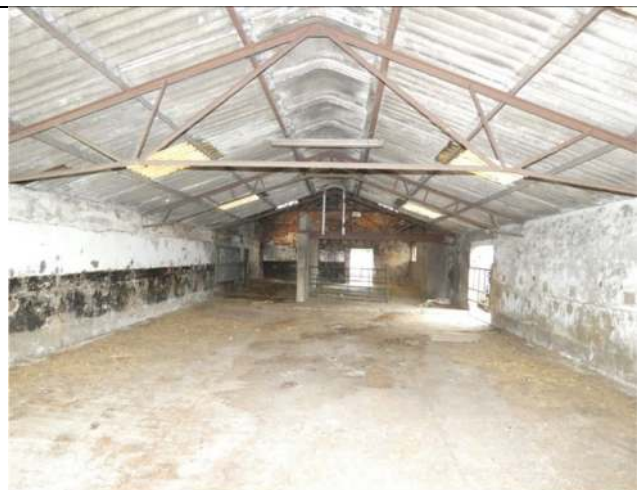
Photograph 54. The interior of Barn 5 (view to north-east)

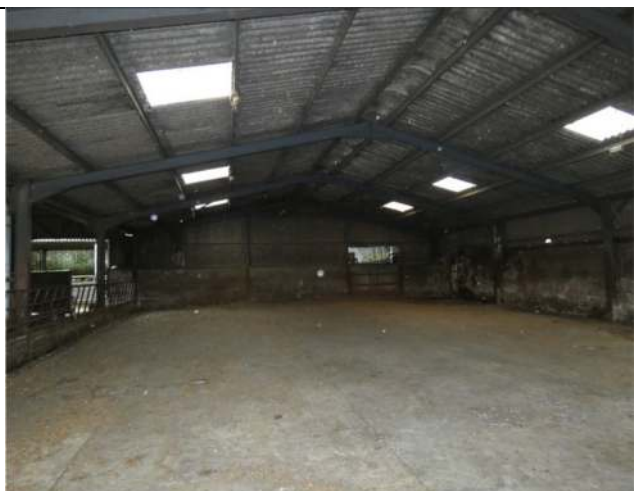
Photograph 57. The interior of Barn 6

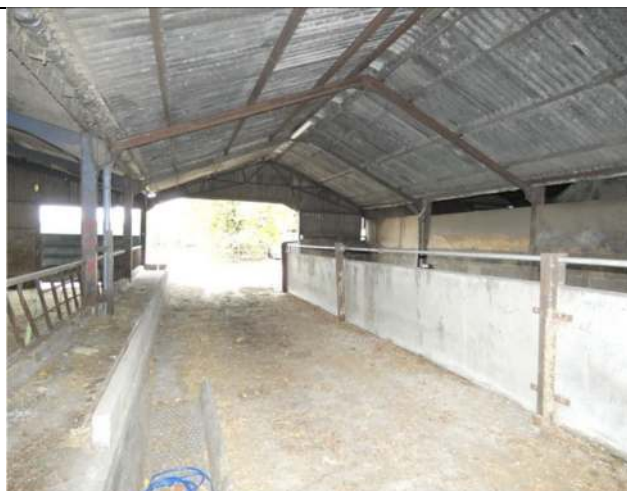
Photograph 58. The interior of Barn 7

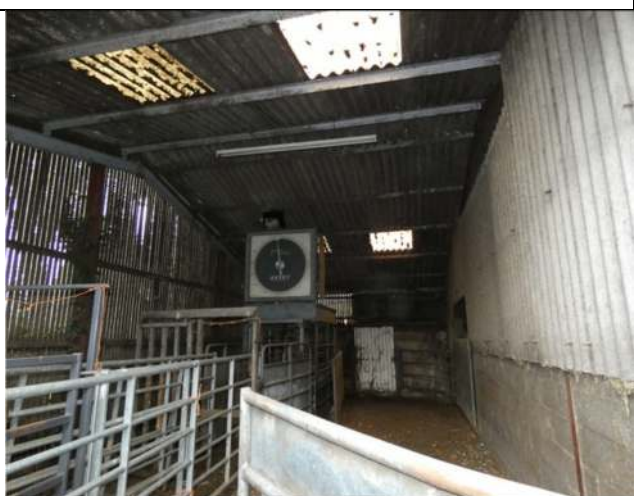
Photograph 59. The interior of Barn 17

The proposed work to Barns 3, 5, 8 and 17 will result in the loss of wren and pigeon nesting. In Britain, all wild birds are granted legal protection under the Wildlife & Countryside Act 1981 (as amended), the Bern Convention and the EC Birds Directive. The legislation protects the birds and their eggs and nests while being built or in use. This protection makes it an offence to intentionally kill, injure, take or have in possession any wild bird or egg. It is also an offence to intentionally damage or destroy the nest of any wild bird while it is being built or in use. Therefore, the following must be adhered to:

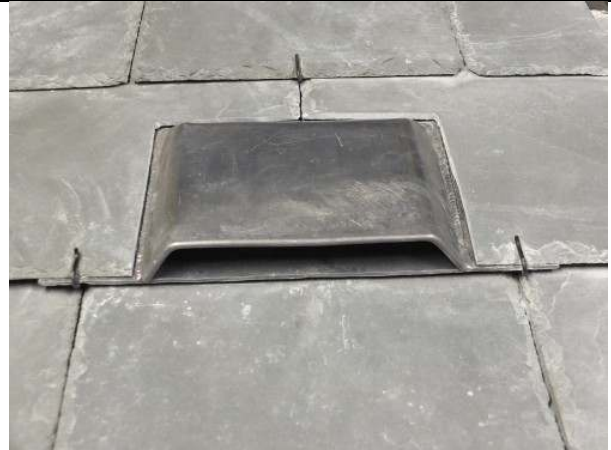
Photograph 64. Example of a bat access slate

- Roofing material will be removed carefully by hand under the supervision of a licensed ecologist.
- If evidence of a bat roost is discovered during slate/tile removal, the roost will be reinstated in accordance with the ecologist's instructions. Reinstating roosts may involve providing access to the cavities between the slates/tiles, lining and battens (Figure 3; Photograph 64). A bitumastic lining (e.g. 1F Roofers (BS8747) Felt) will be laid over the modern breathable membrane within these cavities to prevent bats from becoming entangled in the fibres of the breathable membrane (Figure 4). To prevent bats from moving onto the breathable membrane at the end of the cavities, a block of wood will be installed between the battens to create a sealed roosting area.

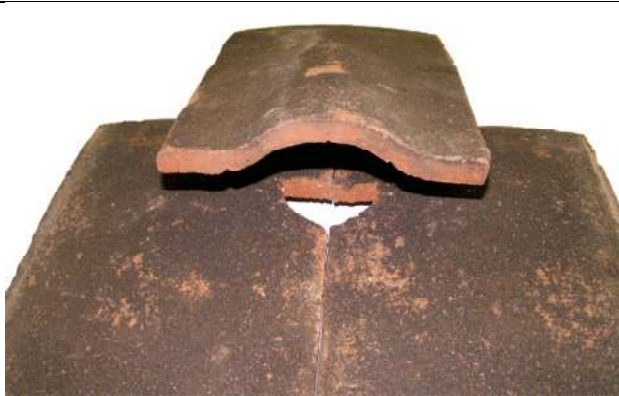
Photograph 65. Example of bat access tile
