## **ARBORICULTURAL SURVEY**

**ARGUILE PLACE  
HINCKLEY  
LEICESTERSHIRE  
LE10 0GH**

**Prepared for  
Midland Property Management Ltd  
Whitehouse Court  
New Road  
Featherstone  
Nr Wolverhampton  
Staffordshire  
WV10 7NW**

**7<sup>th</sup> October 2024**

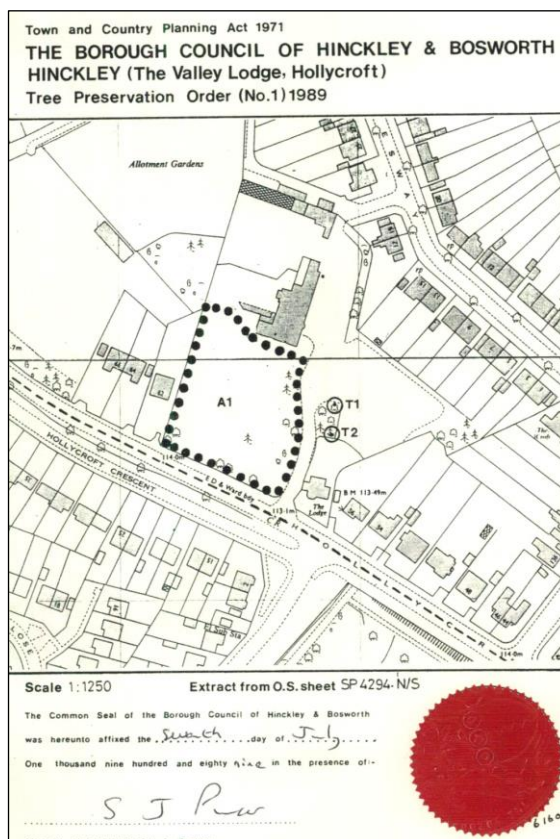
**Figure 1: Copy of the tree preservation order plan**

- 2.1** The subject trees are protected by the Hinckley and Bosworth Borough Council (Hinckley (The Valley Lodge, Hollycroft) Tree Preservation Order (No.1), which was made in 1989. This is an area order which predates the redevelopment of the site and covers all of the trees that were growing within the grounds to the front of Valley Lodge when it was made. Accordingly, with the exception of the removal of dead wood, it will be necessary to obtain the written consent of the Borough Council prior to any works being undertaken to these.

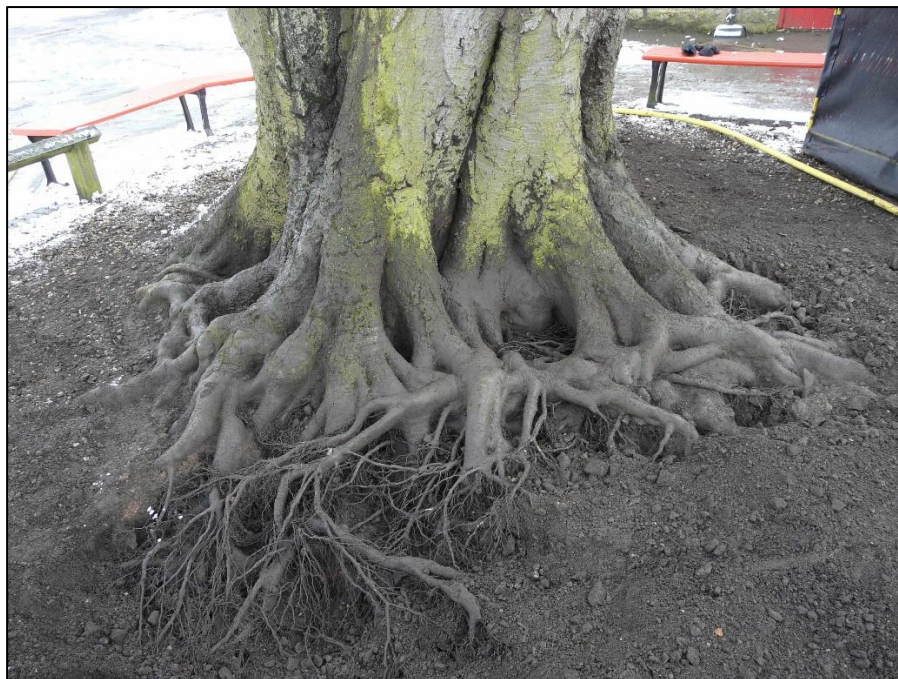
**Photograph 10: Example of an air spade investigation being undertaken on a beech tree colonised by the Giant polypore and a further fungus**

**5.7.3** Given its proximity to both the adjacent house and the road, I recommend that further investigations be undertaken utilising an air spade operated by a specialist contractor to expose the underside of the buttress roots to assess the extent of decay associated with the fungal colonisation and its likely impact on the immediate and longer term stability of the tree. This information can then be used to inform the future management of the tree.

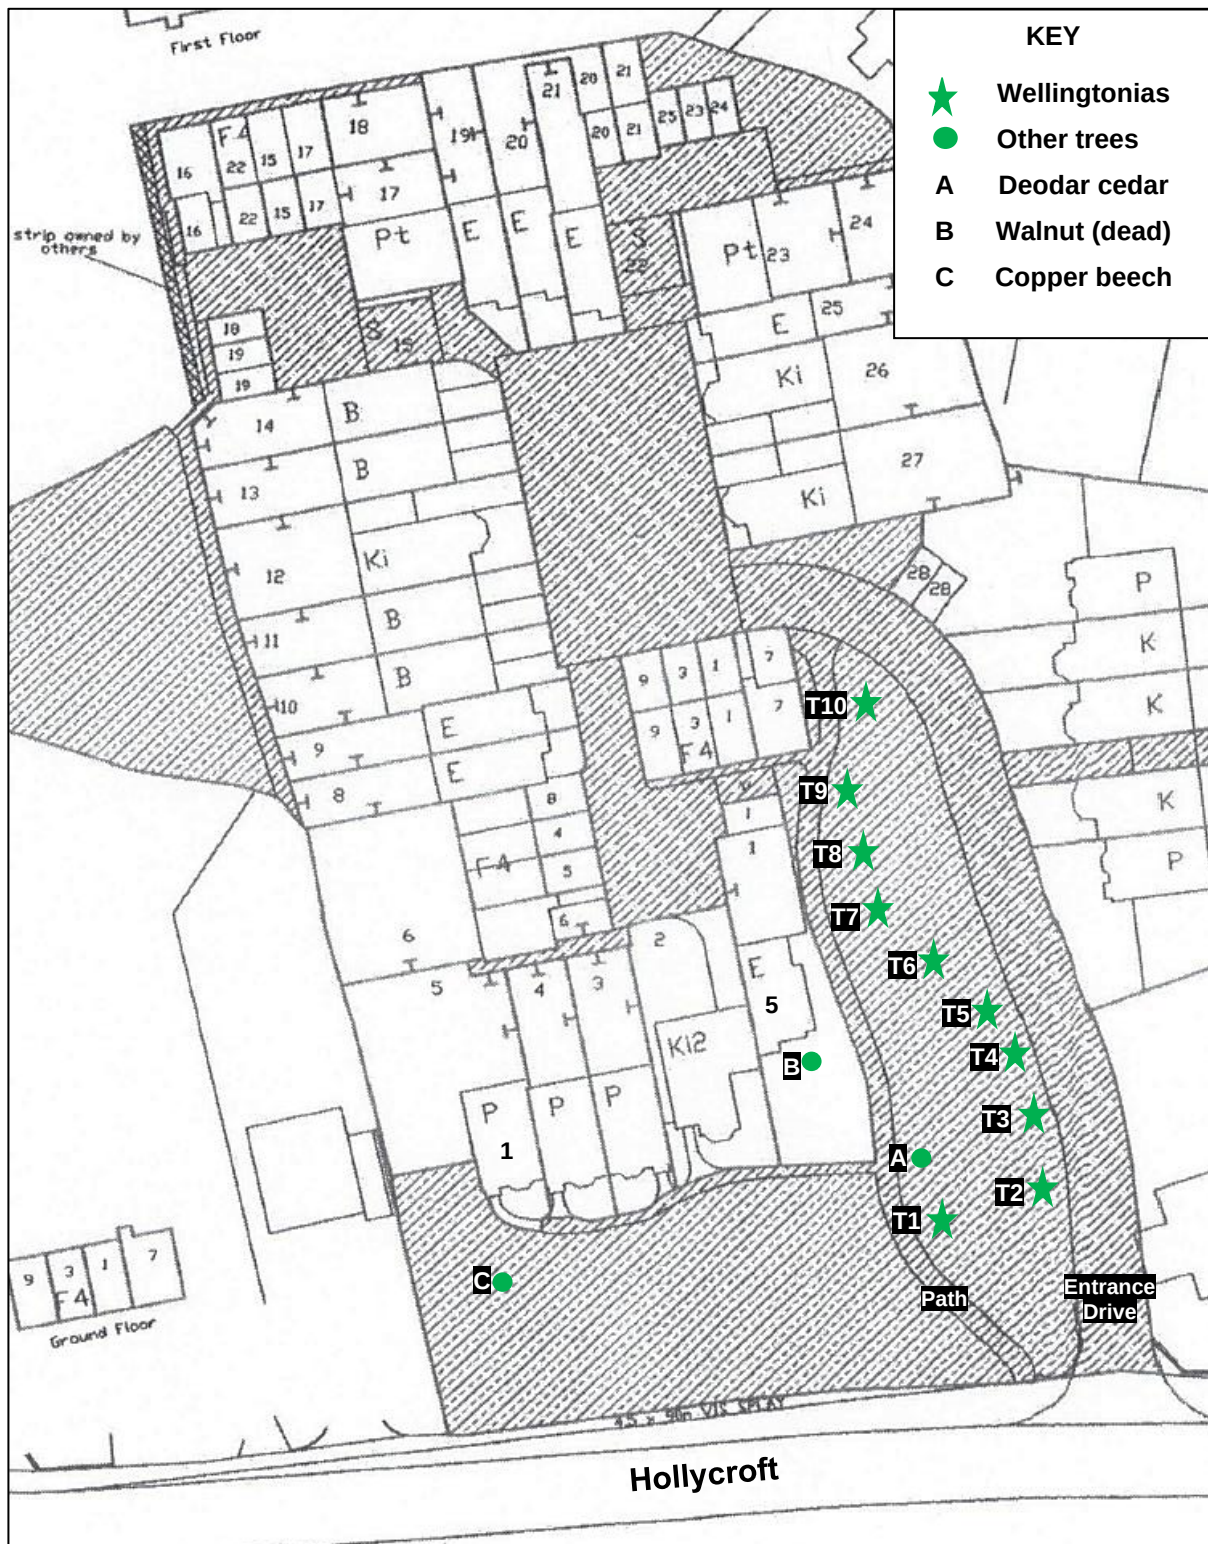
## INDICATIVE TREE LOCATION PLAN

- 3.1** I have updated the plan prepared for the 2002 report, which shows the approximate stem positions and survey numbers of the wellingtonias, to add the stem plots and reference letters of the three additional trees included in the report. A copy of the annotated extract of the plan is included at Appendix 1.
