## **Phase I & II Geo-Environmental Assessment**

### **Markfield Services**

Little Shaw Lane  
Markfield  
Leicestershire  
LE67 9PP

**EPS Project Reference:** UK26.7708

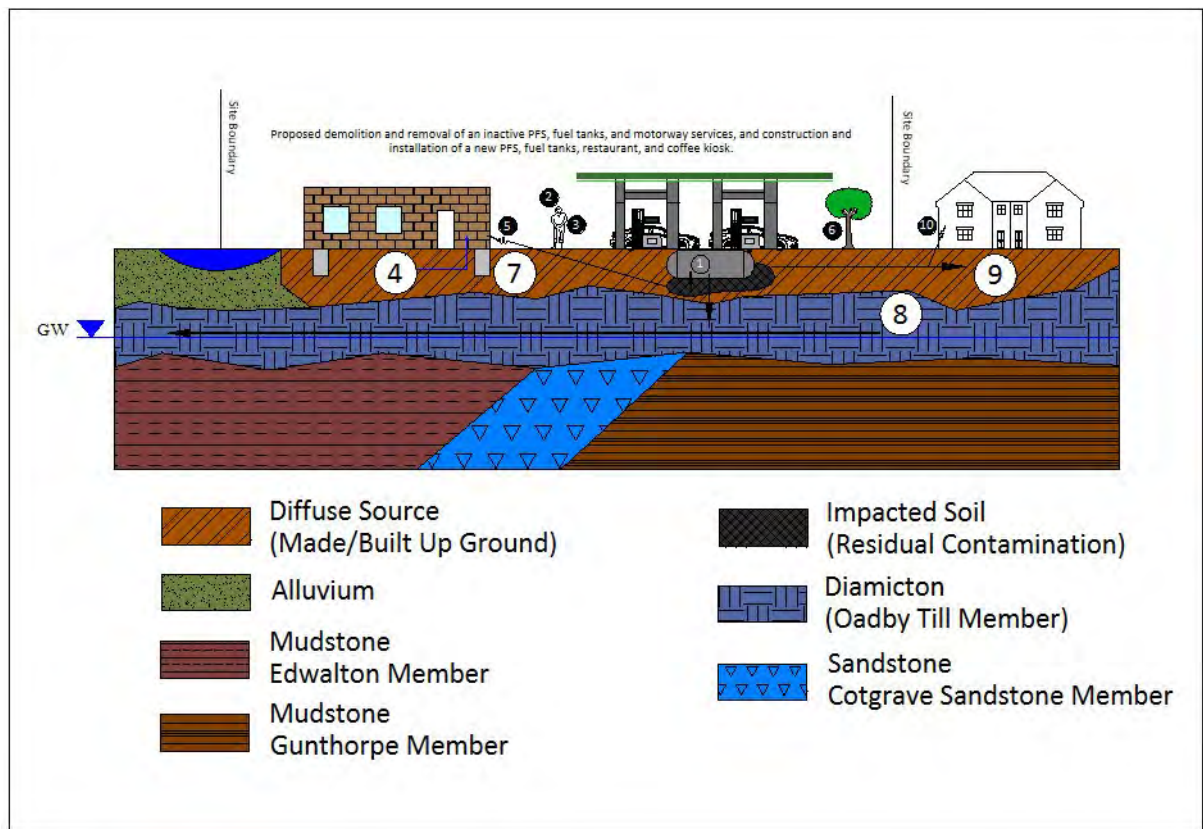
### **Illustrative Conceptual Site Model – Markfield Services, Leicestershire**

#### **Potential Contaminant Linkages:**

1. Leakage from primary and / or secondary containment and on-site migration of contaminants
2. Direct contact and inadvertent ingestion by eating and smoking with dirty hands
3. Inhalation of fugitive dusts
4. Ingress / diffusion through permeable potable water supply pipes
5. Volatilisation of organic compounds to indoor air
6. Direct uptake via root systems
7. Direct contact with buried structures (i.e. foundations)
8. Leaching of contaminants vertically through unsaturated soils
9. Lateral migration of contaminants through unsaturated soils
10. Off-site migration of contaminants in groundwater and subsequent volatilisation of organic compounds to indoor air

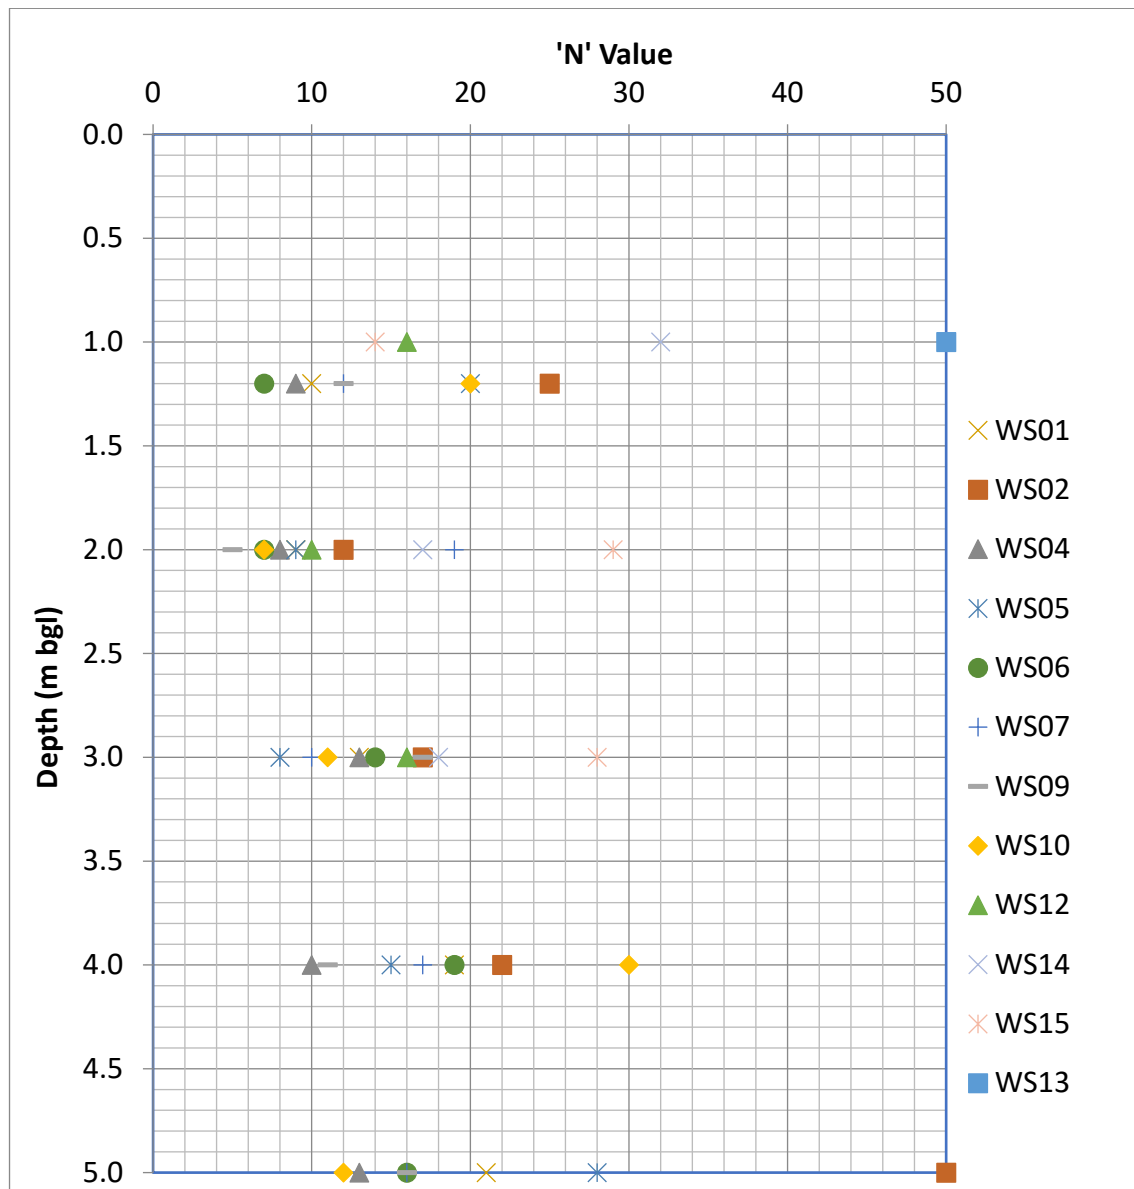
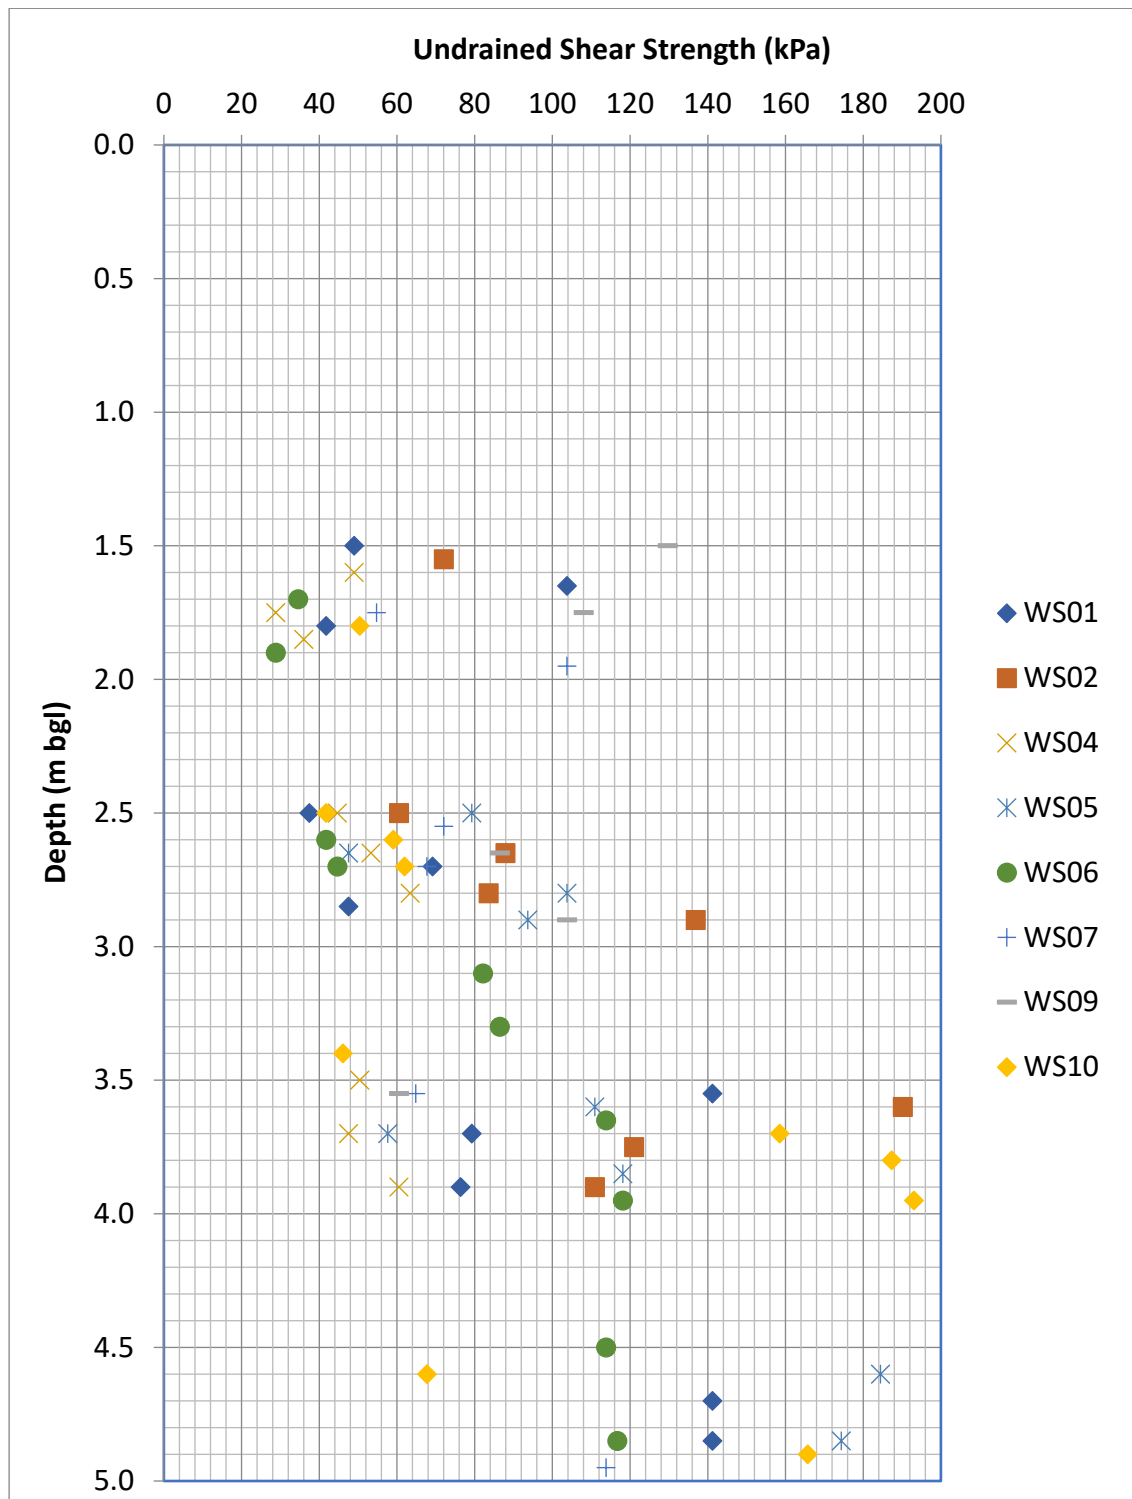
The in-situ testing indicates soil strength is typically firm, but occasionally soft and stiff for the predominantly cohesive soils of the Oadby Member. Rare, thin layers of granular material were also identified, and the strength of these sections were recorded as medium dense.
