# *Structural Inspection*

*Project:* **Manor House Farm  
45 Main Street  
Carlton  
CV13 0BZ**

*Project No:* **23-20021**

*Document No:* **0-030**

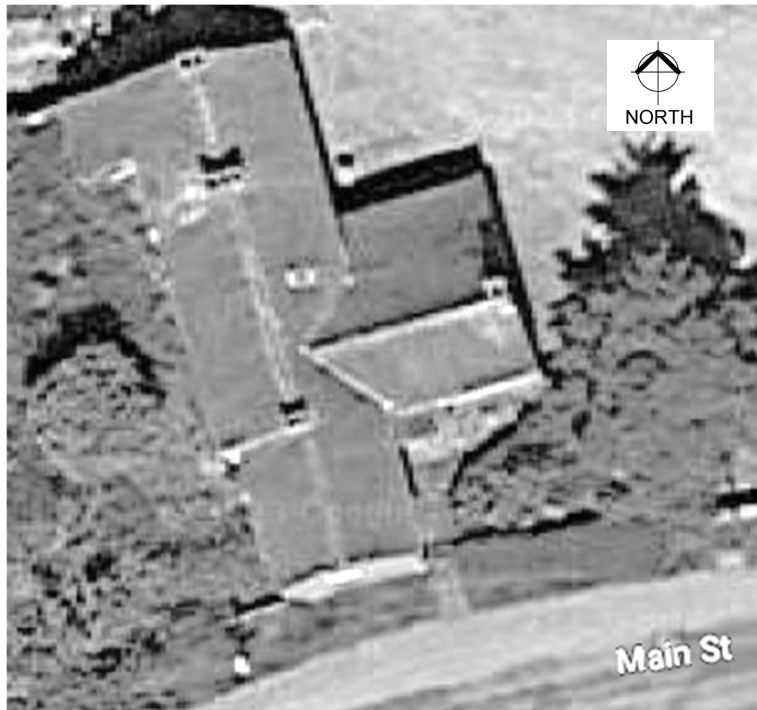
Figure 1

- 2.1 Manor Farm House is located to the north side of Main Street on an approximately north-south axis, and is primarily rectangular on plan but with an orthogonal wing projecting from the eastern-facing elevation. [Figure 1]
