# Site Investigation Report

158684.1.USI

Auger were commissioned by Crawford & Co to undertake a site investigation and CCTV inspection of the underground drainage within the area of concern (AOC) at the property.

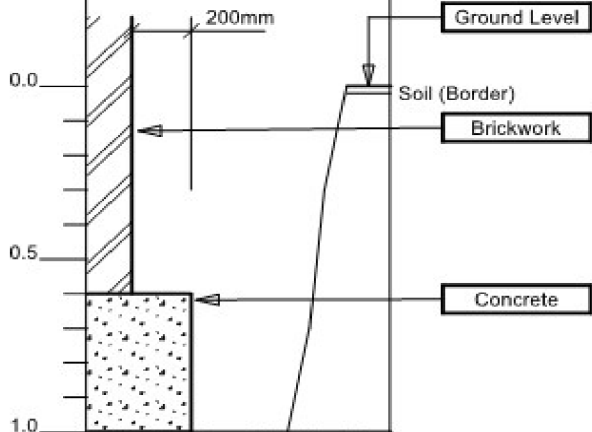
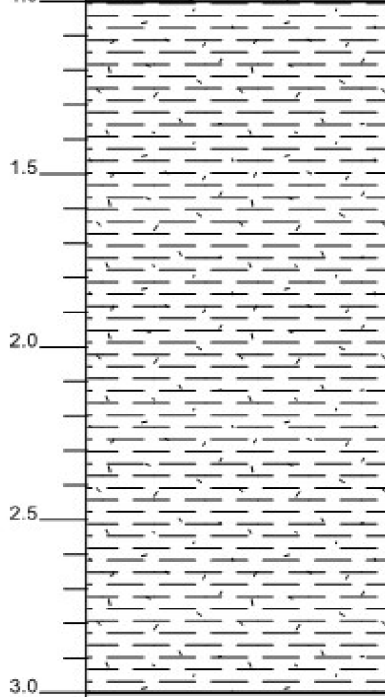
# Trial Hole Log No.1

Trial hole 1 was moved to the **left hand side soil bed to avoid going through the raised patio.** The trial hole reached the depth requested and the footing was discovered. A root sample was taken at 1.0m and soil samples were taken at 1.0m, 1.5m, 2m and 2.5m.

| Depth<br>(m) | Symbolic Log | Strata Description | Insitu Tests | | Soil<br>Sample | Root<br>Sample |
|---|---|---|---|--|---|---|
| 2.0 | | Dry very stiff brown fine to medium<br>gravelly silty CLAY | 82kpa | | Soil<br>@ 2m | |

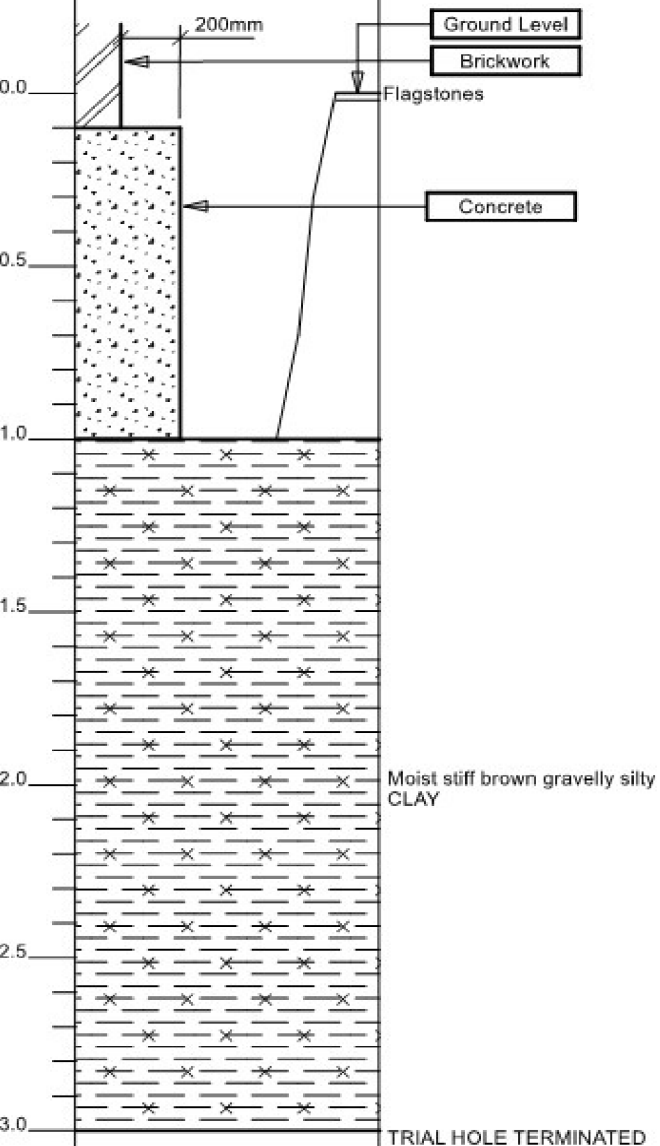
## Trial Hole Log No.2

Trial hole 2 was moved to the **right hand side of the conservatory to avoid going through the raised patio.** The trial hole reached the requested depth and the footing was discovered. A root sample was taken at 1.0m and soil samples were taken at 1.0m, 1.5m, 2.0m and 2.5m.

| Depth<br>(m) | Symbolic Log | Strata Description | Insitu Tests | | Soil<br>Sample | Root<br>Sample |
|---|---|---|---|--|---|---|
| 2.0 | | Moist stiff brown gravelly silty<br>CLAY | 80kpa | | Soil<br>@ 2m | |
