BS5837:2012 Tree Survey  
Land at Kirkby Moats Industrial Estate  
Newbold Road  
Kirkby Mallory  
Leicestershire  
NGR SK45547 01853

| <p>smas<br/>worksafe<br/>consultant<br/>www.smasltd.com<br/>as recognised by<br/>SSIP SAFETY<br/>SCHEMES IN<br/>PROCUREMENT</p> | Report prepared by:<br>C Barker | Date Issued: 15 March 2023 |

# **BS5837 Tree Survey, Land at Kirkby Moats Industrial Estate**

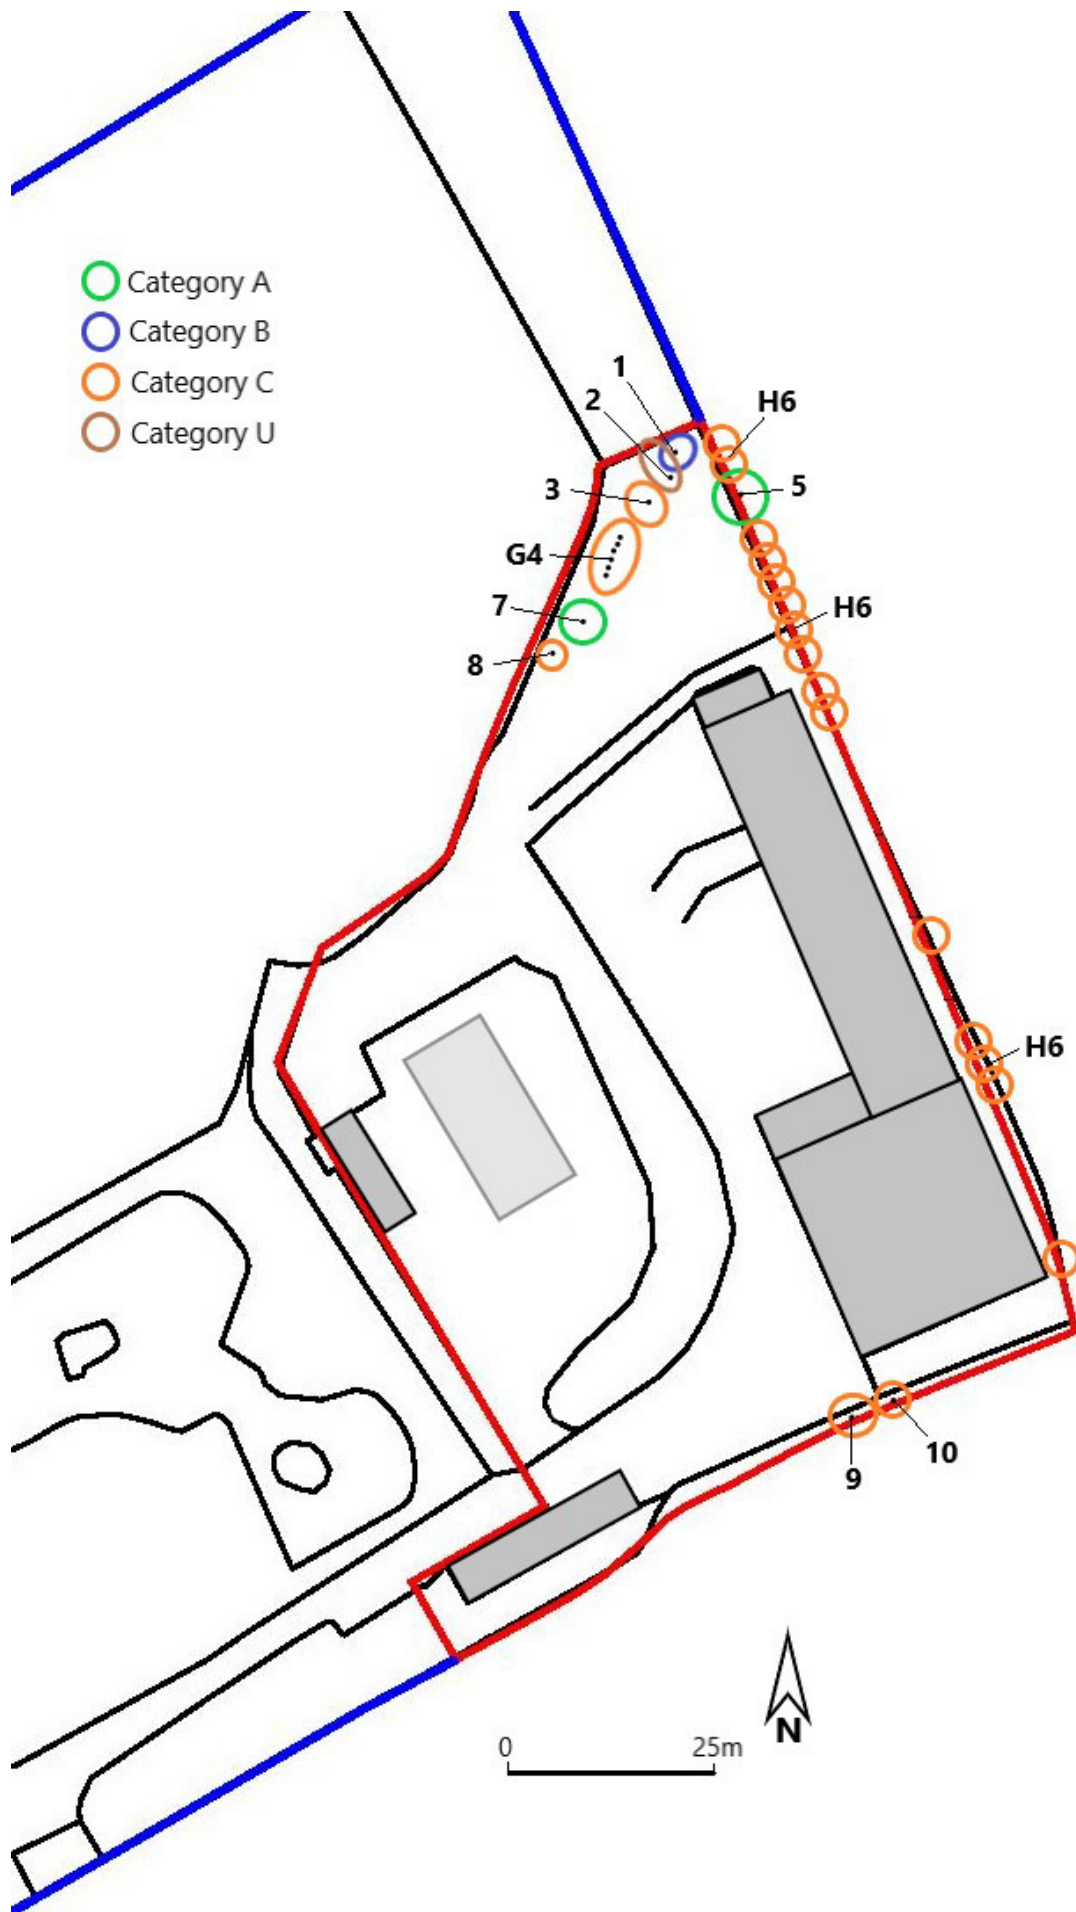
Figure 3 – Tree Category Plan

| Ref | Tree | Category | Potential Impact of development |
|---|---|---|---|
| T5 | Oak | A2 | The calculated RPA extends into the edge of the area identified for the construction of the soakaway. It is recommended that the shaping of the soakaway should be amended to run along the outside edge of the RPA of this tree rather than disturb ground within this area. The RPA will need to be protected by fencing as the soakaway is constructed. |
