# Asbestos Survey

**Client Name:** Mr James Godwin  
**Address:** 8 Wood Lane  
Norton-Juxta  
Atherstone  
CV9 3QB  
**Purpose of Report:** ASBESTOS MANAGEMENT SURVEY  
**Report Reference:** AMS|MJC|2025  
**Inspection Date:** 16 Apr 2025  
**Surveyor Name:** C McLean BSc Hons, MCIOB, CSRT, CSSW, DipDEA, UKAS-P402/P405  
**Building Surveyor Engineer Name:** Greg Owen BSc (Hons) C Build E, MCABE

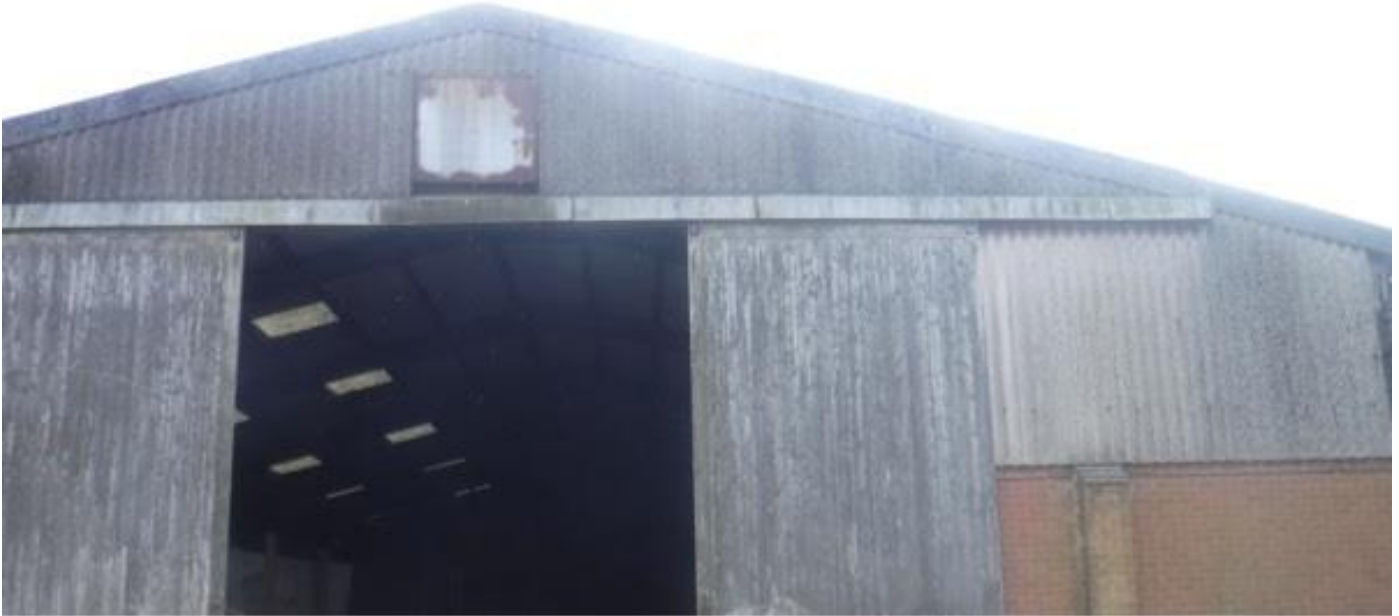
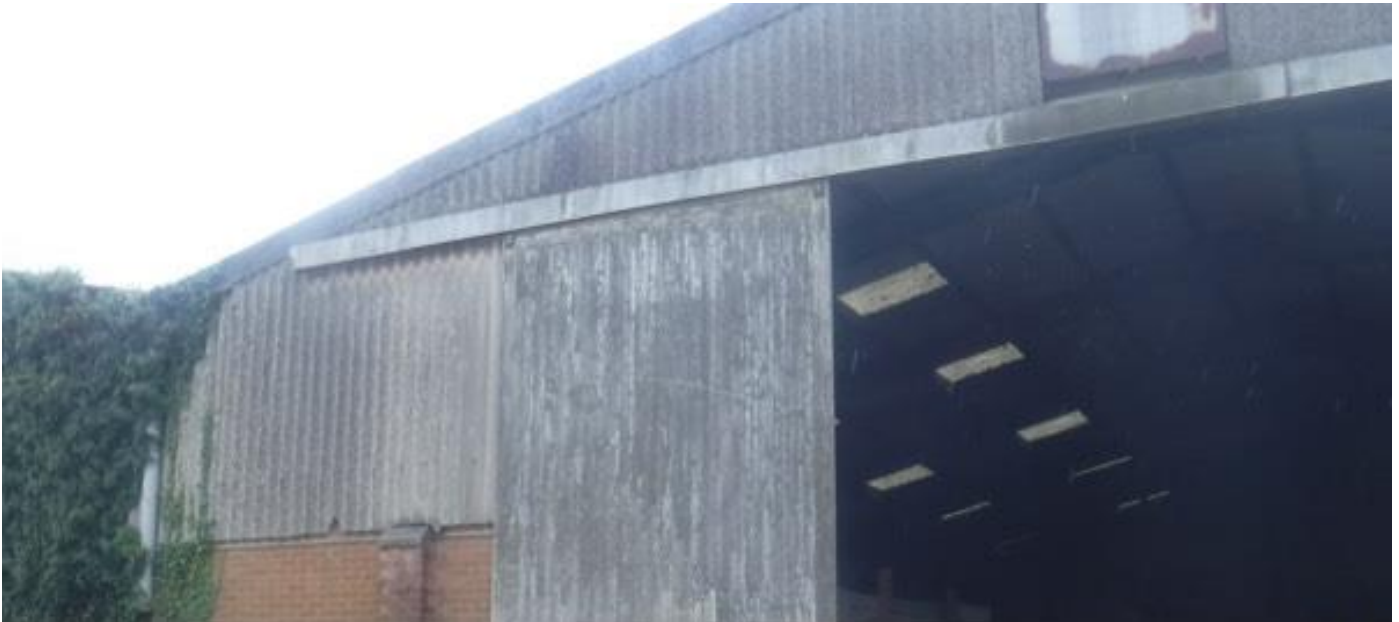
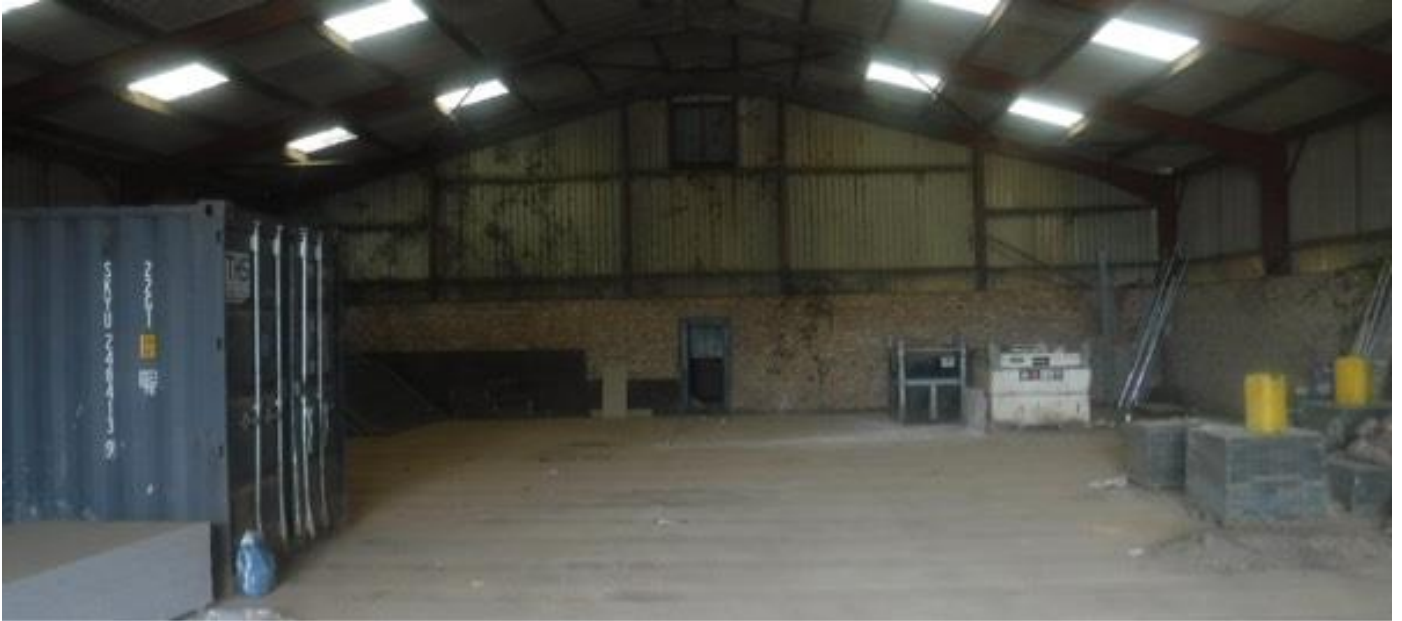
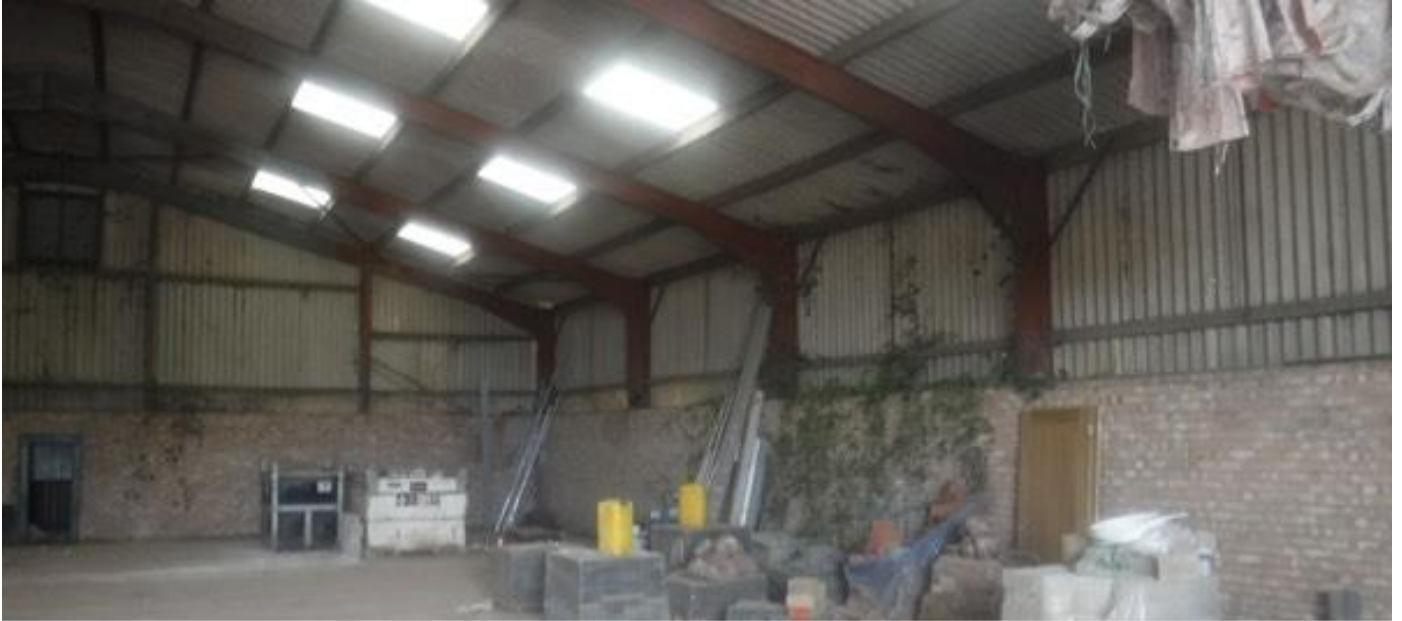
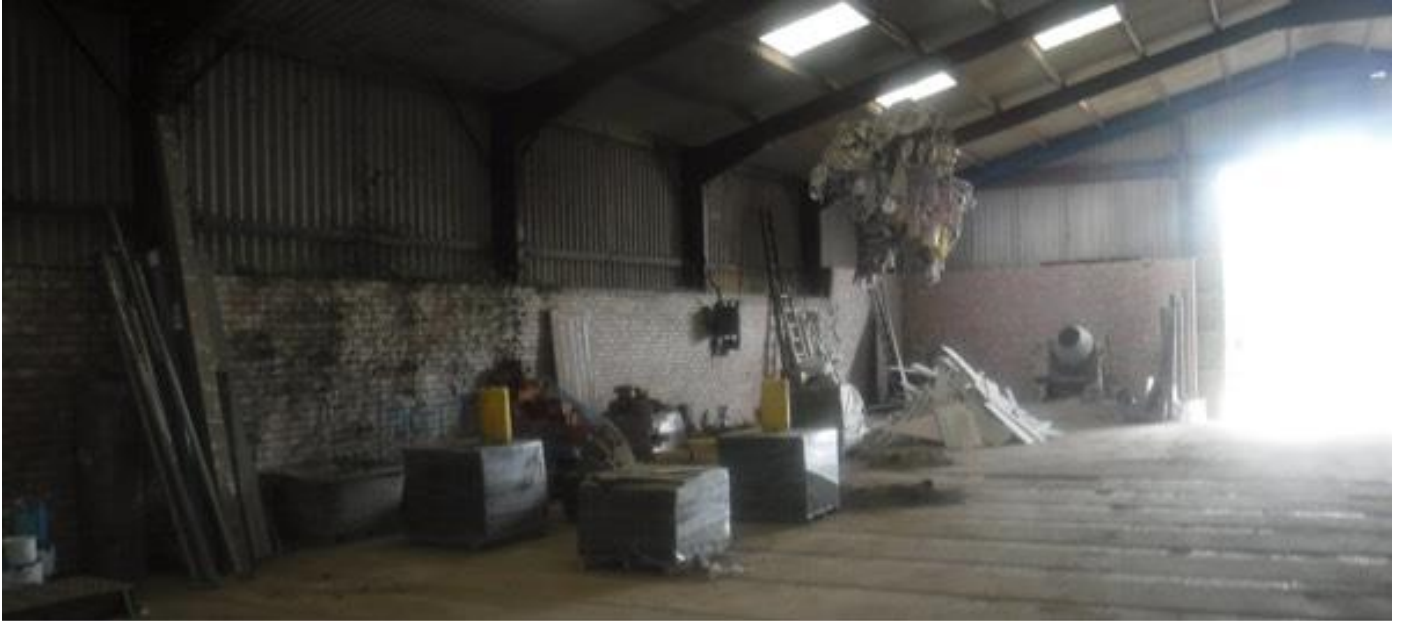
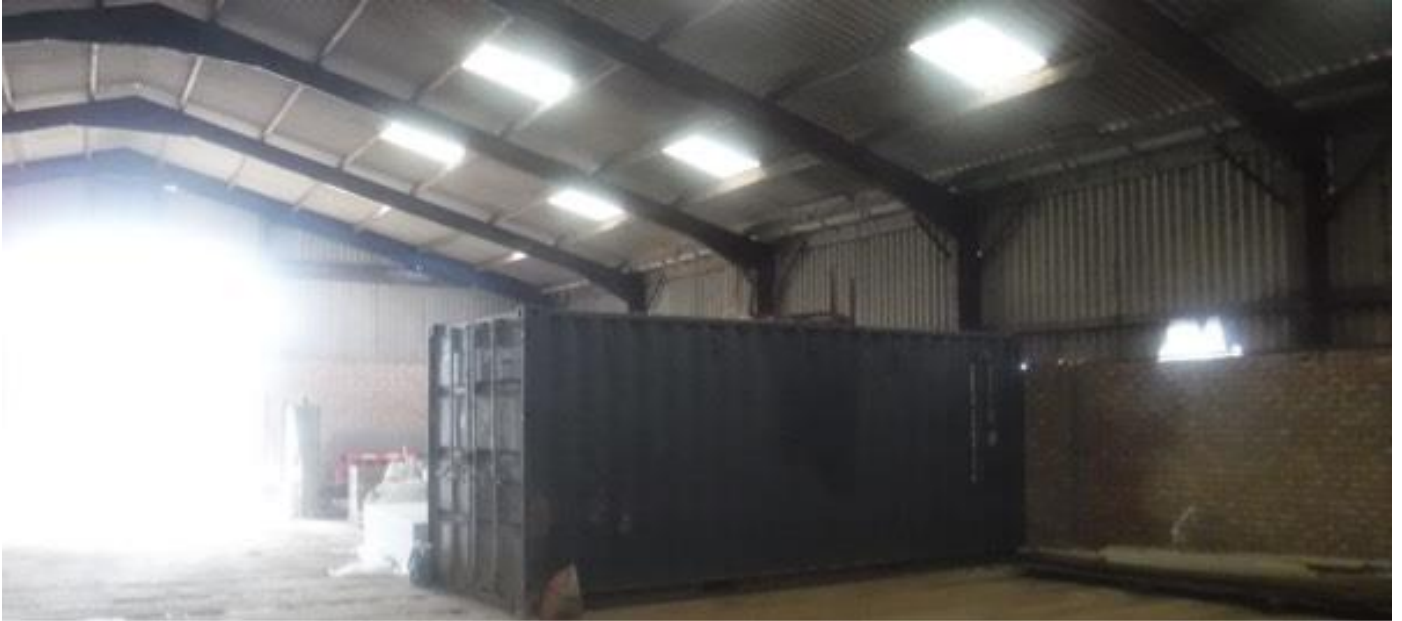
**Barn 1**

| <ul style="list-style-type: none"> <li>The larger attached agricultural buildings had profiled fibre cement roof coverings which were <u>compromised and generally in a poor condition, the majority of walls had a similar fibre cement sheet covering to the upper elevations, water was discharged into a mixture of fibre cement and PVCu gutters and down pipes.</u></li> </ul> |

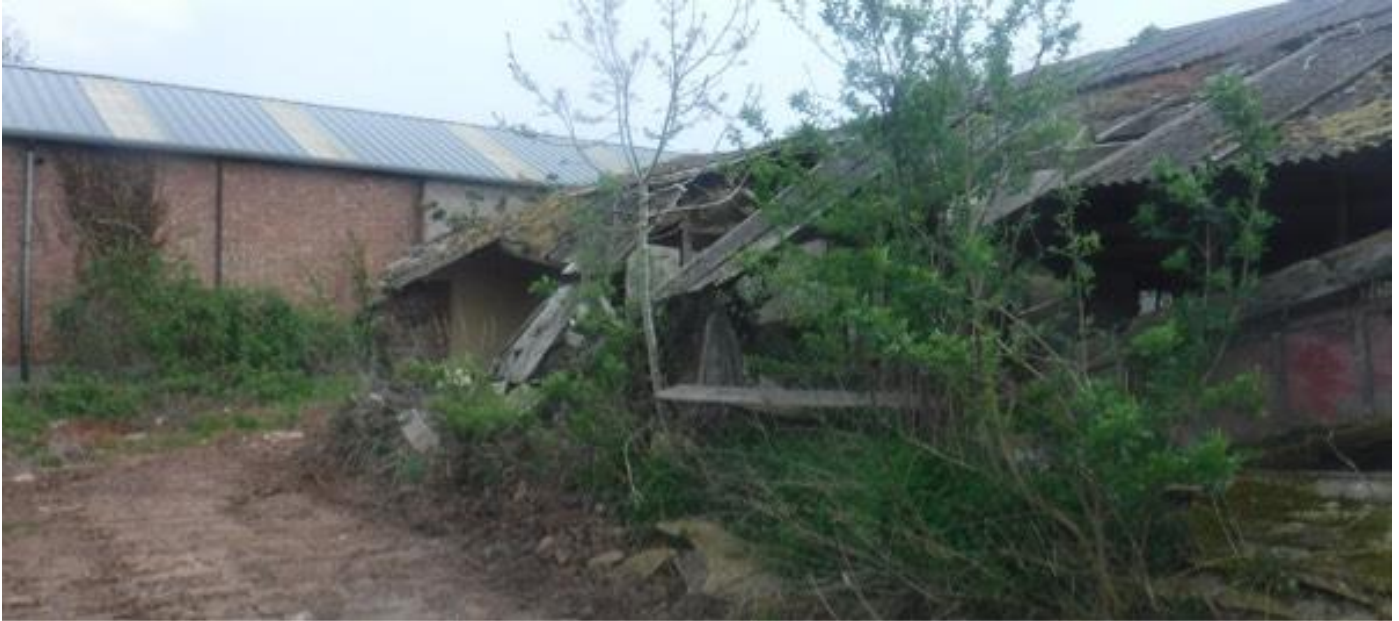
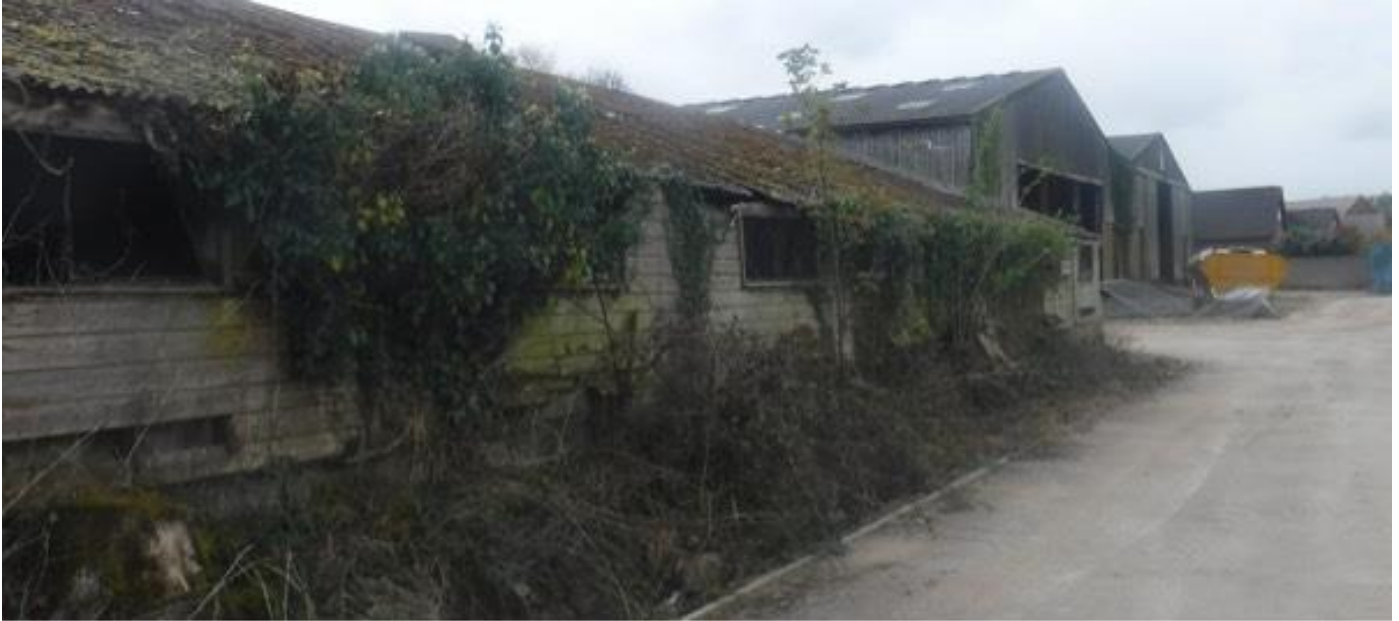
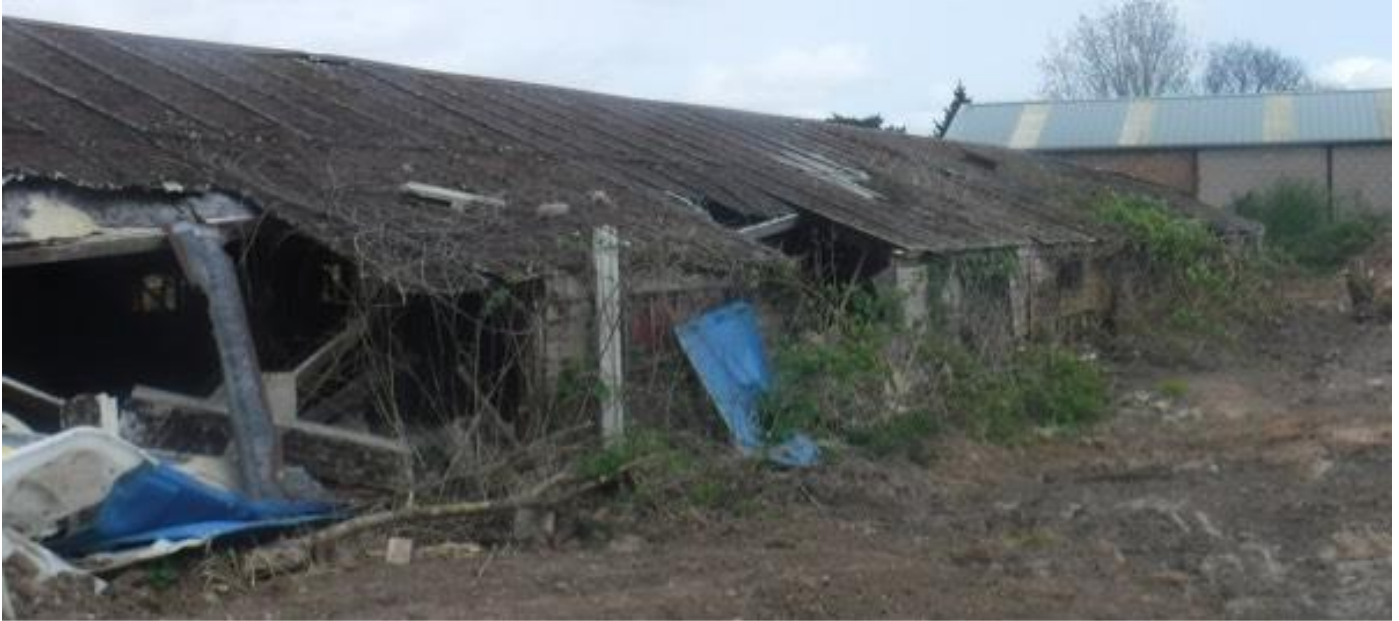
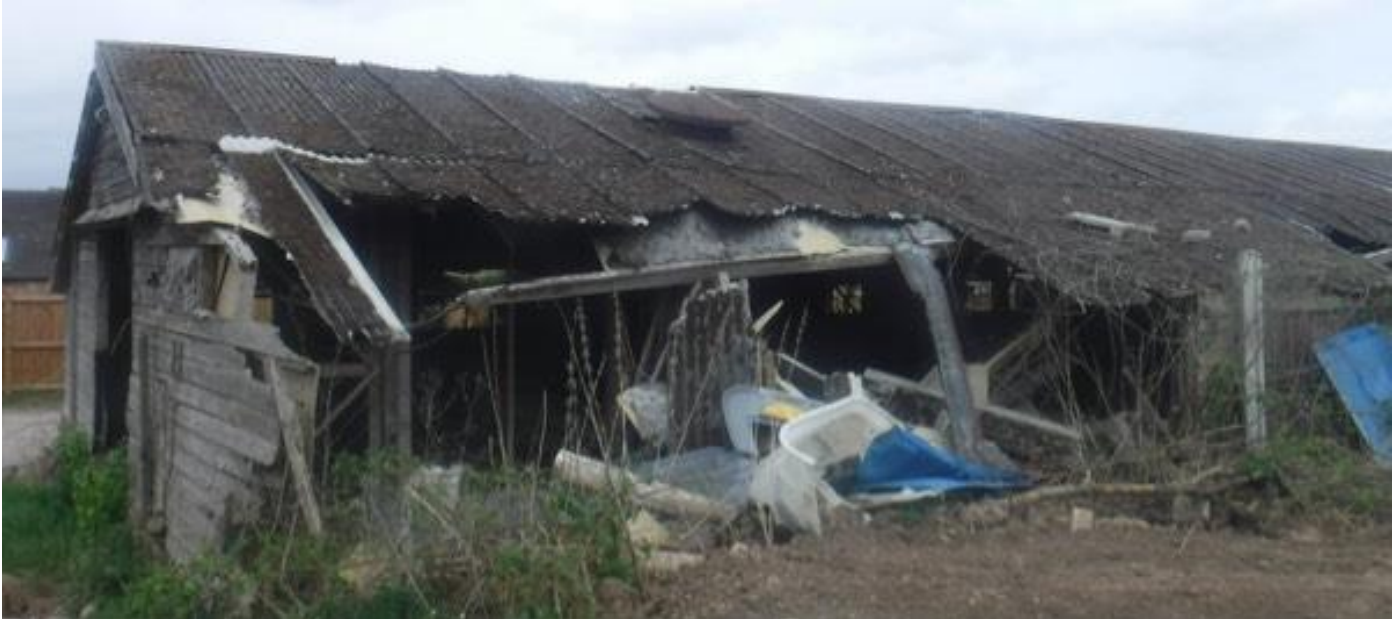
## Barn 3

- The timber framed agricultural building was partially collapsed and in a poor condition. The internal walls and vaulted ceiling had a flat board fibre cement lining, the roof had a profiled roof sheet covering, there were no gutters to the building.
