**Phase 1 Land Contamination  
Risk Assessment**

**Change of Use of Agricultural  
Buildings to Dwellings (C3) with  
Associated Site Works**

**Hill Farm, Markfield Lane,  
Botches ton LE9 9FH**

**Date: December 2020**

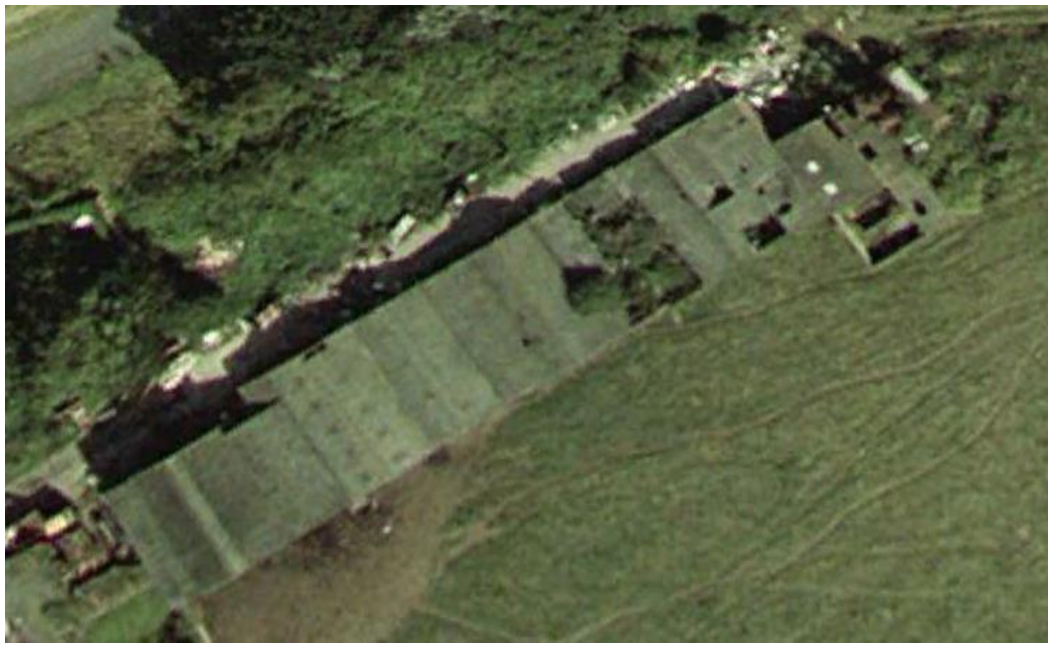
| Date | Description |
|---|---|
| 31/12/1999 | The site is shown as occupied by a row of barns orientated north east to south west, much like that seen on the site walkover. However, the open area still remains as a barn at this time. The barn here shows vegetations and trees growing through the roof. The barns in the north eastern extent of site show areas of broken roofing. The access track and the ground north west of it appear occupied by storage and refuse. |

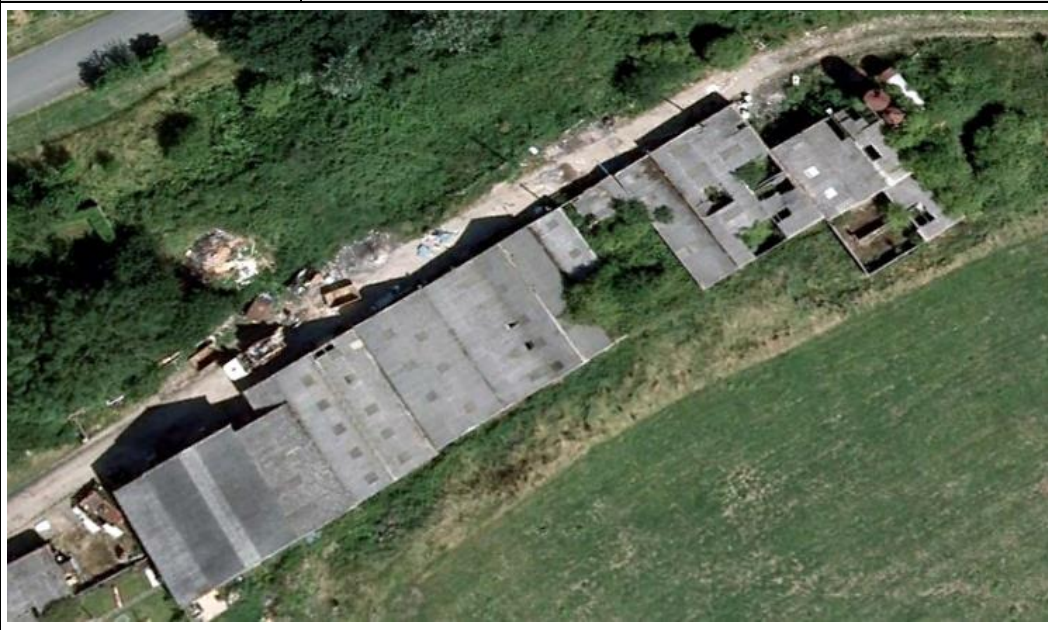
| Date | Description |
|---|---|
| 24/07/2006 | The northeaster barns and the barn occupying the present-day open area show further dilapidation and areas of missing roofing (indicating broken corrugated materials on site). Possible grain silos or tanks can be seen immediately north east of the north easternmost barn. Skips, refuse and refuse heaps can be made out adjacent to Barns No.2 and the access track. |

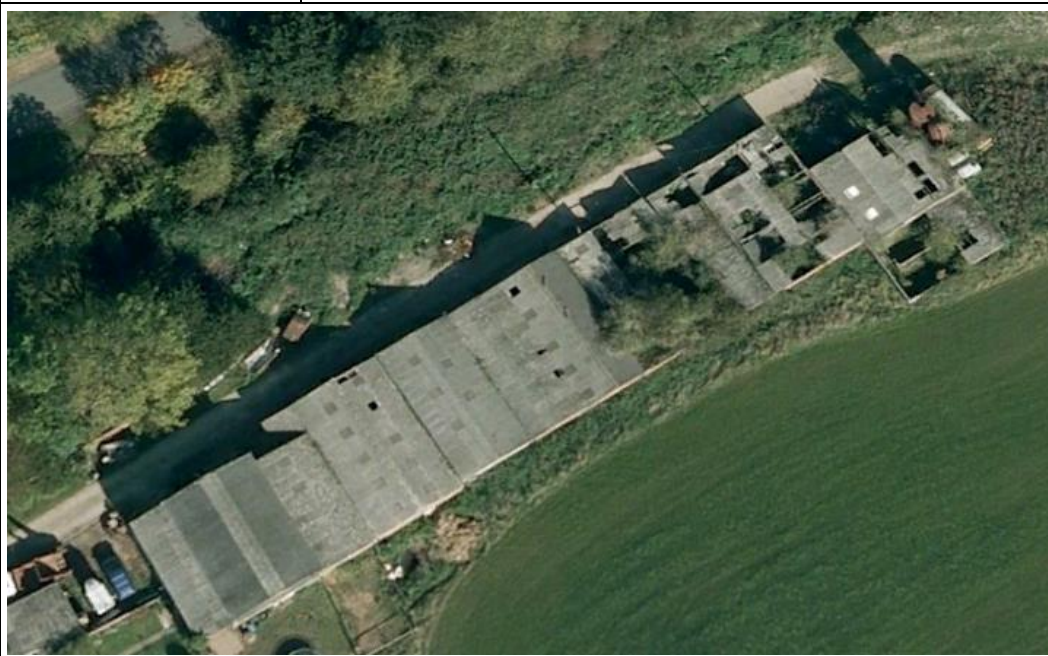
| Date | Description |
|---|---|
| 28/09/2011 | The skips and debris have been moved from the site access track. The refuse pile is likely vegetated at this time. |

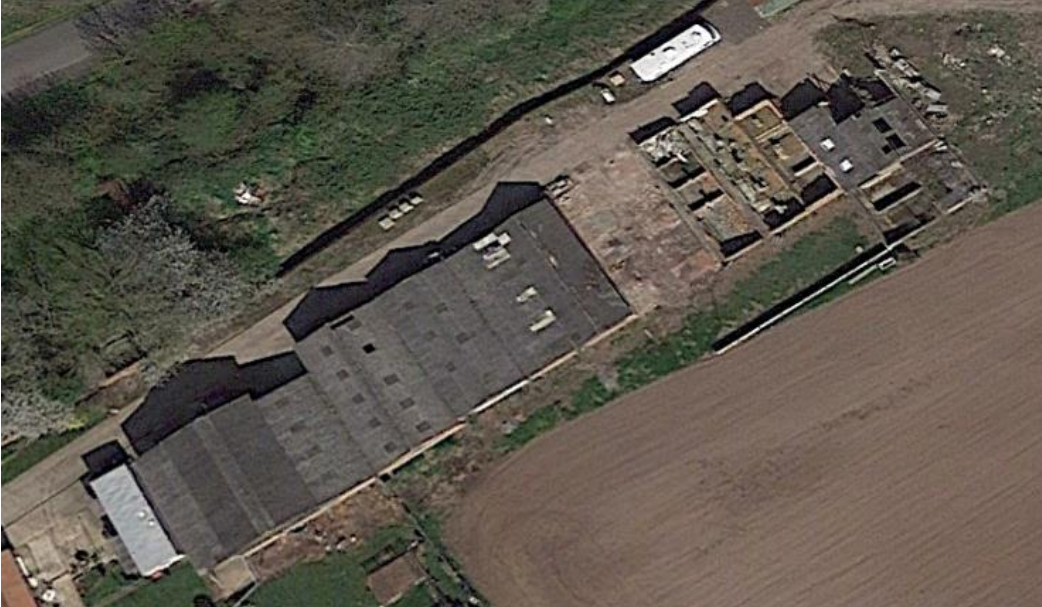
| Date | Description |
|---|---|
| 21/04/2015 | <p>The dilapidated barn occupying the present-day open area has been demolished at this time and the roofing removed from the north eastern barns. The area north west of the access track formerly occupied by vegetation, refuse and skips has been cleared the present-day fencing installed. The shipping containers can be seen at this time and a large mobile home can be seen parked on the made ground deposits south west of the containers. An amount of debris can be seen immediately north east of site and off-site, assumed associated with demolition of north eastern barns, grain silos etc. A static caravan is now located immediately south west and off-site of the south westernmost barn.</p> |

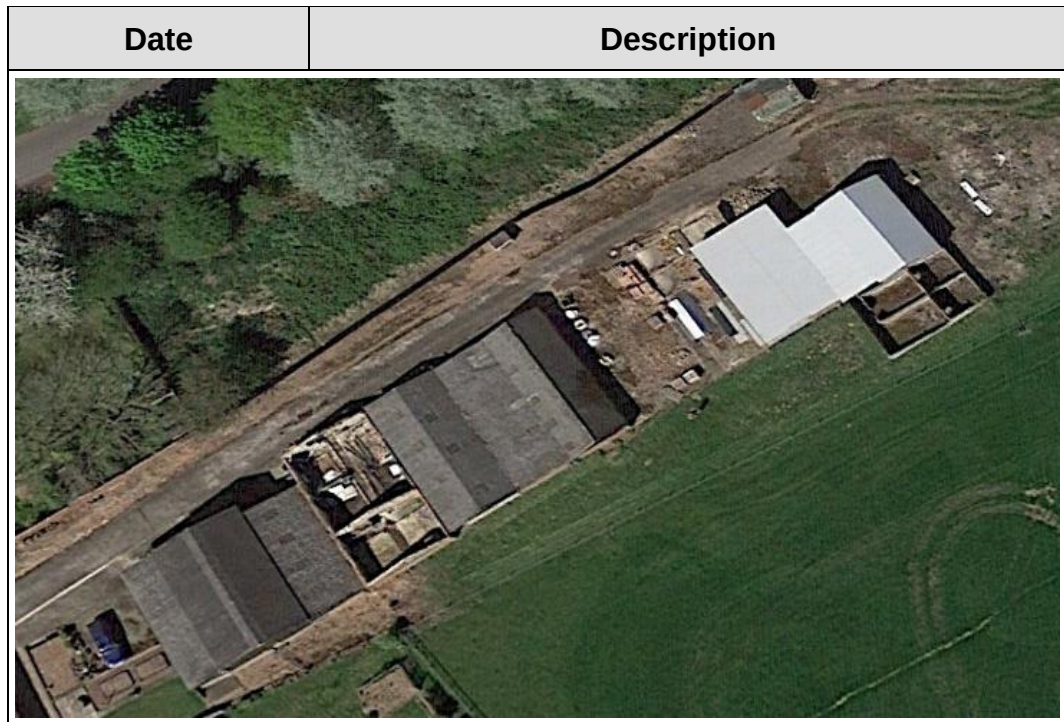
| Date | Description |
|---|---|
| 21/04/2020 | <p>The new metal roofing has been installed on the north eastern barns and materials storage can be seen in the cleared open area. One of the red-bricked barns forming Barn No.2 has had its roofing removed. The vegetation adjacent and within the north western boundary of site has been scraped clear, leaving a brown area running the length of the north western boundary. This now leaves the site as seen on the site walkover.</p> |
