# **Phase 2 Land Contamination Risk Assessment**

**Change of Use of Agricultural  
Buildings to Dwellings (C3) with  
Associated Site Works**

**Hill Farm, Markfield Lane,  
Botcheston LE9 9FH**

**Date: March 2021**

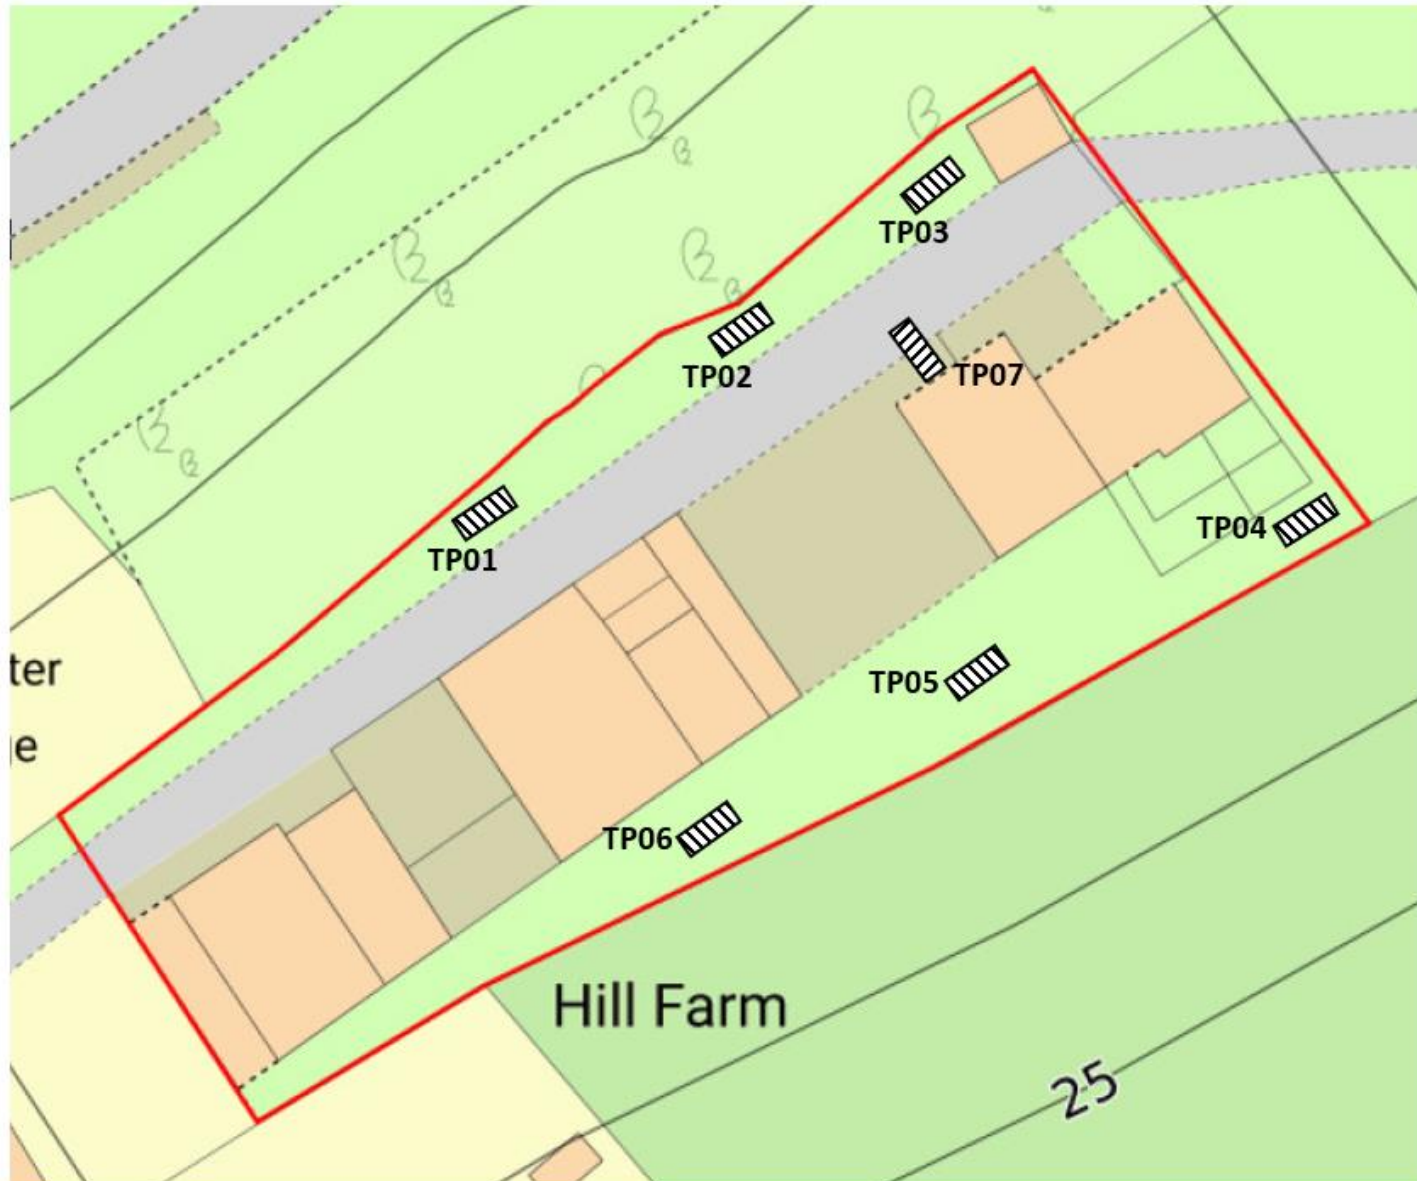
**SITE PLAN INCLUDING TRIAL PIT LOCATIONS**

It is recommended that a Phase 3 Remediation Strategy and Verification Plan be produced for the development and implemented during the site works. This should involve the encapsulation of identified hotspots of contamination, with particular attention paid to the northern western

boundary of site, from the location of TP01 to TP03. The area of TP07 should be excavated and replaced with certified clean materials.
