# Drainage Report

**Arthur Street  
Arthur Street  
Barwell**

### 36913 Arthur Street - CCTV Survey Report : 25/09/20

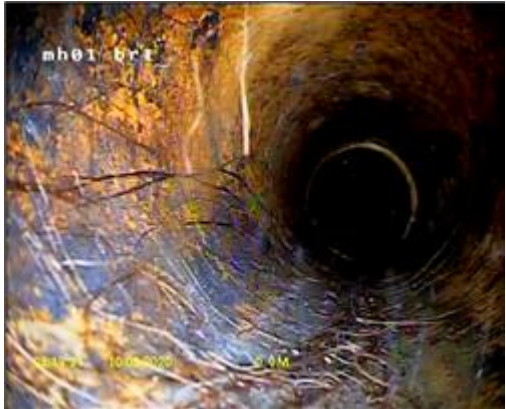
| Pos | Video Ref | Code | Cont. | Description | Image |
|---|---|---|---|---|---|
| 00.0m | 0:00:00 | MH | | Start node type, manhole, reference mh01 br1 | Image Provided - Ref: 0_0<br> |

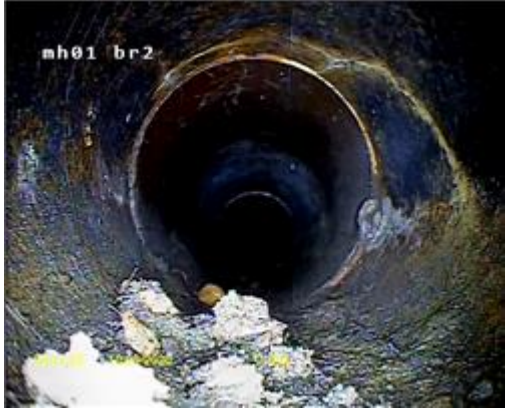
| Pos | Video Ref | Code | Cont. | Description | Image |
|---|---|---|---|---|---|
| 00.0m | 0:00:00 | MH | | Start node type, manhole, reference mh01 br2 | Image Provided - Ref: 1_0<br> |

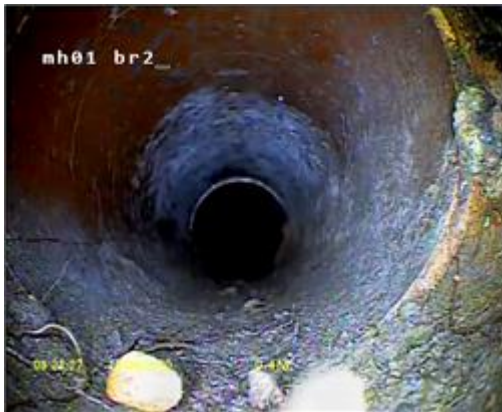
| Pos | Video Ref | Code | Cont. | Description | Image |
|---|---|---|---|---|---|
| 00.3m | 0:00:03 | RF | S2 | Roots fine 0.3m - 6.5m - Severity 1 | Image Provided - Ref: 1_3<br> |

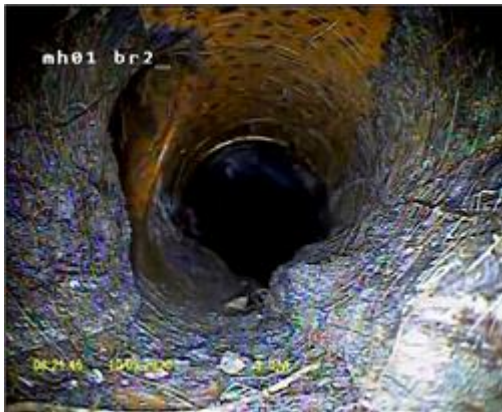
| Pos | Video Ref | Code | Cont. | Description | Image |
|---|---|---|---|---|---|
| 03.0m | 0:00:21 | JN | | Junction at 09 o'clock: 100mm Diameter | Image Provided - Ref: 1_4<br> |

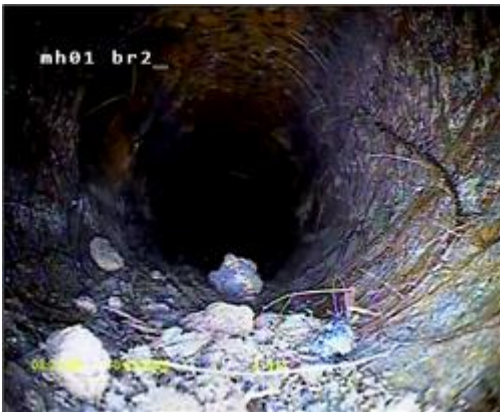
| Pos | Video Ref | Code | Cont. | Description | Image |
|---|---|---|---|---|---|
| 04.8m | 0:00:31 | JN | | Junction at 09 o'clock: 100mm Diameter | Image Provided - Ref: 1_6<br> |

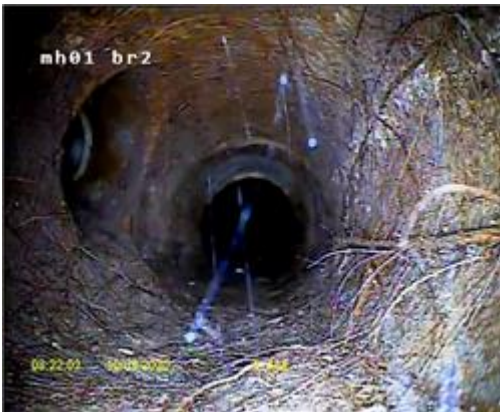
| Pos | Video Ref | Code | Cont. | Description | Image |
|---|---|---|---|---|---|
| 05.6m | 0:00:38 | JN | | Junction at 09 o'clock: 100mm Diameter | Image Provided - Ref: 1_7<br> |

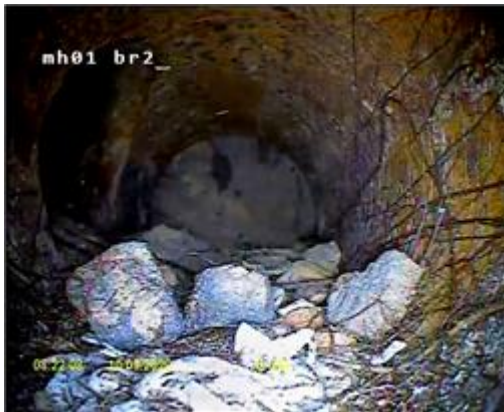
| Pos | Video Ref | Code | Cont. | Description | Image |
|---|---|---|---|---|---|
| 06.3m | 0:00:44 | JN | | Junction at 09 o'clock: 100mm Diameter | Image Provided - Ref: 1_9<br> |

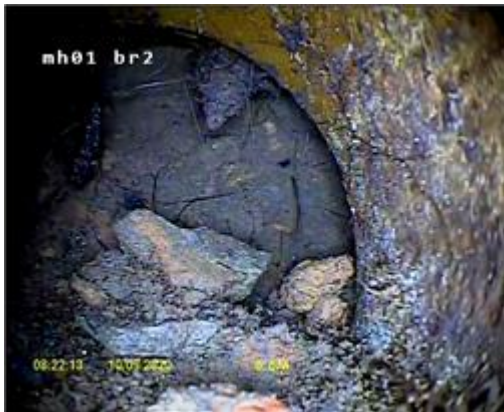
| Pos | Video Ref | Code | Cont. | Description | Image |
|---|---|---|---|---|---|
| 06.6m | 0:00:49 | SA | | Survey abandoned<br>Survey Abandoned - Capped Off | Image Provided - Ref: 1_9999<br> |

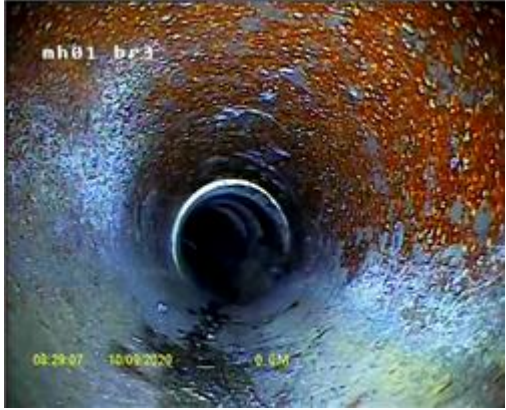
| Pos | Video Ref | Code | Cont. | Description | Image |
|---|---|---|---|---|---|
| 00.0m | 0:00:00 | MH | | Start node type, manhole, reference mh01 br3 | Image Provided - Ref: 2_0<br> |

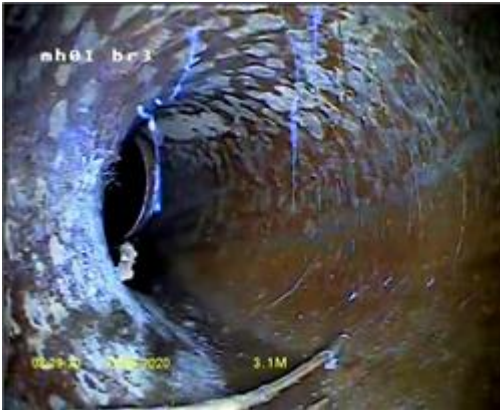
| Pos | Video Ref | Code | Cont. | Description | Image |
|---|---|---|---|---|---|
| 03.2m | 0:00:23 | LL | | Line of drain/sewer deviates left | Image Provided - Ref: 2_3<br> |

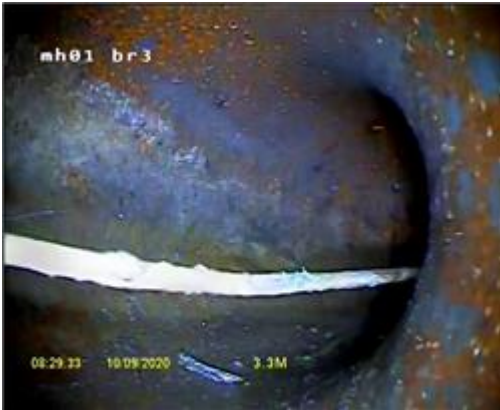
| Pos | Video Ref | Code | Cont. | Description | Image |
|---|---|---|---|---|---|
| 03.4m | 0:00:26 | LR | | Line of drain/sewer deviates right | Image Provided - Ref: 2_4<br> |

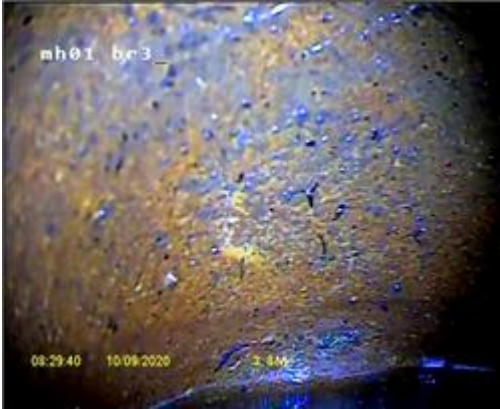
| Pos | Video Ref | Code | Cont. | Description | Image |
|---|---|---|---|---|---|
| 03.9m | 0:00:33 | GYF | | Finish node type Gully, reference Gully Gully | Image Provided - Ref: 2_9999<br> |

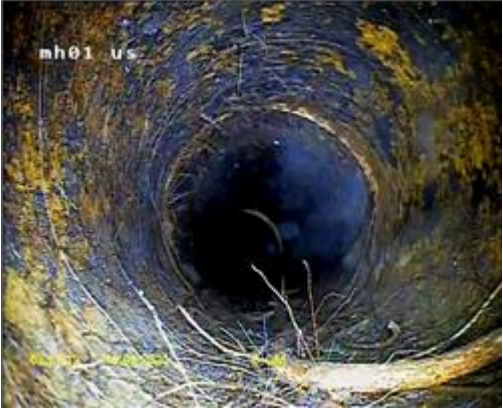
| Pos | Video Ref | Code | Cont. | Description | Image |
|---|---|---|---|---|---|
| 00.0m | 0:00:00 | MH | | Start node type, manhole, reference mh01 us | Image Provided - Ref: 3_0<br> |

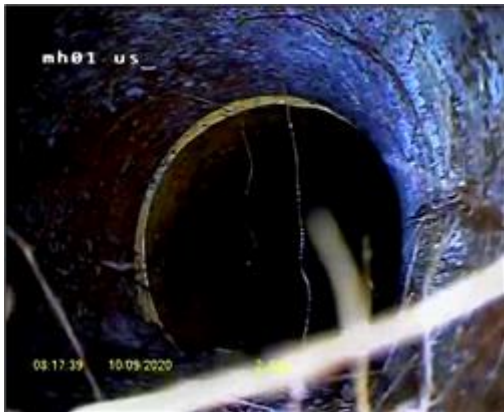
| Pos | Video Ref | Code | Cont. | Description | Image |
|---|---|---|---|---|---|
| 03.0m | 0:00:27 | LR | | Line of drain/sewer deviates right | Image Provided - Ref: 3_7<br> |

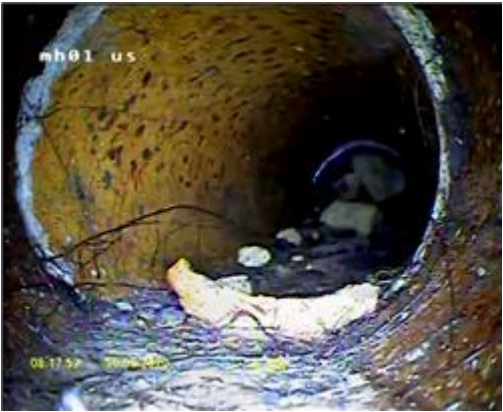
| Pos | Video Ref | Code | Cont. | Description | Image |
|---|---|---|---|---|---|
| 04.9m | 0:00:40 | LR | | Line of drain/sewer deviates right | Image Provided - Ref: 3_9<br> |

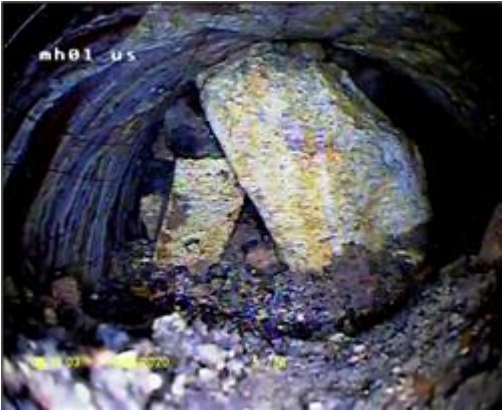
| Pos | Video Ref | Code | Cont. | Description | Image |
|---|---|---|---|---|---|
| 05.9m | 0:00:51 | SA | | Survey abandoned<br>Survey Abandoned - Capped Off | Image Provided - Ref: 3_9999<br> |

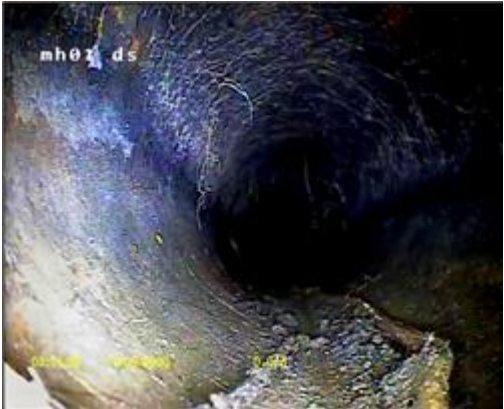
| Pos | Video Ref | Code | Cont. | Description | Image |
|---|---|---|---|---|---|
| 00.0m | 0:00:00 | MH | | Start node type, manhole, reference mh01 ds | Image Provided - Ref: 4_0<br> |

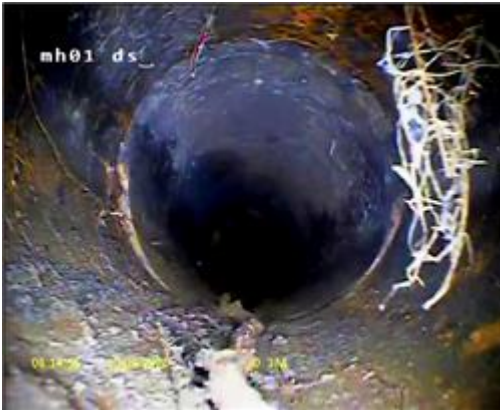
| Pos | Video Ref | Code | Cont. | Description | Image |
|---|---|---|---|---|---|
| 00.3m | 0:00:04 | RF | S2 | Roots fine 0.3m - 16m - Severity 1 | Image Provided - Ref: 4_3<br> |

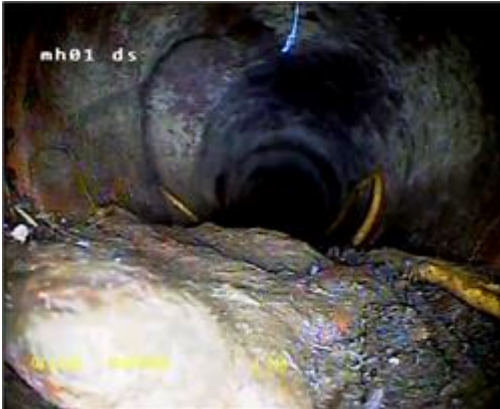
| Pos | Video Ref | Code | Cont. | Description | Image |
|---|---|---|---|---|---|
| 01.3m | 0:00:09 | JN | | Junction at 09 o'clock: 100mm Diameter | Image Provided - Ref: 4_5<br> |

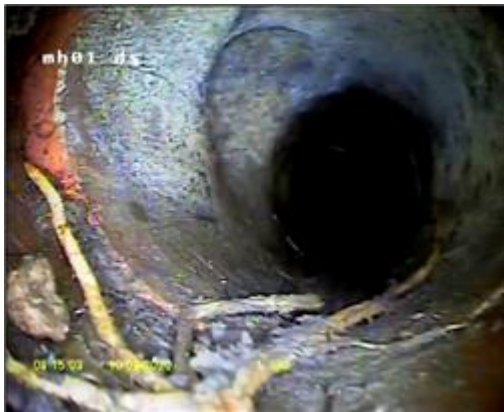
| Pos | Video Ref | Code | Cont. | Description | Image |
|---|---|---|---|---|---|
| 01.9m | 0:00:13 | JN | | Junction at 09 o'clock: 100mm Diameter | Image Provided - Ref: 4_6<br> |

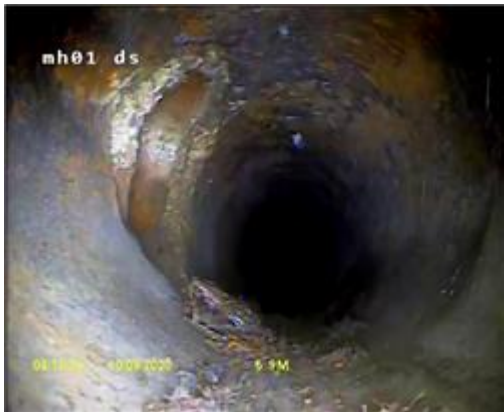
| Pos | Video Ref | Code | Cont. | Description | Image |
|---|---|---|---|---|---|
| 07.0m | 0:00:37 | CN | | Connection other than junction at 09 o'clock: 100mm Diameter | Image Provided - Ref: 4_9<br> |

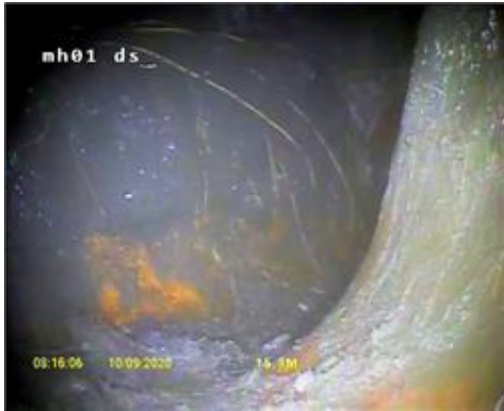
| Pos | Video Ref | Code | Cont. | Description | Image |
|---|---|---|---|---|---|
| 16.0m | 0:01:15 | MHF | | Finish node type, manhole, reference mh02 mh02 | Image Provided - Ref: 4_9999<br> |

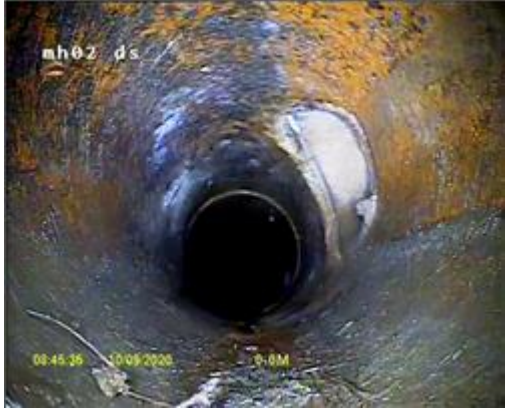
| Pos | Video Ref | Code | Cont. | Description | Image |
|---|---|---|---|---|---|
| 00.0m | 0:00:00 | MH | | Start node type, manhole, reference mh02 ds | Image Provided - Ref: 5_0<br> |

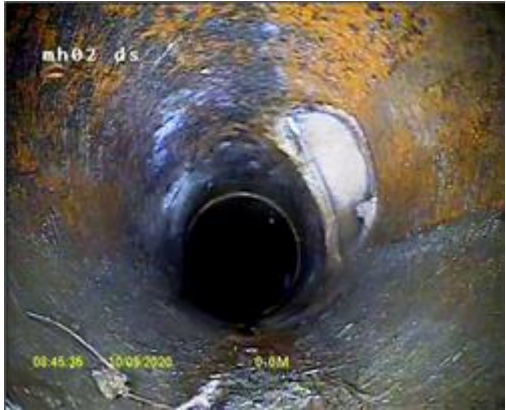
| Pos | Video Ref | Code | Cont. | Description | Image |
|---|---|---|---|---|---|
| 00.3m | 0:00:00 | CN | | Connection other than junction at 03 o'clock: 100mm Diameter | Image Provided - Ref: 5_1<br> |

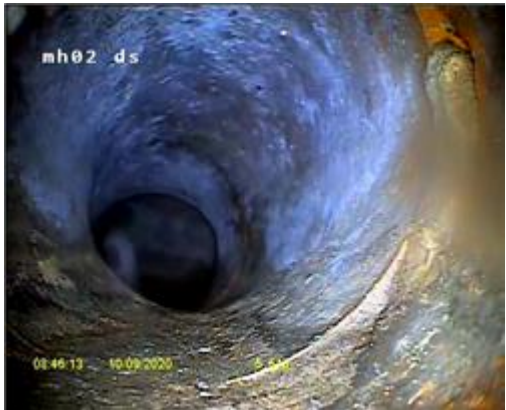
| Pos | Video Ref | Code | Cont. | Description | Image |
|---|---|---|---|---|---|
| 05.7m | 0:00:36 | LL | | Line of drain/sewer deviates left | Image Provided - Ref: 5_2<br> |

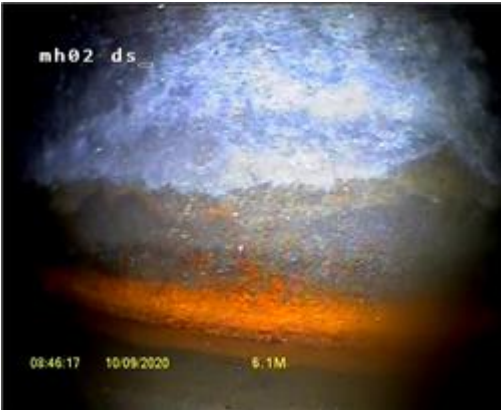
| Pos | Video Ref | Code | Cont. | Description | Image |
|---|---|---|---|---|---|
| 06.1m | 0:00:40 | BRF | | Finish node type, major connection without manhole, reference main connection main connection | <div>Image Provided - Ref: 5_9999</div> |

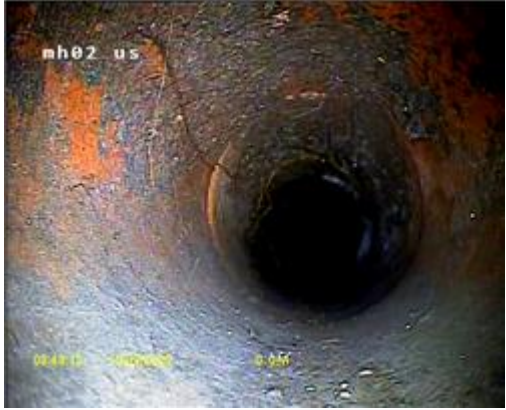
| Pos | Video Ref | Code | Cont. | Description | Image |
|---|---|---|---|---|---|
| 00.0m | 0:00:00 | MH | | Start node type, manhole, reference mh02 us | Image Provided - Ref: 6_0<br> |

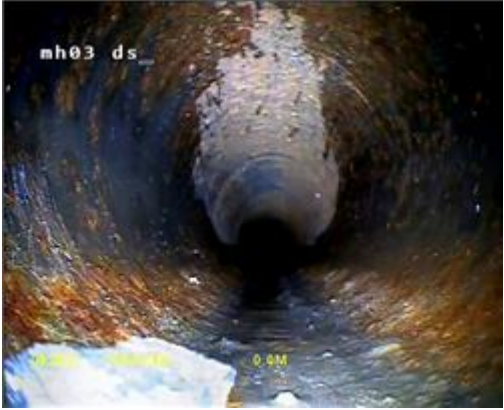
| Pos | Video Ref | Code | Cont. | Description | Image |
|---|---|---|---|---|---|
| 00.0m | 0:00:00 | MH | | Start node type, manhole, reference mh03 ds | Image Provided - Ref: 7_0<br> |

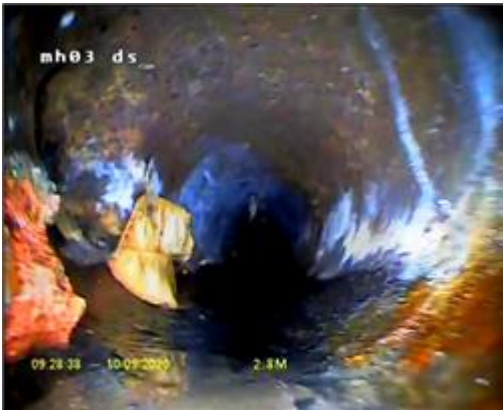
| Pos | Video Ref | Code | Cont. | Description | Image |
|---|---|---|---|---|---|
| 03.0m | 0:00:16 | JN | | Junction at 09 o'clock: 100mm Diameter | Image Provided - Ref: 7_2<br> |

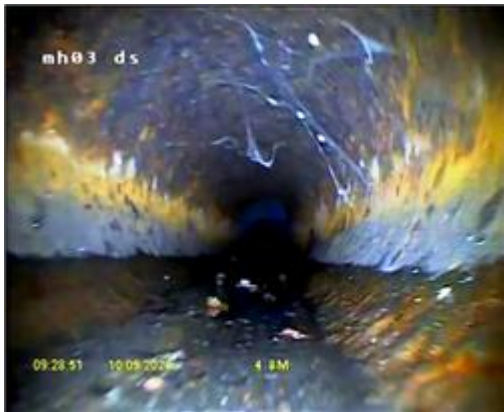
| Pos | Video Ref | Code | Cont. | Description | Image |
|---|---|---|---|---|---|
| 04.8m | 0:00:29 | WL | | Water level: 10% Height/Diameter | <p>Image Provided - Ref: 7_3</p> |

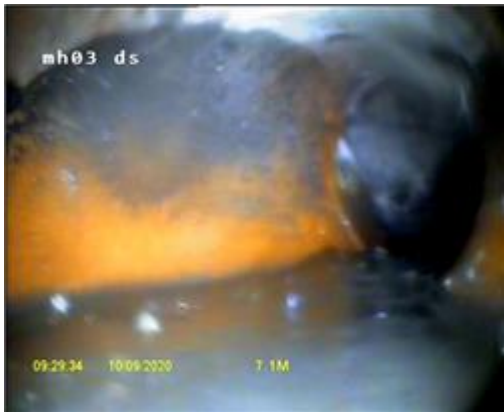
| Pos | Video Ref | Code | Cont. | Description | Image |
|---|---|---|---|---|---|
| 07.2m | 0:01:12 | LR | | Line of drain/sewer deviates right | <p>Image Provided - Ref: 7_5</p> |

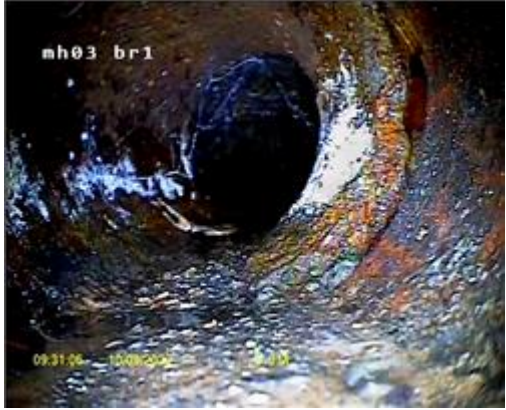
| Pos | Video Ref | Code | Cont. | Description | Image |
|---|---|---|---|---|---|
| 00.0m | 0:00:00 | MH | | Start node type, manhole, reference mh03 br1 | Image Provided - Ref: 8_0<br> |

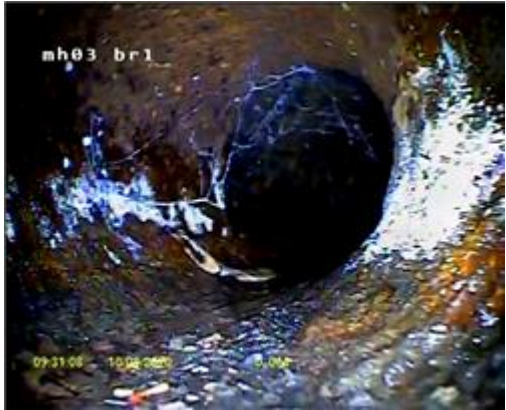
| Pos | Video Ref | Code | Cont. | Description | Image |
|---|---|---|---|---|---|
| 00.3m | 0:00:02 | LR | | Line of drain/sewer deviates right | Image Provided - Ref: 8_1<br> |

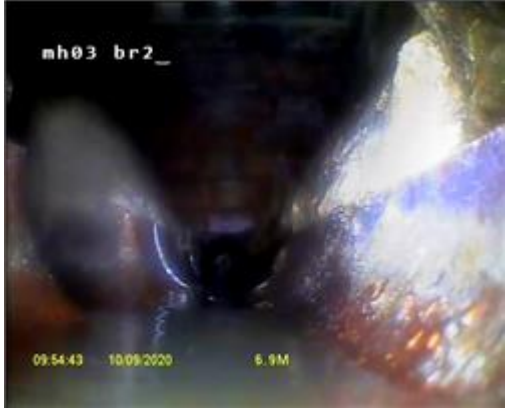
| Pos | Video Ref | Code | Cont. | Description | Image |
|---|---|---|---|---|---|
| 06.9m | 0:00:41 | MHF | | Finish node type, manhole, reference internal mh01 internal mh01 | <p>Image Provided - Ref: 9_9999</p> |
