# Hinckley Cottage Hospital Mount Road, Hinckley Leicestershire

*Historic Building Recording and Investigation (Level 3)*

*Report prepared for:  
NHS Property Services*

CA Project: MK1187

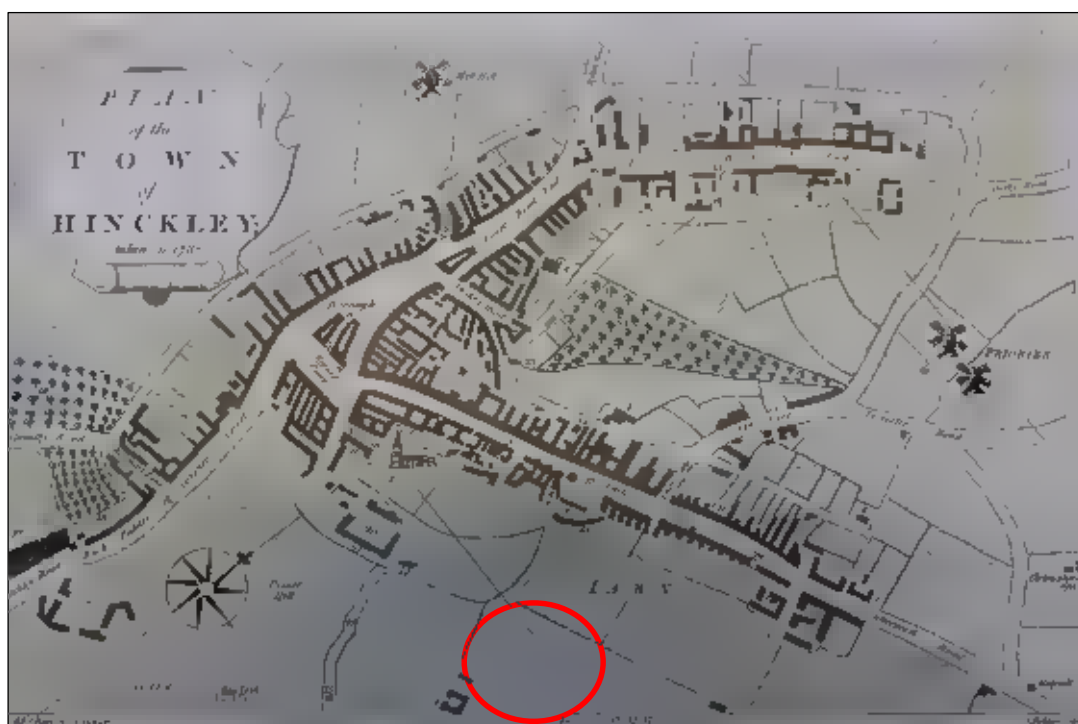
Fig. 2 1782 map by J Robinson (approximate area of the Site circled in red)

4.7. During this period, and as was occurring across the country, Hinckley's open land was enclosed by an Act of Parliament in 1759 and though cartography does not exist from this period, a map of 1782 by J Robinson (Fig. 2) does show the northern part of the Site of the building within enclosed land and describes it as 'lawn', which generally refers to grassy ground indicating it was likely in use as pasture at this time. As later mapping indicates (see Fig. 5), the Site included part of a farmstead at this time, possibly comprising a barn or similar outbuilding, with the house and probably attached outbuildings to the south. Unusually, the Tithe apportionment does not include any reference to these buildings. No above ground remains of any of the former farmstead buildings survive and negligible below ground remains of such structures is anticipated.

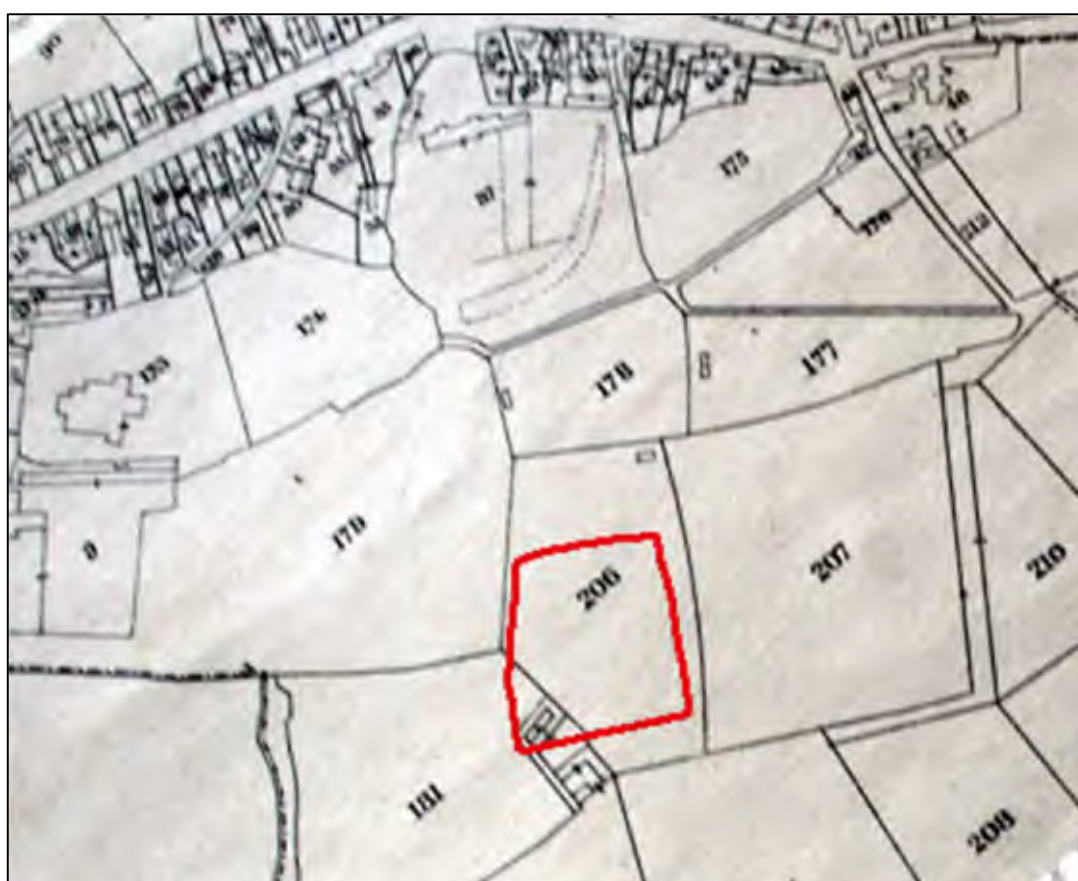
Fig. 3 The 1844 Tithe map (reproduced from the Genealogist – Crown copyright. Reproduced courtesy of the National Archives, London and database rights 2025)

4.9. Cartographic evidence chronicles the expansion of the town. On the 1844 Tithe map (Fig. 3) the Site and its environs is under the ownership of William Orton (Plot 205, site of the car park) John Power Esquire (Plot 207 'the lawn'), Thomas Smith (Plot 206 'mount piece') and Nicholas Hurst (Plots 177 'hovel lawn close' and 178 'first lawn'), who was the owner of the castle mound lands and Castle Hill House. There are two new buildings depicted within the Site at this time. The northern-most of these buildings within 'hovel lawn close' is likely to be a 'hovel', i.e. a simple shed/outbuilding with may have been used to shelter animals or for storage, from which the field derives its name (Field 1989; '*grass ground or land containing a shed*'). The southern building within the Site appears to be a similar structure and the reference to lawns and thus pastures indicate both were likely animal shelters.

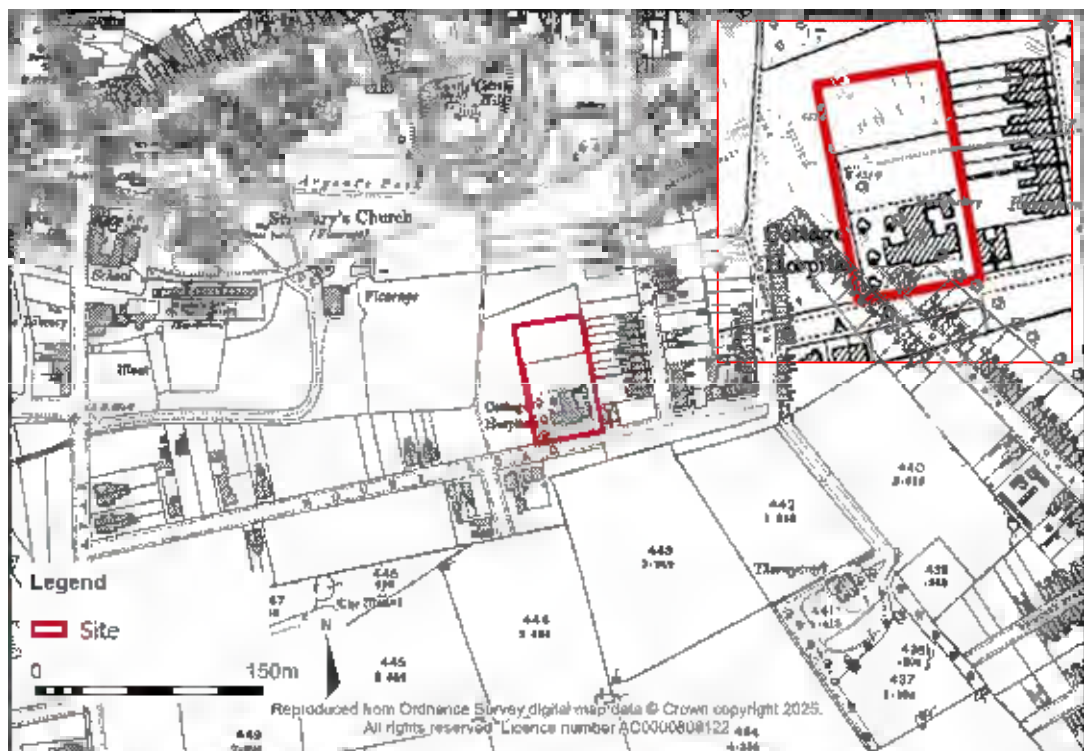
Fig. 5 Extract of the 1903 Ordnance Survey map

- 4.11. In 1903 (Fig. 5) the 2nd Edition Ordnance Survey map illustrates that Cottage Hospital has been built in its earliest plan form, and terraced domestic development has occurred along the roadsides of Hill Street and Mount Lane, five of which were included within the present Site boundary. The previous field pattern of earlier maps has been broken up with the urban expansion of the town, and the small building in the north of the Site environs has been demolished and its location incorporated into the rear gardens of the three new detached houses built in the north of the Site.

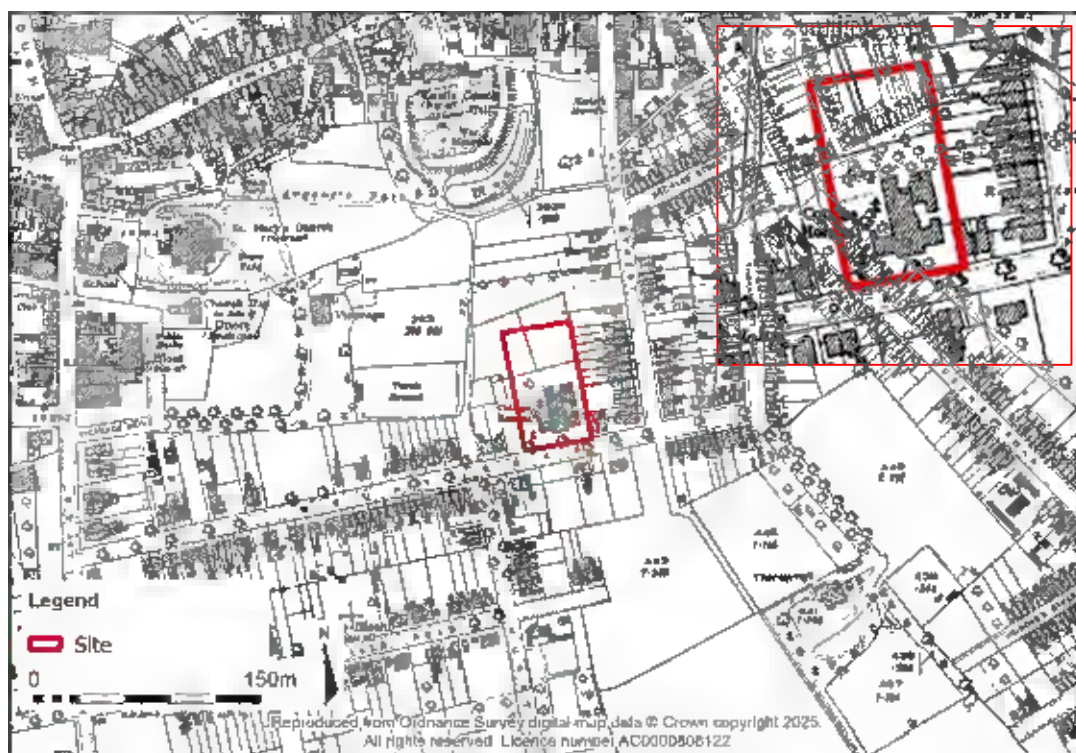
**Fig. 6 Extract of the 1924 Ordnance Survey map**

- 4.12. The hospital has clearly been extended northwards by 1924 (Fig. 6), and considerable further residential development has occurred adjacent to the Site and within the study area. This includes extensive new terraced and detached buildings on Mount Road and Thorneycroft Road (was Mount Lane)..

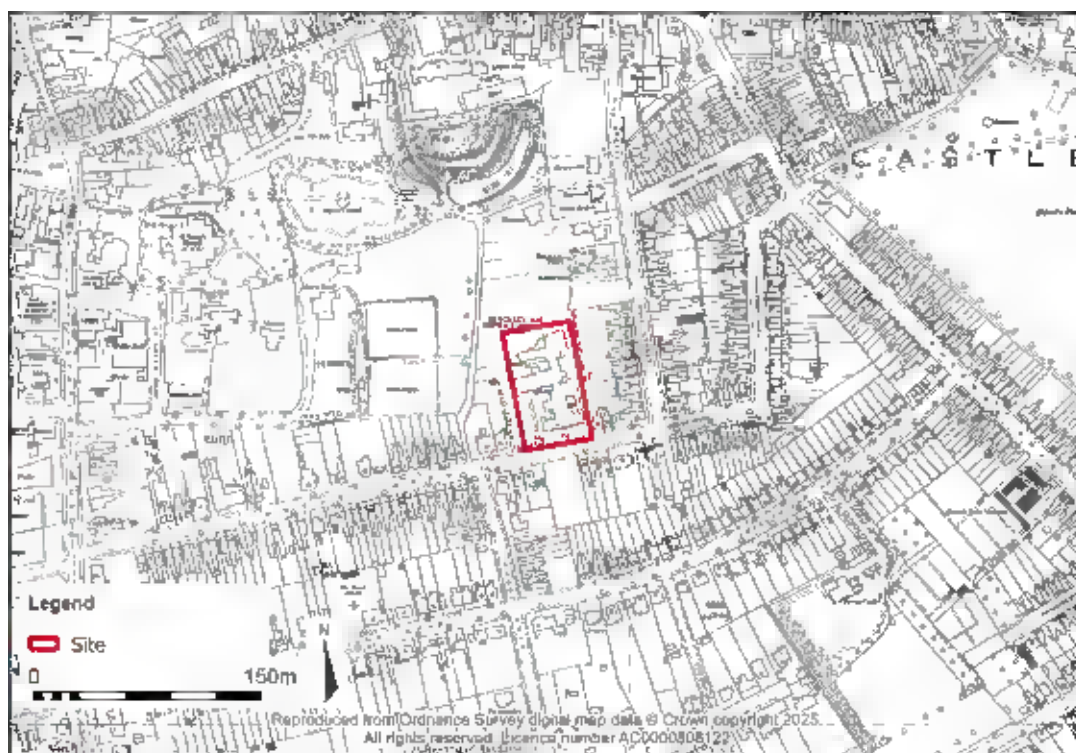
**Fig. 7 Extract of the 1961 Ordnance Survey map**

- 4.13.** Maps of the 20th century (Figs. 6, 7 and 8) detail the expansion of the hospital part of the Site. The 1961 Ordnance Survey map shows the greatly extended Cottage Hospital, with open land, likely gardens, occupying much of the north of the Site and what looks to be a semi-detached pair of dwellings in the south-west corner of the Site. The detached dwellings on Hill Street in the north-east corner of the Site environs remain extant but have been altered and incorporated into the hospital function as they are labelled as Nurses Home and Rehabilitation Centre. The dwellings in the south-east corner of the Site appear to remain as private homes at this time.

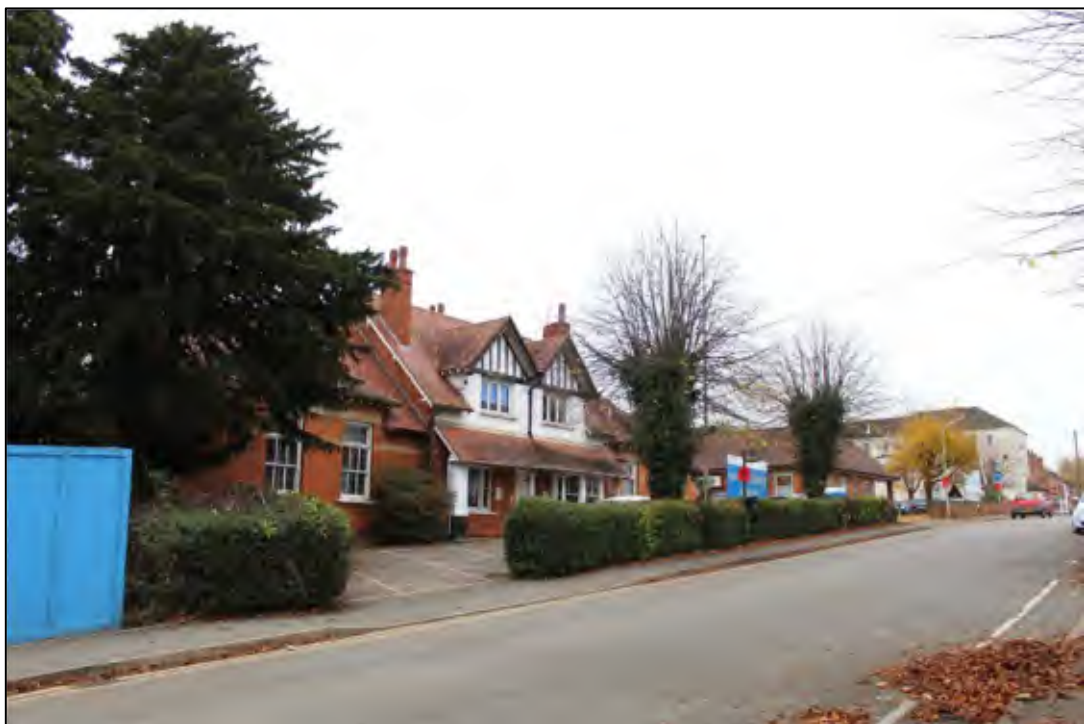
**Photo 3**  
**east**

**Principal (south-east) elevation as viewed from Mount Road, looking north-**

- 5.7. The principal elevation is the south-west facing elevation, and overlooks Mount Road (Photos 3 and Photo 4). This elevation was specifically designed to look like a domestic building in an Arts and Crafts style, rather than having an 'institutional' type of appearance. It is also the most decorative of the elevations, featuring brick dentil detailing beneath each window; carved sandstone lintels and yellow brick string courses to the side wings, and leaded light windows to the central section. The walls are of red brick laid in English bond, and the roofs are of gabled form with red tiled covering; the roofs have overhanging eaves with protruding and exposed rafter feet which seems to be a specific feature.

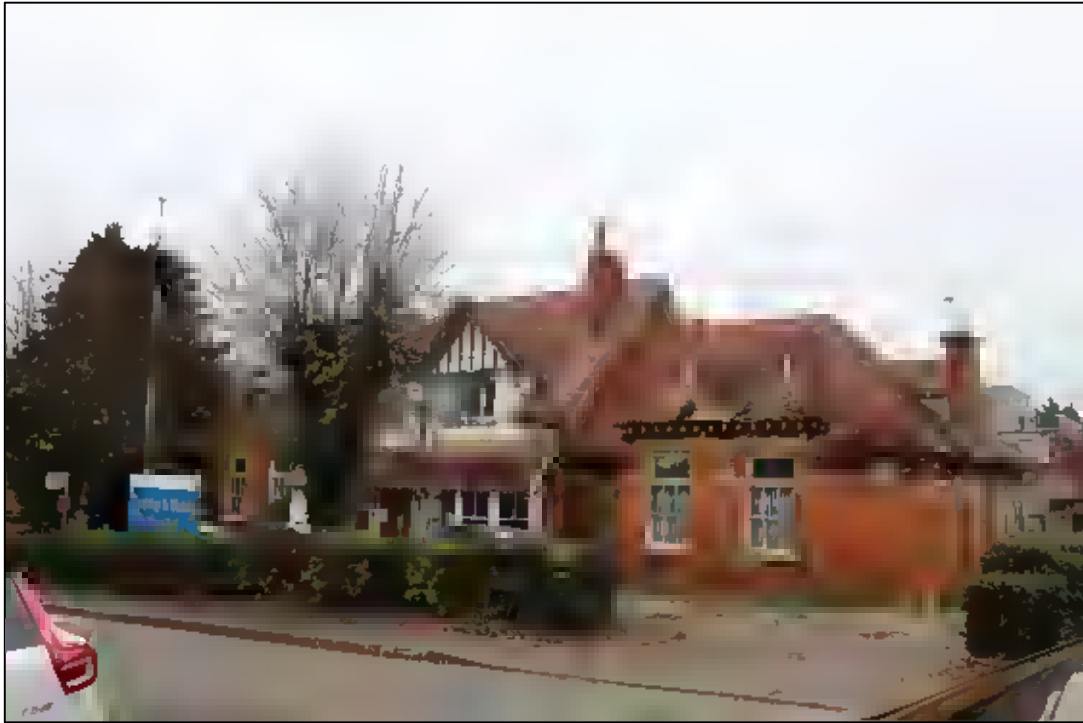
**Photo 4**  
**west**

**Principal (south-east) elevation as viewed from Mount Road, looking north-**

**5.8.** The principal façade (Photo 4) is six bay symmetrical arrangement with two wings and a two bay projecting central section. The central two bays are of two-storey height, while the flanking wings are of one-storey height, albeit with high roofs/ceilings to accommodate the ward rooms (see Fig. 12). The central section is of red brick to the ground floor level, with painted roughcast render to the first floor (Photo 4). The central section has a double gabled roof with Tudorbethan stud detail, beneath which are two windows at first floor level; these are later replacements with metal frames and tripartite casements.

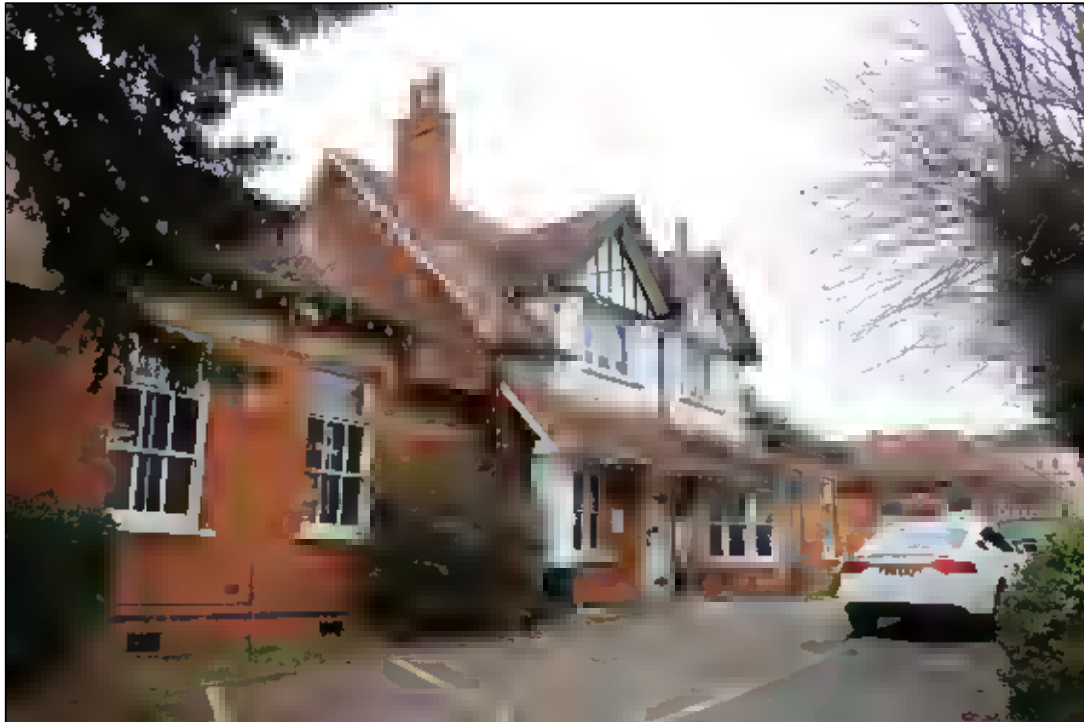
**Photo 5** Principal (south-east) elevation, looking north-east

**5.9.** The central section has a covered entrance veranda supported by plain timber columns with square detailed capitals and plinths (Photos 5 and 6). This was the original and main entrance into the cottage hospital, and has remained relatively unchanged from its original 1900 construction. There is a projecting 3-light bay window to the left of the entrance door (Photo 6), which is a sturdy timber boarded door with decorative black ironwork hinges and door furniture. The bay window on the north side has three large sliding 1/1 sashes with horns, with the upper panes made up of rectangular lead lights (Photo 7). The window left of the entrance door is tripartite 1/1 sash with horns and lead light detail in the upper panes (Photo 7).

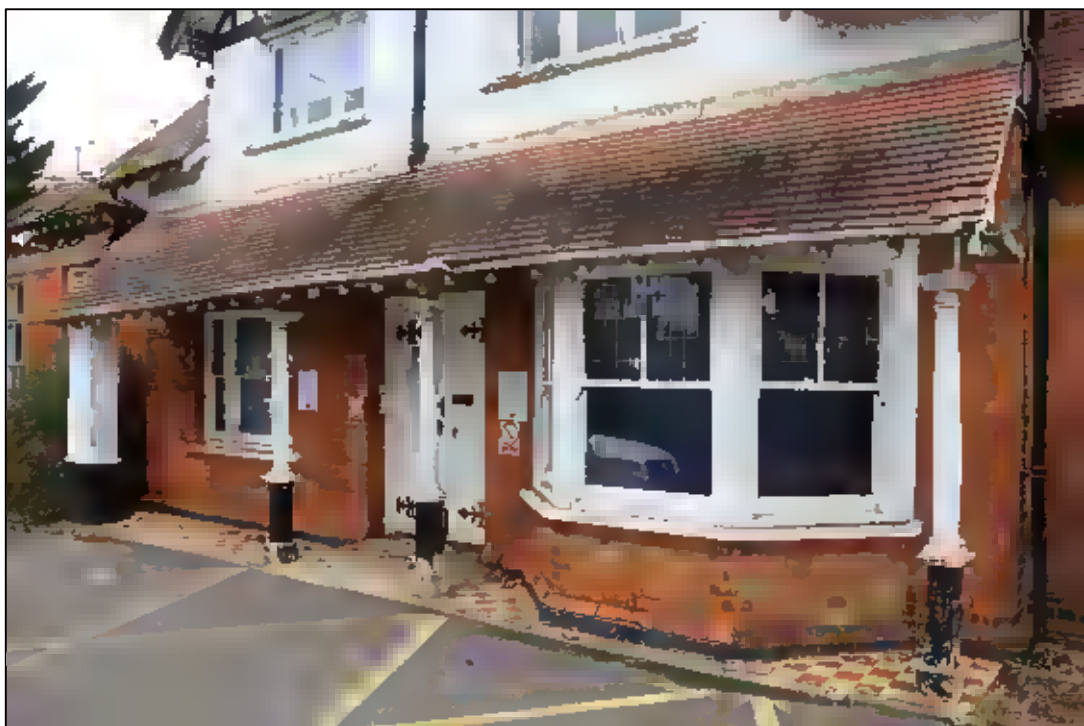
**Photo 6** Principal (south-east) elevation: central entrance

- 5.10.** A concrete ramp leads to the main entrance door, which is a later addition, and the original tiles survive to each side of the ramp, consisting of red and cream tiles in a chequerboard pattern. At the ground floor level, there is a row of red canted bricks,

below which is a line of engineering bricks, which is likely to protect from water ingress as well as a decorative detail (Photo 6).

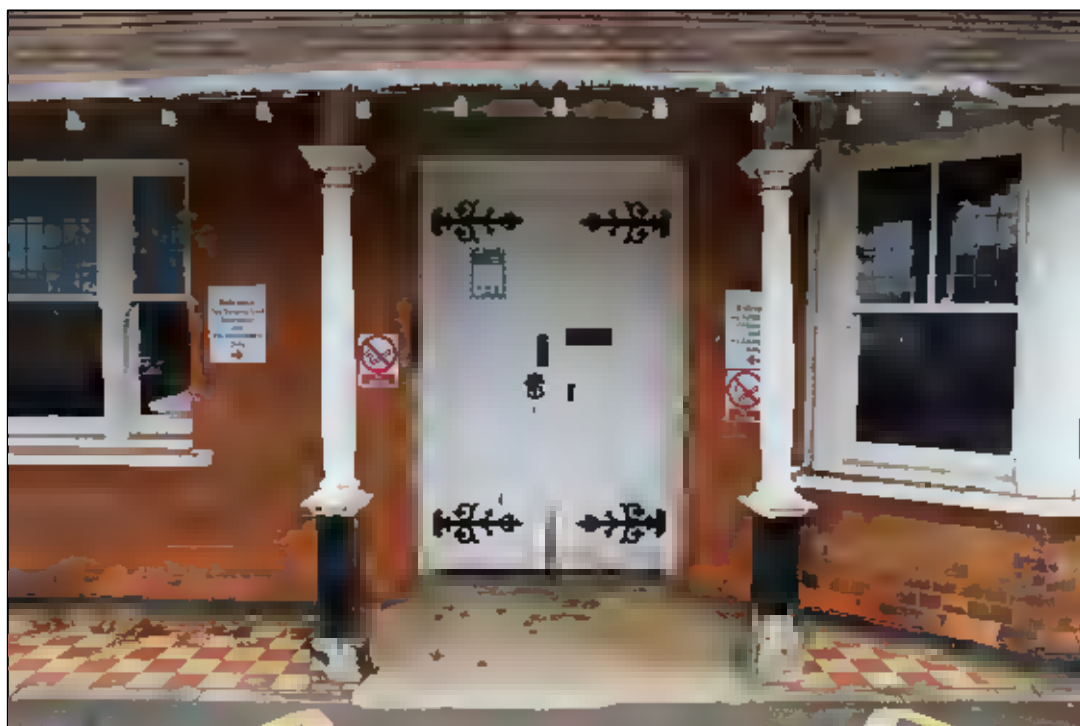
**Photo 7** Principal (south-east) elevation: entrance doors

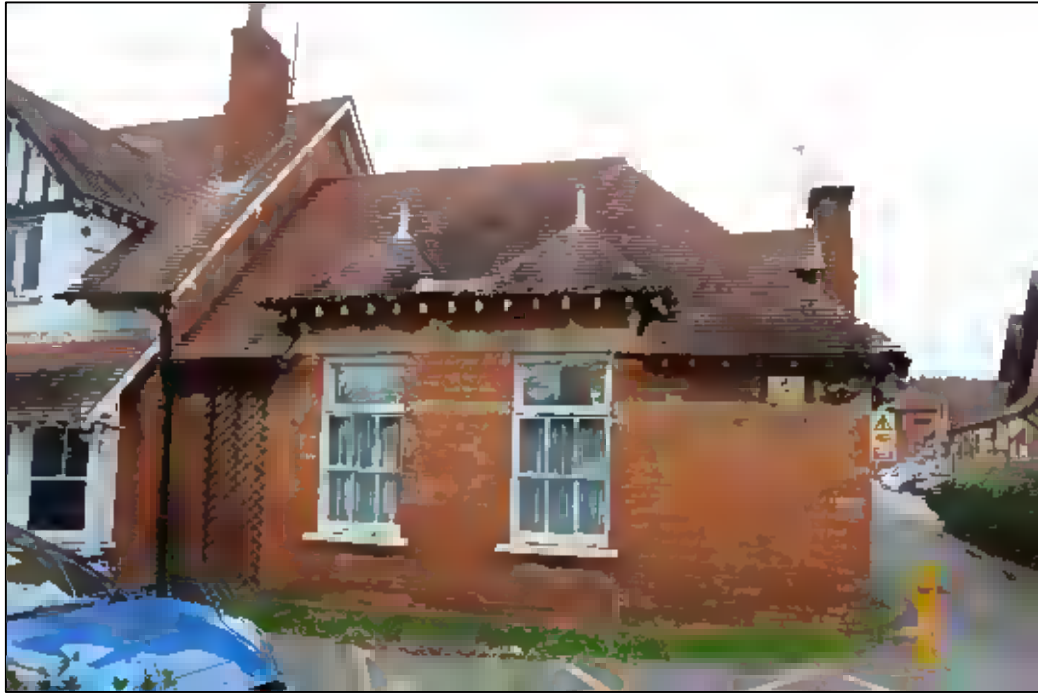
**Photo 8** Principal (south-east) elevation: north side

- 5.2. Various windows have been replaced in ad hoc styles and materials, with a mixture of original timber sashes, Crittall and uPVC, though again the principal front elevation appears to retain the original timber sashes (3/3 with a top light on the wings and horns), albeit in poor condition (Photo 8).

**5.11.** Each flanking wing is made up of two bays, with a gabled roof structure. Each wing also has projecting roof dormers with decorative finials (Photo 8), which align with the windows below. The north wing has two timber windows formed of 3/3 sashes, with a hopper casement window over (Photo 8). The elevation has a decorative band formed of two rows of yellow bricks (Photo 8) and decorative sandstone detailing above the windows.

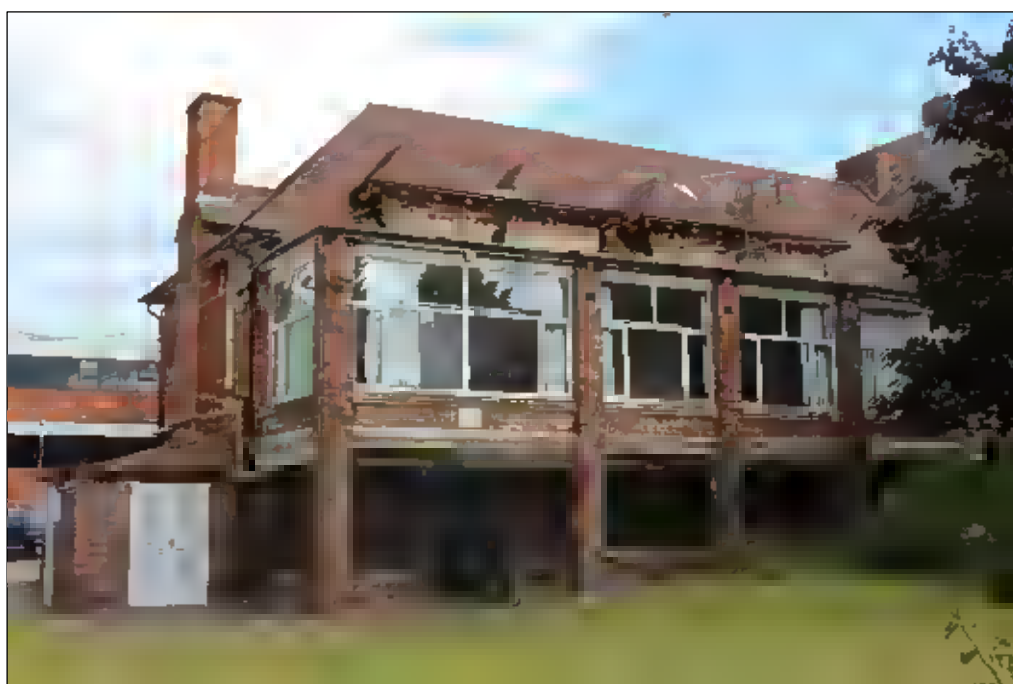
**Photo 10**      **View of the Atkins ward, c. 2019- looking north-east**

- 5.15.** At the time of the survey, some sections of the building on this elevation had already been demolished, including the records wing and the Atkins ward (see Fig. 10). The main photographs have recorded the elevation after this demolition, however Photo 10 (taken in 2019 on an earlier site visit) shows the Atkins ward as it appeared before demolition. The former Atkins ward was added in 1938, and at this date was built to function as the women's ward. Plans from 1937 detail and specify the joinery for a new set of verandah windows attached to the 1938 extension (see Appendix 2). These were replaced in later years with what looked to be uPVC windows. The Atkins ward also had decorative details which reflected the first 1900 phase of the building such as the double gable features to the roof level.

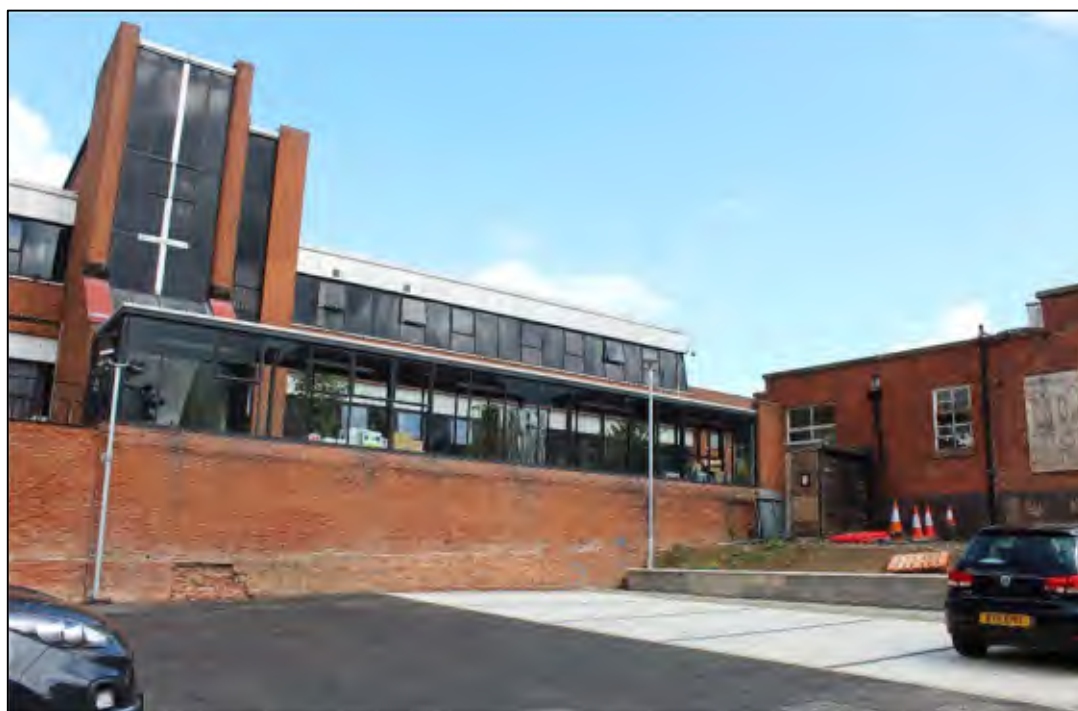
**Photo 11**      **South-west elevation: view of glaze link, looking north**

- 5.16. The glazed link was added in 1978 to connect the cottage hospital to the new health centre (see Fig. 10). Due to the changing ground levels the link is slightly higher than one-storey level, and is formed of a red brick foundation laid in stretcher bond, with a metal-framed, glazed covered corridor above (Photo 11).

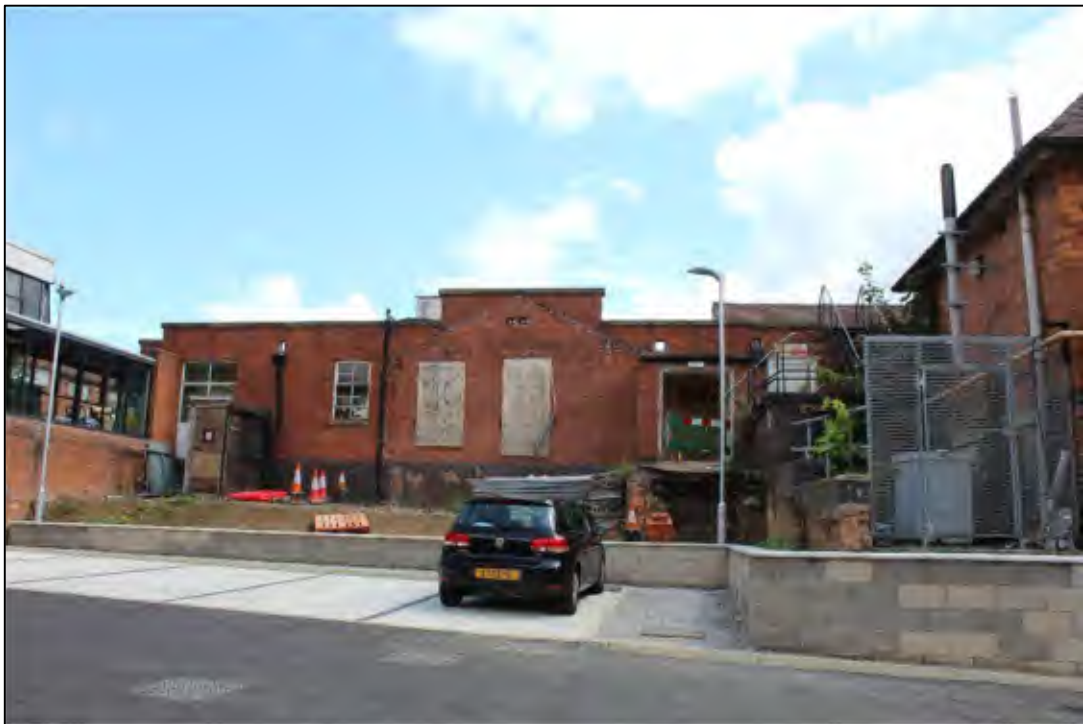
**Photo 12**      **South-west elevation: north section (1938 phase)**

- 5.18. At the time of recording in 2025, there was an exposed gabled brick section in the centre, with two boarded up windows, which is where the demolished records wing was formerly located (Photo 12). Photo 13 depicts this wing in 2019 before it was demolished. It was two-storeys in height, with a gabled roof. The walls were of red brick laid in Flemish bond, and the upper level was covered with external weatherboarding; a slightly unusual feature not seen anywhere else on the building. The windows appeared to be the original 1930's, 12-light Crittall windows with one small opening hopper at the centre top of the window. There was also an external

- 5.19.** Immediately to the south of this structure was a flat-roofed projecting section with an open doorway; this once provided external access from the hospital via a flight of stairs which has also been demolished. It also has a south-facing window, and former entrance on the north-facing wall which formerly gave access to the records wing (Photo 12).

- 5.20.** To the south of this entrance opening there are three timber framed sash windows; the north window is of the 3/2 light arrangement seen elsewhere on the building, while the other two windows are of a more simple 1/1 arrangement. All have simple timber lintels and canted brick cills, and these appear to date to the original 1938 phase build. There is also a cast-iron hopper head and downpipe against this wall with decorative detail, including a rose symbol (Photo 12 and Photo 14).

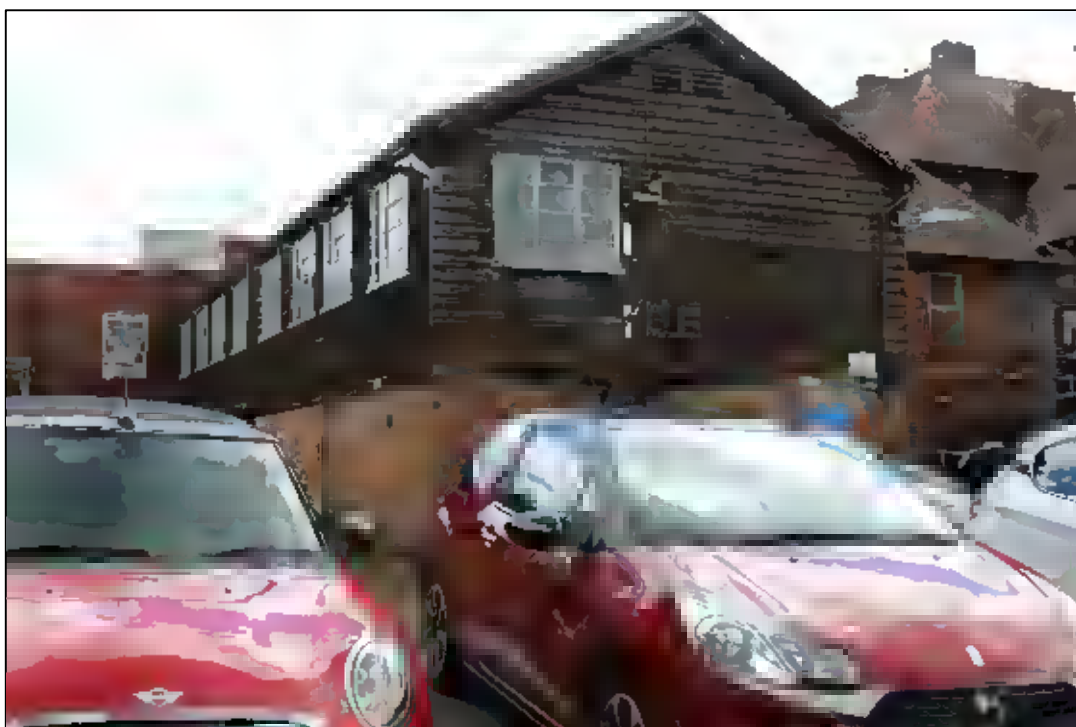
**Photo 13** View of the former records wing c. 2019, before demolition

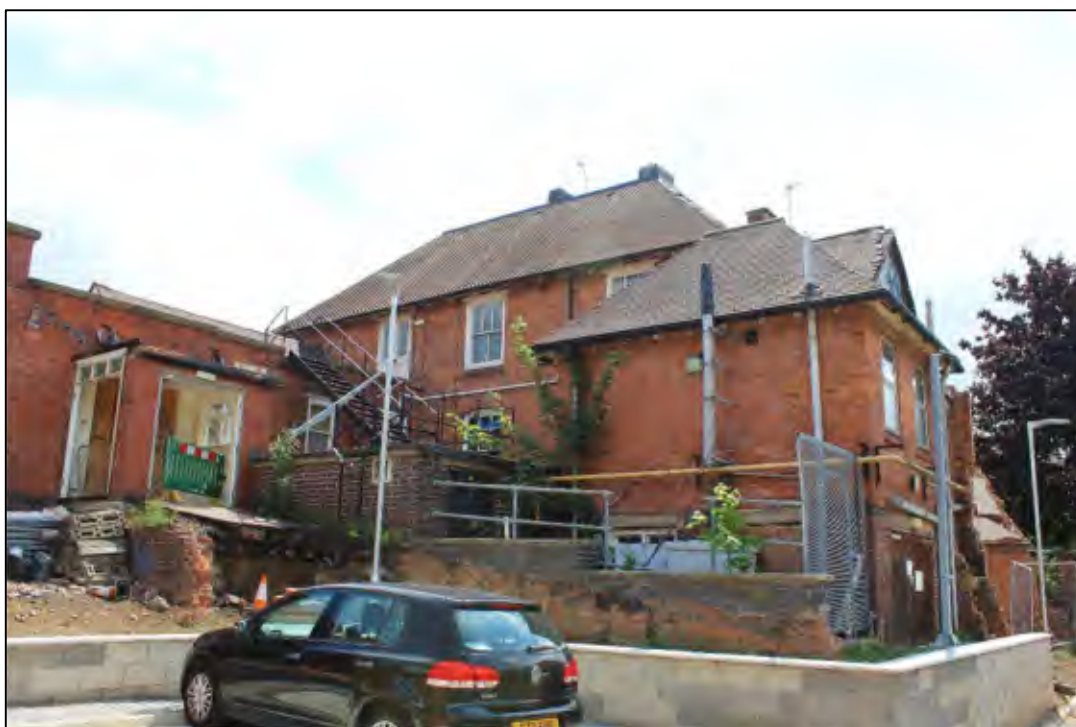
**Photo 14**      **South-west elevation: 1938 Phase, looking south-east**

- 5.21.** There is also a metal access stair to the roof at this location, which was likely added at a later date for service and roof access. Below this at ground floor level is a single-storey, projecting brick structure of blue engineering brick with a flat roof. This was not accessible at the time of survey, and does not appear on floorplans; there did not appear to be any internal access to this structure (Photo 14). It may have been used for storage or to house plant/equipment related to the hospital services.

- 5.22.** Further south is a projecting section of the elevation; there is a two-storey part at the rear (west), and an additional two-storey section attached on the west side. The higher two-storey section at the back comprises a ground floor and first floor level. The section at the front, although it is two storeys in height, actually comprises the basement on the lower level and the 'ground floor' on the upper level; this is due to the changing ground levels on the Site (Photo 14).

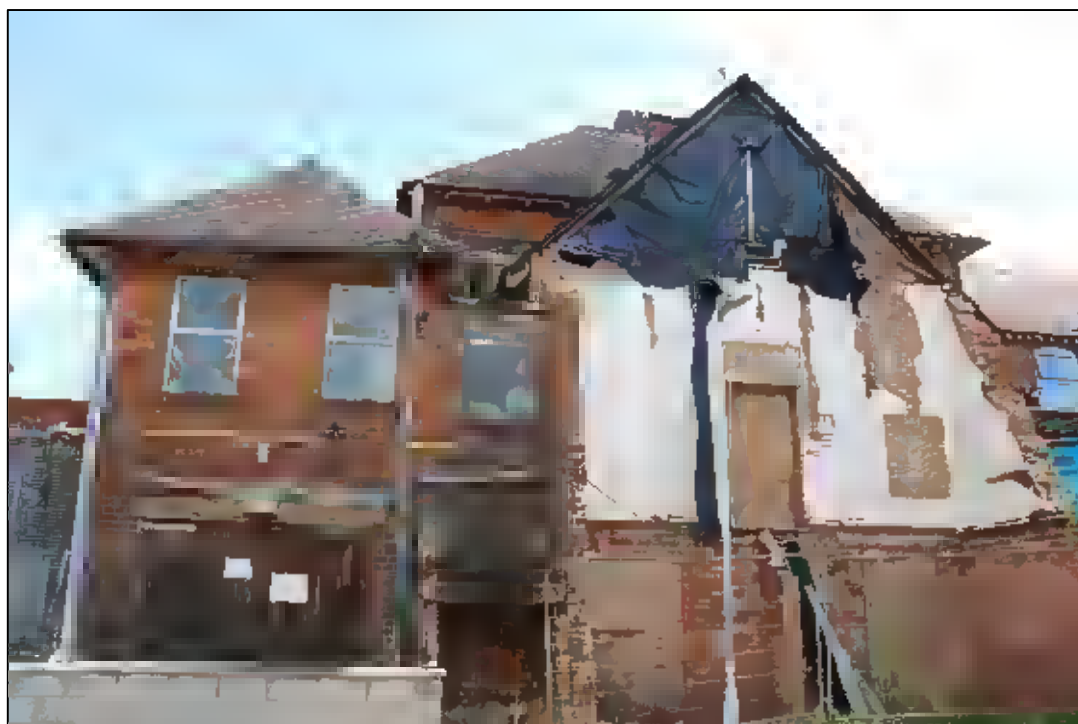
**Photo 15**      **South-west elevation: 1939 phase, showing demolished area**

- 5.24.** The south-facing wall is where the Atkins ward was formerly attached, and has now been demolished, leaving an exposed gabled section (Photo 15). There is a blocked single door to the upper (ground) level, and two blocked single openings to the basement level. The exposed wall sections show that the walls here were solid brick of 1.5-brick thickness (Photo 15).

- 5.25.** To the north of this area, there are three simple 1/1 sash windows to the first floor, and a third casement window in the centre; all of these are likely later replacements (Photo 15). There is a set of double-leaf timber doors with concrete lintel over at ground floor level; to the south of these doors is an opening in the building structure which is the remnants of a demolished staircase, with several surviving reinforced

concrete steps at the top. The presence of this staircase and its former use is unclear, as it does not appear to give access to anything at the upper level; it is possible that there was formerly a doorway where the casement window is now located.

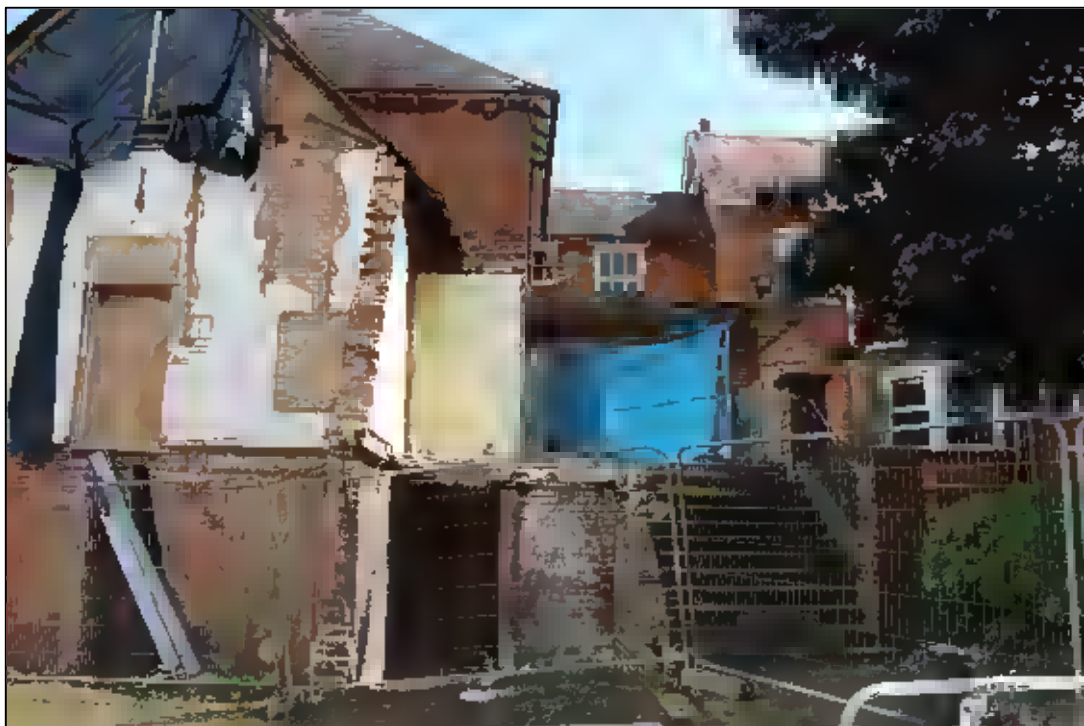
**Photo 16**      **South-west elevation: 1928 phase**

**5.27.** To the south of this area is another external staircase which gives access to the interior of the building (Photo 16). The original 1938 plans show the staircase but does not indicate the reason for including it, and it was probably built to provide another entrance and exit to the building and improve circulation. The steps are cement or concrete, with brick parapet walls, brick pillars with flat concrete or stone caps, and metal handrails. The entrance to the building is a projecting, single-storey brick structure with a hipped roof over which is a surviving part of the verandah (Photo 16). The entrance is formed of uPVC glass doors with flanking glazed panels which are relatively recent replacements. There is a uPVC window to the south-facing return

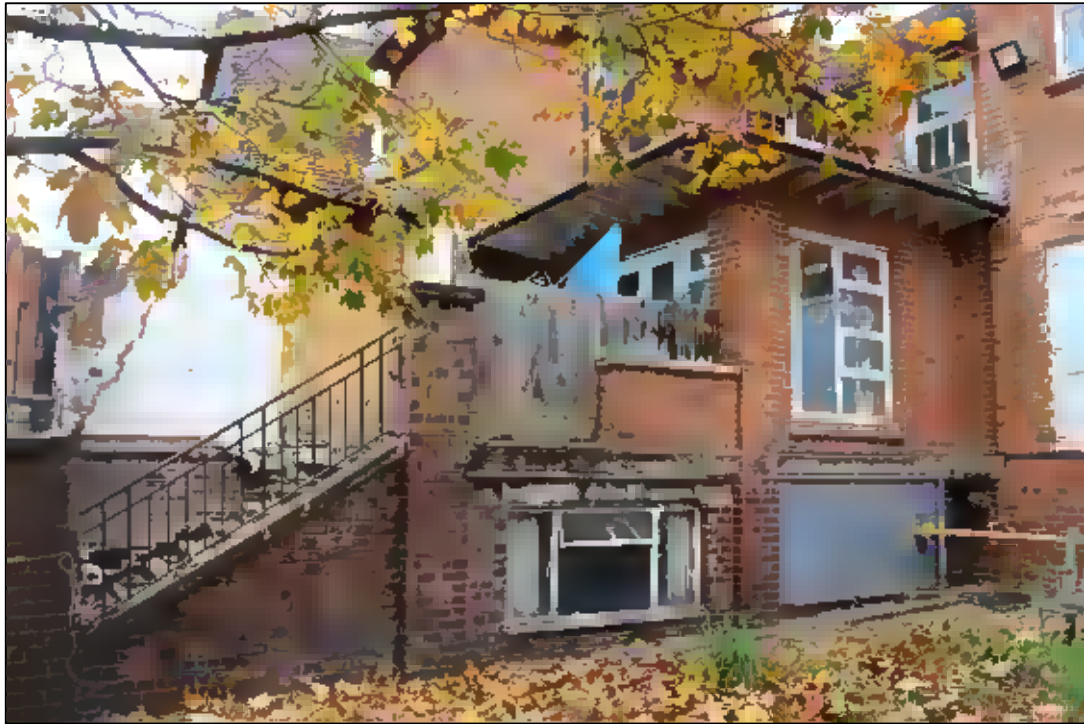
**Photo 17**      **South-west elevation: Detail of external stairs**

**5.28.** There is a metal-framed tripartite casement window with small top-hung opening and safety glass (Photo 17). This is a later replacement, with the typology of the window suggesting that it is of mid-late 20th century date. This window has a concrete lintel above the window with some simple recessed detailing and a tiled cill. There are concrete structural transverse beams in the wall above each window opening. There is some difference in the colour of the brickwork at this lower level, which is darker in appearance than the brickwork on the level above; this may be due to weathering, or suggest that the walls of the entrance area above were rebuilt at some later stage.

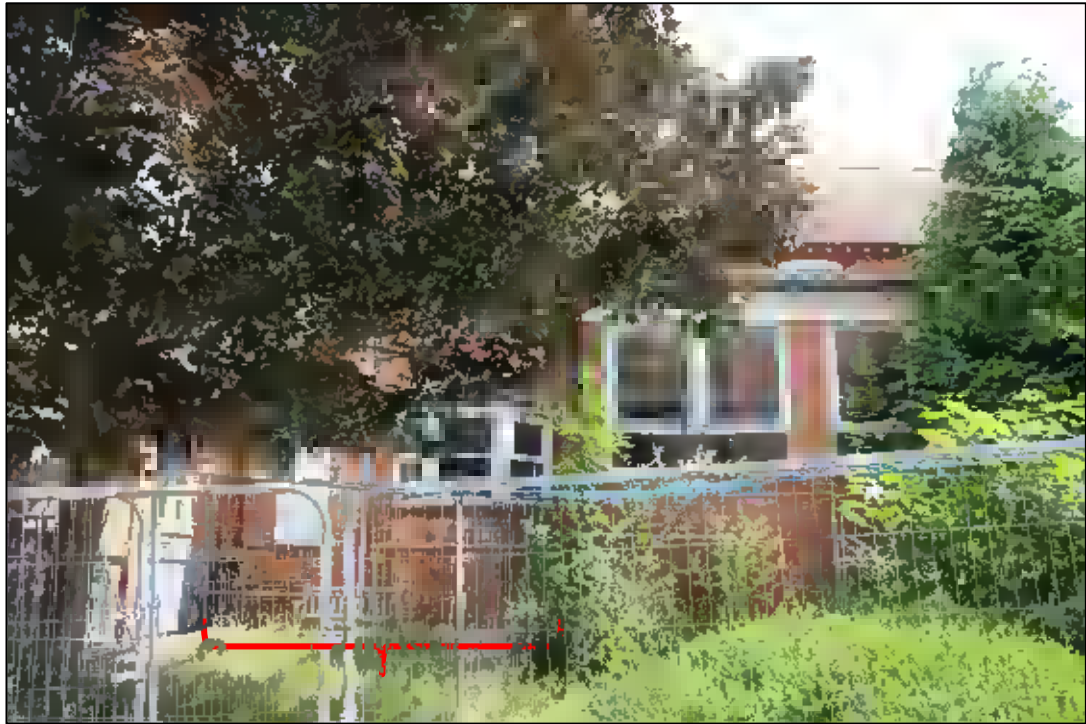
**Photo 18**      **South-west elevation: 1928 phase, indicated in red**

**5.30.** The 1928 phase of the elevation is formed of two bays (Photo 18). To the ground floor there is single door on the north side, which is above ground level and has no external access; it is possible that there was formerly some kind of staircase which has since been removed, and the door has not been used in recent years. To the right hand bay is a canted bay window which has three uPVC casement windows in each section, with leaded light upper panes. There are three windows to first floor level; these are all uPVC replacements, although they appear to be in the original window openings with thin concrete or cement cills with brick dentil detailing below, and arched brick lintels above.

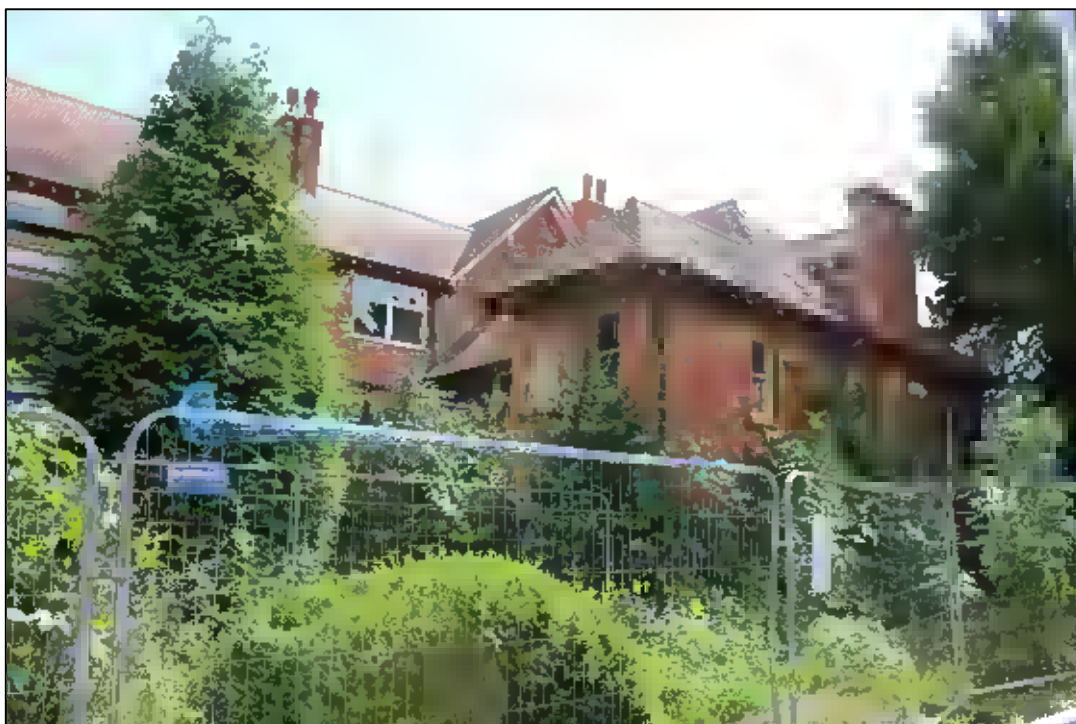
**Photo 19**      **South-west elevation: 1900 phase, looking south-east**

- 5.31.** The last part of the elevation is comprised of the original 1900 build (Photo 19). It is formed of seven axial bays, and has sections of both one-storey and two-storey height with a series of intersecting gabled roofs. At the north end are two bays, with the ground floor level actually comprised of a single-storey 1938 extension to house the new children's ward (Fig. 10). This section is also of red brick in Flemish bond; there are two windows to the north-facing return wall, two at the west-facing wall, and one on the south-facing return wall. All windows are tripartite casement uPVC windows which are relatively recent replacements. The first floor bays are the 1900 part of the building and there are three windows which are relatively recent uPVC replacements, although within the original window openings with thin concrete or cement cills with brick dentil detailing below, and arched brick lintels above. There is a small brick chimney stack to the roof level above.

- 5.33.** The projecting wing of the building, which houses the ward, although it appears to be at a higher level above the ground, is actually comprised of one internal floor level (Photo 19). The north-facing return wall of the ward section has two windows formed of 3/3 sashes, with a single fixed panel over. This is the same style as those seen on the flanking wings of the principal elevation, and are believed to be from the original 1900 build.

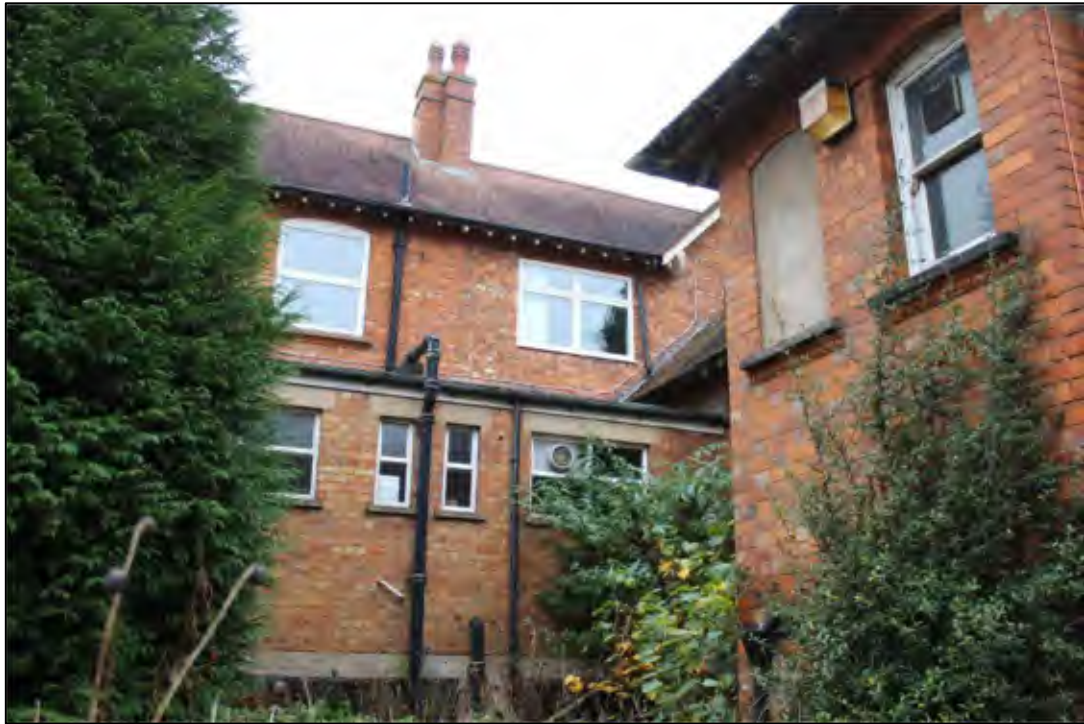
**Photo 20**      **South-west elevation: 1900 phase, looking south-east**

- 5.34.** The ward wing has a projecting section at its north end, which has one window to the east-facing return wall, and two windows to the north-facing wall at the upper level (Photo 20). One of the windows is boarded over and possibly missing. The other is a 1/1 timber sash with horns; both window openings have arched brick lintels and slim concrete cills with brick dentil detailing below. These windows appear to be original.

- 5.32.** There are two bays on the section between the children's ward and the projecting part of the elevation which houses one of the original ward rooms (see Fig. 10). There are four small casement windows to the ground floor; which appear to be later replacements, with concrete lintels and slim concrete cills. Beneath these windows at basement level is an exposed structural concrete beam, with two openings below covered by metal grilles (Photo 20). There are two windows to the first floor, one

arched and one flat-headed; both of these are later uPVC replacements. There is a brick chimney stack to the roof level above (Photo 20).
