# Hinckley Cottage Hospital Mount Road, Hinckley Leicestershire

*Historic Building Recording and Investigation (Level 3)*

*Report prepared for:  
NHS Property Services*

CA Project: MK1187

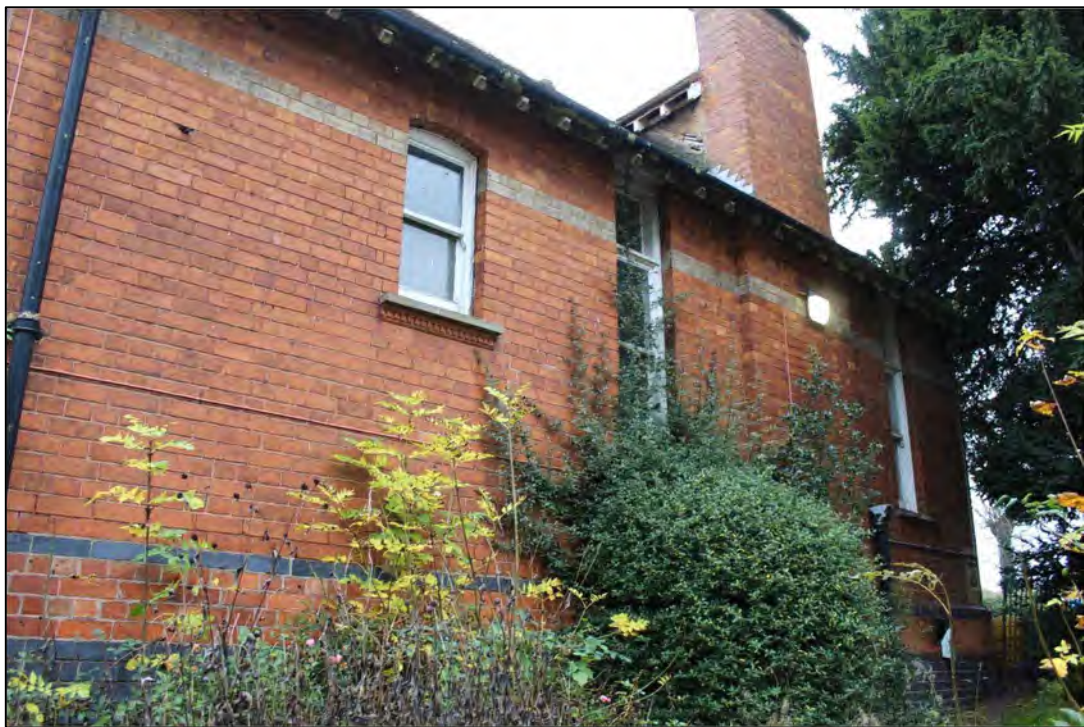
**Photo 21**      **South-west elevation: 1900 phase, exterior of ward**

- 5.35.** The west-facing wall of the ward has an externally protruding chimney breast and a large brick chimney stack above, which was used to heat the ward when first constructed (Photo 21). The wall of the elevation is red brick laid in English bond. There is a projecting brick plinth at ground floor level on the south side formed of a

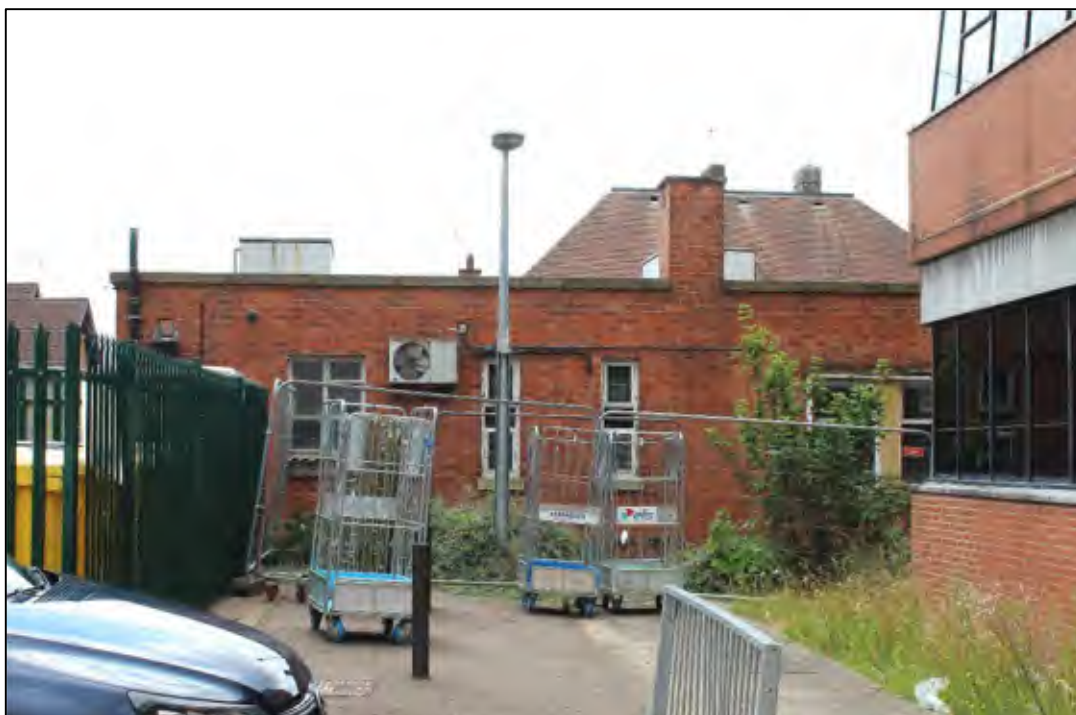
**Photo 23**      **North-west elevation**

**5.38.** The rear elevation is one storey in height and has a simple and utilitarian appearance (Photo 23). The east part of the elevation is comprised of the 1938 extension of the Building, and the west of the brick-built elevation (not visible in Photo 23) is formed of the brick and glass. The wall is formed of red brick laid in Flemish bond, with

cement flaunching at the roof level above a brick parapet which hides the flat roof area. There are three, four casement-style windows with metal frames in varying sizes with concrete or cement cills, and a brick-built chimney to the centre of the brick-built elevation. The glazed link is visible from the west side of the Building and is discussed under the south-west elevation.

4.23. In 1971 the X-Ray department was built on to the east elevation of the cottage hospital. In 1978 the Site was further developed by the addition of the Health Centre (Photos 11 and 23) which was joined to the Cottage Hospital via a glazed link corridor. Further development occurred in 1995 with the addition of the Orchard Resource Centre. A Physiotherapy 'portacabin' building was established in the south-west corner of the Site in the late 1980s; this has also been demolished and replaced with a Diagnostics and Endoscopy building.

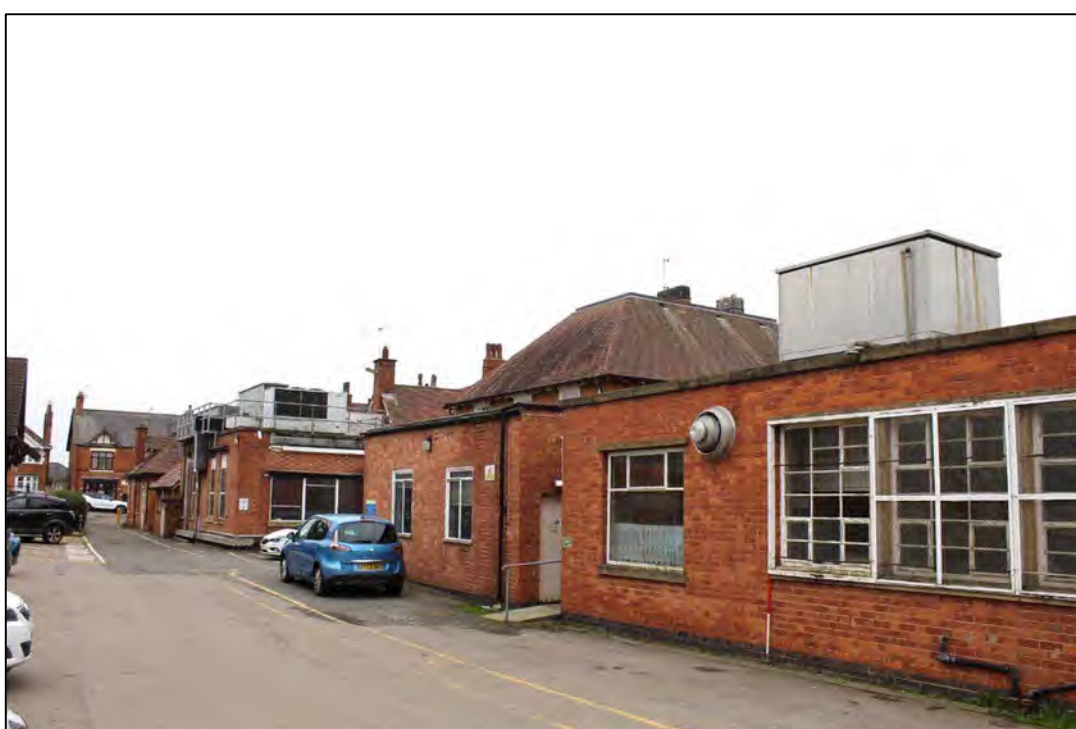
**Photo 25**      **Overview of the north-east elevation, looking south-west**

**5.40.** The north section of the 1939 phase is single-storey in height, with a flat roof structure (Photo 25 and Photo 26). This part of the building houses the kitchen quarters. The walls are of red brick laid in Flemish bond with cement flaunching to the roof level, and three rows of glazed bricks laid in English bond at ground floor level. At the north

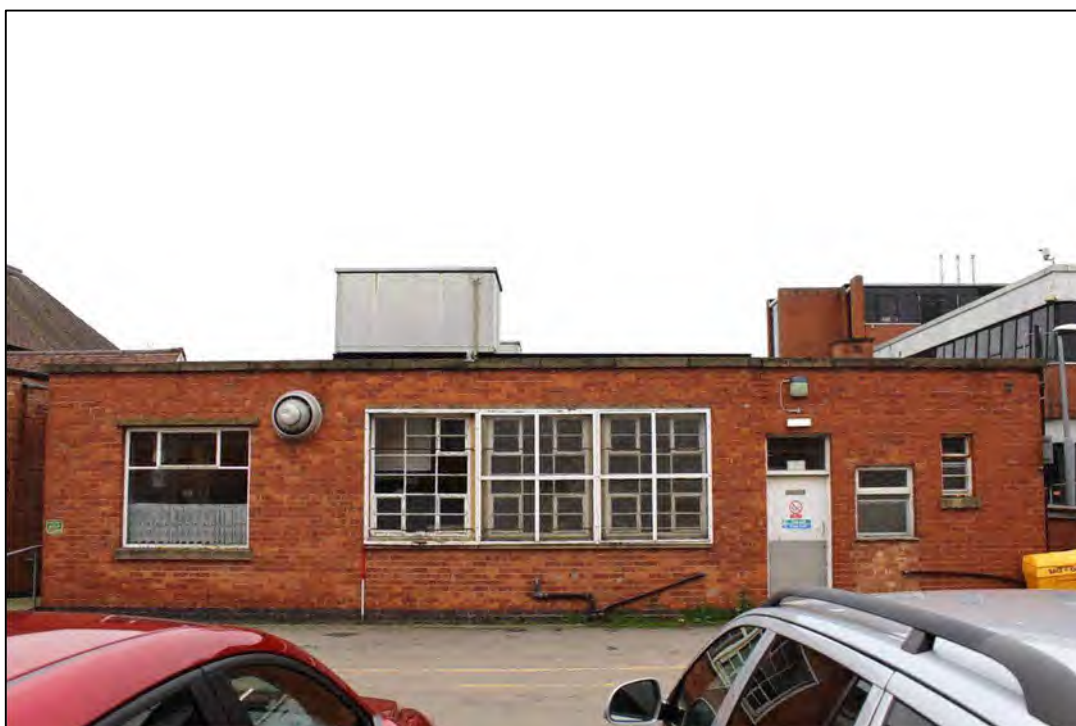
**Photo 26** North-east elevation: 1938 phase, north section formed of the kitchen areas

end there are two windows and a single fire escape access door with glazed panel over. One of the windows is timber framed and one metal framed, and both with two 1/1 arrangement with top-hung casements. The smaller metal-framed window has a substantial cement or concrete cill, while the other does not, which may indicate that one was inserted later than the other. In the centre of this section is a large triple window. Each metal-framed window has 18 lights, with the bottom 6 lights having textured glass, and each window has four small hopper windows to each corner to allow for good ventilation of the interior spaces. This triple window has then been covered over externally by a form of secondary glazing formed of panels of metal framing with metal glazing bars and metal transverse rods, and glass panes. One of the glass panes is missing. This appears to be a later addition, and was possibly added to improve the thermal performance of the 1930s windows.

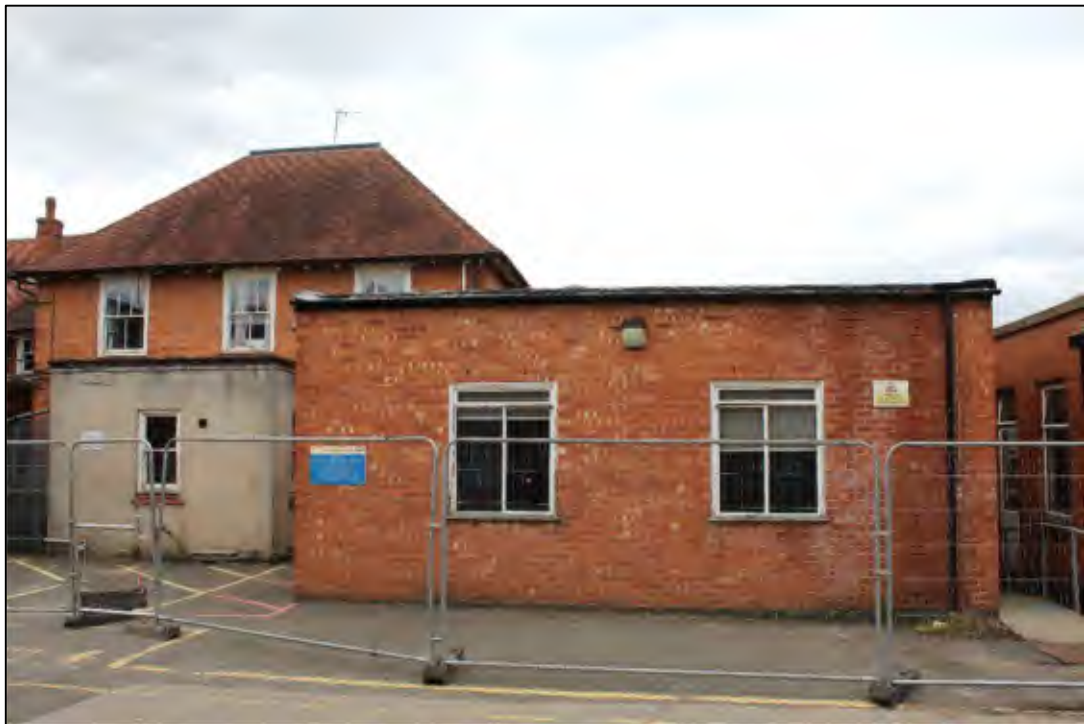
**Photo 27**      **North-east elevation: 1938 phase, central section formed of the x-ray department**

- 5.42. The central protruding section of the 1938 phase houses the X-ray department, and is one-storey in height with a flat roof structure (Photo 27). This, like the others, is formed of red brick walls and is laid in stretcher bond. The north-facing wall had a brick pier to the centre, and a single timber entrance door on the east side (the door is a relatively recent replacement) with a soldier course brick lintel over.

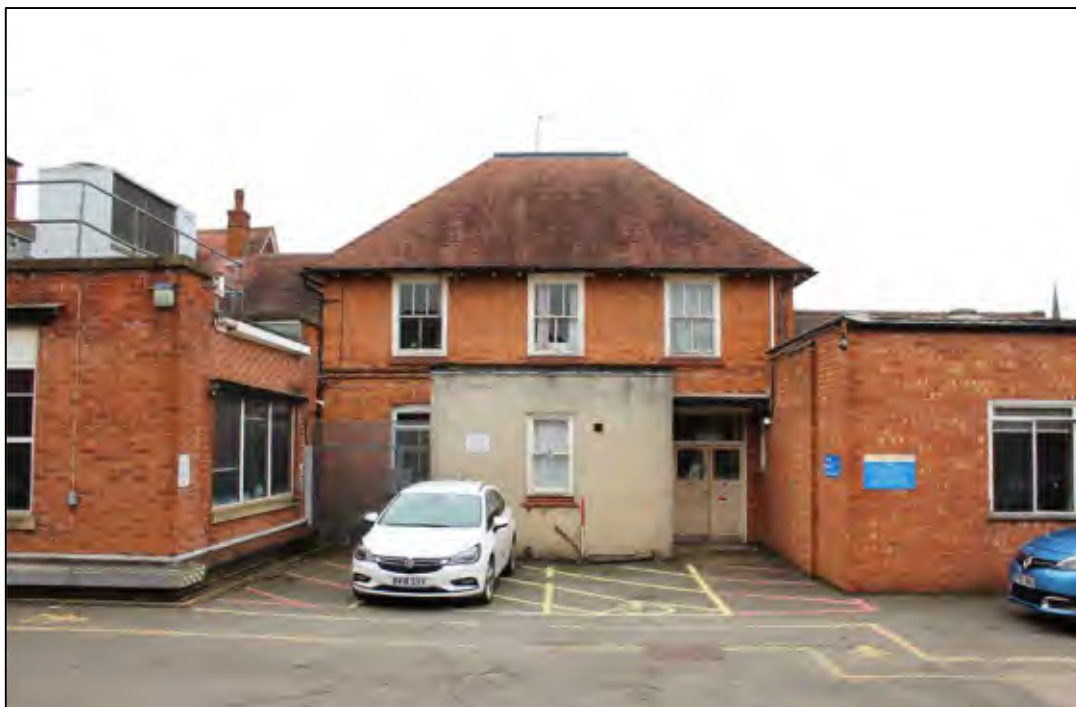
**Photo 28**      **North-east elevation: 1938 phase, south section**

- 5.46. The south bay has one window at ground floor level; it has an arched head with an arched brick lintel, and a slim concrete or cement cill (Photo 28). The window itself is uPVC and the whole window arrangement appears to possibly be a later insert, as it differs in typology from the other windows on this elevation. There are three timber sash windows at first floor level on this section. They are all of 3/2 arrangement with horns, a simple timber lintel, and canted brick cill; these appear to be the original 1938 form.

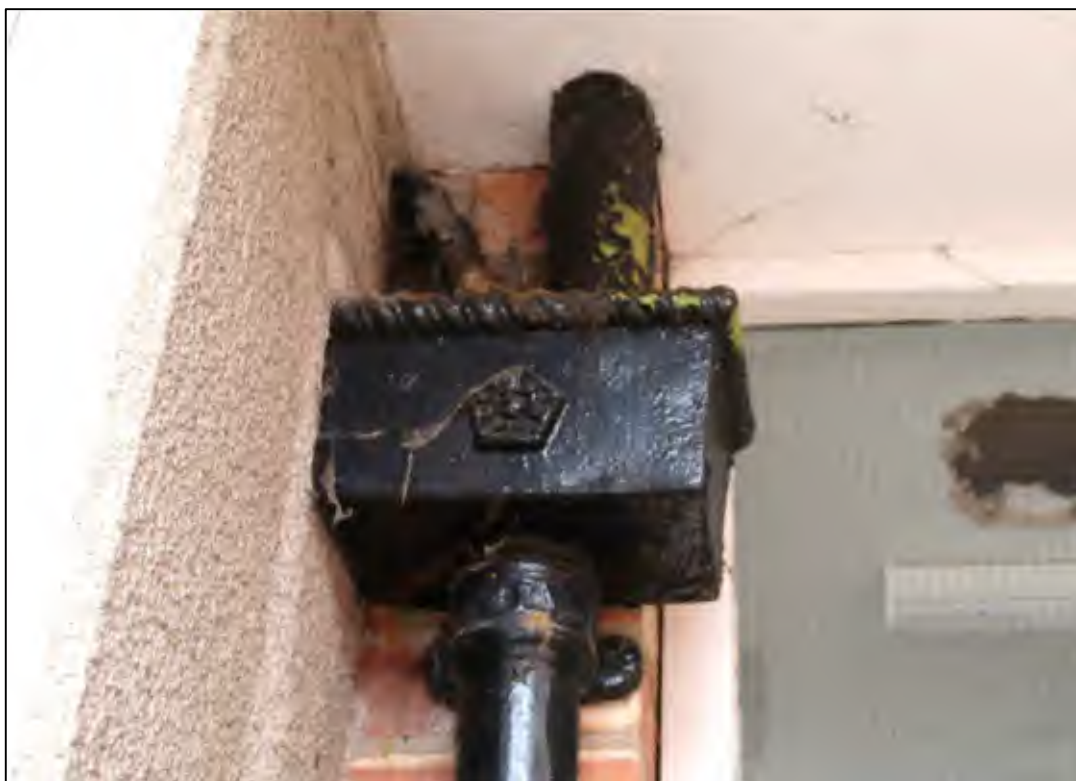
**Photo 29**      **Downpipe detailing with heraldic rose detailing**

- 5.45. The north bay at ground floor level has a timber double access door with glazed panel above, protected by a canopy above which creates a sheltered entrance. When first constructed, the adjacent internal room was a ward, and it is possible that there was a window in this location. In recent years, these doors have given access to the X-ray and ultrasound department reception room inside. To the south side of the doors is a cast iron hopper head and downpipe (Photo 29), with decorative detailing including a rose emblem.

- 5.6. The external fabric is largely red brick in English Bond formation, combined with some sandstone detailing and decorative yellow brick string courses. Brick dentil detailing can also be seen under a number of principal windows and carved sandstone lintels over. The roof coverings are of red clay tile. The building has a variety of external rainwater goods, ranging from the original cast iron with decorative detailing (Photo 29) to modern plastic pipes.

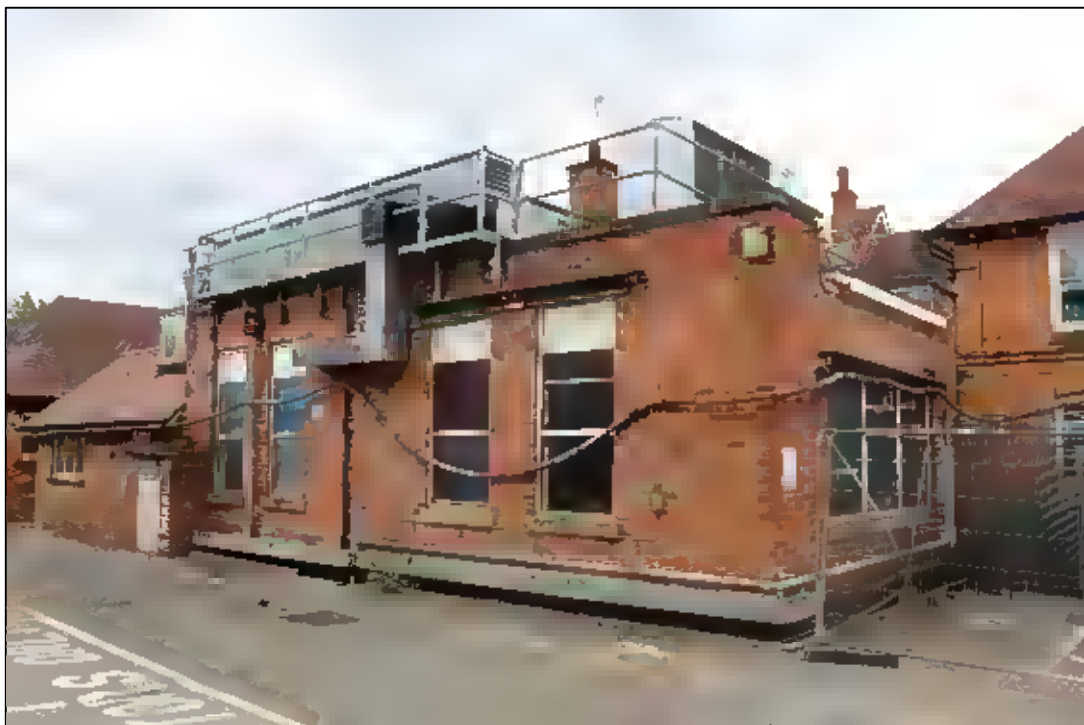
**Photo 30**      **North-east elevation: 1928 phase**

5.48. The 1928 phase of the elevation comprises a projecting one-storey section, with a two-storey level behind (Photo 30). The single-storey section is of red brick laid in Flemish bond, with cement flaunching at roof level and a flat roof structure. There are four windows to the east-facing wall, all identical, comprised of two glazed panels and a 'blind' panel at the top, and concrete or cement cills. These windows appear to be later replacements after the original 1928 build. There is one large tripartite window to the north-facing wall of the same typology. This part of the building has a series of service ducts to the roof and wall, with a metal guardrail at roof level to allow safe service access; these are all later additions to support the functioning of the operating theatre inside.

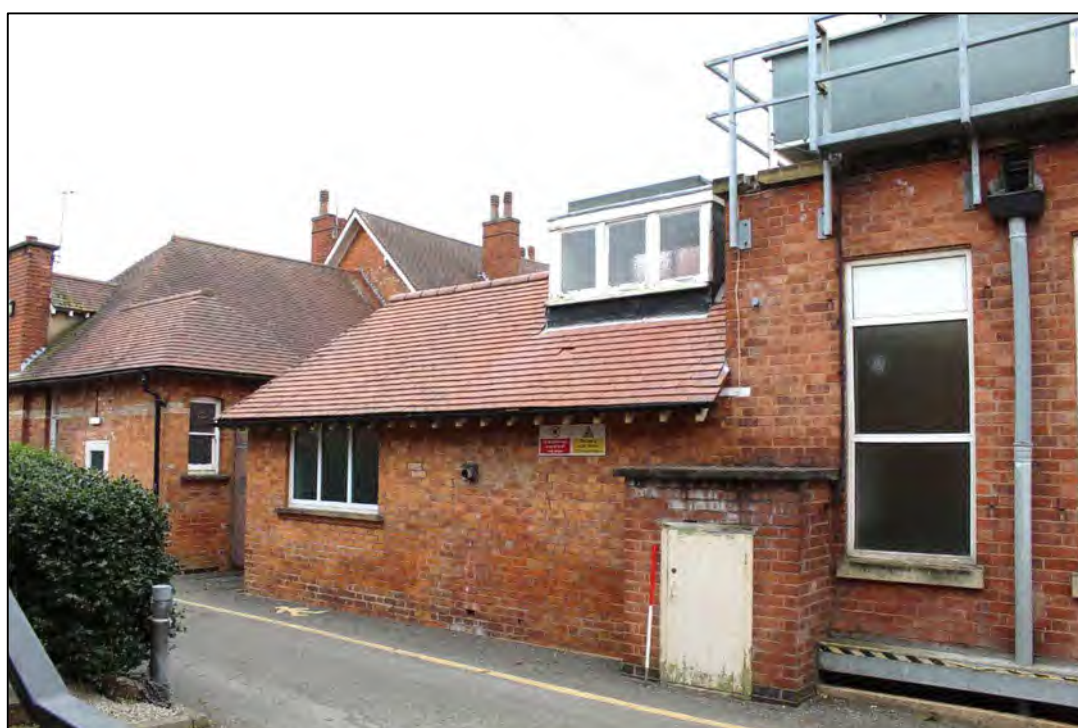
**Photo 31**      **North-east elevation: 1900 phase, north side**

5.49. To the south side of the 1928 phase is a small brick-built structure with a flat concrete or cement roof and timber batten access door (Photo 31). Its function is unclear, although it may be some kind of storage facility. There are two windows to the second-storey level above, which are mostly obscured by the ground floor level, but appear to be timber-framed sash windows of the 3/2 type seen elsewhere on the building.

5.50. The 1900 phase of the elevation is comprised of both single-storey and two-storey areas, with a series of interesting hipped and gabled roof forms (Photo 31). The north

side of the 1900 phase is formed of two bays, and has a single-storey ground floor section and a two-storey area behind (Photo 31). The ground floor section is attached to the 1928 phase; it is constructed of red brick laid in Flemish bond, and a hipped roof with a tripartite dormer window, which appears to be a later addition. The eaves of the roof have exposed rafter feet, the same design feature seen elsewhere on the 1900 part of the building. There is one window at ground level which is a timber tripartite design with fixed panes, and a slender cement or concrete cill with brick dentil detailing below. The window itself is a later replacement within the original opening. The south-facing return wall has a large uPVC window, which is a later replacement, and a single access door.

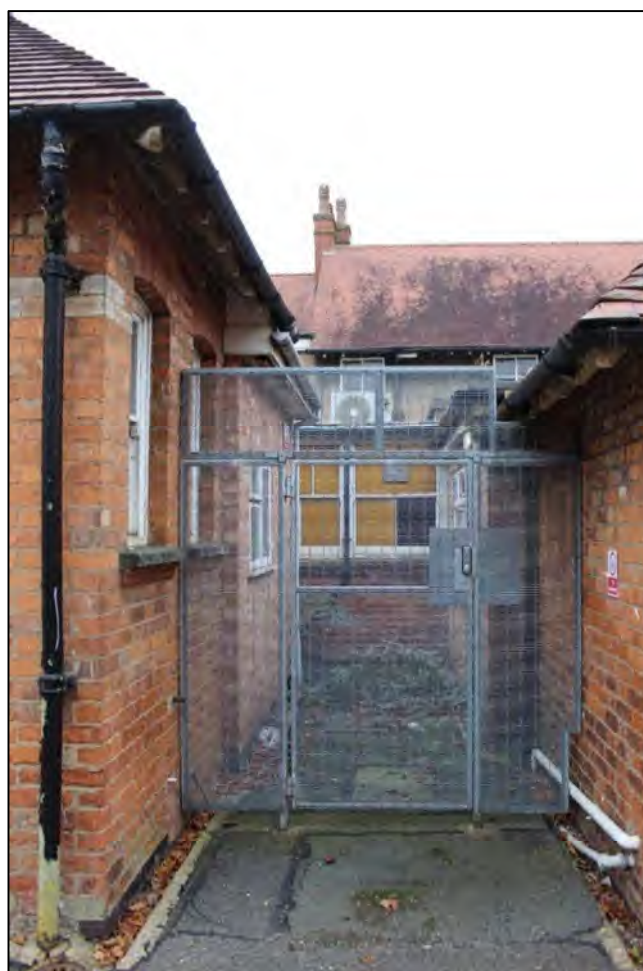
**Photo 32** North-east elevation: 1900 phase, central section

5.52. The central section of the 1900 phase comprises a projecting one-storey ground floor area with the two-storey part of the elevation rising above (Photo 32). The ground floor is recessed in between the north and south sides of the 1900 phase (Photo 32, Fig. 10). There are two windows to ground floor level which could not be closely inspected at the time of survey but appear to be timber framed, and one window to the first floor which is of the same metal-framed type as those on the north section.

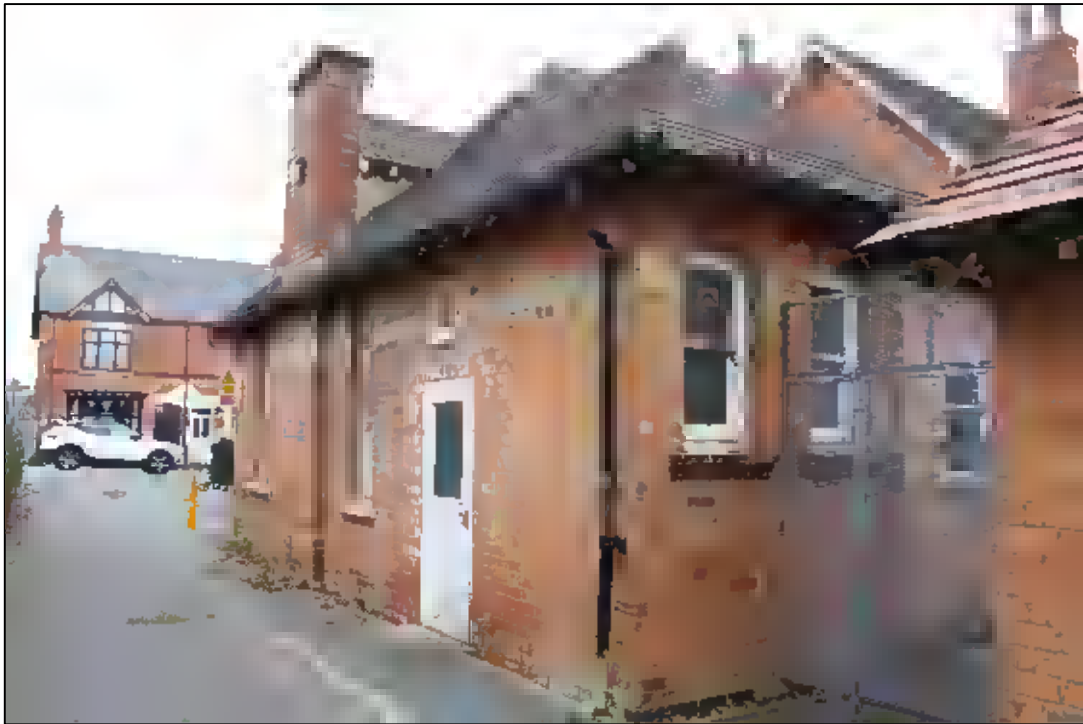
**Photo 33 North-east elevation: 1900 phase, south side**

5.53. The south section of the 1900 phase comprises the north ward and ancillary areas at the ground floor level, with the second storey level rising behind it (Photo 33). The ancillary area to the north-east of the ward area was extended at some stage after 1938 (see Fig. 10 for phasing). There is a north-facing window to the ward area, which is hidden from external view, but appears to be a later replacement with safety glass. The ancillary section on the north-east corner of the ward building has three north-facing windows (Photo 32); the two windows on the right are timber framed 1/1 sash windows with horns, textured glass, and cement or concrete cills with brick dentil detailing beneath. The third window is on the later extension, and appears to be timber-framed and of a later casement style.

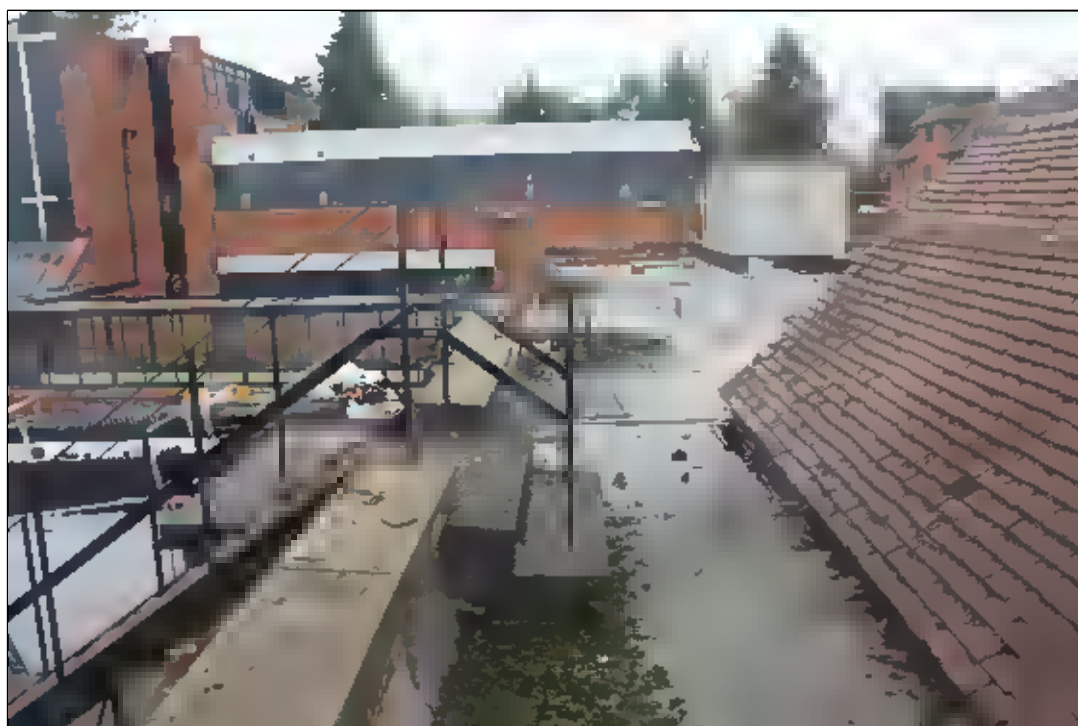
**Photo 34** View of roof area on 1930 phase (west side) looking north-west

- 5.55. There was no direct access to the roof areas during the site visits, however areas of the roof were visible from inside the building. The roof areas consist of both the pitched roofs, covered in clay tiles, and flat roof areas behind brick parapet walls with cement flaunching (Photo 34 and Photo 37). There are metal staircases giving access to the roof from the ground floor, as well as stairs to give access to different levels of the roof (Photo 34 and Photo 35).

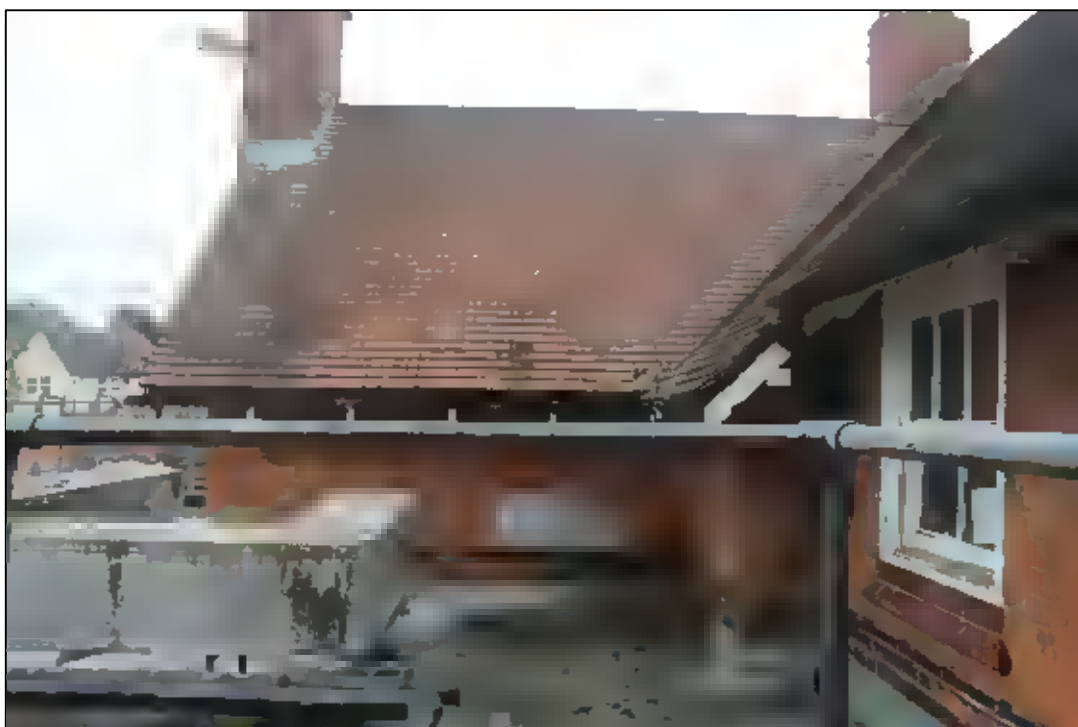
**Photo 35**      **View of roof area on 1938 phase at first floor level (east side) looking south-east**

- 5.56. As previously discussed, the roof areas have accrued various additions over the years to accommodate the needs of the hospital, including a number of service and ventilation ducts (Photo 35 and Photo 37). Parts of the roof have also been fitted with key clamp safety barriers to the parapets in order to accommodate safe access (Photo 36).

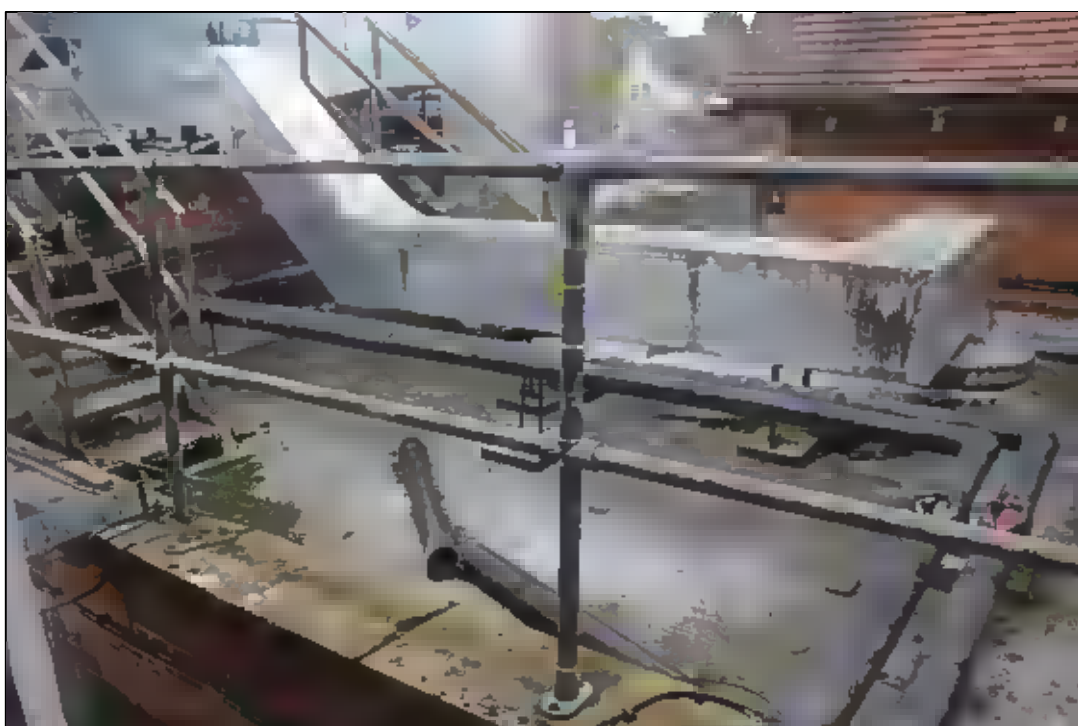
**Photo 36**      **View of roof area on 1938 phase at first floor level (east side) looking south-east- 2**

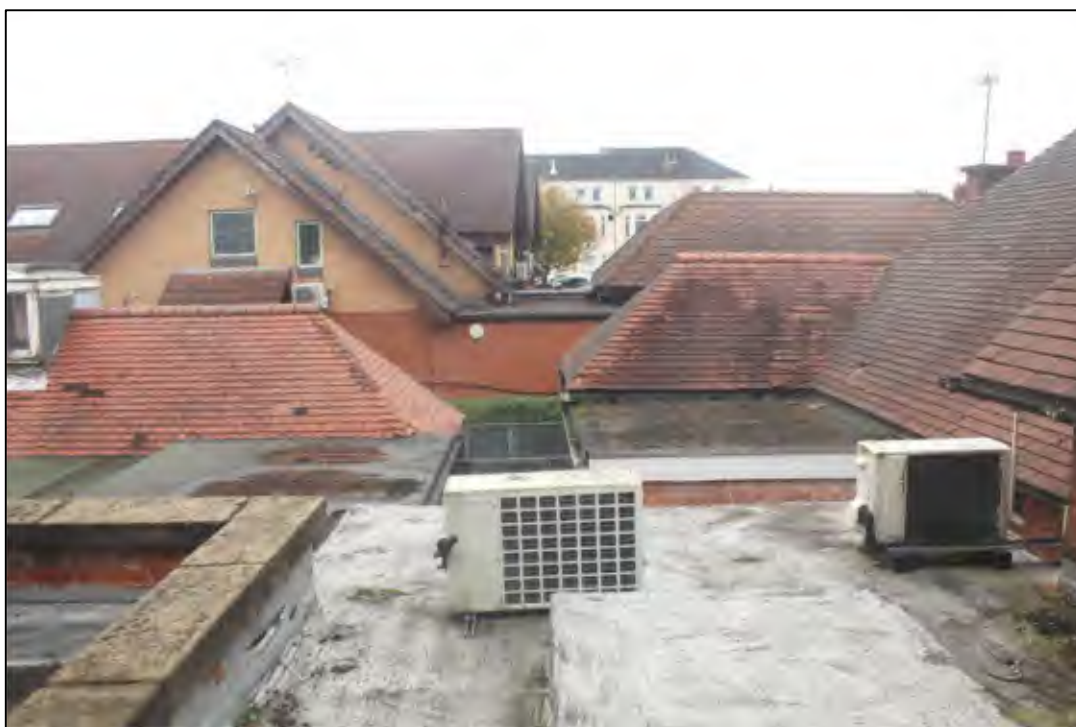
**Photo 37**      **View of roof area on 1900 phase at first floor level (east side)**

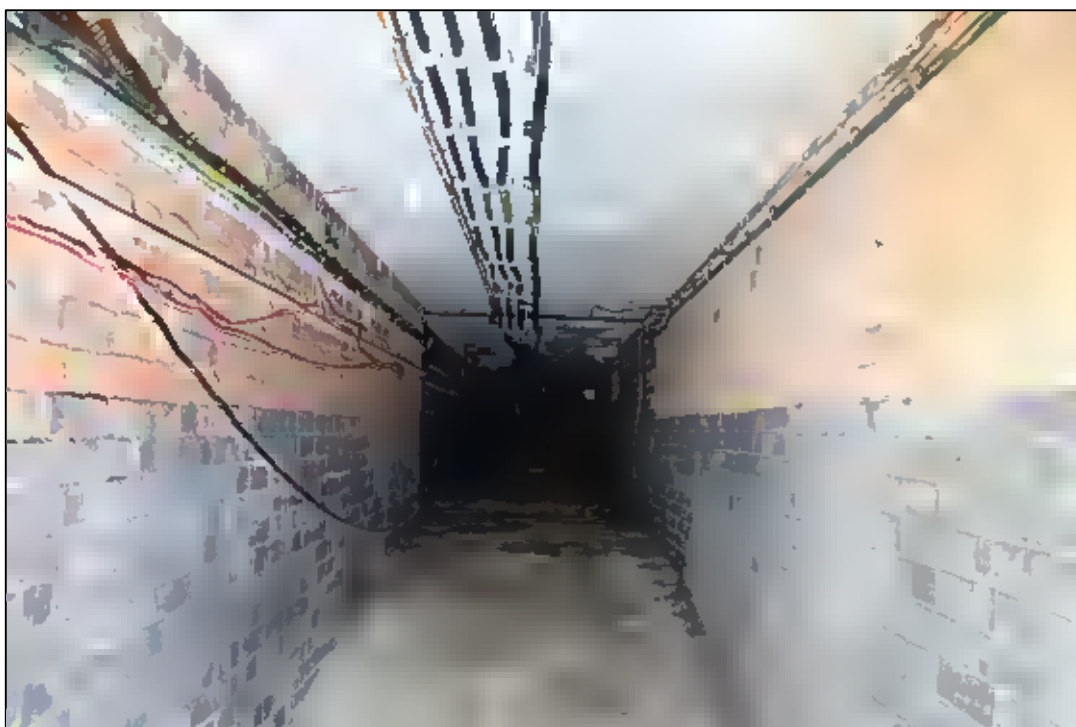
**Photo 42**      **View of corridor in basement area with remaining services and cabling**

**5.63.** At the time of the second site visit, the basement (which had been inaccessible due to asbestos in previous site visits) had been stripped out, and there were little to no fixtures and fittings remaining (Photo 40). The basement did, however still house a generator and two boilers, in addition to remaining electrical cabling and some older pipework (Photos 41 and 42). The basement structure is comprised of brick walling, mostly red brick laid in a mixture of Flemish and English bonds, with some areas constructed of engineering bricks; possibly for additional strength (Photos 42 and 43). The floors are of concrete, and the ceilings appear to be constructed of reinforced concrete.

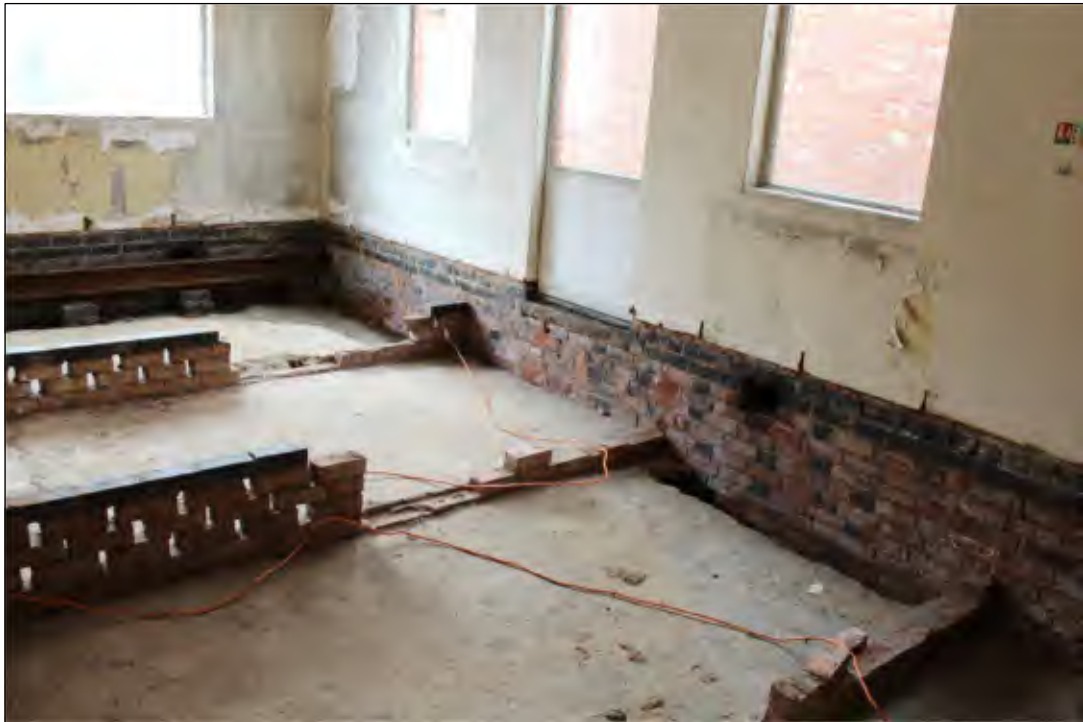
**Photo 50**      **View of G4, former dining room, showing floor detail after asbestos strip**

**5.73.** A photograph taken after the asbestos strip shows part of the surviving floor structure after stripping of the floor boards (Photo 50). The room had a suspended timber floor, below which were a series of internal brick sleeper walls with gaps between the bricks to aid cross ventilation (known as honeycomb construction). These sleeper walls are of red brick topped with a row of engineering bricks. Interestingly, the height of the sleeper walls is different, which may have been to accommodate the sloping ground levels. There are also ventilation gaps in the external walls, and there is a structural steel H-beam at the base of the east-facing wall, suspended on small engineering brick piers. The asbestos strip has revealed floor and foundation structures in other rooms of the building, most of which had a similar suspended floor construction.

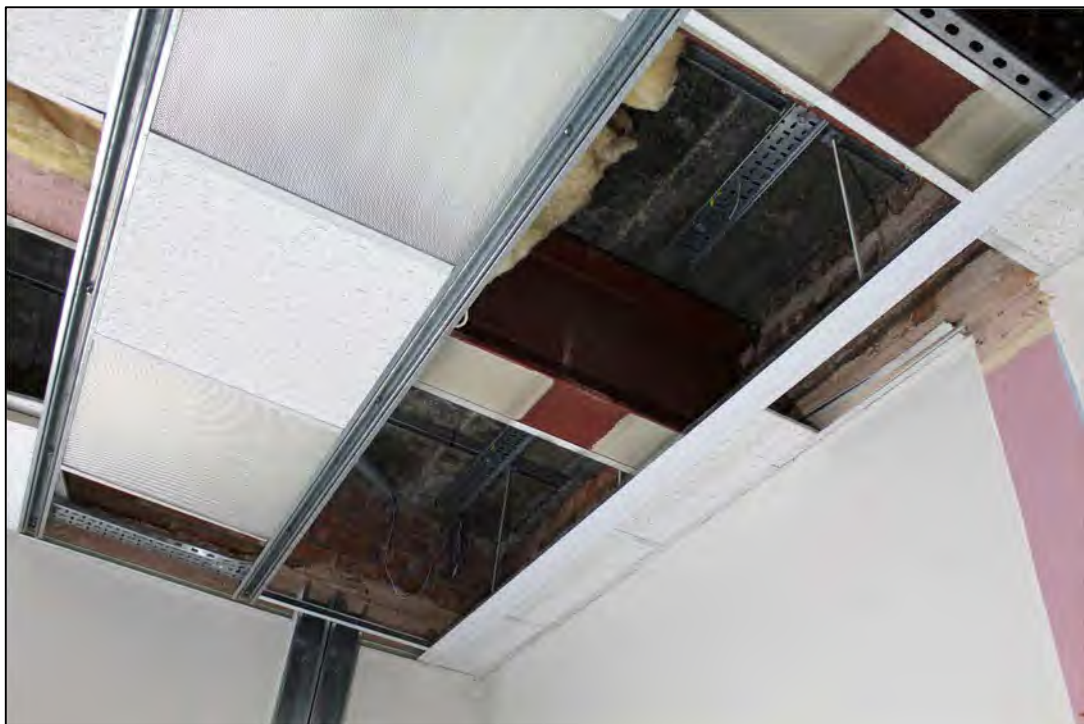
**Photo 57**      **Detail of ceiling in G14**

**5.80.** G14 was the main X-ray room at the time of the hospital's closure (Photo 56). This area was an extension added to the original 1939 x-ray department; although it is not clear at what date it was constructed, it was possibly around the mid-late 20th century. It is rectangular in plan form with windows to the east wall and an access door in the north-east corner leading to the exterior. Some modern X-ray machinery and equipment were left in the room, and a fitted cubicle area is in the north-west corner. There are no features of note.

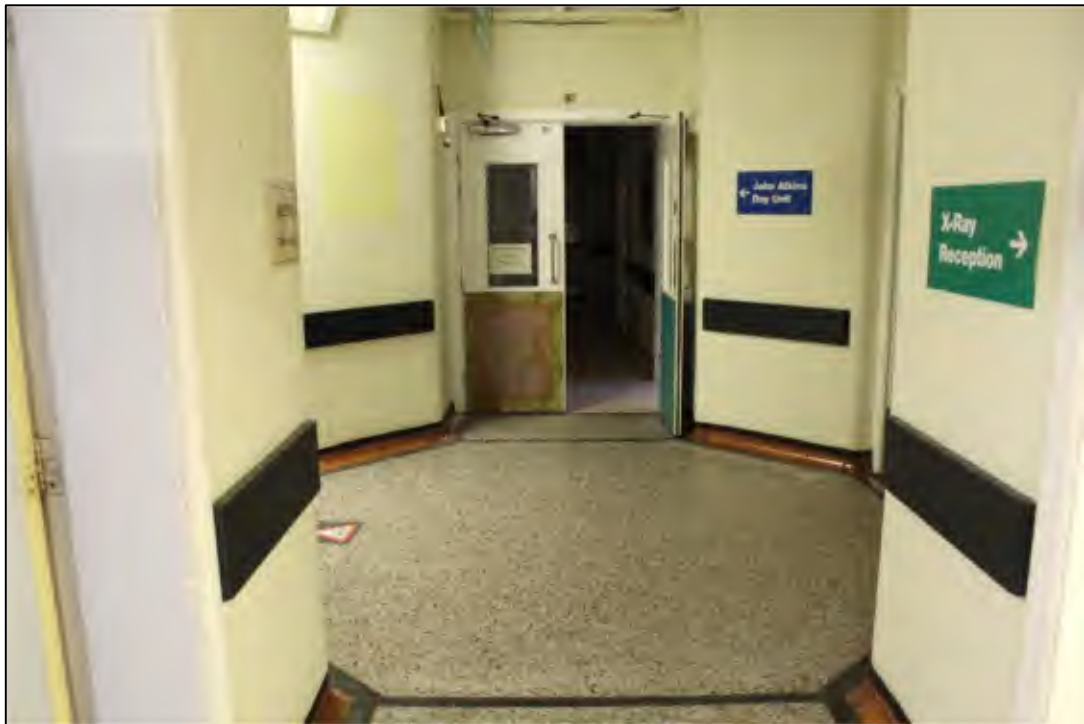
**Photo 63** Overview of the octagonal central access space (G21) looking west

**5.85.** G21 is an access area which is located roughly in the centre of the ground floor (Photo 63). It is comprised of a central octagonal space, with access corridors extending out to the north (leading to the catering department and health centre), east (to the X-ray department), west (to an area of wards and the former Atkins ward), and south to the 1928 phase of the ground floor. This part of the access corridor has retained its original, 1938 terrazzo flooring with glazed tile upstands, and the wall sections between the four access corridors have been finished with curved bullnose bricks to the corners to create a smooth, streamlined appearance.

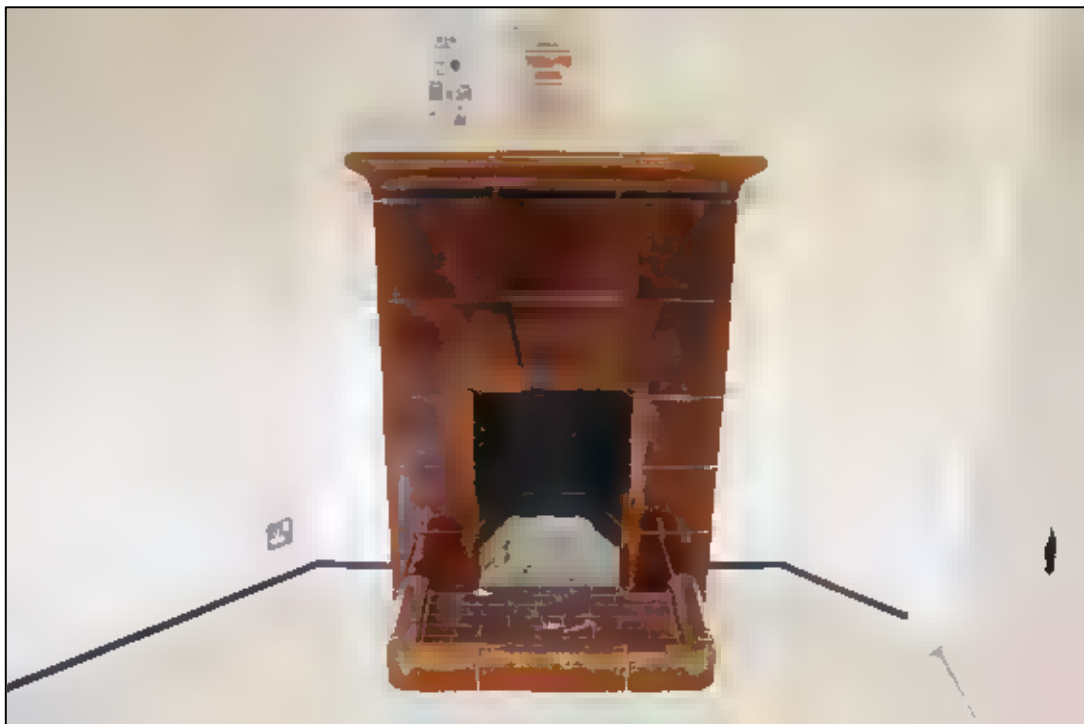
**Photo 66** Overview of G23, a former ward room- 1938 fireplace

**5.87.** The access corridor is an extension of area G21, see Paragraph 5.82. Room G23 was originally a private ward room, but appears to have been used as a general ancillary room in recent years (Photo 65). It has retained its 1938 fireplace to the south-east corner of the room; the fireplace was produced by Candy and Co, a tile maker and manufacturer formerly based in Newton Abbott, Devon (the company ceased production in 1998<sup>1</sup>). The fireplace is of a fairly simple design with a glazed tile surround and a curved glazed tile fender which protects the hearth (Photo 66). The cast iron hearth has the product name, patent number and manufacturer's stamp (Photo 67). The same design of fireplace survives in other parts of the 1930 building phase.

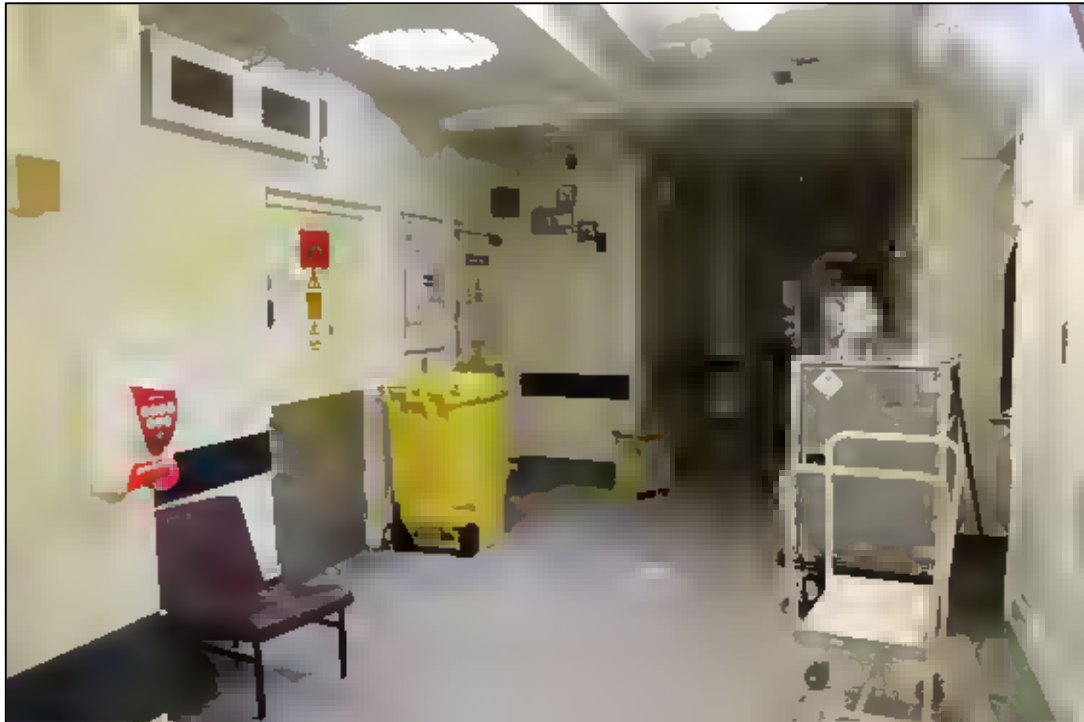
**Photo 71** View of access corridor in 1928 phase, looking south

- 5.92.** Area G31 comprises the central access corridor and the 1928 staircase to the first floor (Photo 71). The central corridor has retained its historic terrazzo flooring, although the glazed upstand has been removed in this area. The 1938 plans revealed that the terrazzo flooring was actually a 1938 replacement, and that the earlier flooring in the 1928 and 1900 phases was quarry tile. The staircase is of an open-well arrangement and has a fairly simple design (Photo 72). The flat balusters alternate between large and smaller sizes, with the larger balusters having a pierced heart and line detailing; it has simply-carved newel posts and handrails, the latter of which has been left as bare wood, while the rest of the staircase has been painted. This whole area has been extensively redecorated and apart from the flooring and staircase, there are no other historic features of note.

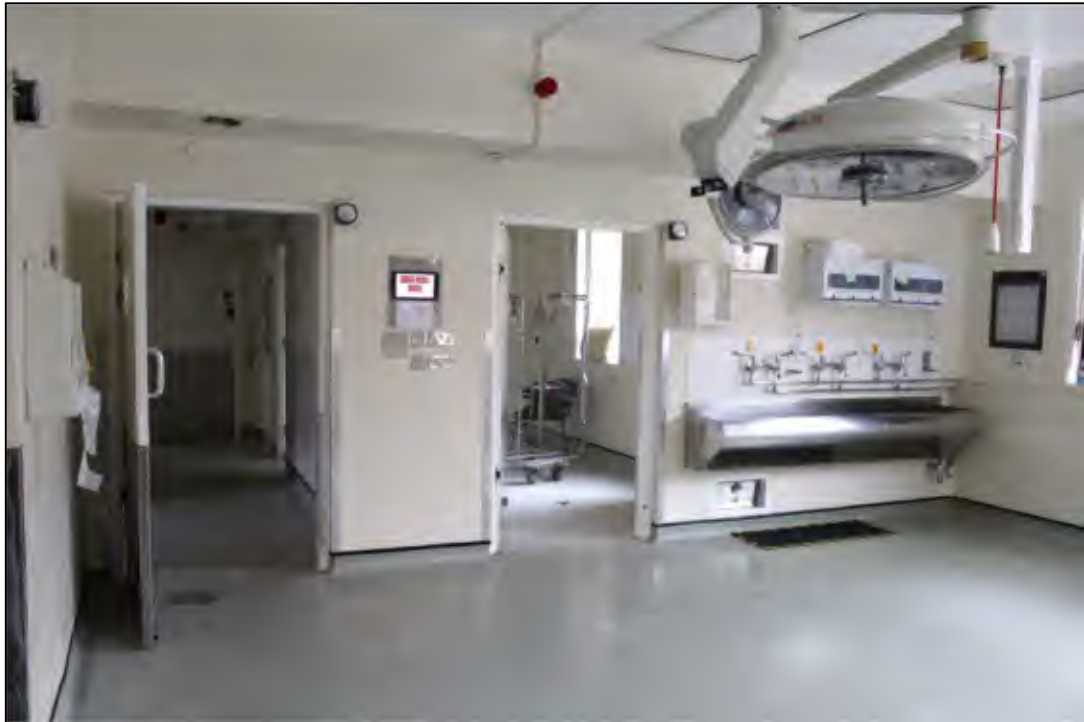
**Photo 73**      **View of G40, the former operating theatre**

5.95. G40 is the operating theatre, and this space appears to have functioned as an operating theatre since its construction, based on the 1938 plans (Photo 73). It has access doors to the lobby (G32), the recovery room (G38), and the anaesthetic room (G41), and windows to the north and east walls. This room originally had terrazzo flooring, and a sink area to the north-west corner; although the sinks have been replaced in the 21st century, they are still located in the same area. This room has a series of panel lights to the ceiling, and the operating lights on mechanical arms are still *in situ*. G41 has also retained its historic function as an anaesthetic room (Photo 74); it formerly had terrazzo flooring and a glazed screen to the south wall, both since removed, and otherwise is largely devoid of features and fittings and has no historic features of note.

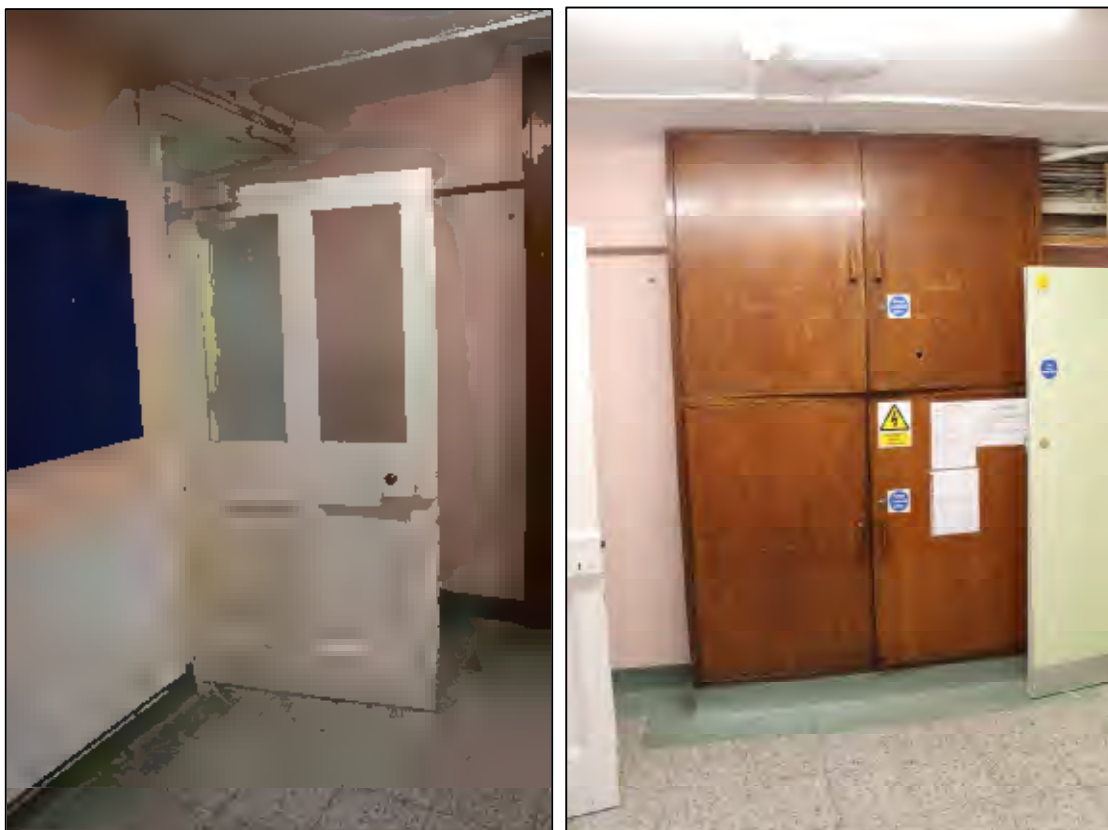
**Photos 77 and 78**

**Detail of door (77) and fitted cupboard (78) in room G44**

**5.99.** Room G44 was being used as the minor operations room when the hospital closed. This larger space has actually been subdivided into two smaller spaces; the north area appears to have been some kind of office space, but there are no fixtures or fittings. The main room has a glazed window to the west wall overlooking the corridor, formed of two panels in a timber frame with safety glass. The terrazzo flooring has been retained, albeit without the glazed upstands, and the four-panelled timber door may be contemporary with the 1900 build (Photo 77). There is also a large timber cupboard which has been fixed to the ground on the south side of the room; it doesn't

appear to date to the original phase, but was likely fitted later in the 20th century (Photo 78). This room was first used as a maids' sitting room.
