# Hinckley Cottage Hospital Mount Road, Hinckley Leicestershire

*Historic Building Recording and Investigation (Level 3)*

*Report prepared for:  
NHS Property Services*

CA Project: MK1187

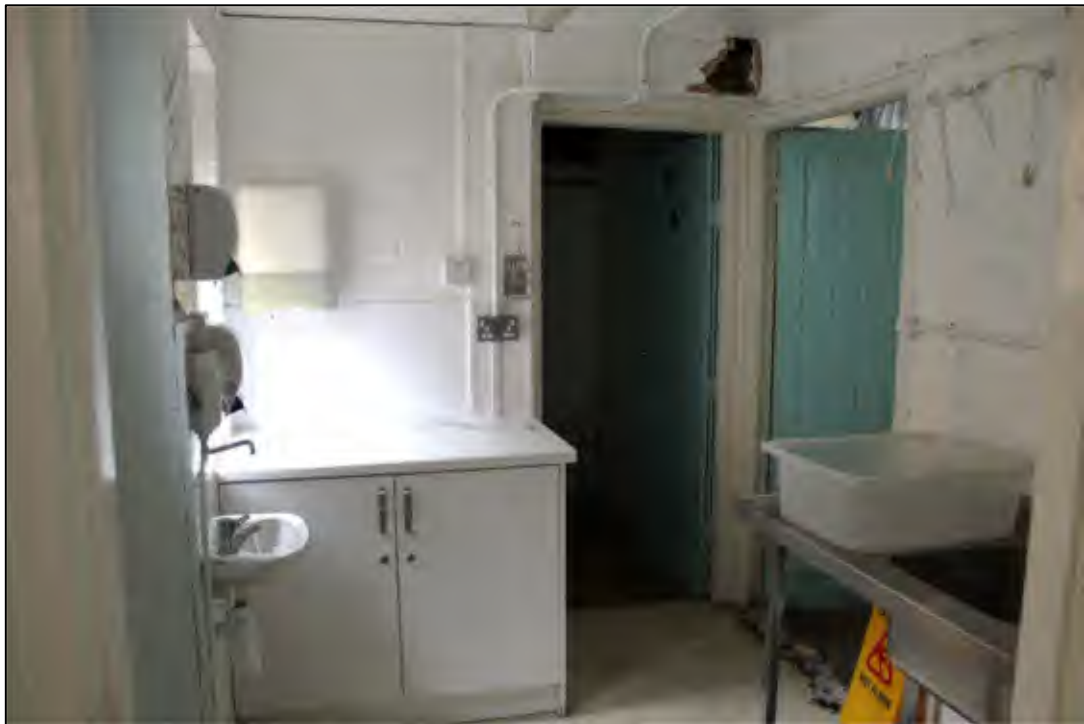
**Photo 81** View of room G48, which is a post-1950's addition

- 5.101.** G48 is a toilet and kitchen area, and appears to have been constructed at a later date after 1938; it does not appear on the 1938 plans of the building, and there is a bricked-up window in the south-east corner which formerly overlooked the courtyard area from room G46 (Photo 81).
- 5.102.** There is an enclosed courtyard area to the west of these rooms which was probably created at the time of the 1928 extension, and has been used as a garden area (Photo 84).

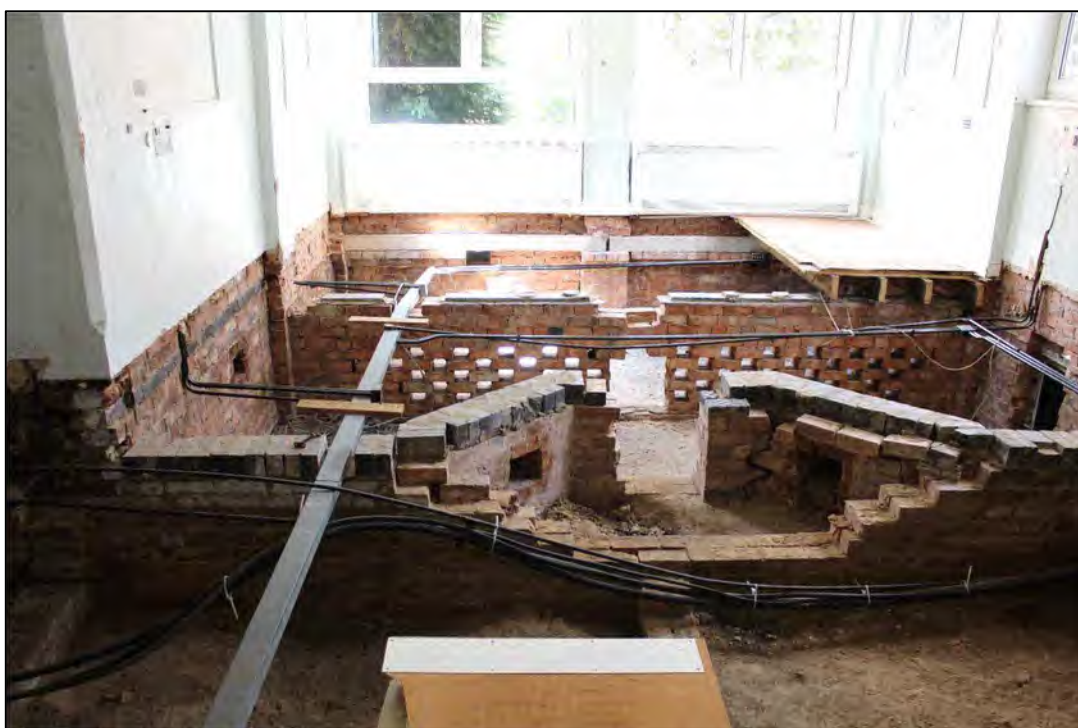
**Photo 87** Detail of sub-floor structure in room G50

**5.104.** G50 is a large, rectangular space which has most recently been known as the Christopher Ward (Photo 86). In the 1938 plans, this room is labelled as the children's ward. The original ward space also encompasses the corridor to the south and room G53, which were added created by subdividing the south end of the room. It has continued to be used as a ward room until the closure of the hospital, retaining its historic function. There is a chimney breast to the north-east corner of the room which has been boarded up, but would have heated the ward prior to the installation of the central heating system. Prior to the asbestos strip, the room had a suspended timber board floor (possibly maple board as in other rooms) which was laid over joists resting on brick sleeper walls (Photo 87).

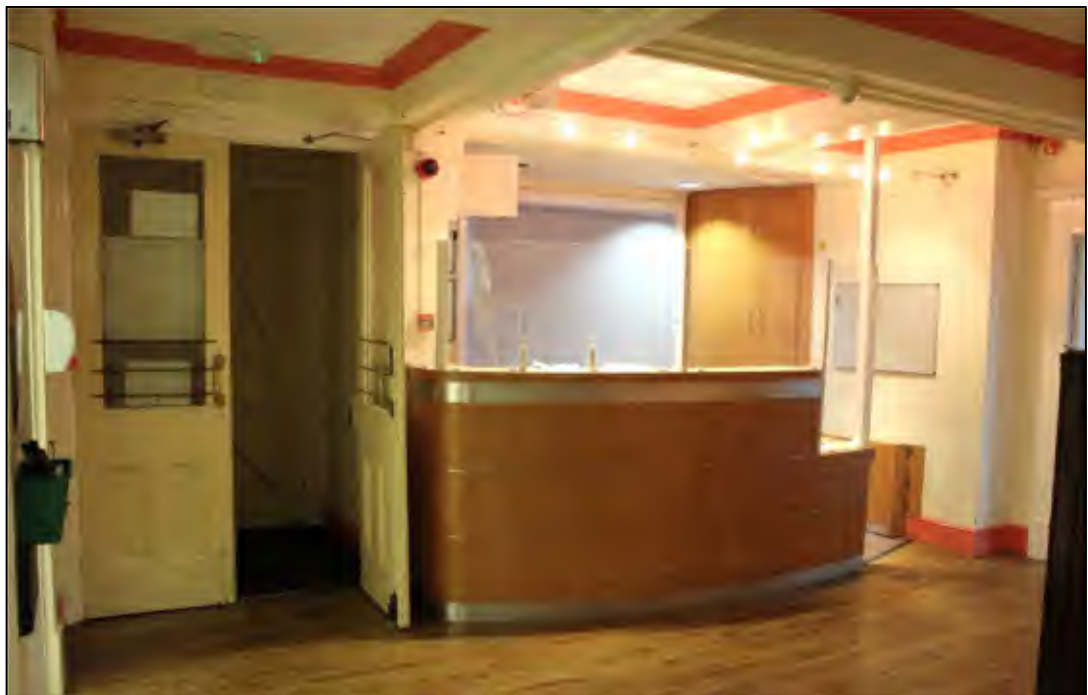
**Photo 92**      **View of 1900 entrance area (G56)**

**5.110.** There is a reception area with an inbuilt desk on the south side of the entrance hall which was probably added in the late 20th or early 21st century to create a defined area for the receptionists to work from (Photo 92). The flooring in the entrance area is timber, although it is not clear if it is the original 1900 flooring. The walls are plastered and painted, and the ceiling has a coffered ceiling with recessed panels framed by plastered beams. A set of narrow double timber doors with glazed panels leads to an enclosed vestibule area, beyond which are the double front doors (Photo 92).

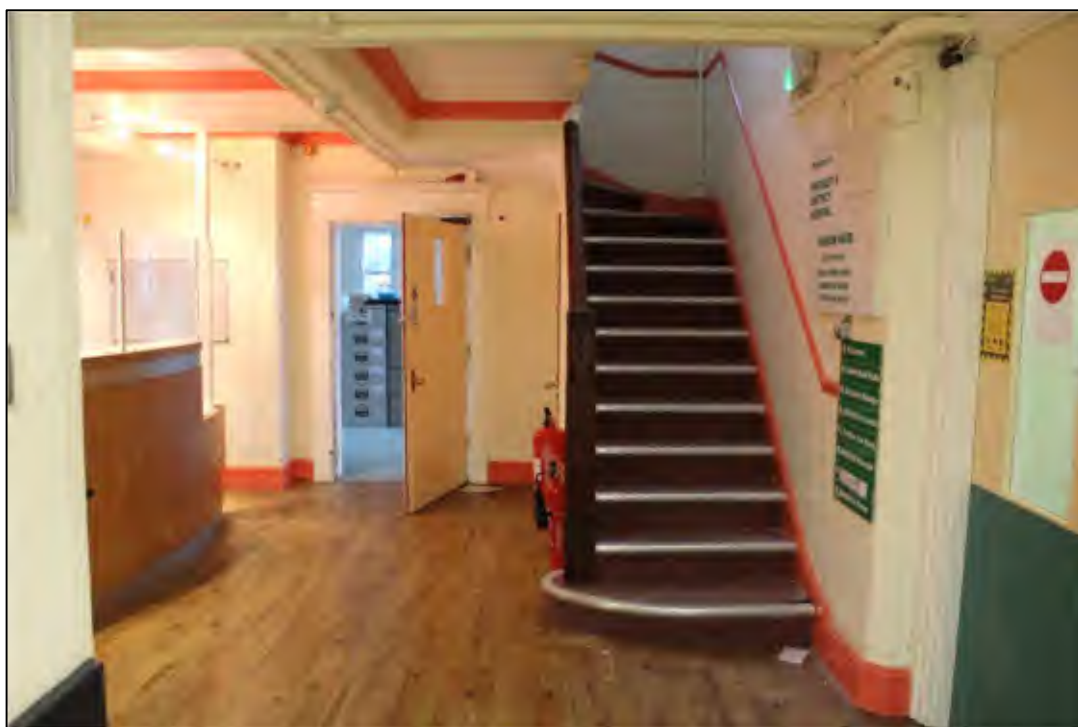
**Photo 93**      **View of 1900 entrance area (G56), looking west**

the day room (G58). The principal staircase has a closed-well arrangement, a solid timber balustrade with simple carved handrail, and a decorative newel post (Photo 93). There is a dado rail which runs up the length of the staircase, and decorative moulded skirting.

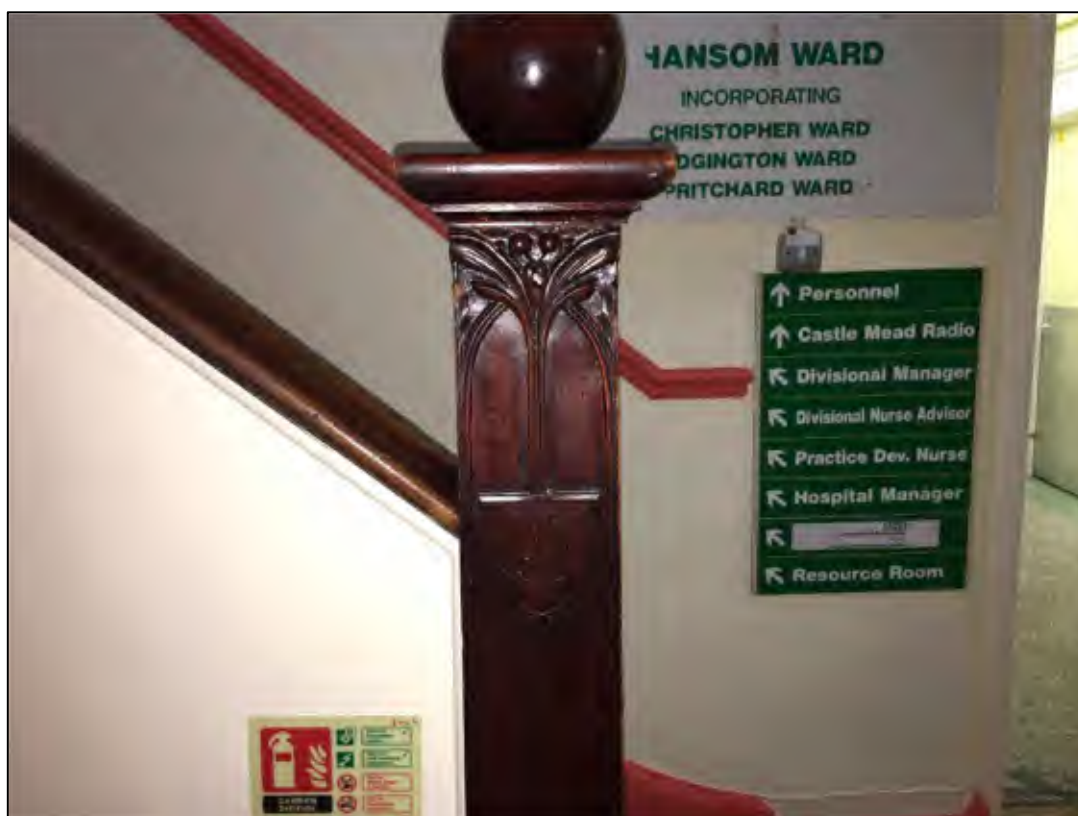
Photo 95 Detail of newel post on original 1900 staircase, looking north, with '1900' date

**5.109.** The newel post has Art Nouveau-type detailing to the top of the post; on the south side the date '1900' is carved into the wood (Photo 95); on the east side are the letters 'HRH' within a shield emblem (Photo 97), and on the north side of the post is a heraldic shield symbol (Photo 96) which is also carved into the commemorative stone on the south-west elevation (Photo 22). The newel post formerly had a cap and ball finial, which had been removed by the time of the November 2024 survey. There is a cupboard under the stairs accessed via a four-panelled timber door.

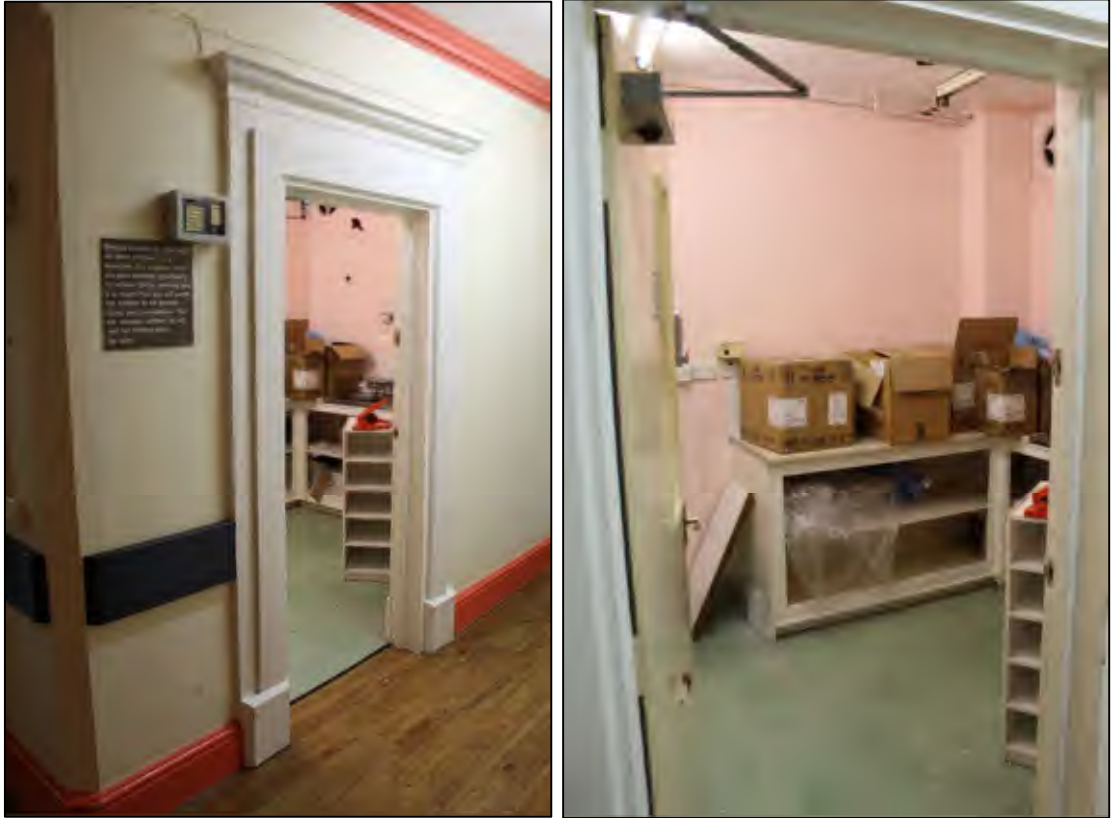
**Photos 98 and 99**  
**G57 (78)**

**Entrance to room G57 with timber surround (98) and interior of room**

- 5.111.** Room G57 is a former duty room, and appears to have been in a similar use in its more recent history. The entrance door to the room has a timber surround with cornice (Photo 98 and Photo 99). There is a chimney breast on the west side of the room, although no usable fireplace, and the recess has been tiled over. There are three narrow cupboards in a vertical line on each side of the fireplace, with panelled cupboard doors (Photo 100).

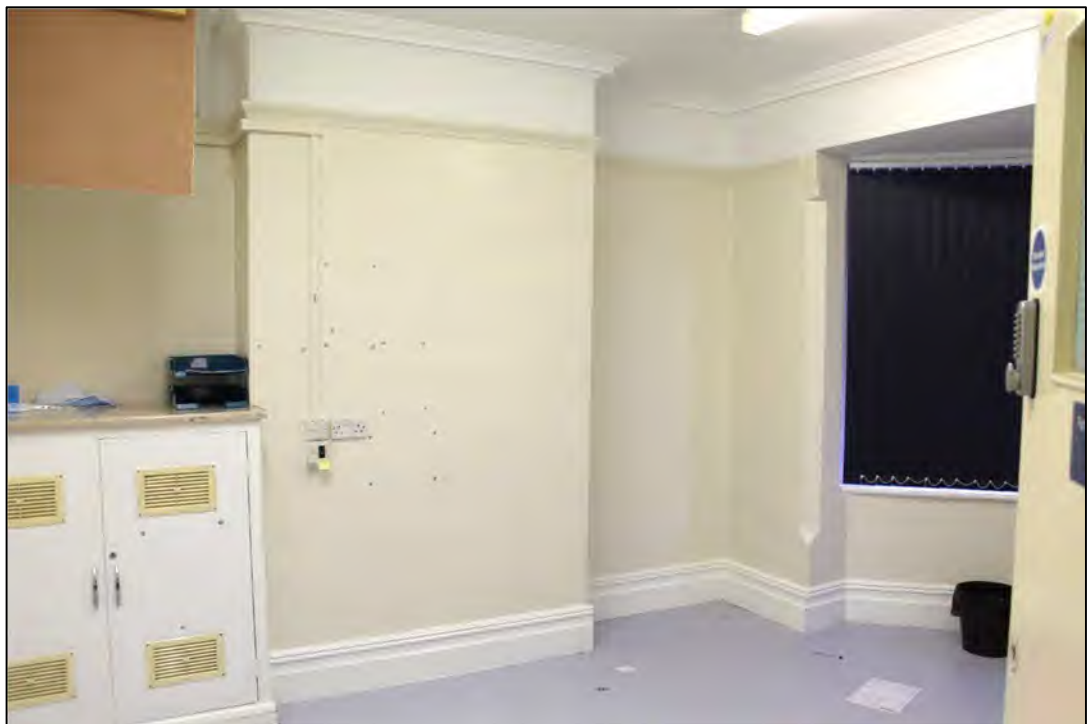
**Photo 101**      **View of room G58, the former day room**

- 5.112.** Room G58 was the former secretary's office, and has been used as a day room in recent history (Photo 101). This has similar architectural detailing to other rooms and spaces in the 1900 phase, with skirting, coving, and the canted bay window with leaded lights. There is a chimney breast in the centre of the east wall which would once have heated the space, but has been blocked up in the 20th or 21st centuries.

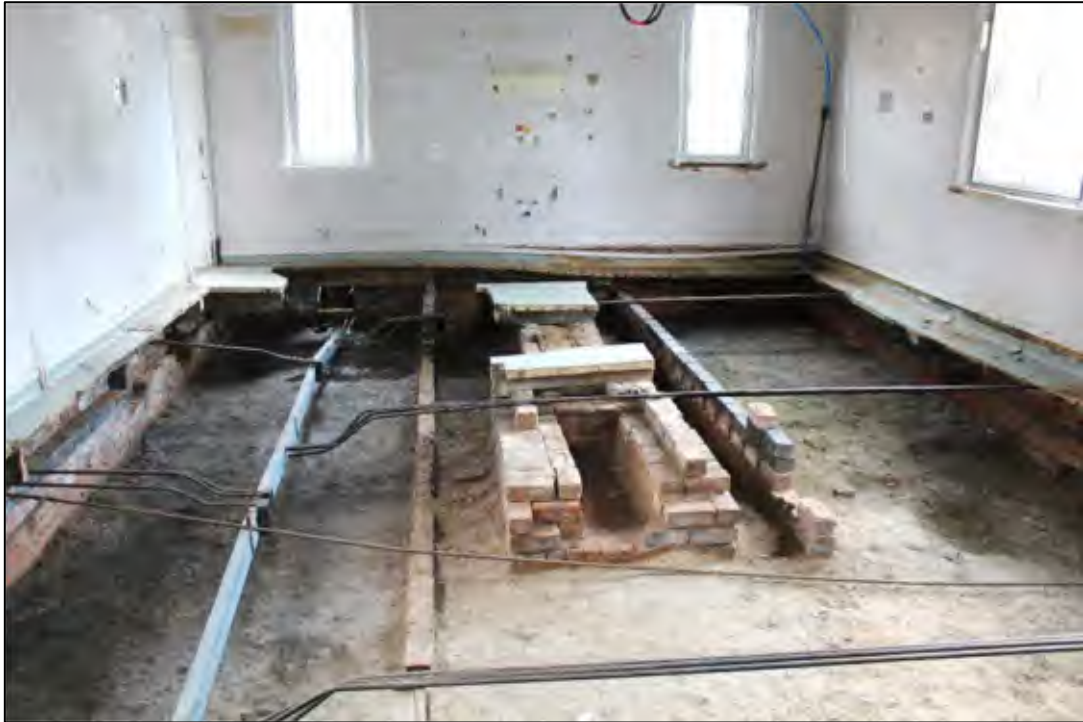
**Photo 104**      **Detail of sub-floor structure in room G60**

- 5.115. There is a small wing to the north-east corner of the room which houses two WCs and a bathroom (G61 and G62). The bathroom area was an additional extension to the existing 1900 phase. These rooms have been updated in recent years, and there are no historic features of note. The asbestos stripping has also revealed the structure below the floor, which has the same suspended floor composition seen in other ground floor rooms (Photo 104).

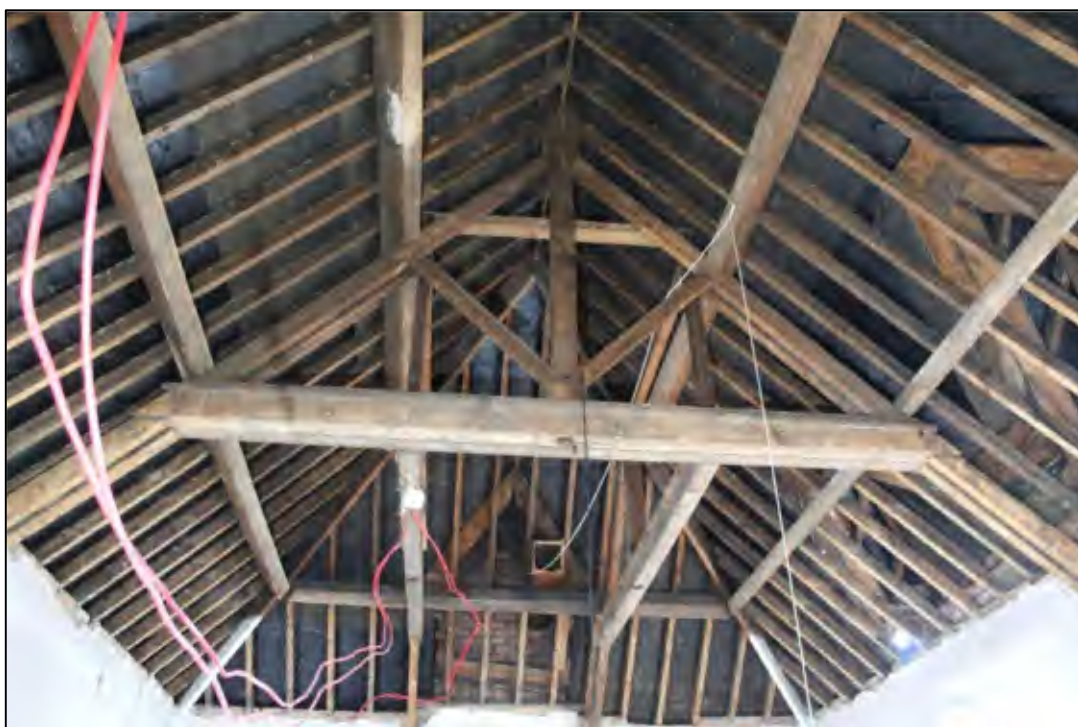
**Photo 105**      **Detail of roof structure in room G60**

**5.114.** The ceiling of the room was originally enclosed and plastered with only part of the timber roof structure exposed. After the asbestos strip, the whole roof structure has been exposed (Photo 103). The roof is formed of a central king post truss with two rows of clasped purlins, transverse beams which supported the former ceiling, and rafters supporting the roof covering (Photo 105).

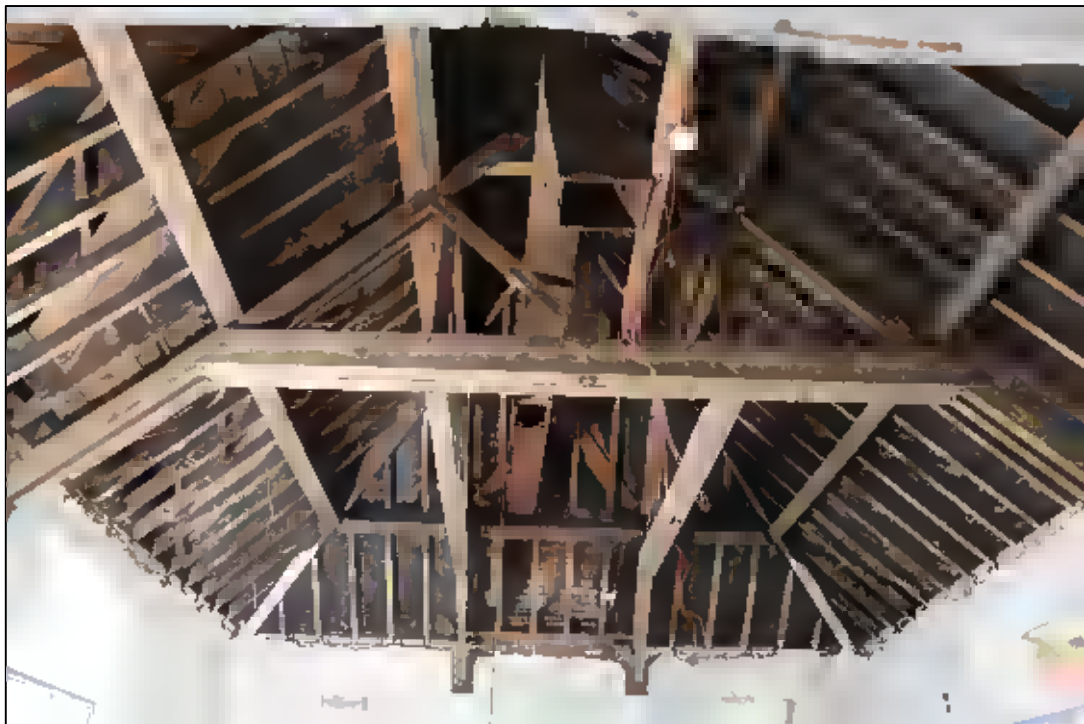
**Photo 107** Detail of roof structure in room G63

5.117. The ceiling of the room was originally enclosed and plastered with the roof timbers boxed in. After the asbestos strip, the whole roof structure has been exposed, and the roof structure appears to be the same as that in room G60 (Photo 107).

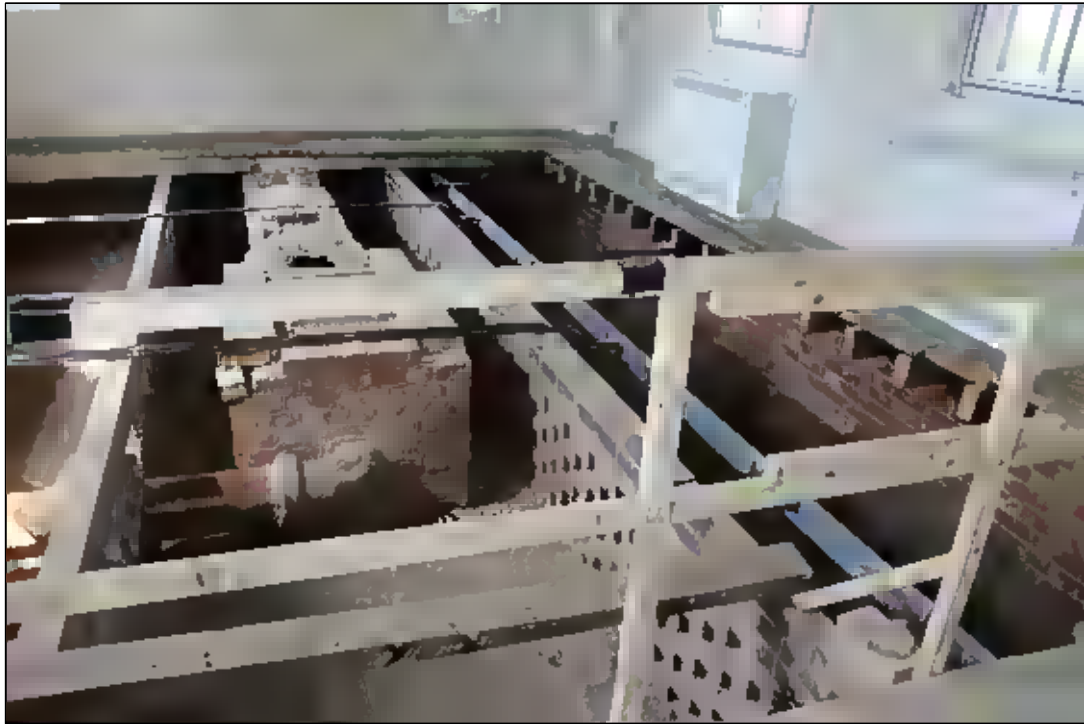
**Photo 108**      **Detail of sub-floor structure in room G63**

**5.118.** There is a small wing to the north-west corner of the room which houses a bathroom (G64). This room has been updated in recent years, and there are no historic features of note (Photo 109). The asbestos stripping has also revealed the structure below the floor, which has the same suspended floor composition seen in other ground floor rooms (Photo 108).

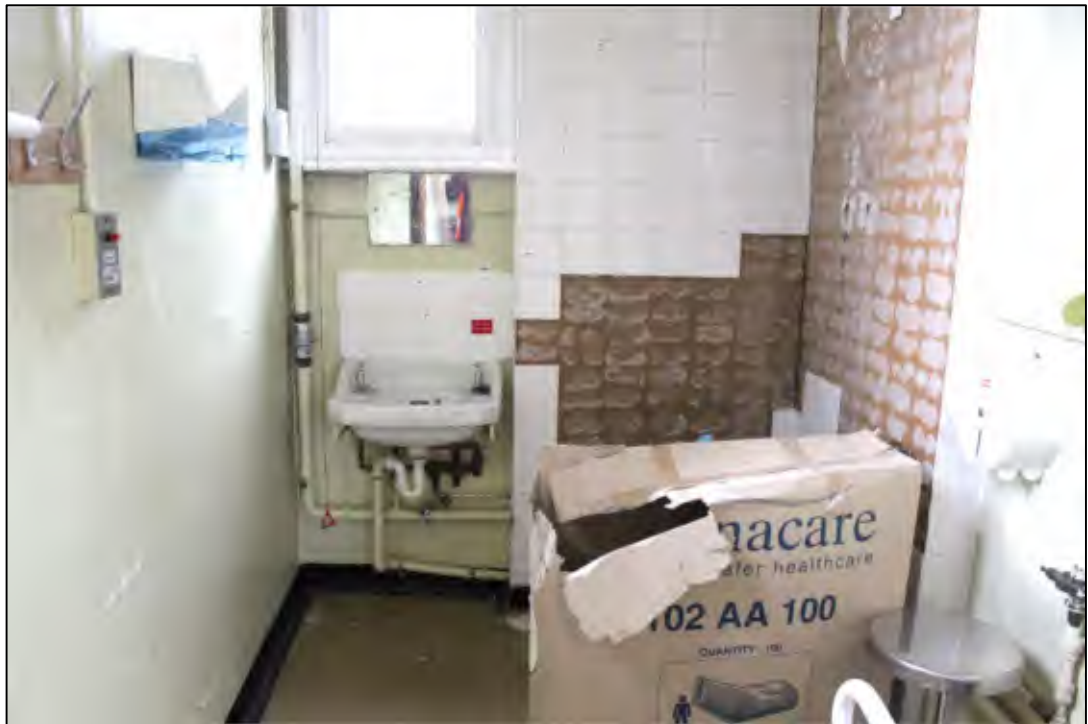
Photo 109 View of room G64

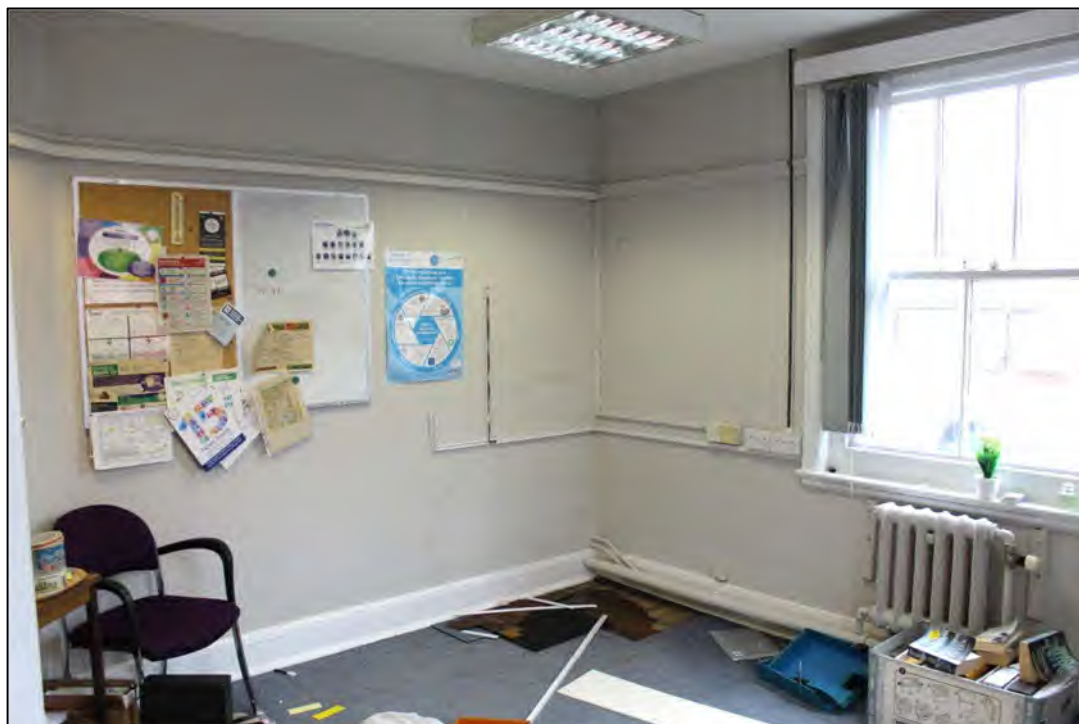
**Photo 114**      **View of room F2**

- 5.123.** Rooms F2 and F4 are essentially mirror images of each other, and both served as staff rooms. They have been refurbished and carpeted, although they appear to have timber flooring beneath, and both rooms have timber skirting and picture rails, but otherwise there are no other features of note in these rooms (Photo 114).

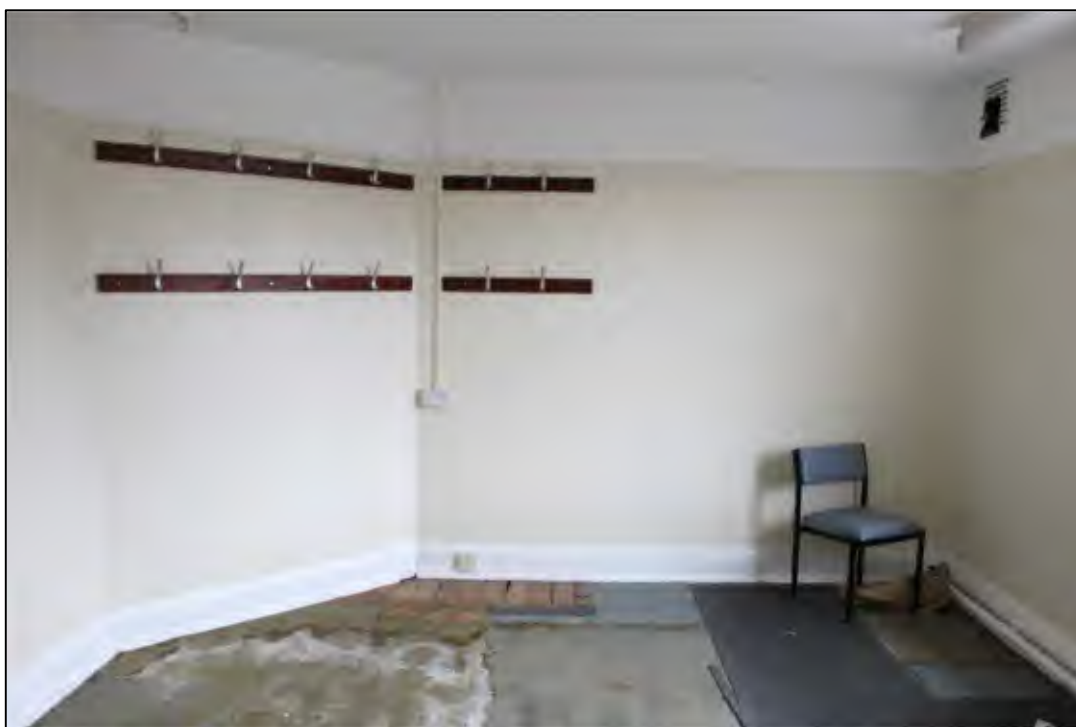
**Photo 116**      **View of room F5**

- 5.125.** Rooms F5, F6, F7 and F8 were all used as offices and have a very similar size, layout and appearance, with F5, F6, F7 and F8 being mirror images of each other (Photo 116). The flooring is timber, although most of it is carpeted, and all rooms have skirting and picture rails. All four rooms would have been heated by fireplaces when first constructed, although a central heating system was also installed in the building. F5 and F6 have both lost their fireplaces, although they have retained their skirting and picture rails. Room F7 has a surviving fireplace in its south-west corner (Photo 117); the hearth itself is gone and was blocked up at some point. The surround is a simple design of dark terracotta glazed tiles with a moulded timber mantel. Room F8

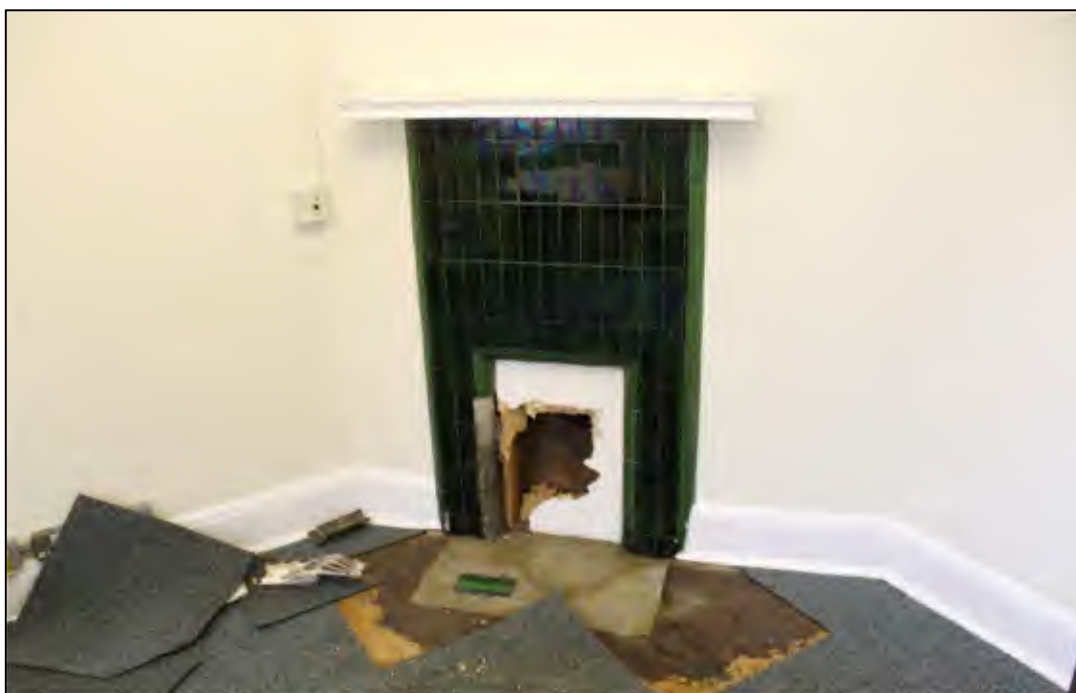
**Photo 118**      **Detail of original 1938 fireplace in room F8**

also has a fireplace in its north-west corner, which is of the same design, but with dark green tiles (Photo 118).

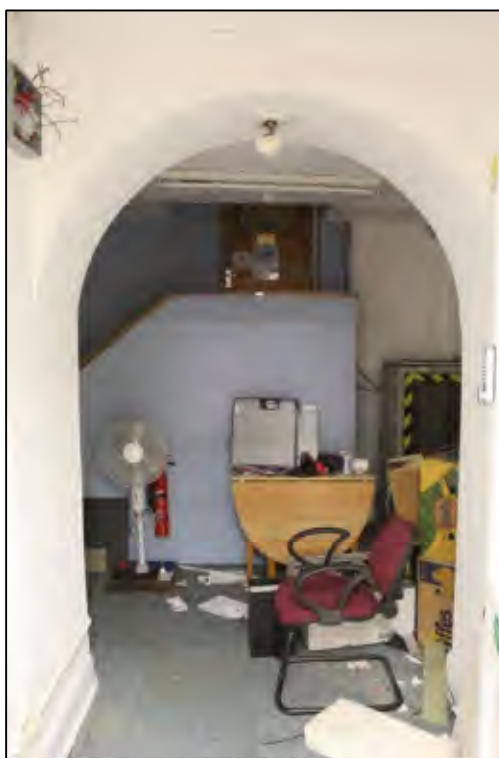
**Photo 119**      **View of room F9, the former entrance to the Castle Mead Radio station room**

**5.126.** Room F9 is an entrance area which lead to the Castle Mead Radio station (Photo 119). This was located on the first floor of the former records office wing, and was demolished before the survey took place. This entrance area is accessed via an arch, and has a small flight of stairs which leads to the studio entrance door.

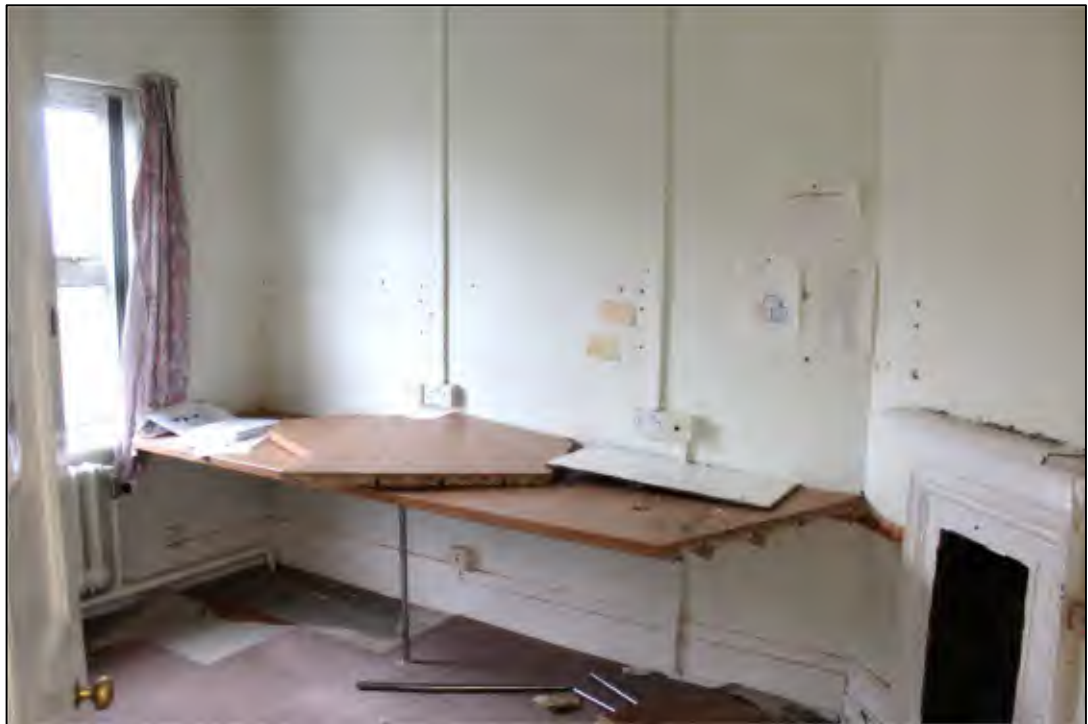
**Photo 121**      **View of room F11**

- 5.127.** This phase comprises four rooms, all of which are accessed directly off the central corridor. The central corridor is painted and carpeted, and has a row of storage cupboards on the east wall with panelled timber sliding doors; these may be of the 1928 date (Photo 120).
- 5.128.** F11 is located on the west side of the floor, and was used as a manager's office (Photo 121). It is similar to the offices in the 1938 phase, with timber flooring, timber skirting and an interwar fireplace to the north-east corner of the room, with red glazed hearth tiles that have been previously carpeted over (Photo 122).

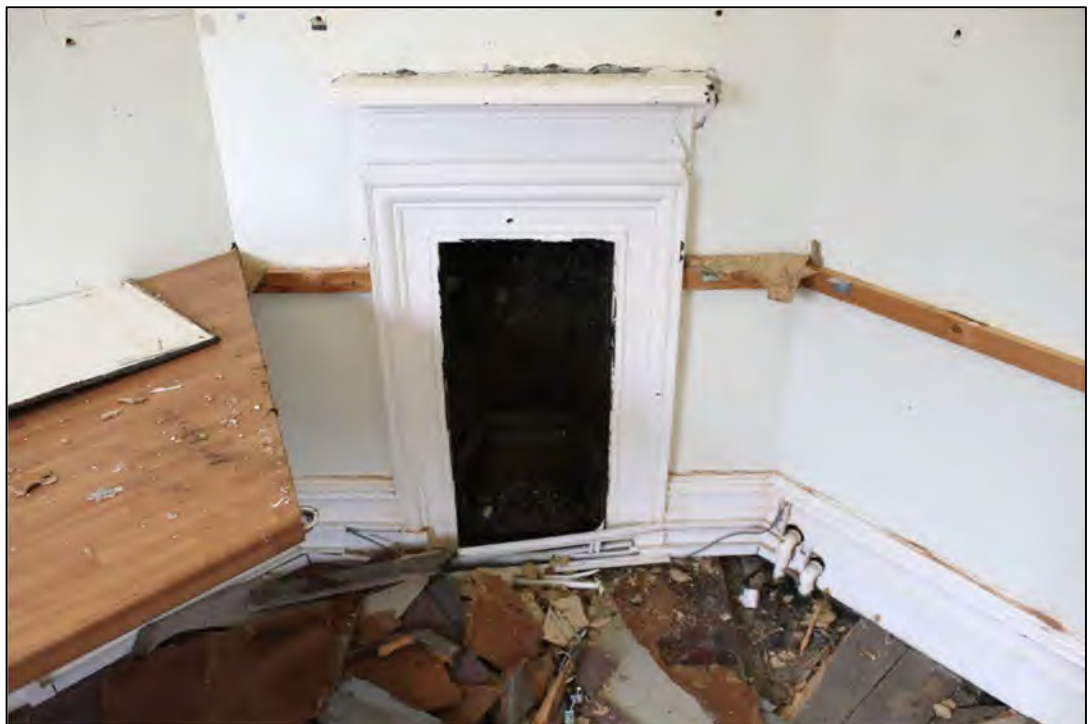
**Photo 122**      **Detail of 1928 fireplace in room F11**

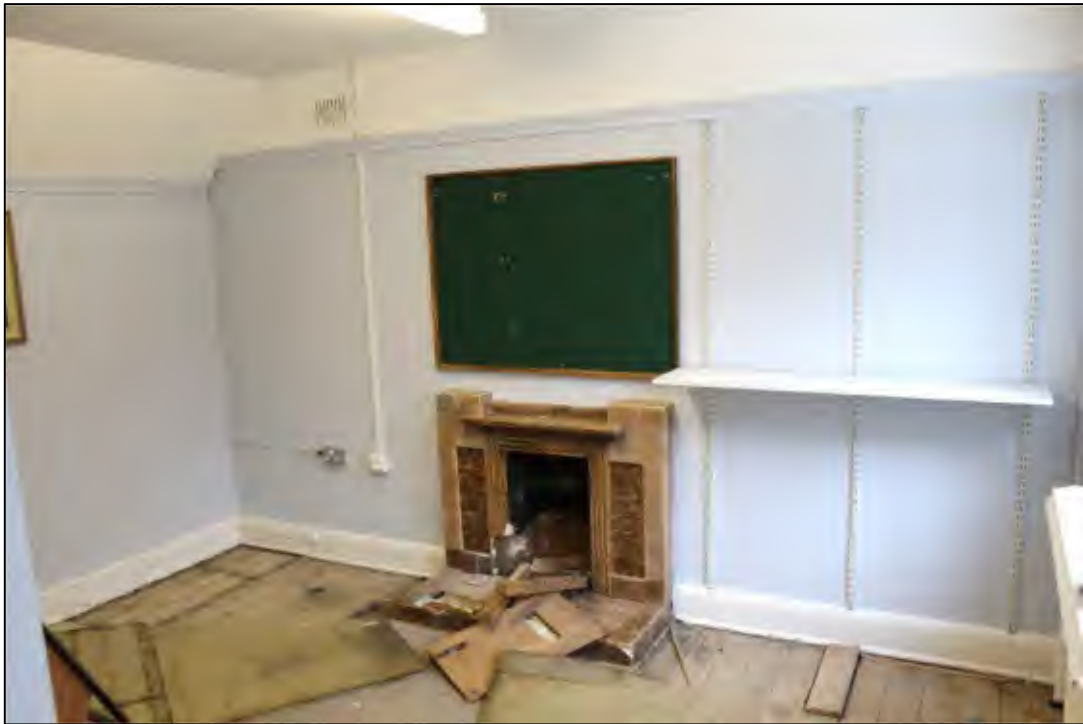
**Photo 123**      **Overview of room F13, with timber flooring and 1930's fireplace**

**5.130.** Room F13 is located on the east side of the corridor, and is rectangular in planform, and larger than the other typical rooms on this floor (Photo 123). It was being used as a 'quiet room' before the hospital closed down. The room has timber skirting and picture rail, and timber flooring (probably pine). There is an Art-Deco style fireplace which is a later addition (this being the 1928 phase) and the only such example seen in the building (Photo 124).

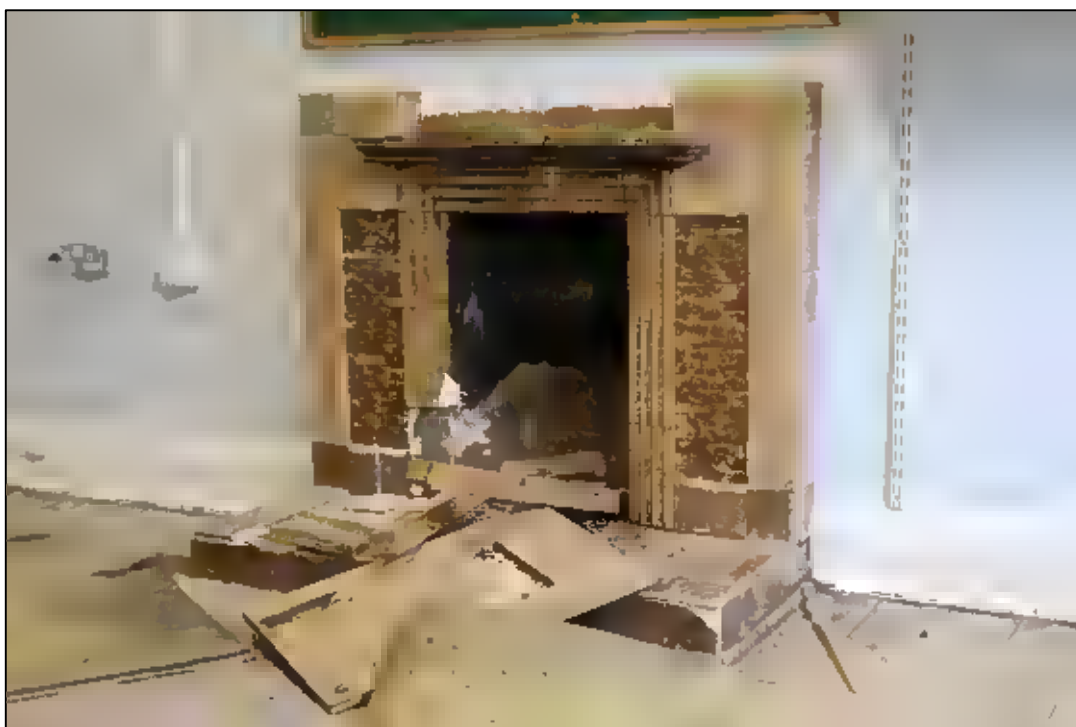
**Photo 124**      **Detail of 1930's fireplace in room F13**

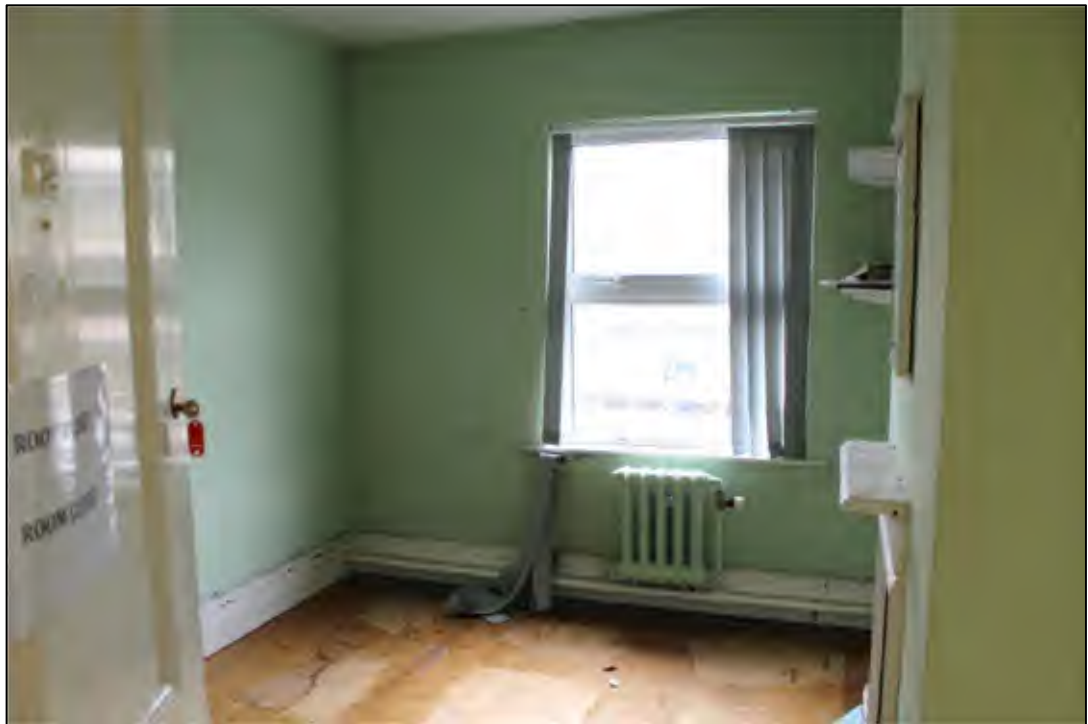
**Photo 125**      **View of room F14**

**5.131.** Rooms F14-F17 comprise a row of offices on the west side of the floor. They are all accessed via the corridor, and each has a west-facing window. They have timber flooring, timber skirting, and four-panelled timber entrance doors, and otherwise have been decorated and in a late 20th/early 21st century style. Room F14 has a surviving fireplace on its north wall, of the same style as that in room F11 (Photo 125 and Photo 126). Rooms F16 and F17 share a chimney breast in their dividing wall, although the fireplace in room F16 has been removed and covered over (Photo 127). F17 has a picture rail, surviving fireplace opening and timber mantel but no surround or hearth (Photo 128).

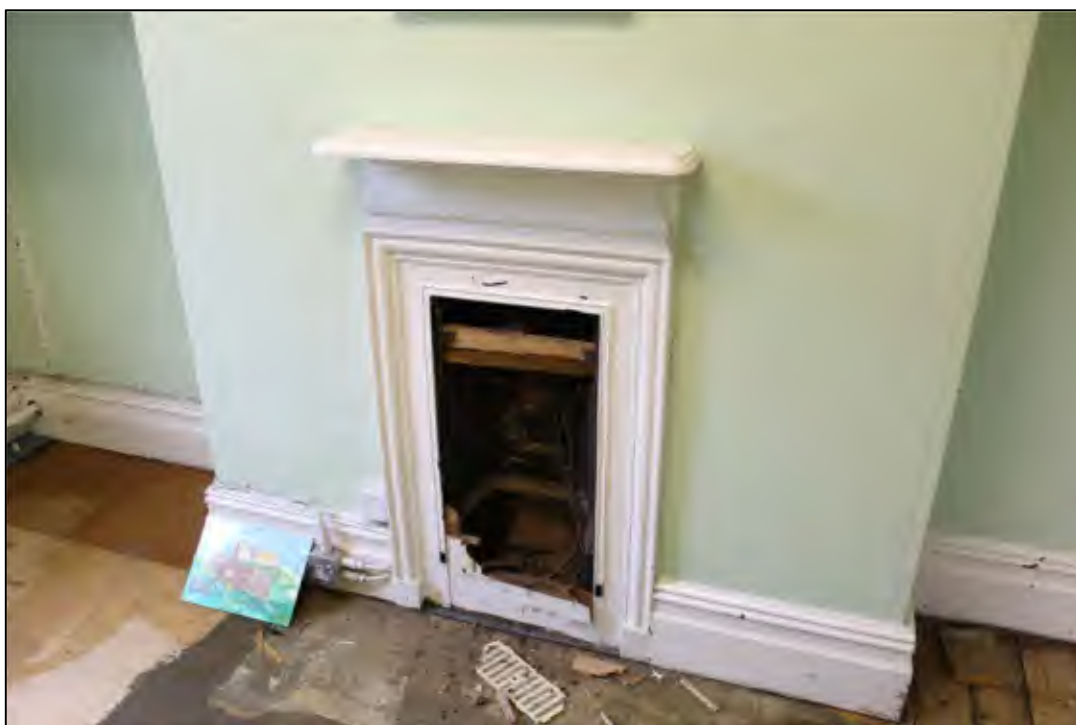
**Photo 126**      **Detail of 1900 fireplace in room F14**

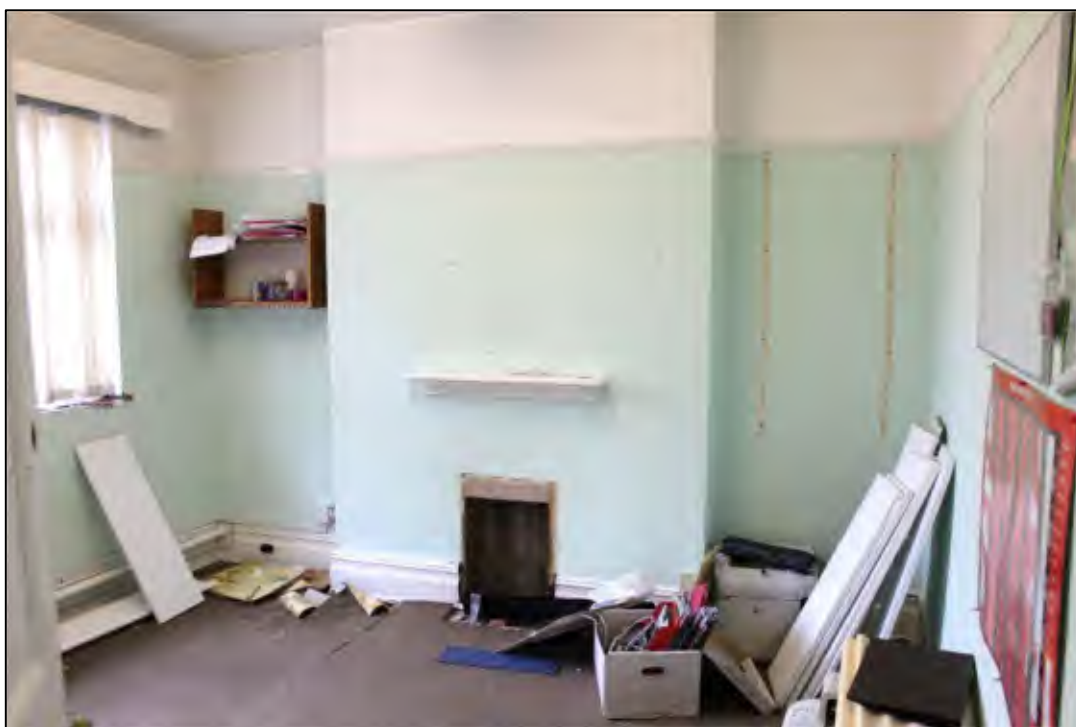
**Photo 128** Overview of room F17, with fireplace removed

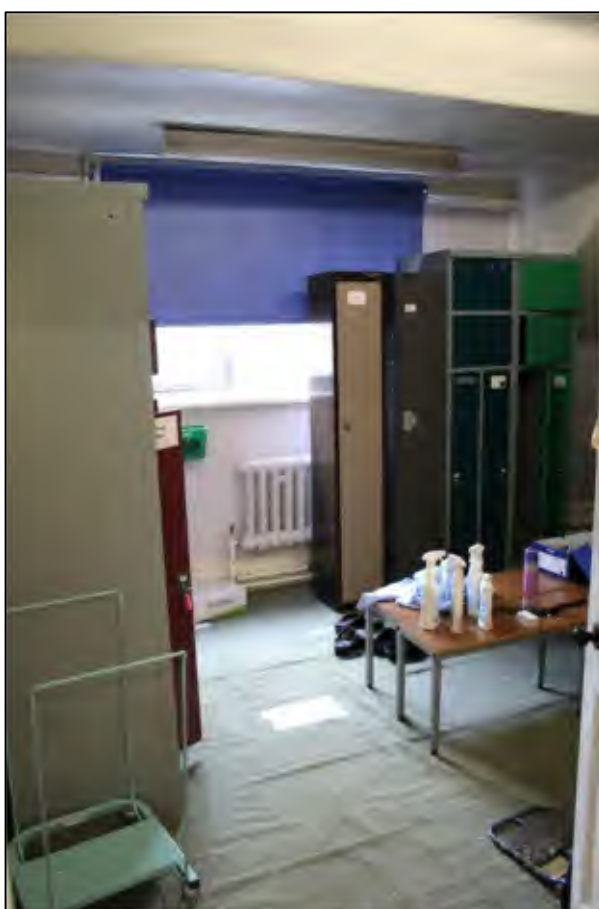
**Photo 129** View of room F18

**5.132.** Rooms F18, F19 and F20 are located the south end of the first floor, accessed via the central corridor, and were used as offices and staff spaces (Photo 129). All rooms are of the same finished and typology; they have timber floors, timber skirting and timber picture rails. All rooms have a chimney breast, although the fireplaces themselves have been removed (bar a timber mantel in room F18). All three rooms have been furnished and decorated in the late 20th/early 21st centuries with carpeted floors and painted walls, and there are no other features of note.
