# Schedule of Works

In support of the Full Planning Application for

## Renovation of Manor House Farmhouse

45 Main Street,  
Carlton

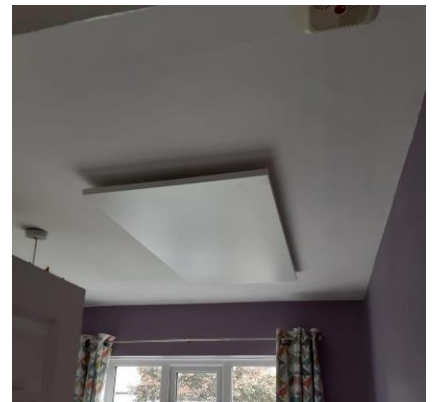
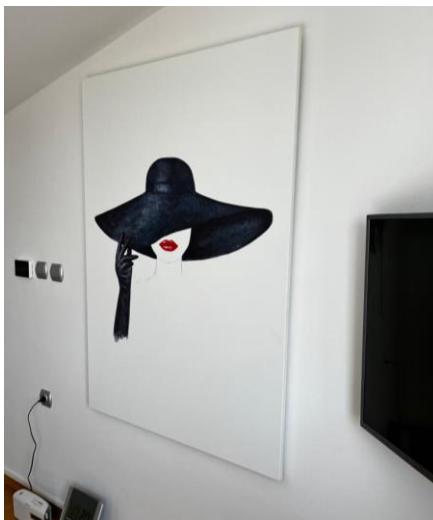
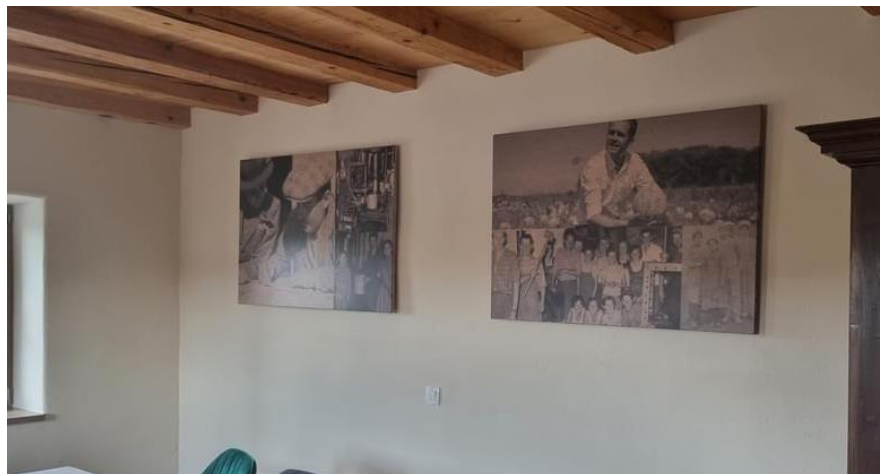
EXAMPLES OF INFRARED PANEL HEATERS AS INSTALLED.

The house is to be heated with a mixture of wood burning fires and infrared panels. The existing floors do not lend themselves to underfloor heating.

They can be removed with minimal damage to the fabric of the building. For further info please see [www.kiasa.co.uk](http://www.kiasa.co.uk)

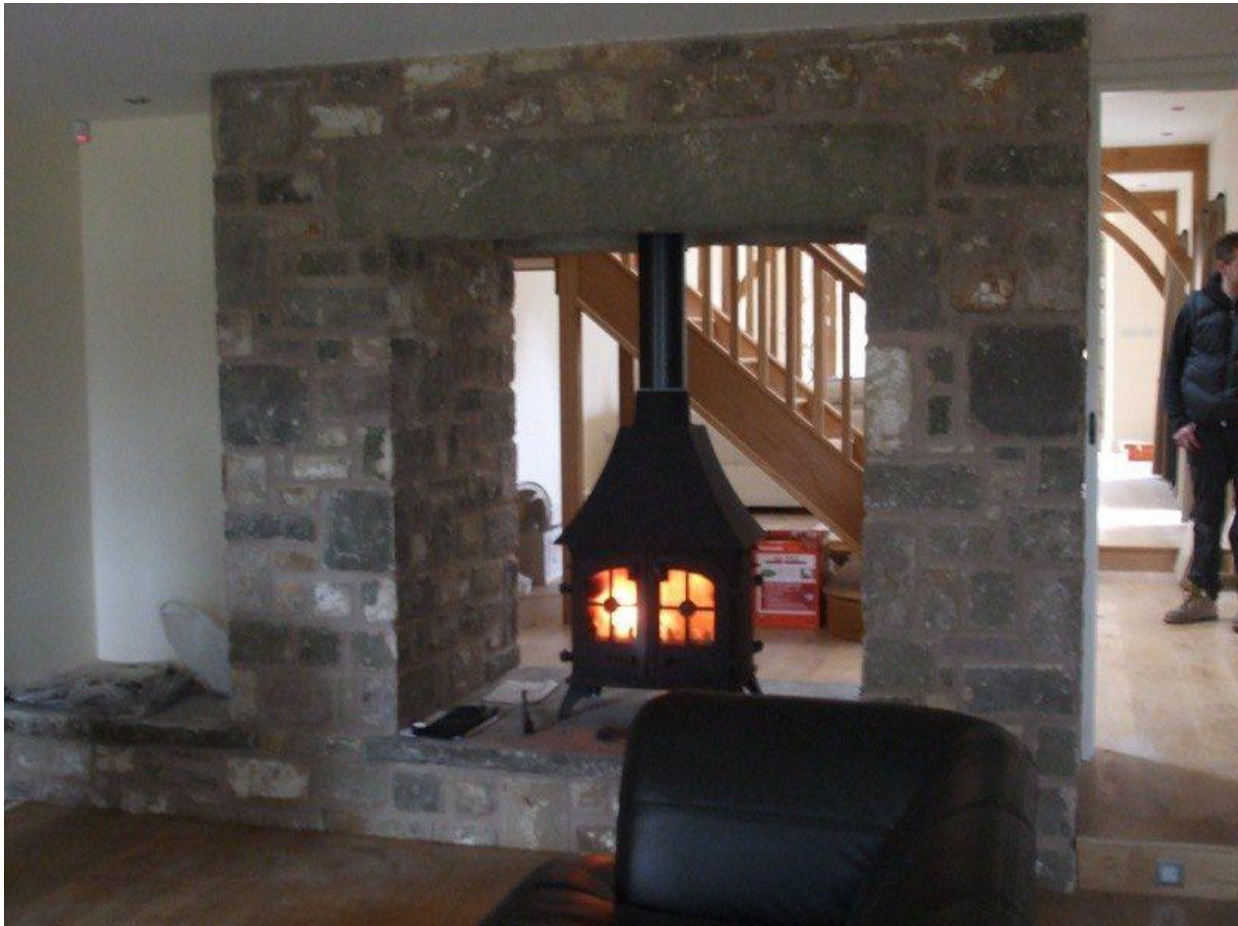
The fireplace between rooms R04 and R05 (FP03) is to have the dividing wall removed at below mantle level to give a view between the rooms. This is to be occupied by a double sided wood burning fire. This will visually unite the two rooms and provide an interesting feature. It is important to update historic building stock with some appropriate new features to maintain their desirability as family homes into the future.

EXAMPLE OF DOUBLE-SIDED FIRE PLACE FEATURE

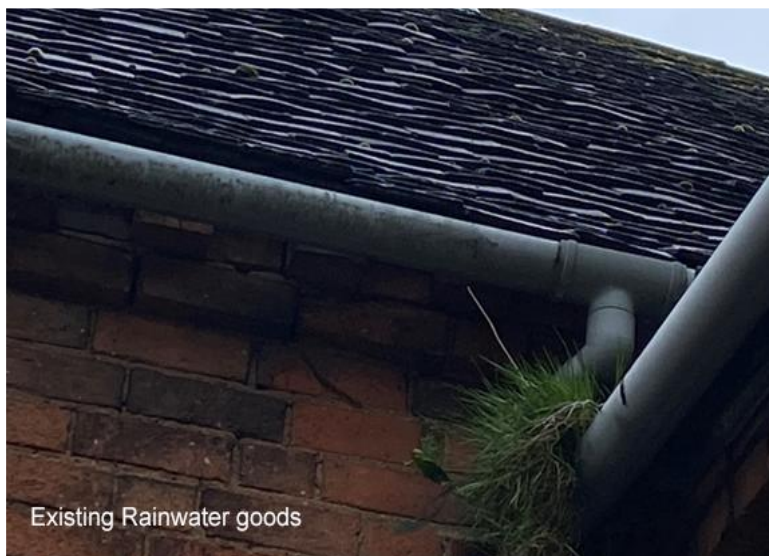
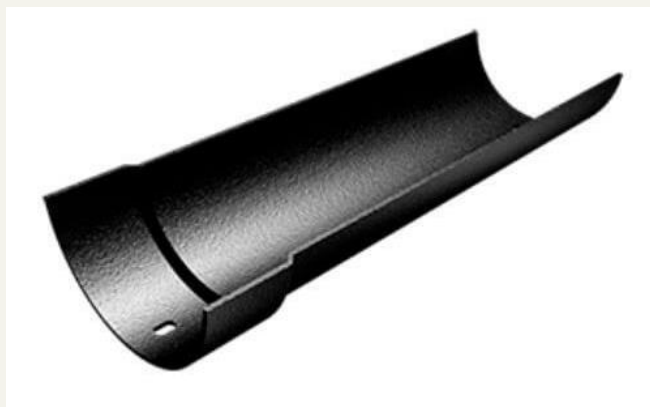
The existing gutters are grey plastic and of poor quality and in a poor state. They are to be replaced with black aluminium heritage gutters with spigot joints and similar black rainwater pipes

Proposed Rainwater Goods

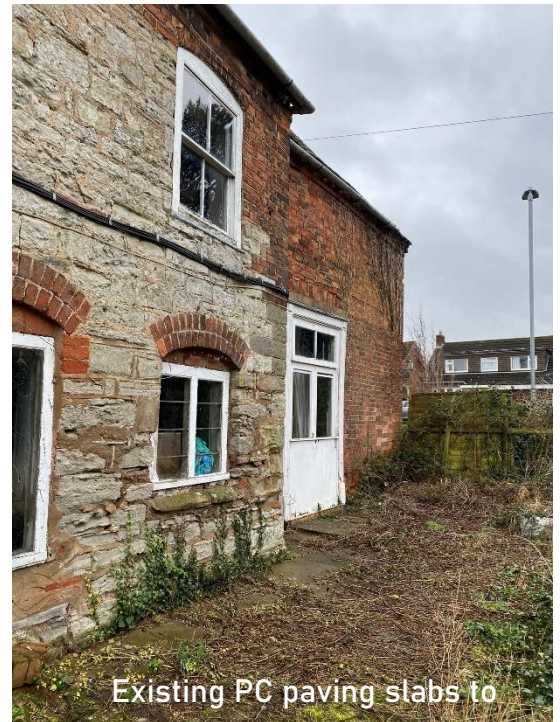
The path to the rear of the house is of pre-cast concrete slabs which are in a poor state and do not complement the historic setting. These are to be removed and replaced with new sandstone paving slabs sourced from a local quarry.

Existing PC paving slabs to

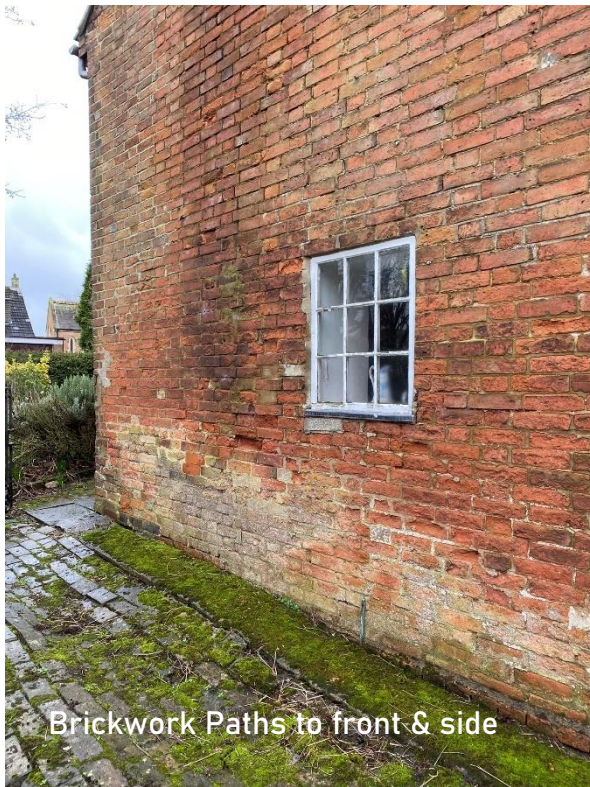
The path which wraps around the front and side of the house is of historic brick paving, which is again in a very poor state of repair. This is more in keeping with the historic setting and so is to be taken up and re-laid with stable foundations.

Brickwork Paths to front & side

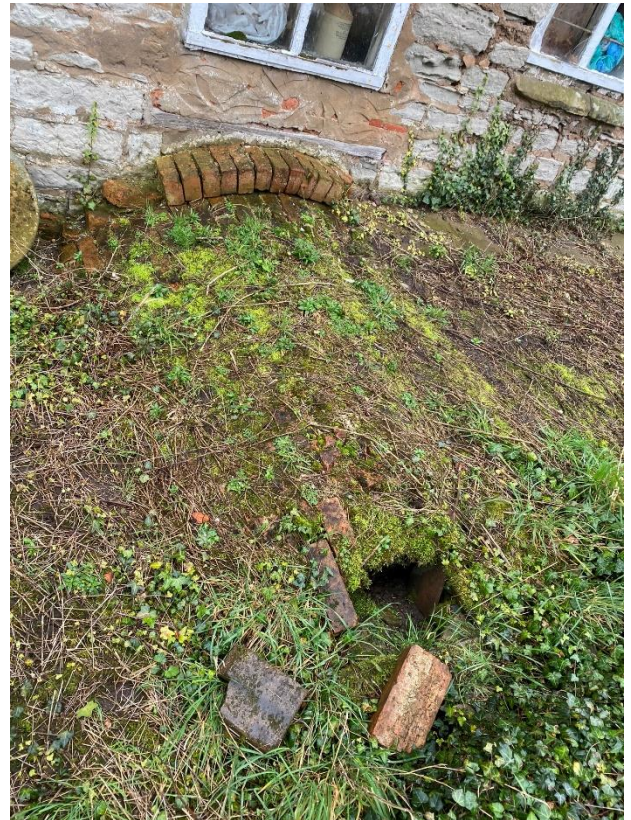
This is the only apparent way to enter the basement and the access stair beneath the arch has been infilled with loose rubble at some past date. This rubble is to be left undisturbed and the new path is to sit either side of the arch structure.

Archway access to basement
