## BAT MITIGATION STRATEGY

THE COACH HOUSE  
RECTORY LANE  
MARKET BOSWORTH  
LEICESTERSHIRE

| Report Title: | Bat Mitigation Strategy for The Coach House, Market Bosworth |

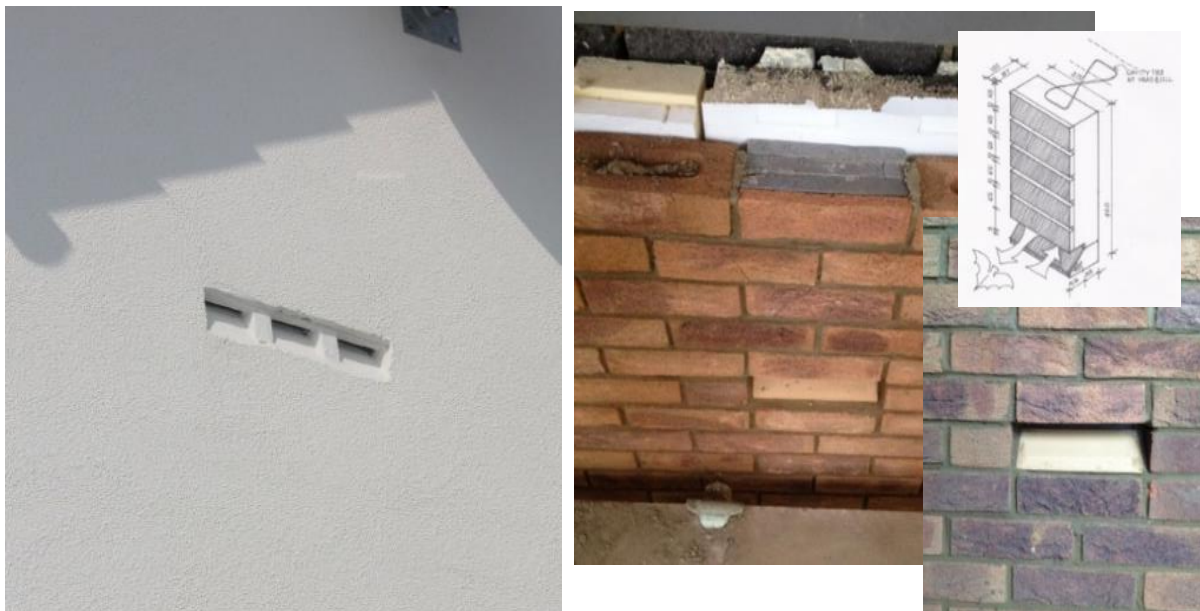
Enclosed bat tubes will be installed on the gable ends of the dwelling such that the access slot to the box fits flush with the wall, allowing a bat to land below and crawl up into the box. An example of an installed Habitat box is provided in figure 5 below.

Figure 3: Examples of bat tubes fitted within the brickwork of an exterior wall.

There will be 4 of these tubes installed.
