## **Arboricultural Impact Assessment & Draft Arboricultural Method Statement**

**Site:** 39 Station Road, Desford, New Bungalow.

**Ref:** AIA-25-01-001NB

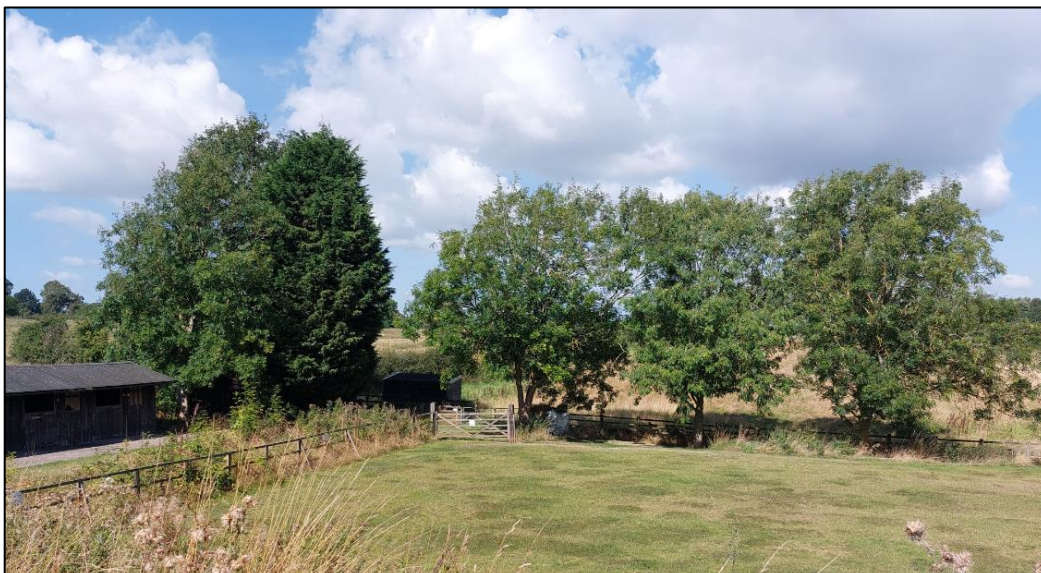
3.14.

- 3.12. Crown lifting to approximately 4-5m above ground level is required to trees T007 and T008.
- 3.13. Low branches over the access on trees T002 – T005 and G001 may also be required to prevent accidental damage from traffic.

Trees T003 – T008 will require crown lifting.

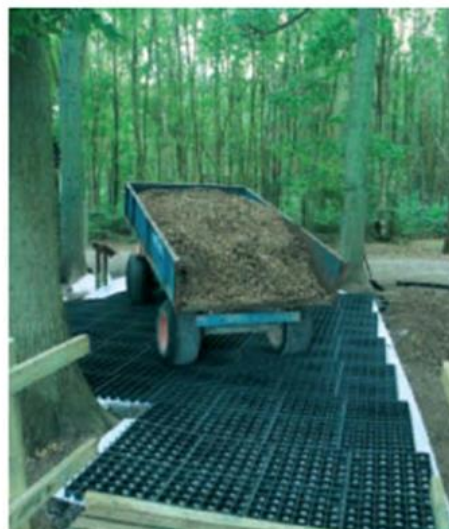
Glynebome Wood.

Pedestrian path in recreational wood and built using a CellWeb™ foundation which was covered with DuolBlock and then filled with woodchip to create a porous surface.
