**BARWELL CAPITAL LIMITED  
HINCKLEY ROAD, BARWELL  
LLFA COMMENT RESPONSE**

**BARWELL CAPITAL LIMITED**  
**HINCKLEY ROAD, BARWELL**  
**LLFA COMMENT RESPONSE**

This document has been created in response to the LLFA comment requirements published by Leicestershire County Council (LCC) in regard to planning application reference's 23/01175/FUL, 23/01177/FUL, 23/01184/FUL, 23/01186/FUL. The comments are dated 09/04/24. The comments are in black and the responses are in red.

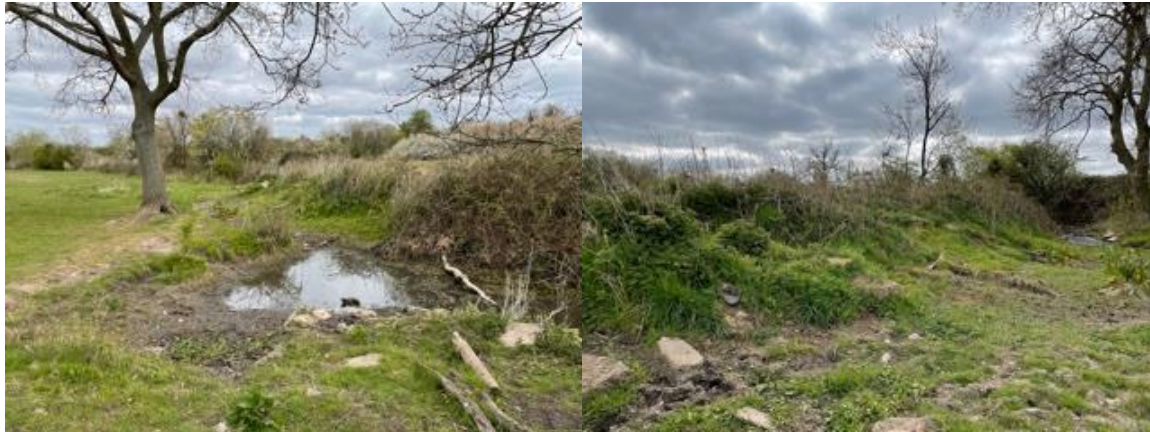
The ditch is rather a minor indentation than a drainage feature. Please see below photographs of the existing watering hole and ditch. Although the ditch and existing ponded area doesn't appear to provide any drainage function, we are proposing the pond to be reshaped to suit the layout and proposed a new 600mm x 600mm ditch running south to north. The ditch is shown to have a 3m easement around it.

*Existing pond looking north*

*Existing pond & ditch looking south*
