# Wood Farm, Coalville, Leicestershire

Historic Building Recording

| Project name | Wood Farm (Bardon 3), Coalville, Leicestershire |
| Type of project | Historic Building Recording |

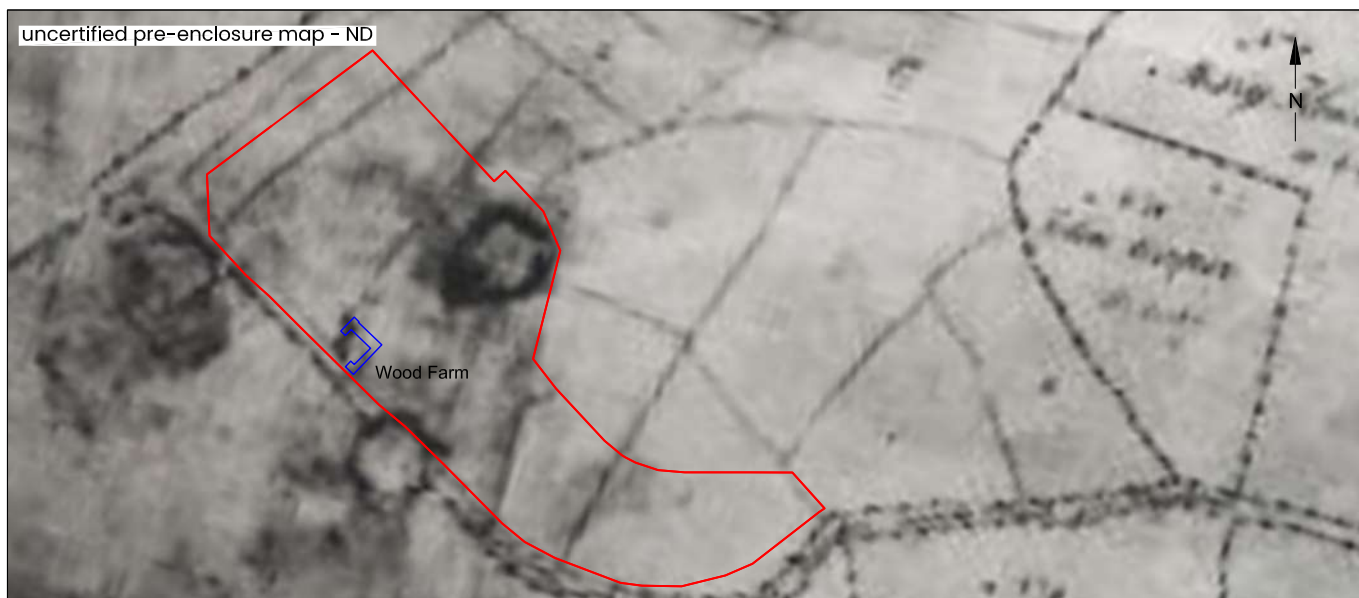
1838 tithe map

Figure 2 - Historical maps  
9650 - Wood Farm, Coalville, Leicestershire: HBR

- 3.2.3 The 1838 Bardon tithe map shows the same northeast-southwest orientated merged ranges in slightly more detail than the previous map indicating a rough U-shaped plan creating an open courtyard to the southeast (Figure 2).

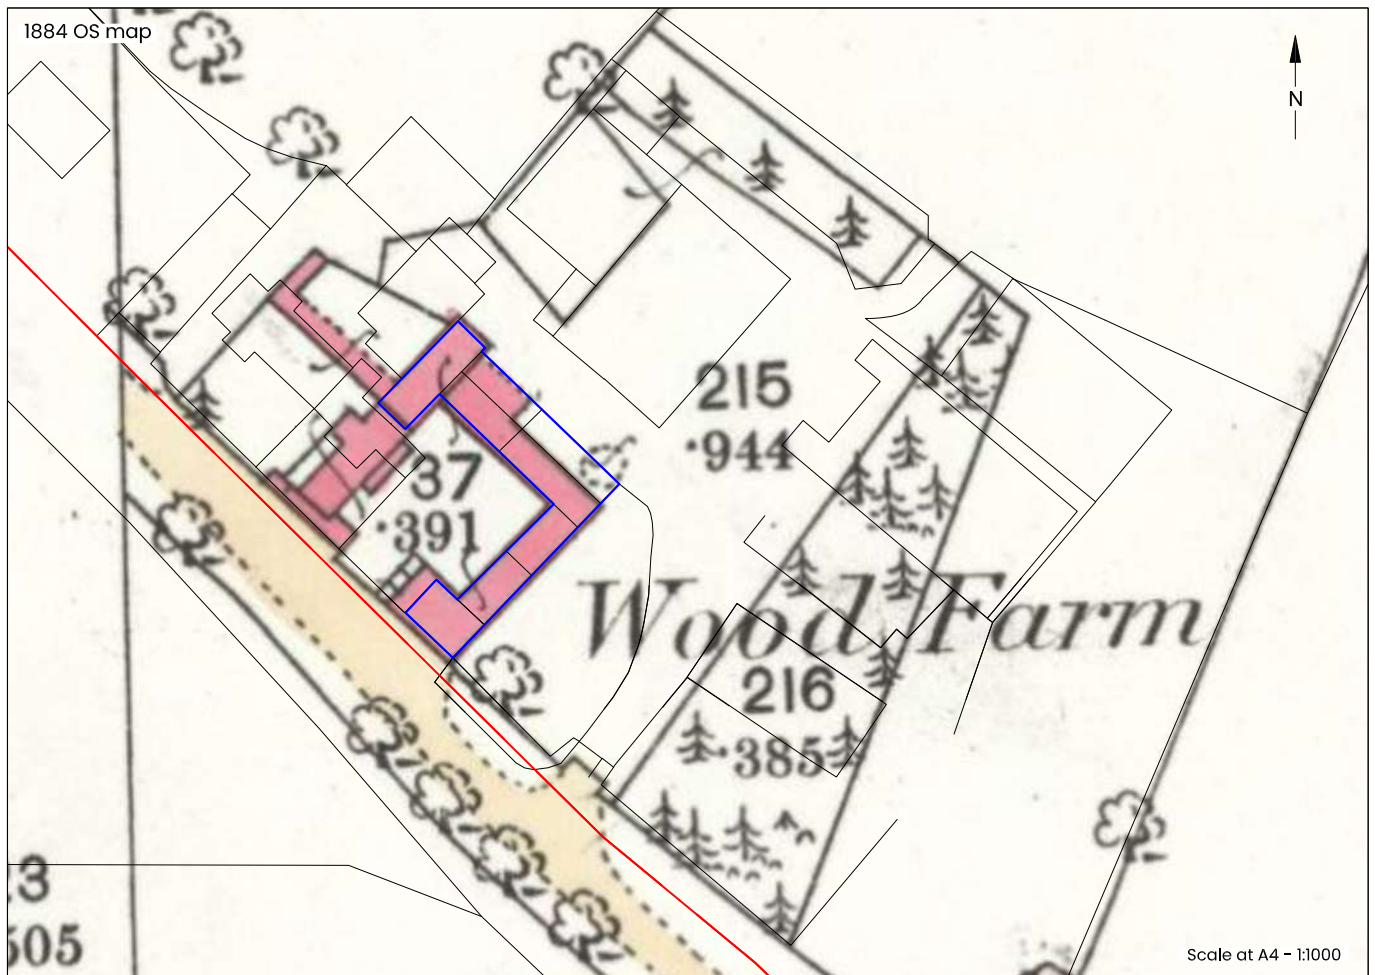
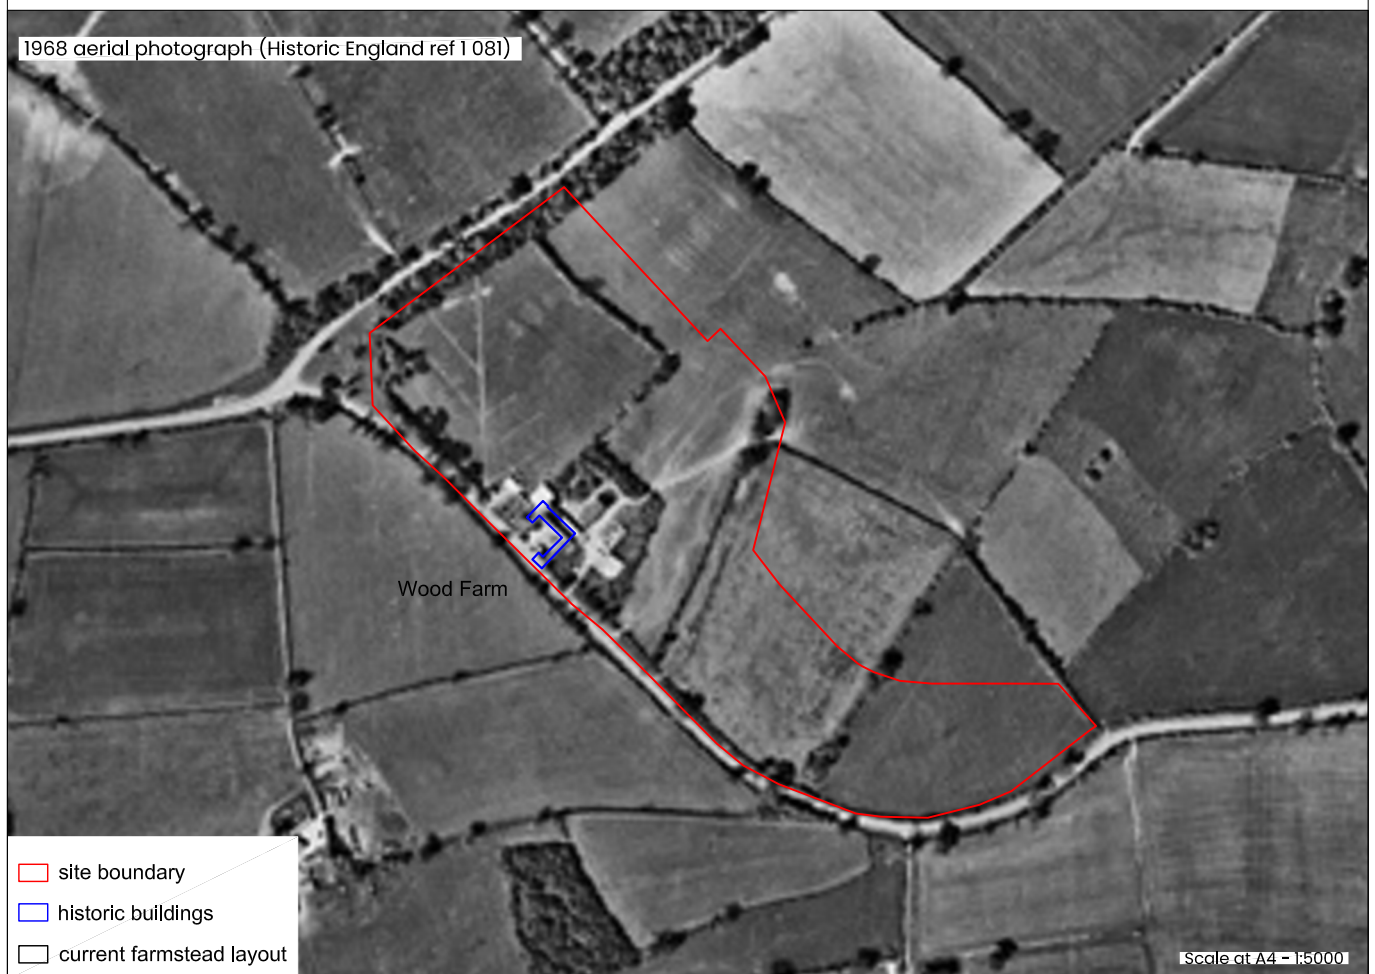
Figure 3 - Historical OS map and aerial photograph  
9650 - Wood Farm, Coalville, Leicestershire: HBR

- 3.2.5 The first edition Ordnance Survey map published in 1884 shows the farmstead further developed including the historic buildings subject to this survey (Buildings 1-6) being in place with the exception of Building 3a (Figure 3). The buildings' codes follow the ones previously assigned and shown on a block plan (Figure 4). The 1884 Ordnance Survey map also shows the now demolished farmhouse to the southwest of Building 1, with the same alignment creating the entire north-western section around the courtyard except for the entrance from Stanton Lane. The farmstead contained several additional buildings including a long and narrow L-shaped range projecting to the northwest from the southwest end of Building 1 forming another enclosed yard. This building is shown as an open-fronted cattle barn facing the northern courtyard. The farmstead appears labelled as 'Wood Farm' comprising two wooded areas towards the northeast and southeast, which remained part of the farmstead at least until the late 1960s as indicated by an aerial photograph taken in 1968, albeit with a small cleared section within the south-eastern area (Figure 3).

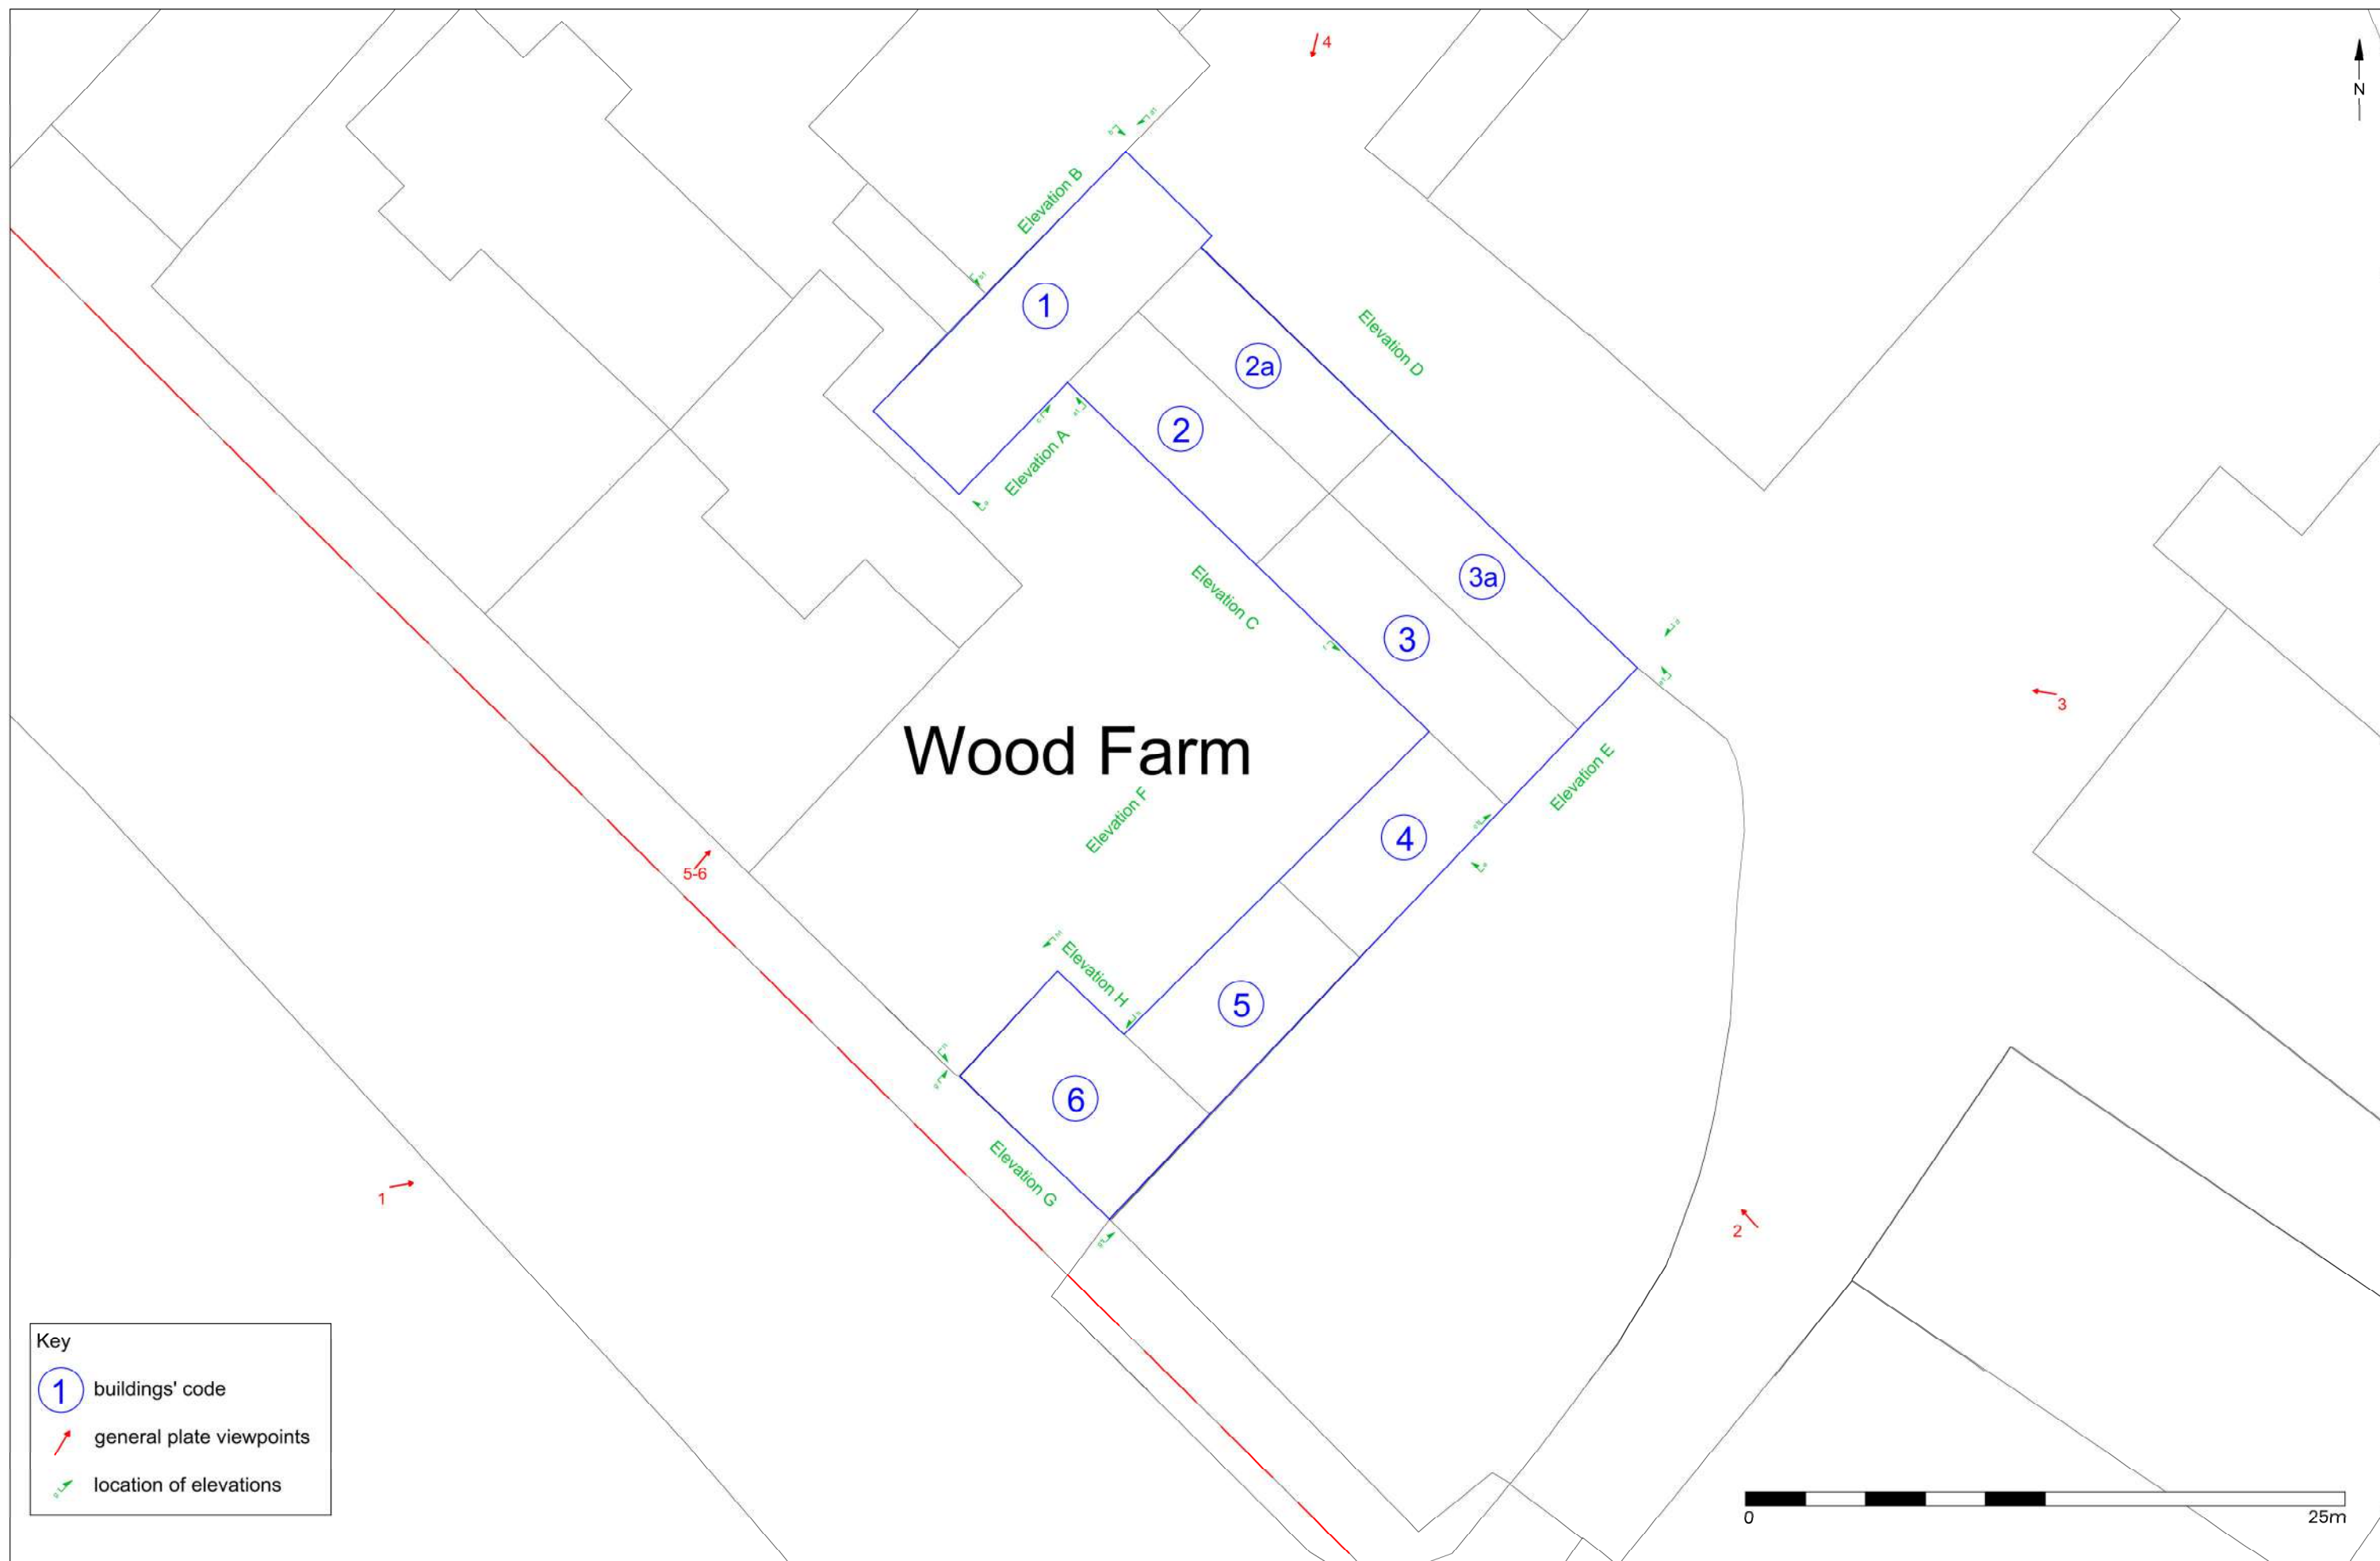
- ① buildings' code
- ↗ general plate viewpoints
- ↗ location of elevations

Figure 4 - Block plan with buildings' code and location of elevations  
9650 - Wood Farm, Coalville, Leicestershire: HBR

- 4.1.4 Numerical codes for each historic building follow those assigned previously in the Historic Building Assessment (Lobb 2020). An overall block plan with the buildings' code has been arranged which also includes the location of the surveyed elevations and general plate viewpoints (Figure 4). Although the historic buildings are amalgamated, creating a slightly irregular U-shaped plan often with contiguous construction fabrics; for the purpose of this report the definition 'building' is used to describe a built structure within the confines of the

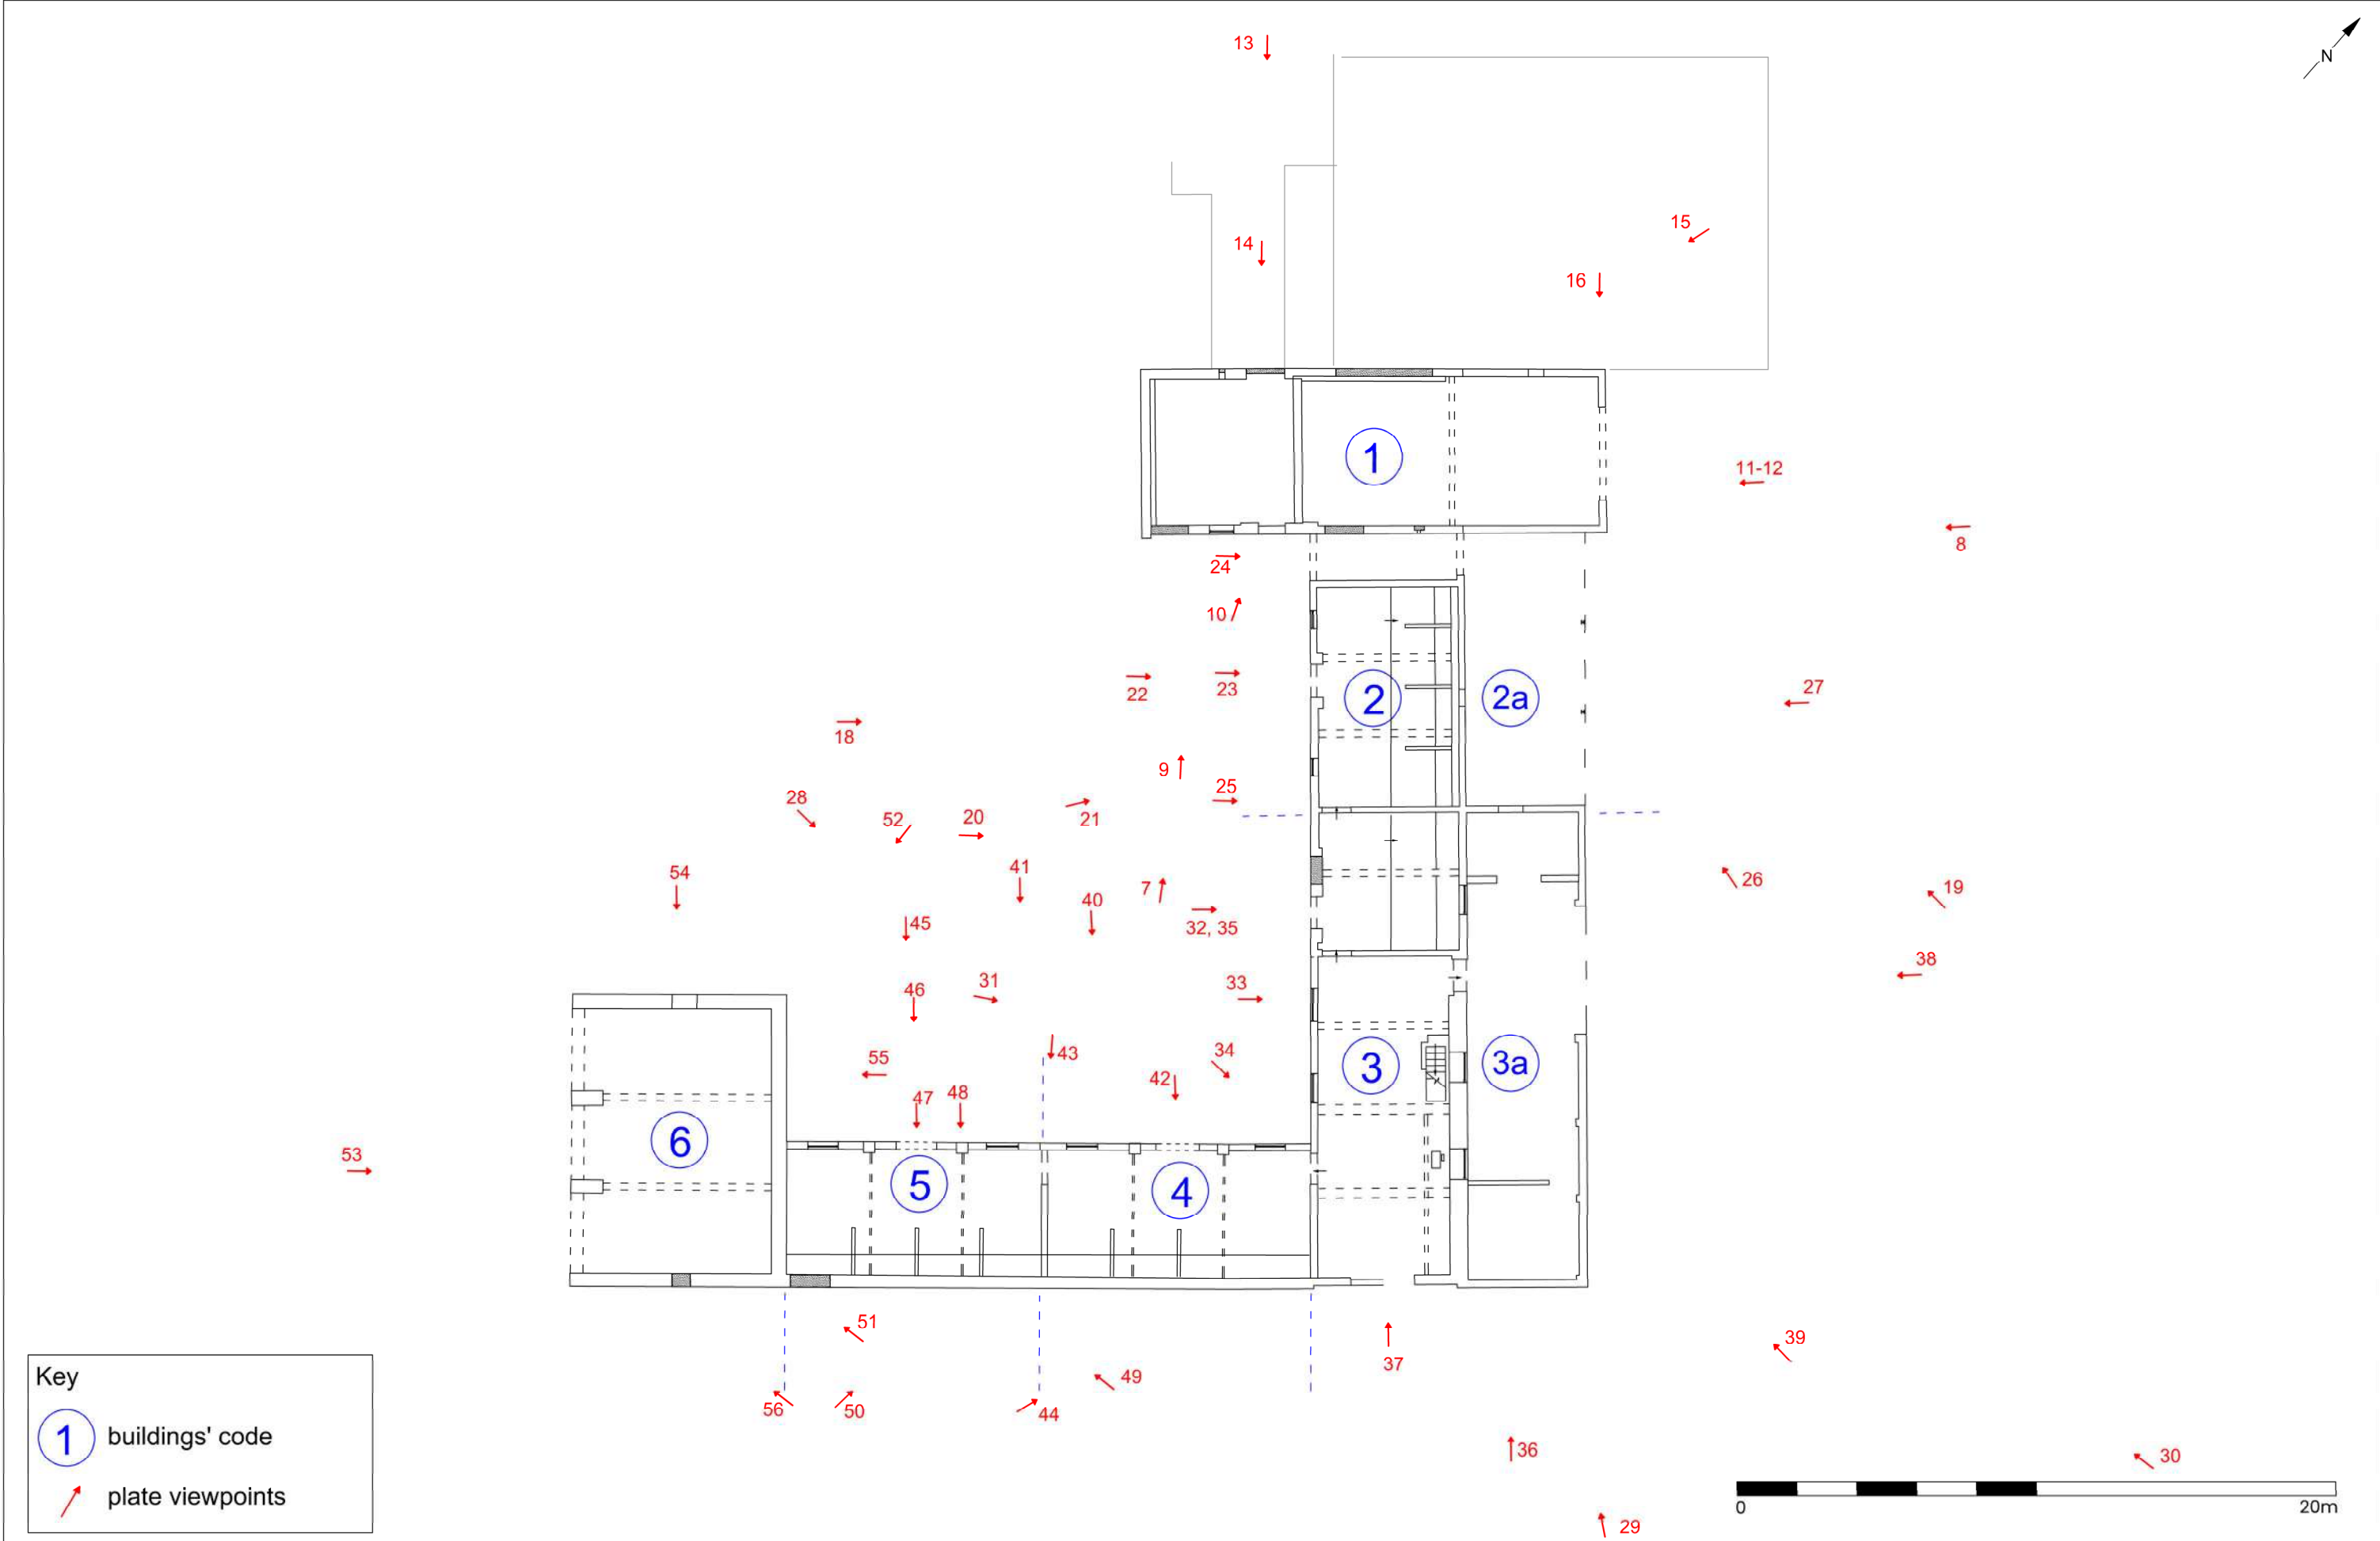
Figure 5 - Plan of the buildings with external plate viewpoints  
9650 - Wood Farm, Coalville, Leicestershire: HBR

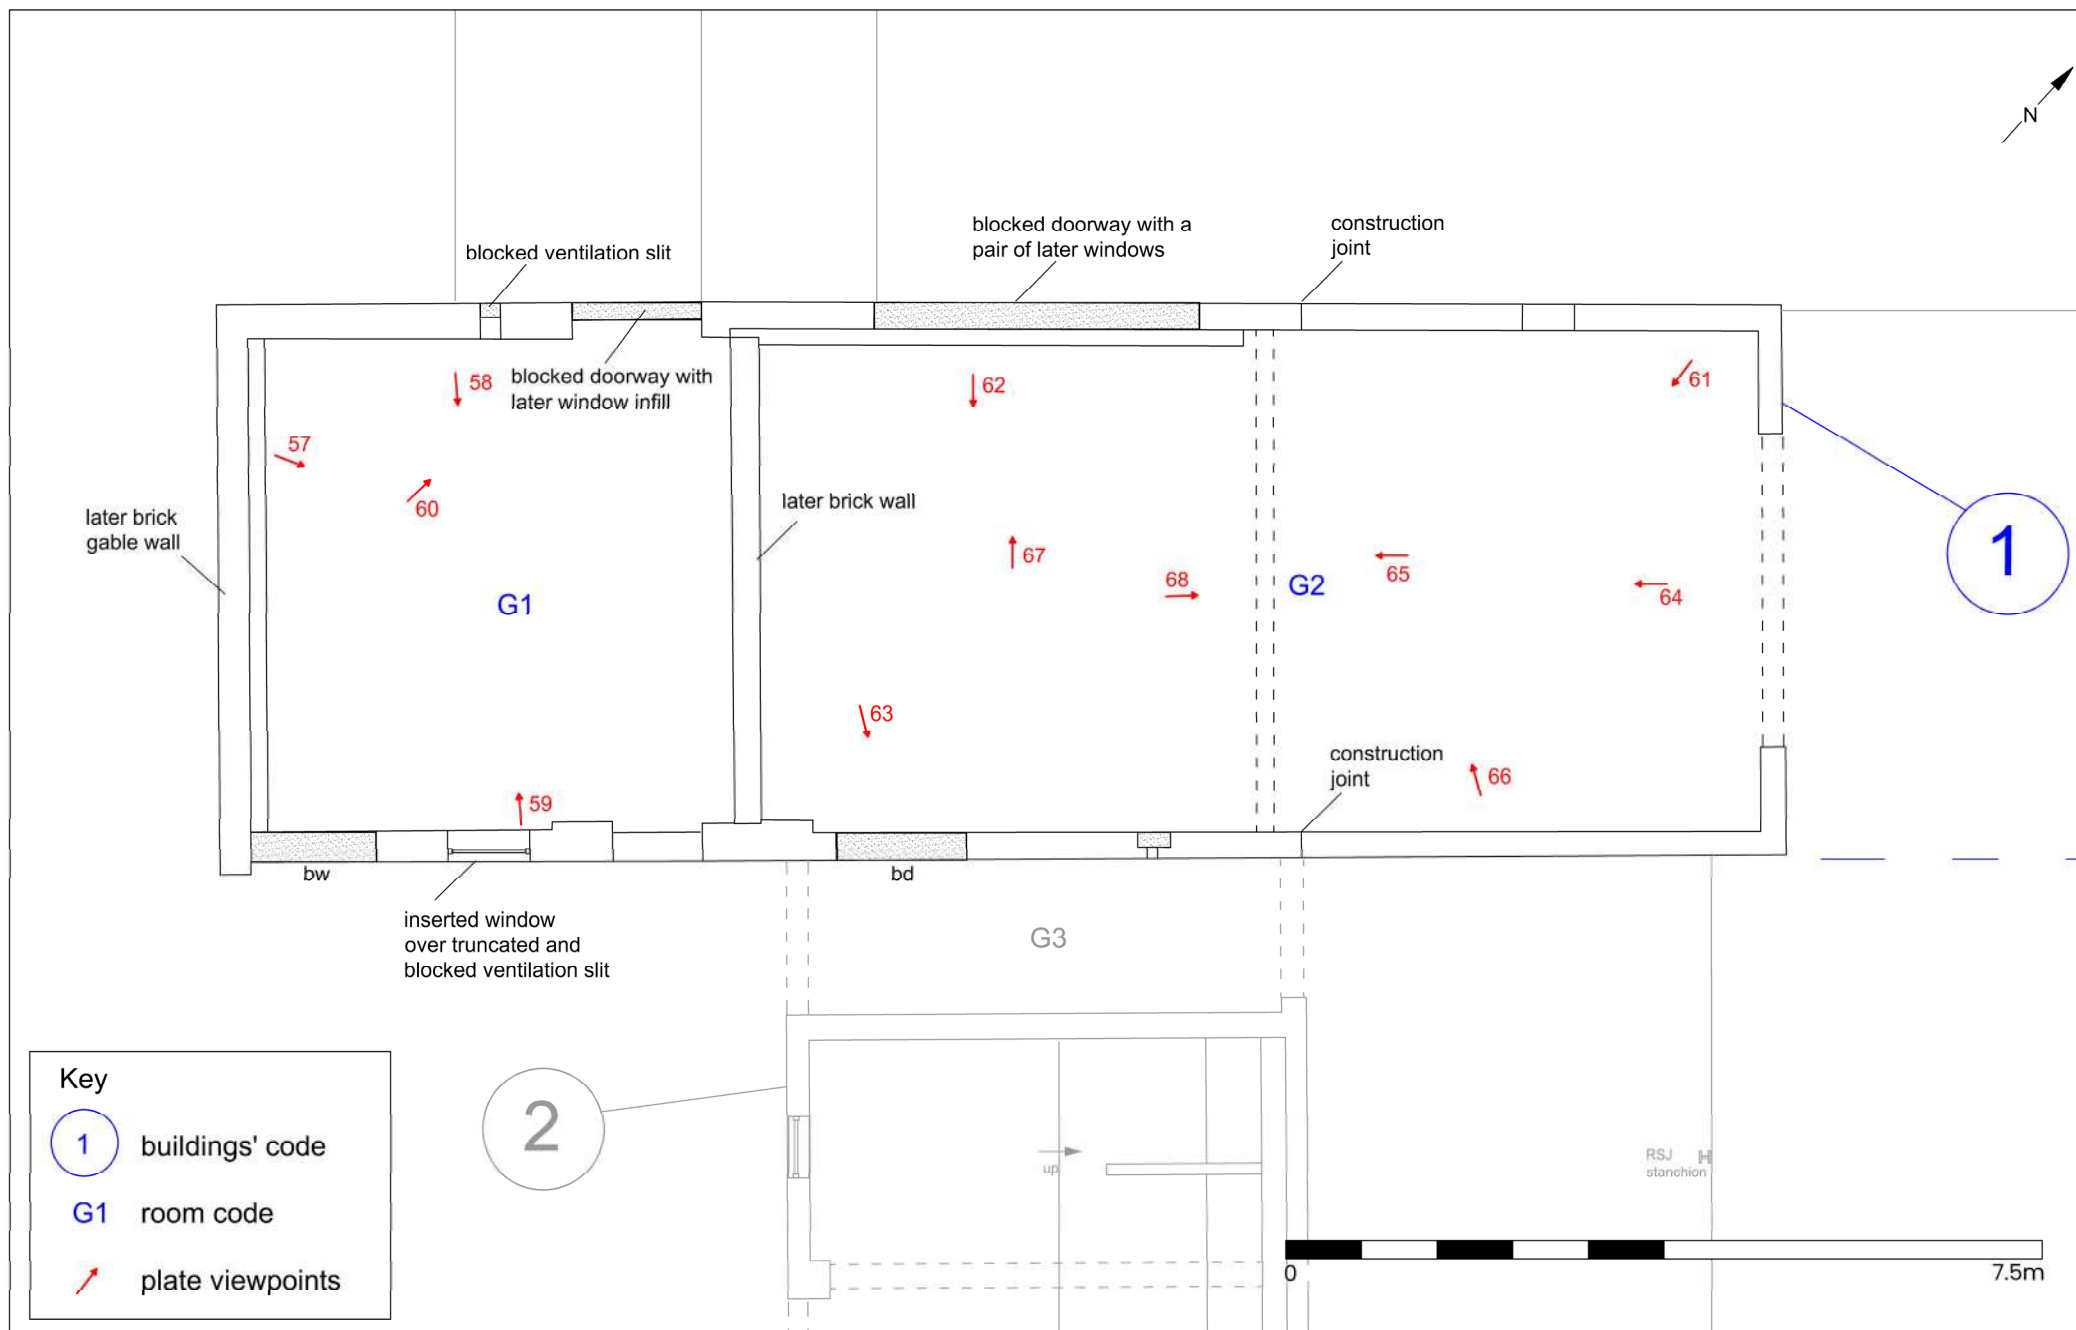
Figure 6 - Ground floor plan of Building 1  
9650 - Wood Farm, Coalville, Leicestershire: HBR

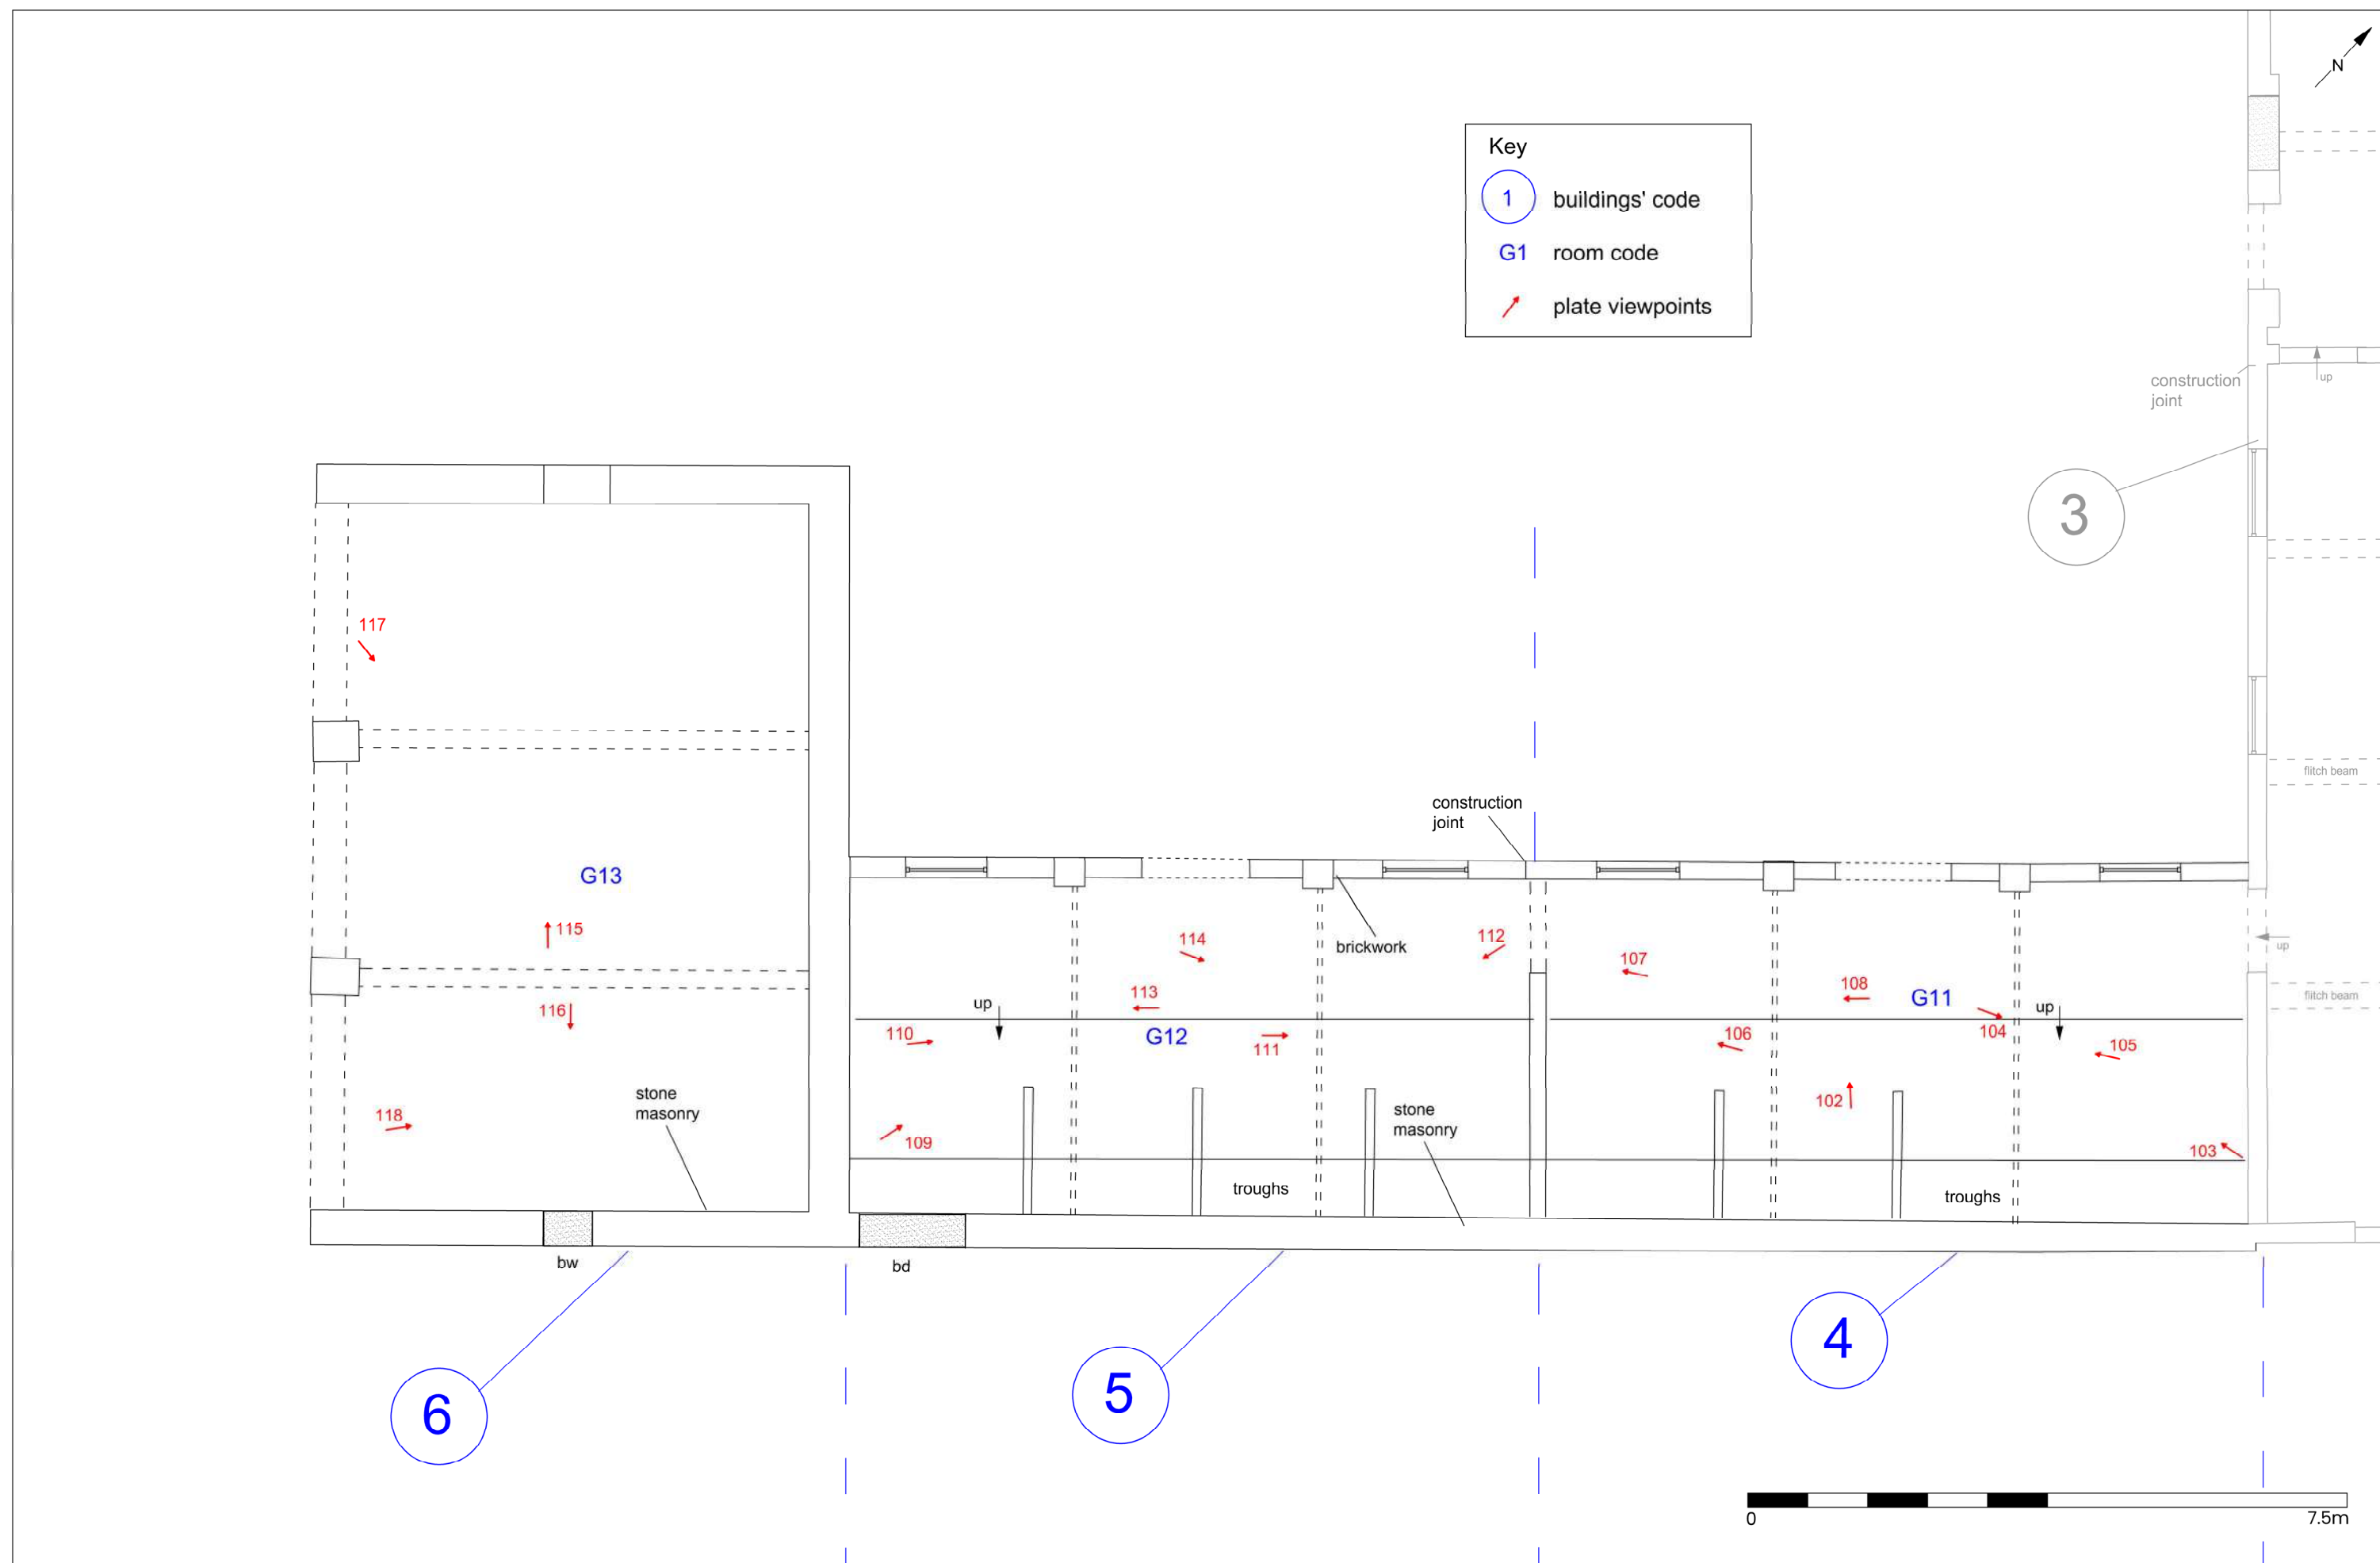
Figure 8 - Ground floor plan of Buildings 4 - 6  
9650 - Wood Farm, Coalville, Leicestershire: HBR

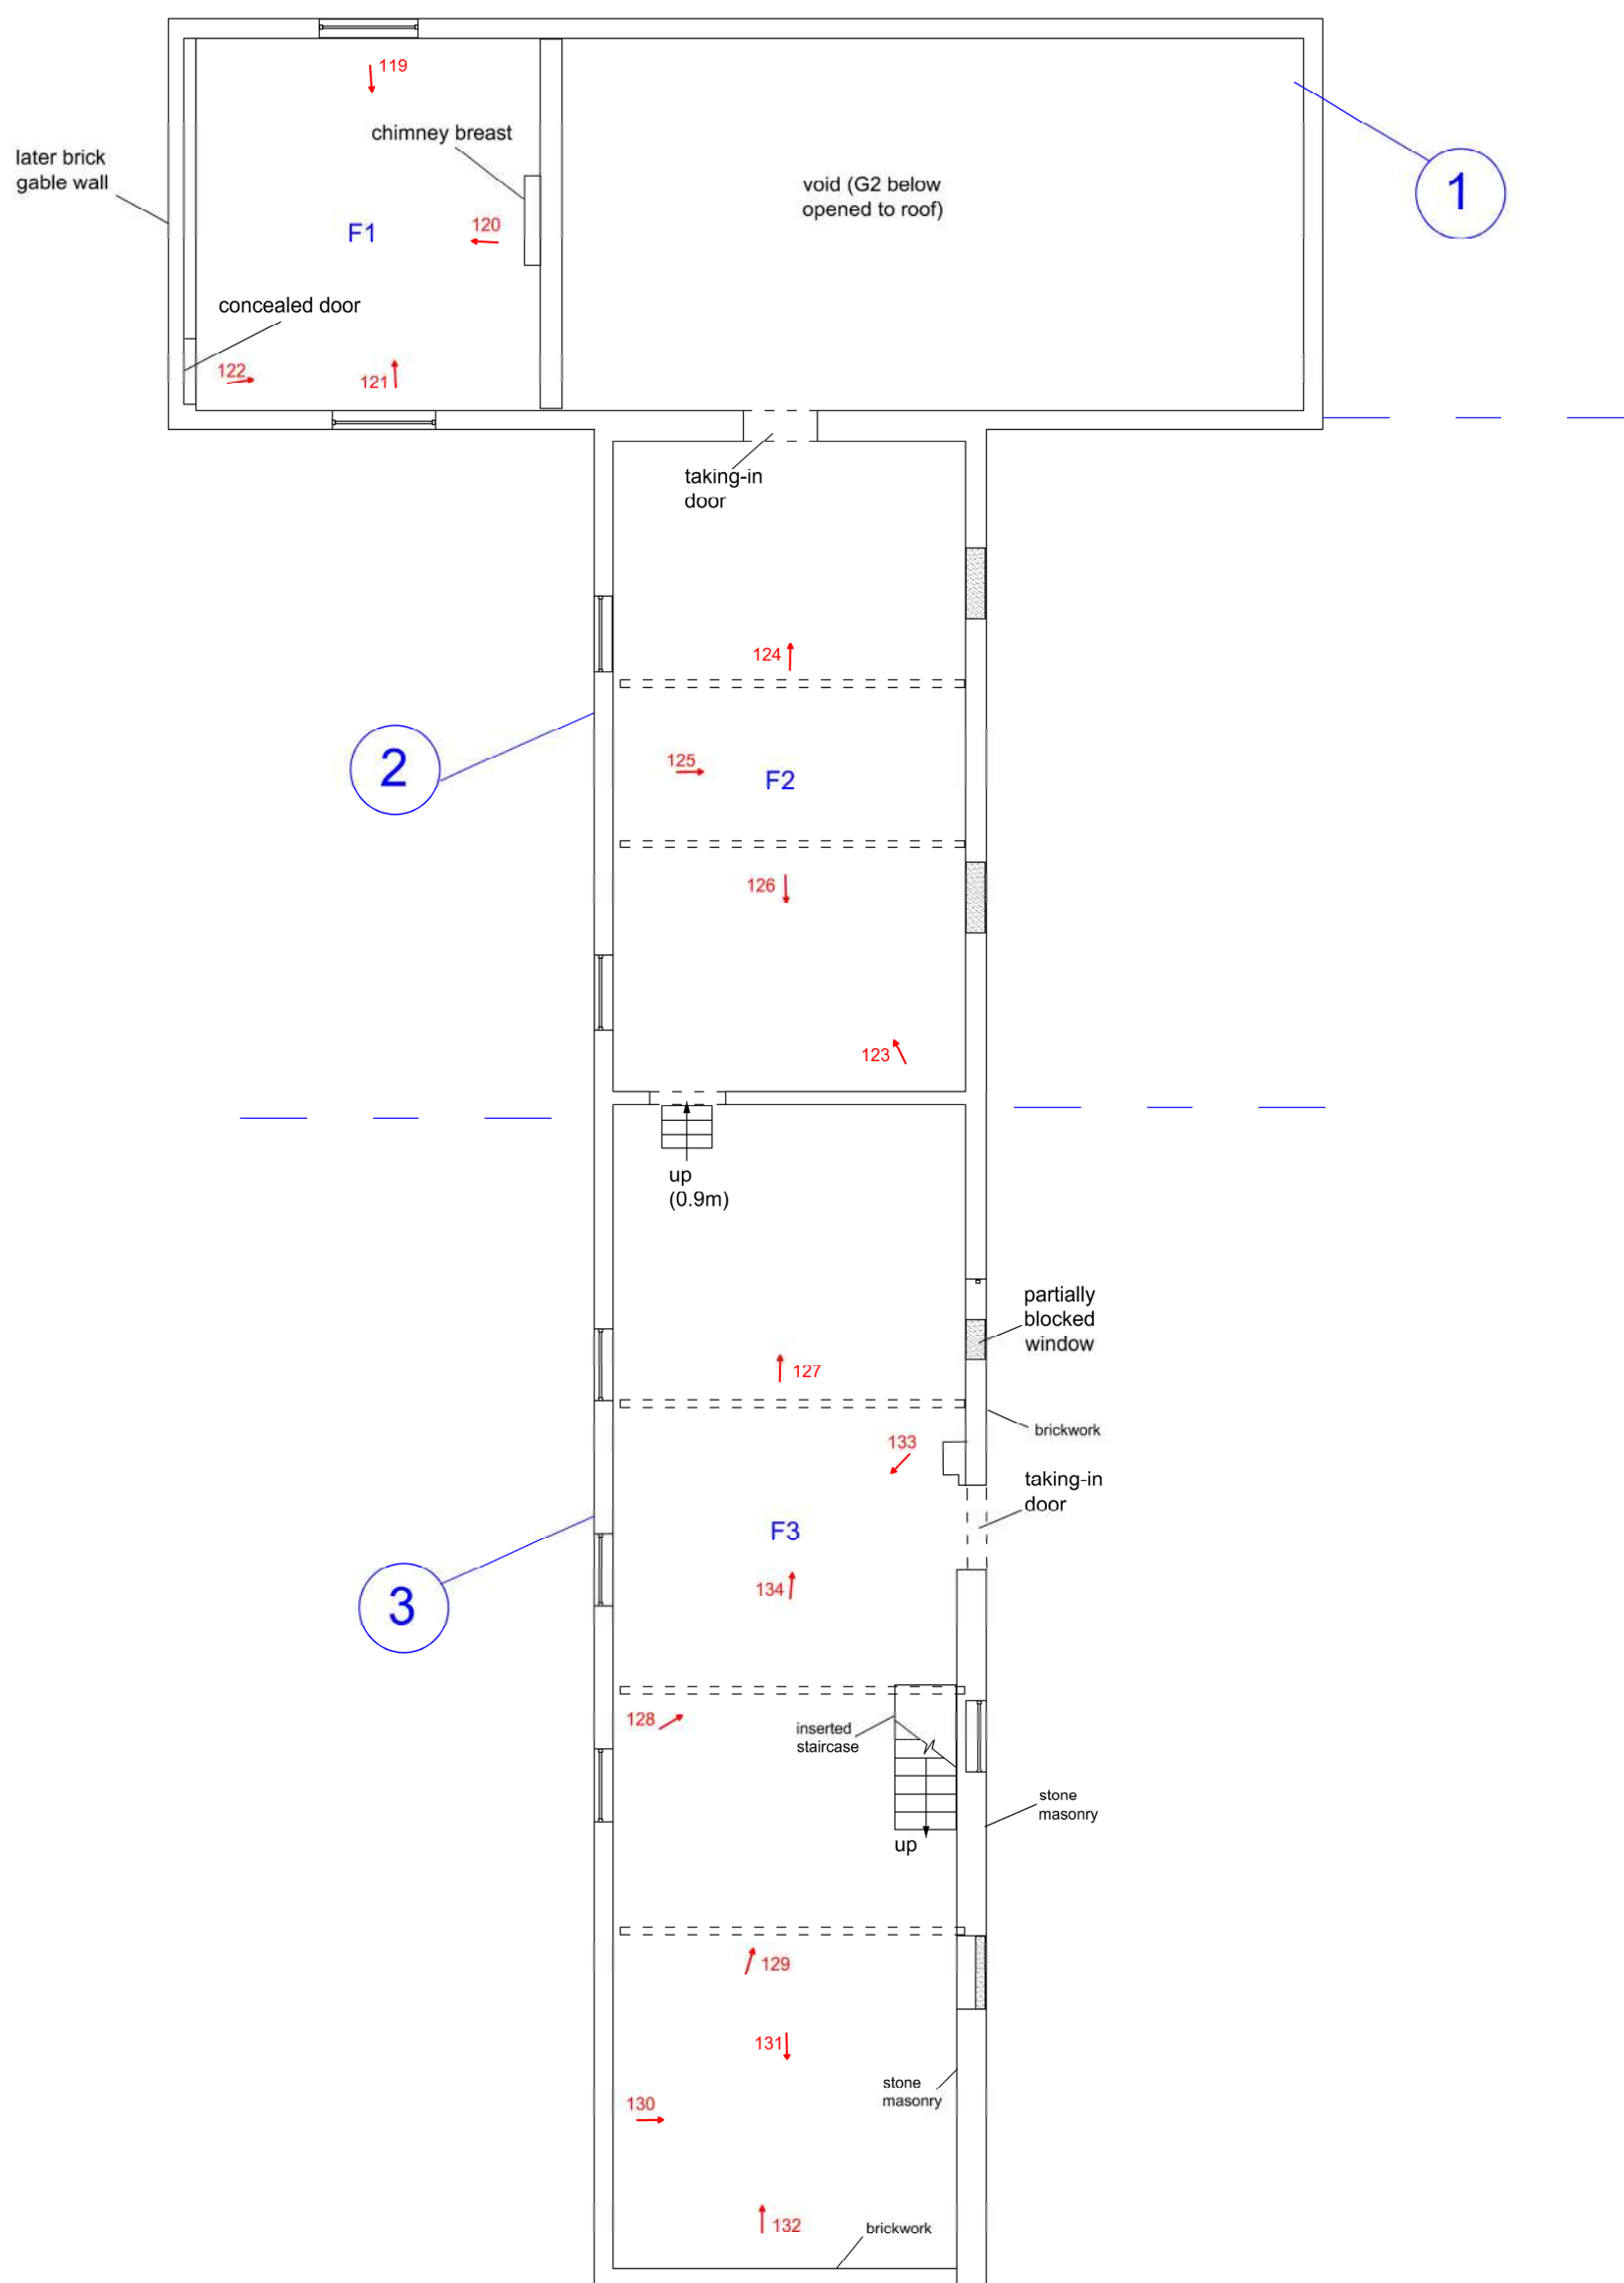
- 1 buildings' code
- F1 room code
- plate viewpoints

Figure 9 – First floor plan of Buildings 1 – 3  
9650 – Wood Farm, Coalville, Leicestershire: HBR
