**LAND AT CLUMP FARM,  
HINCKLEY ROAD,  
LEICESTERSHIRE LE9 7TJ:**

**ARCHAEOLOGICAL  
MANAGEMENT PLAN**

**PCA Report Number: R18365  
March 2026**

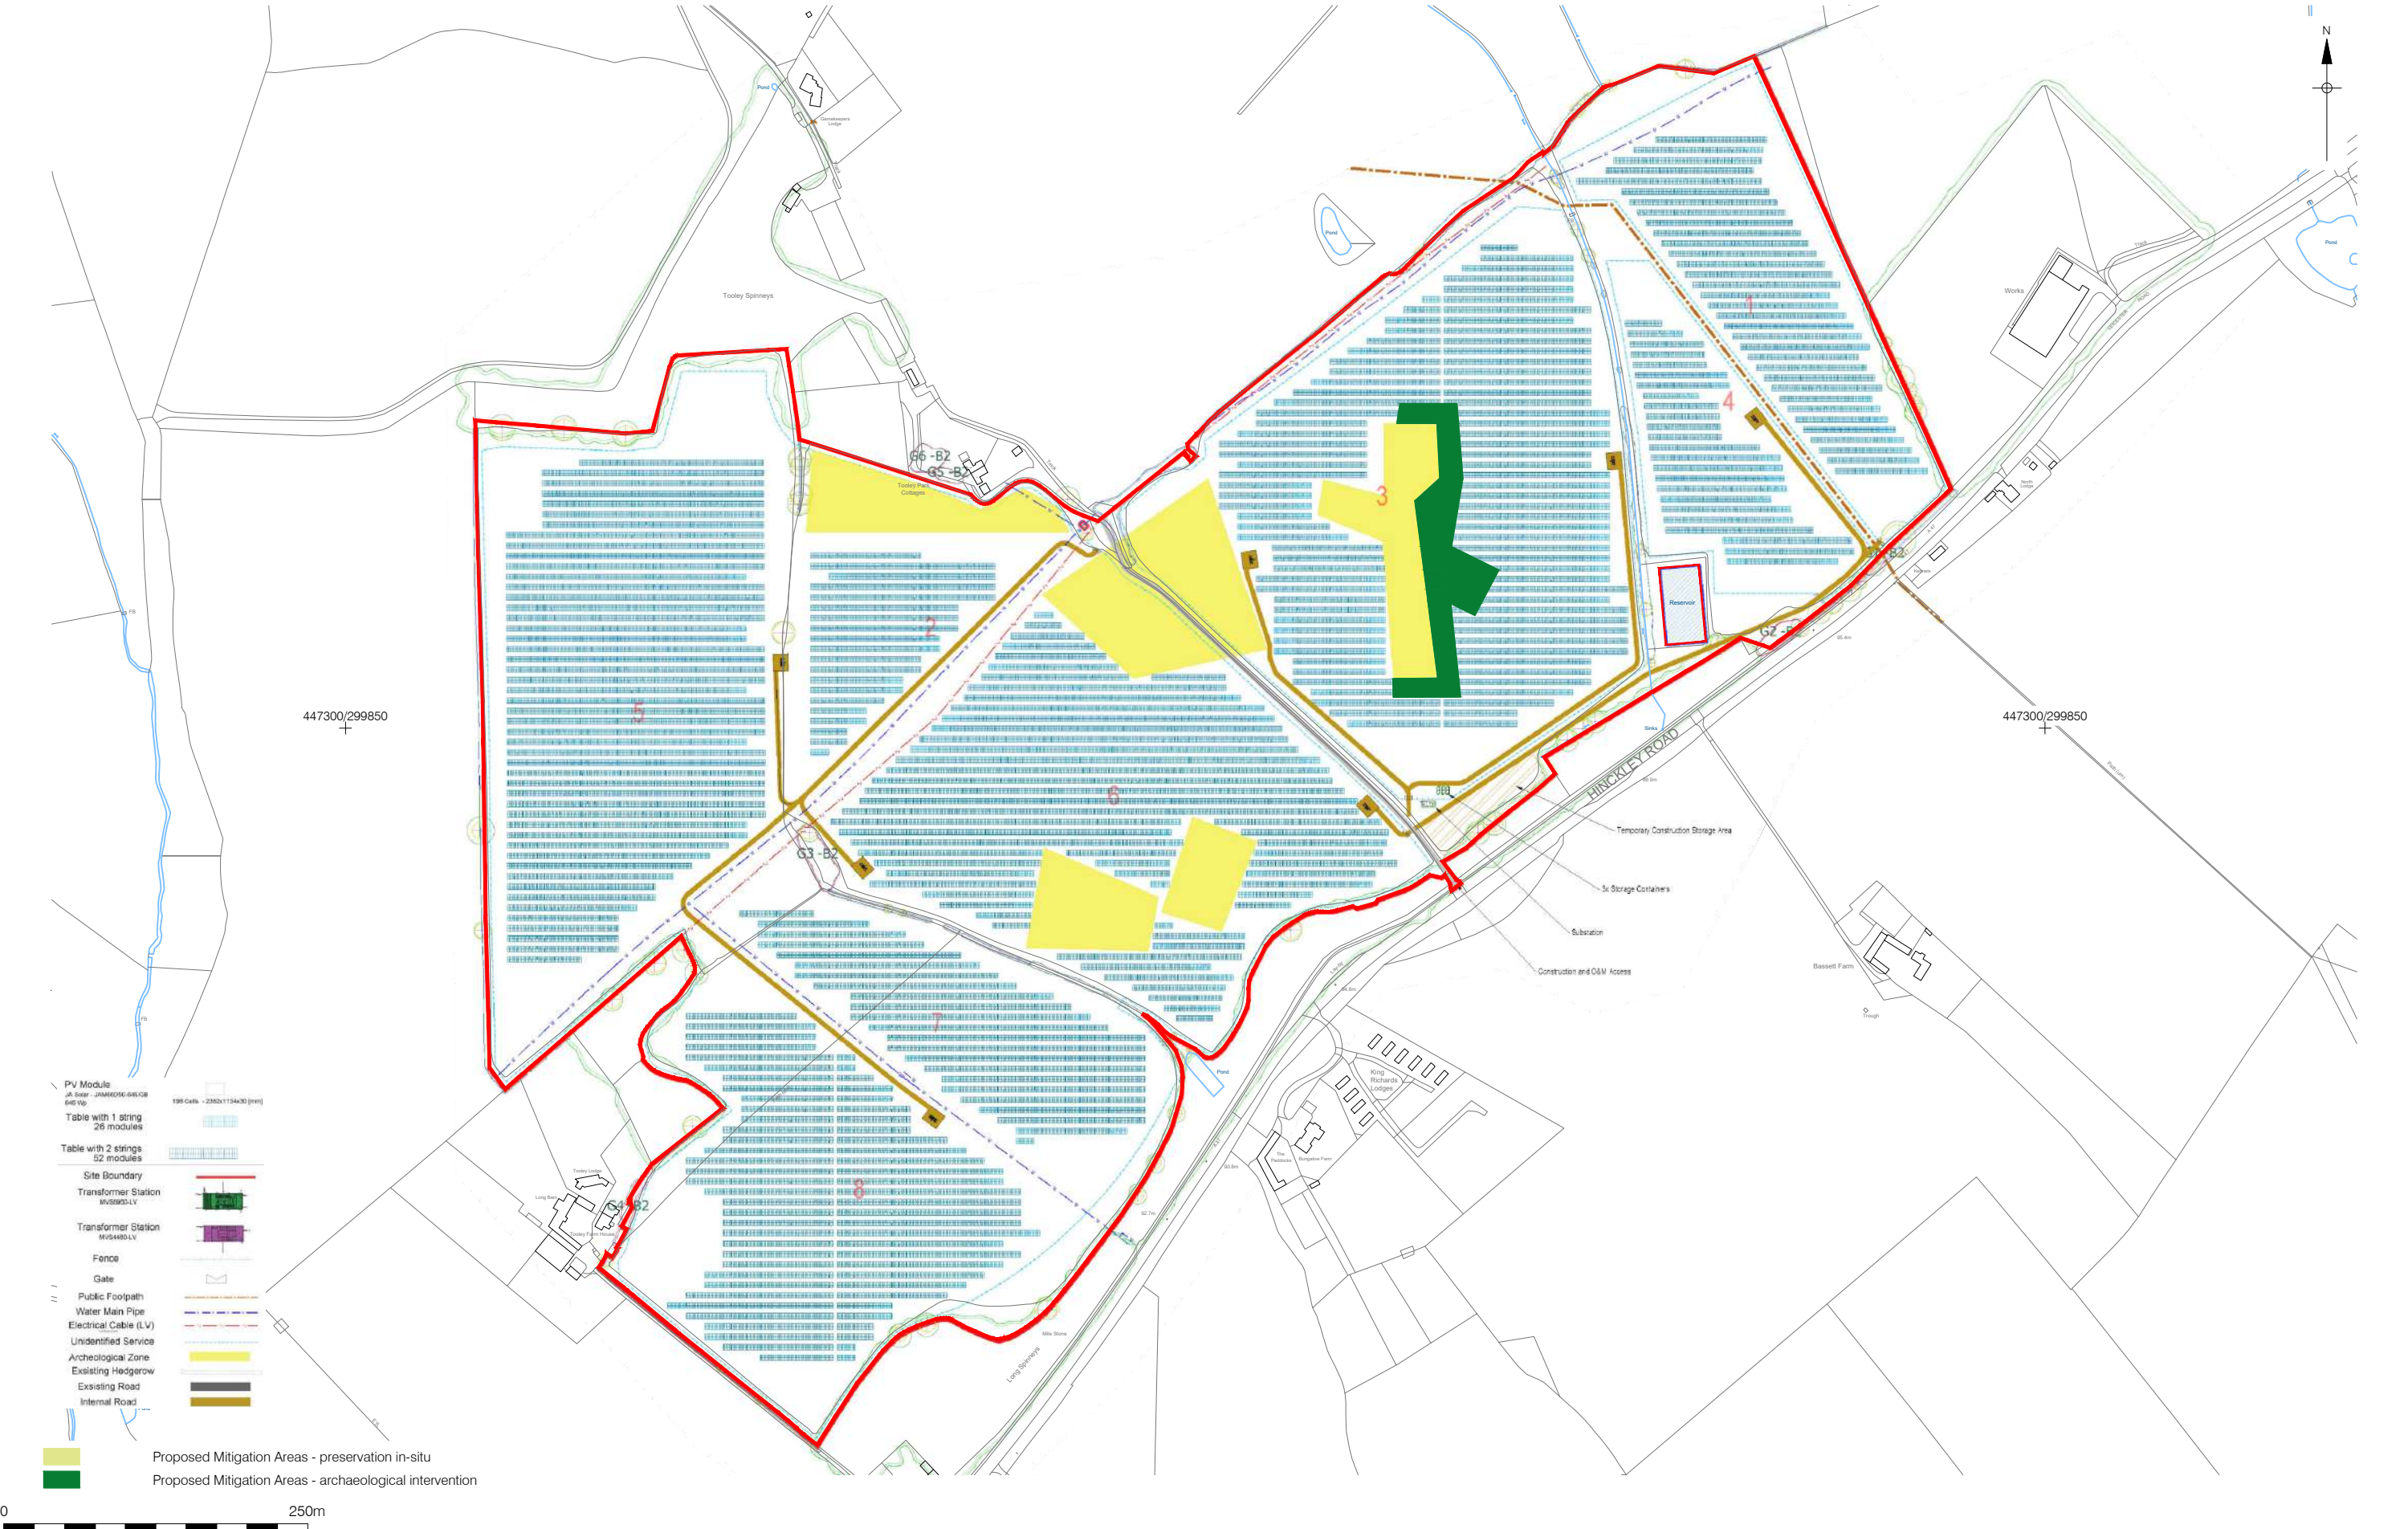
- 5.1.5 The layout and framework or 'tables' are illustrated within figure 2. The mounted panels would be arranged in straight rows across the site with the panels angled at 20 degrees and facing southwards.

6.3.1 Several areas of archaeological significance have been identified within the development area (figures 2 & 3) which will be preserved in situ and record. Prior to the commencement of ground-breaking works, the ACW will produce clear written guidelines to be included in the sites principal Method Statement issued for the use of all construction contractors, outlining the need to avoid unnecessary damage to the known areas of archaeological sensitivity within the site. All contractors will be informed of the archaeological constraints before entering site.

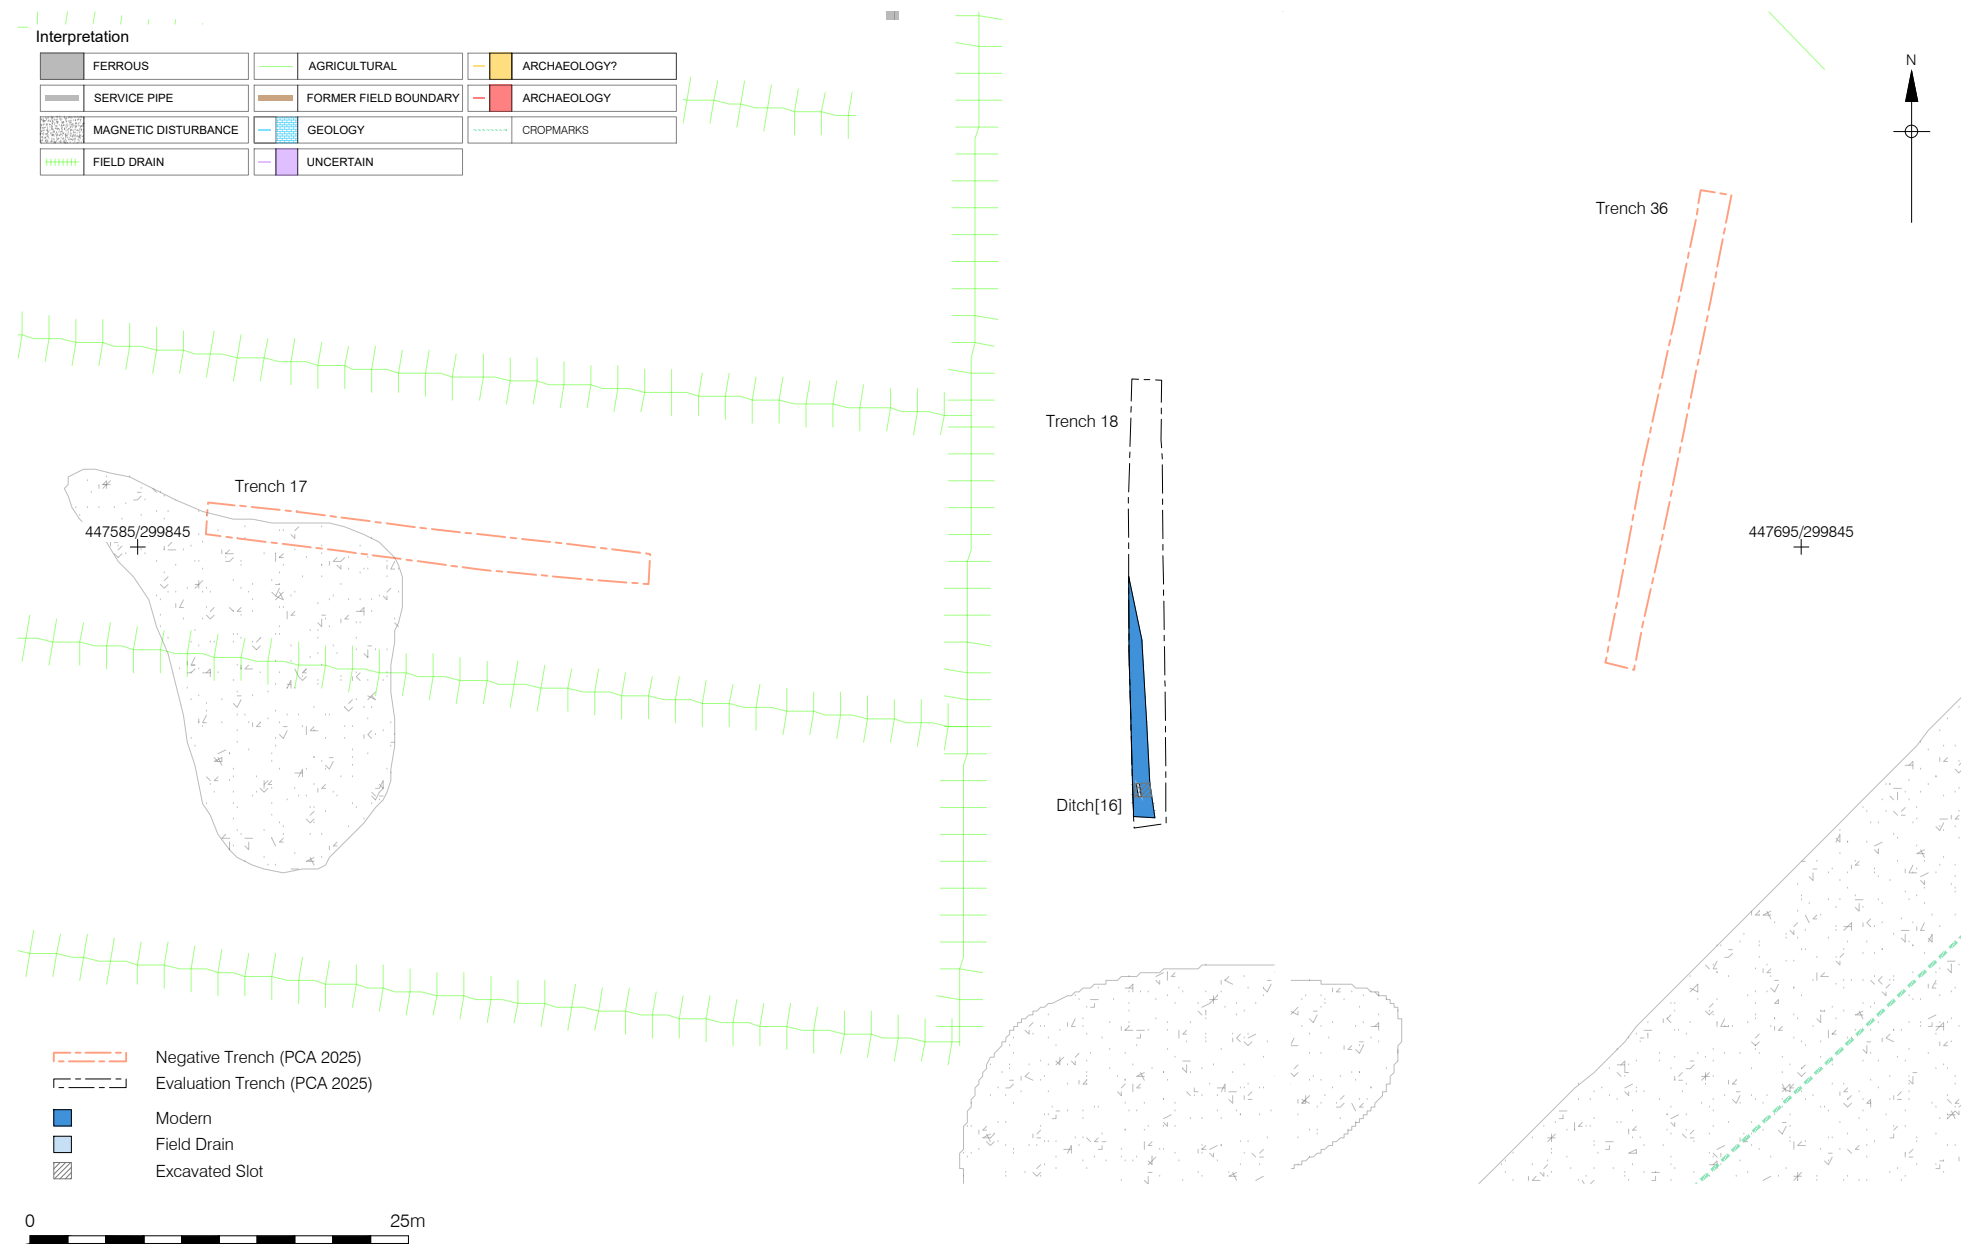
Figure 4  
Area 1 Detailed Plan of Trench 18 Overlain on the Geophysical Survey Results  
1:500 at A4

4.3.10 A similar agricultural boundary confirmed within T186/ 188/ 173 within Area 5. Similarly, the boundary ditch encountered within trench 18 was depicted on the 1980 OS map.

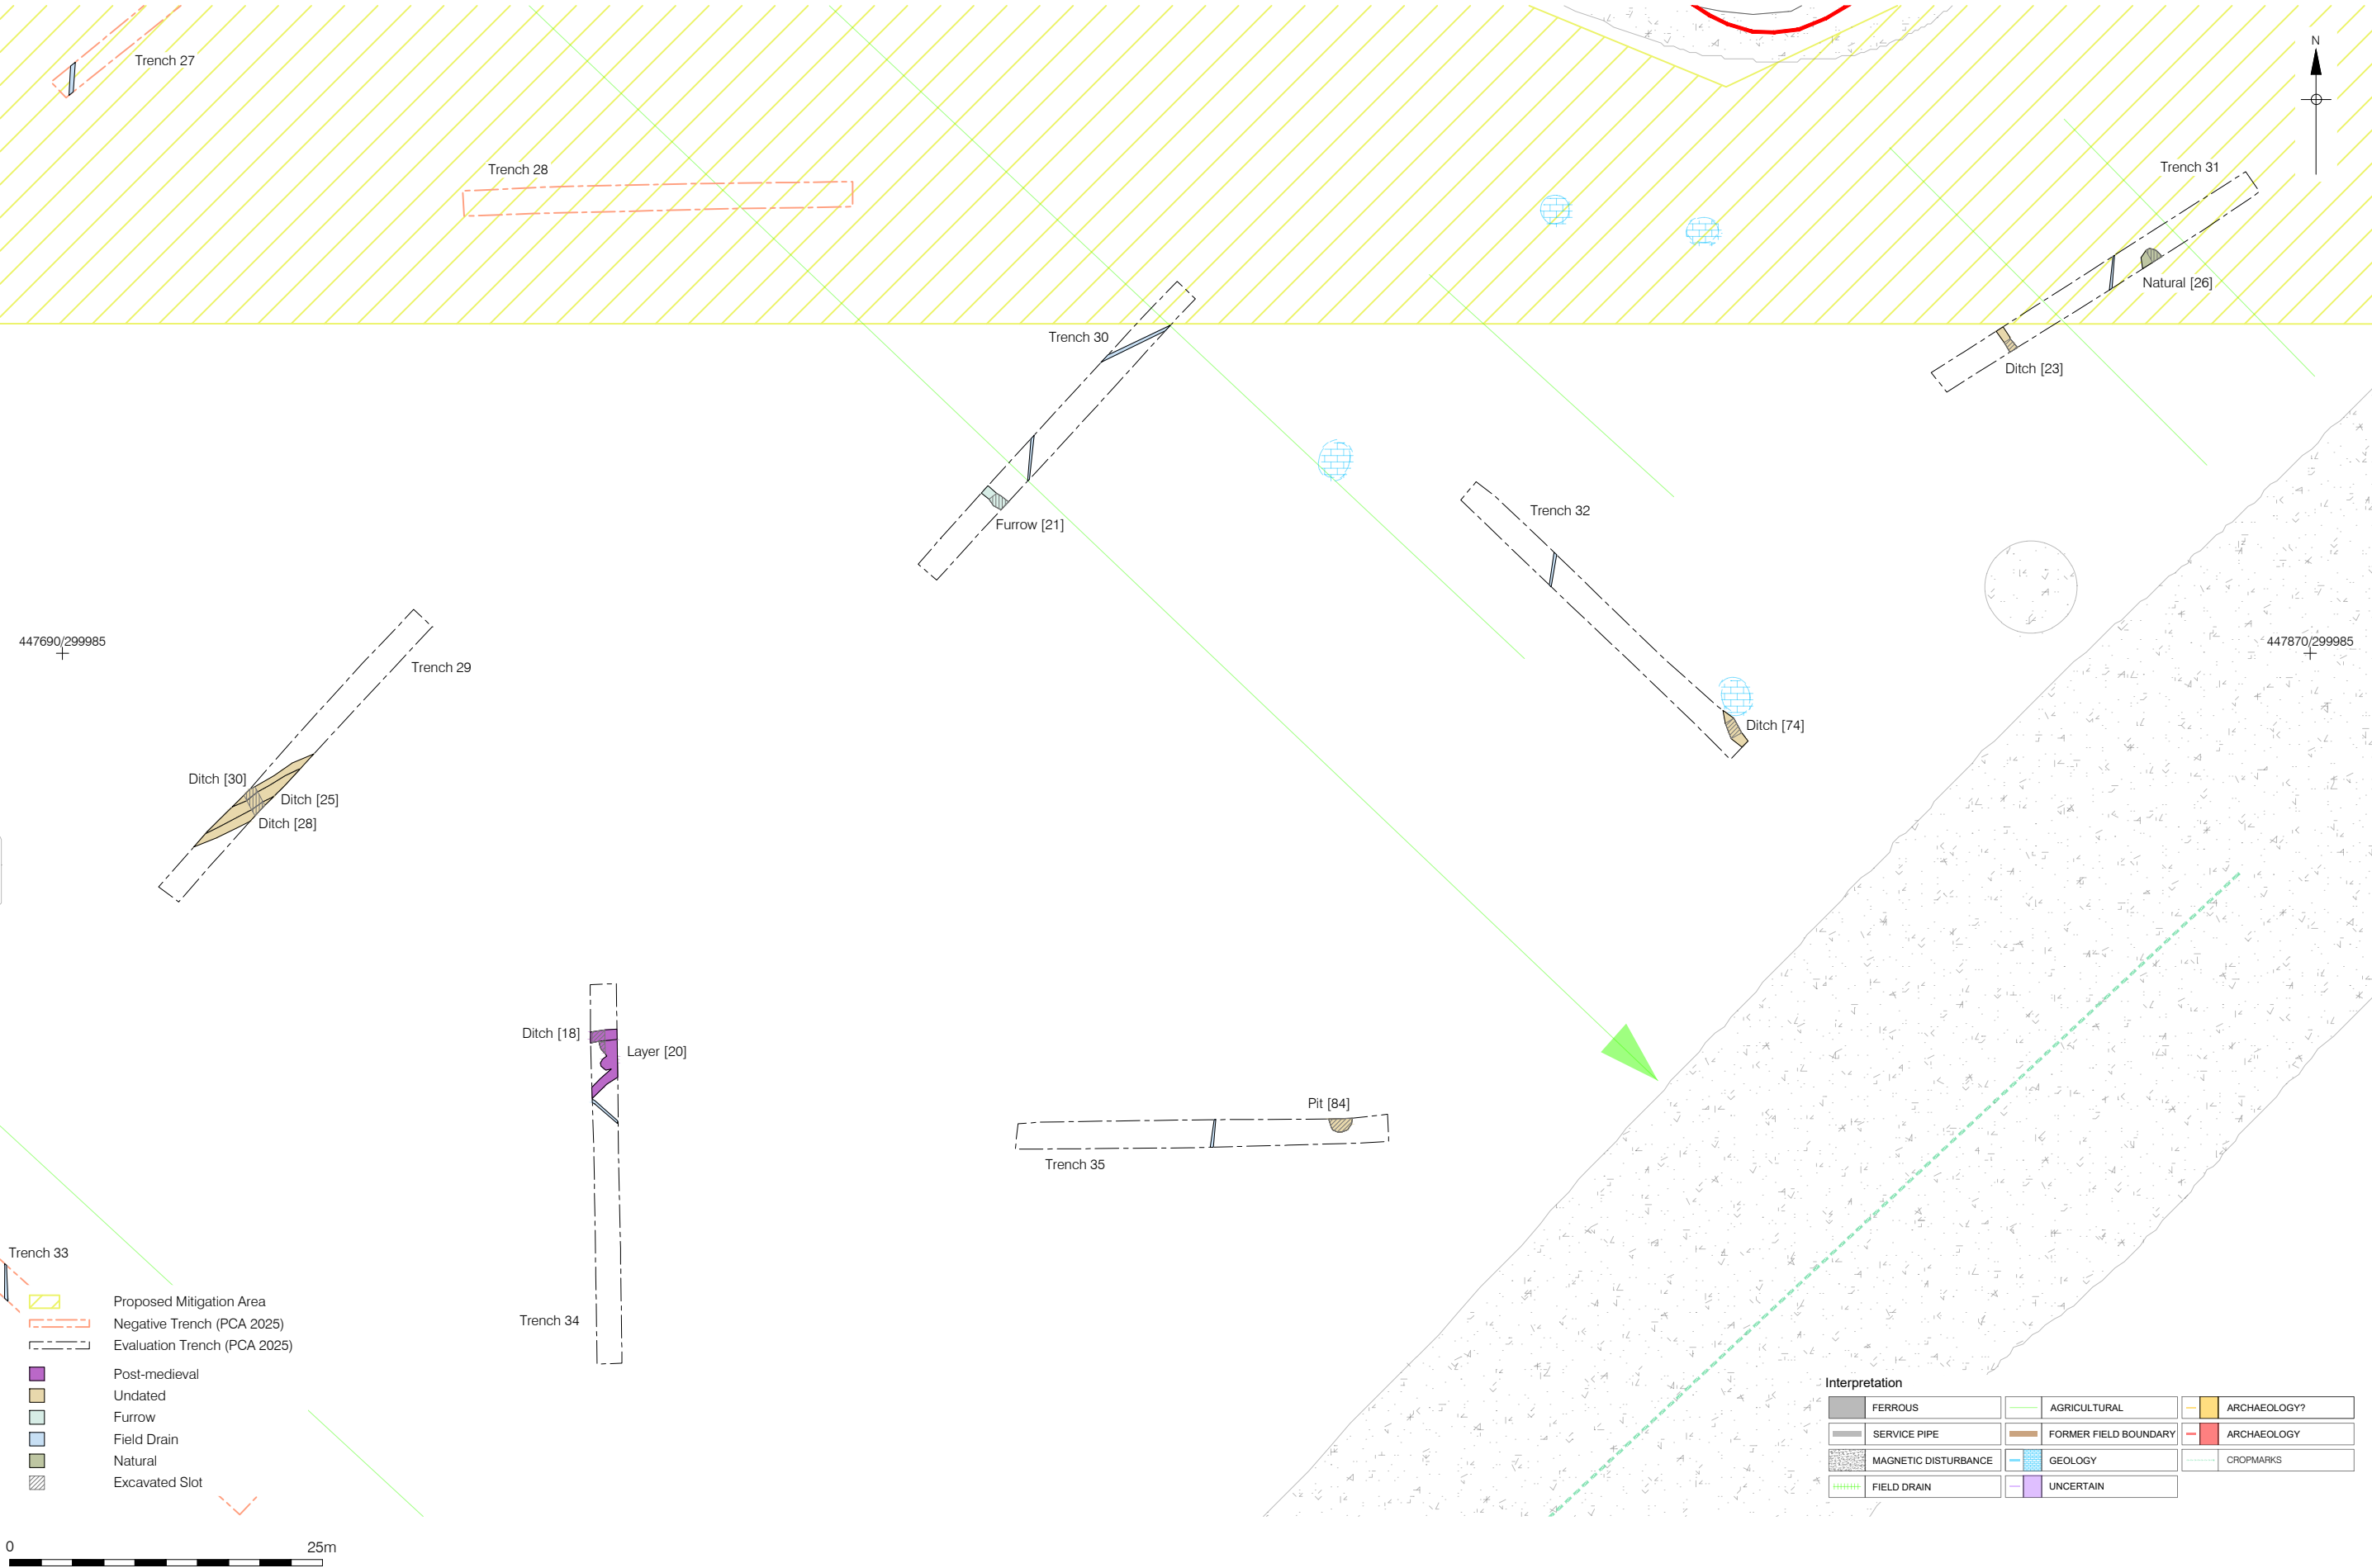
Figure 6  
Area 3 Detailed Plan of Trenches 29-32, 34 and 35 Overlain on the Geophysical Survey Results  
1:500 at A3

- 4.3.21 Trench 29 contained two shallow, parallel linear features [28] & [30] which correspond with a landscaped trackway or woodland ride to the west of Tooley Hall, as shown on the 1851 tithe map.

4.3.7 No features of medieval date were recorded within the site. However, several shallow, parallel linear features were recorded in trenches 30, 31, 129, and 164, which likely represented agricultural furrows. The site was located within the wider bounds of Hereswode Forest during the medieval period, which was in part subject to agricultural activities, but is recorded as becoming a part of the Tooley deer-hunting park in the late thirteenth century.

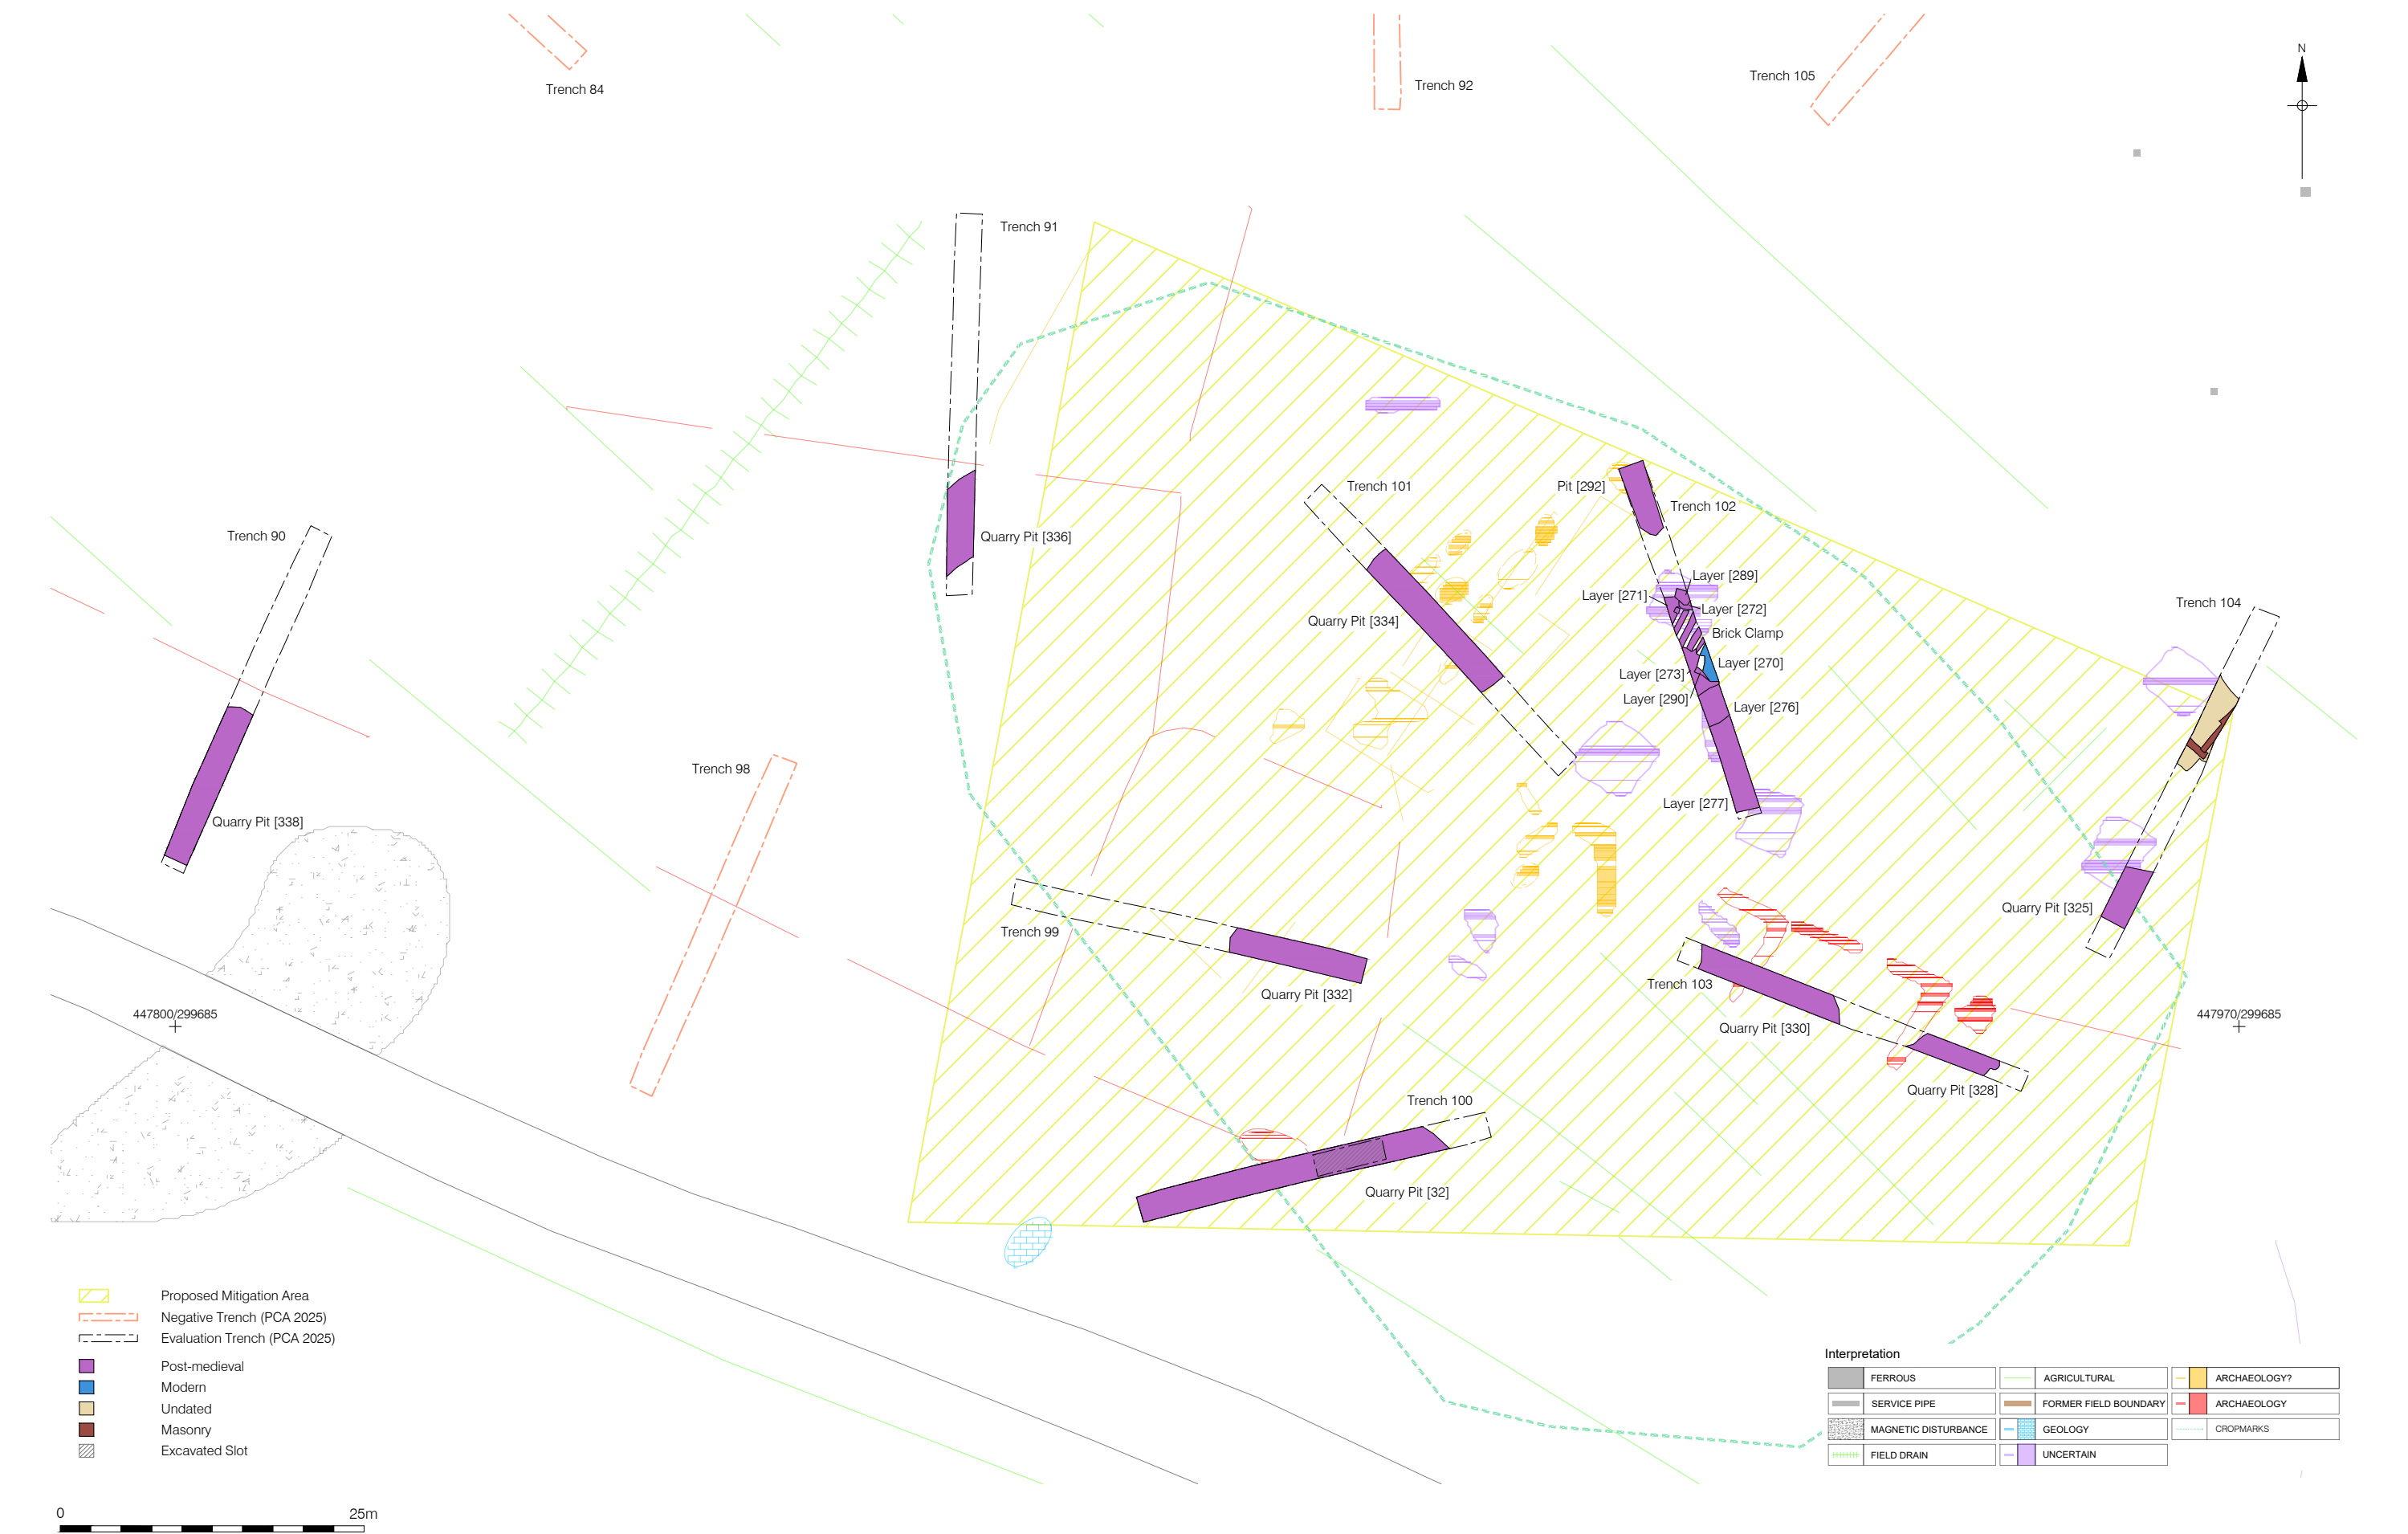
Figure 7  
Area 3 Detailed Plan of Brick Clamps and Quarries Overlain on the Geophysical Survey Results  
1:500 at A3

4.3.12 Centrally within Area 3 was a large group of substantial, deep, subcircular pits (sample excavated within trench 100 and recorded in plan in trenches 90,91, 99, 101, 102, 103, 104). These were interpreted as clay extraction pits, and were likely associated with the brick clamps identified within Trenches 102 & 104.

4.3.13 The clamps were recorded in plan and were typical of post-medieval rural brick making, and likely relate to the provision of bricks for the reconstruction of Tooley Hall c1800. Deposits within trench 122, overlaying the base of the clamp, appeared to represent the dismantling of the brick piles following firing.

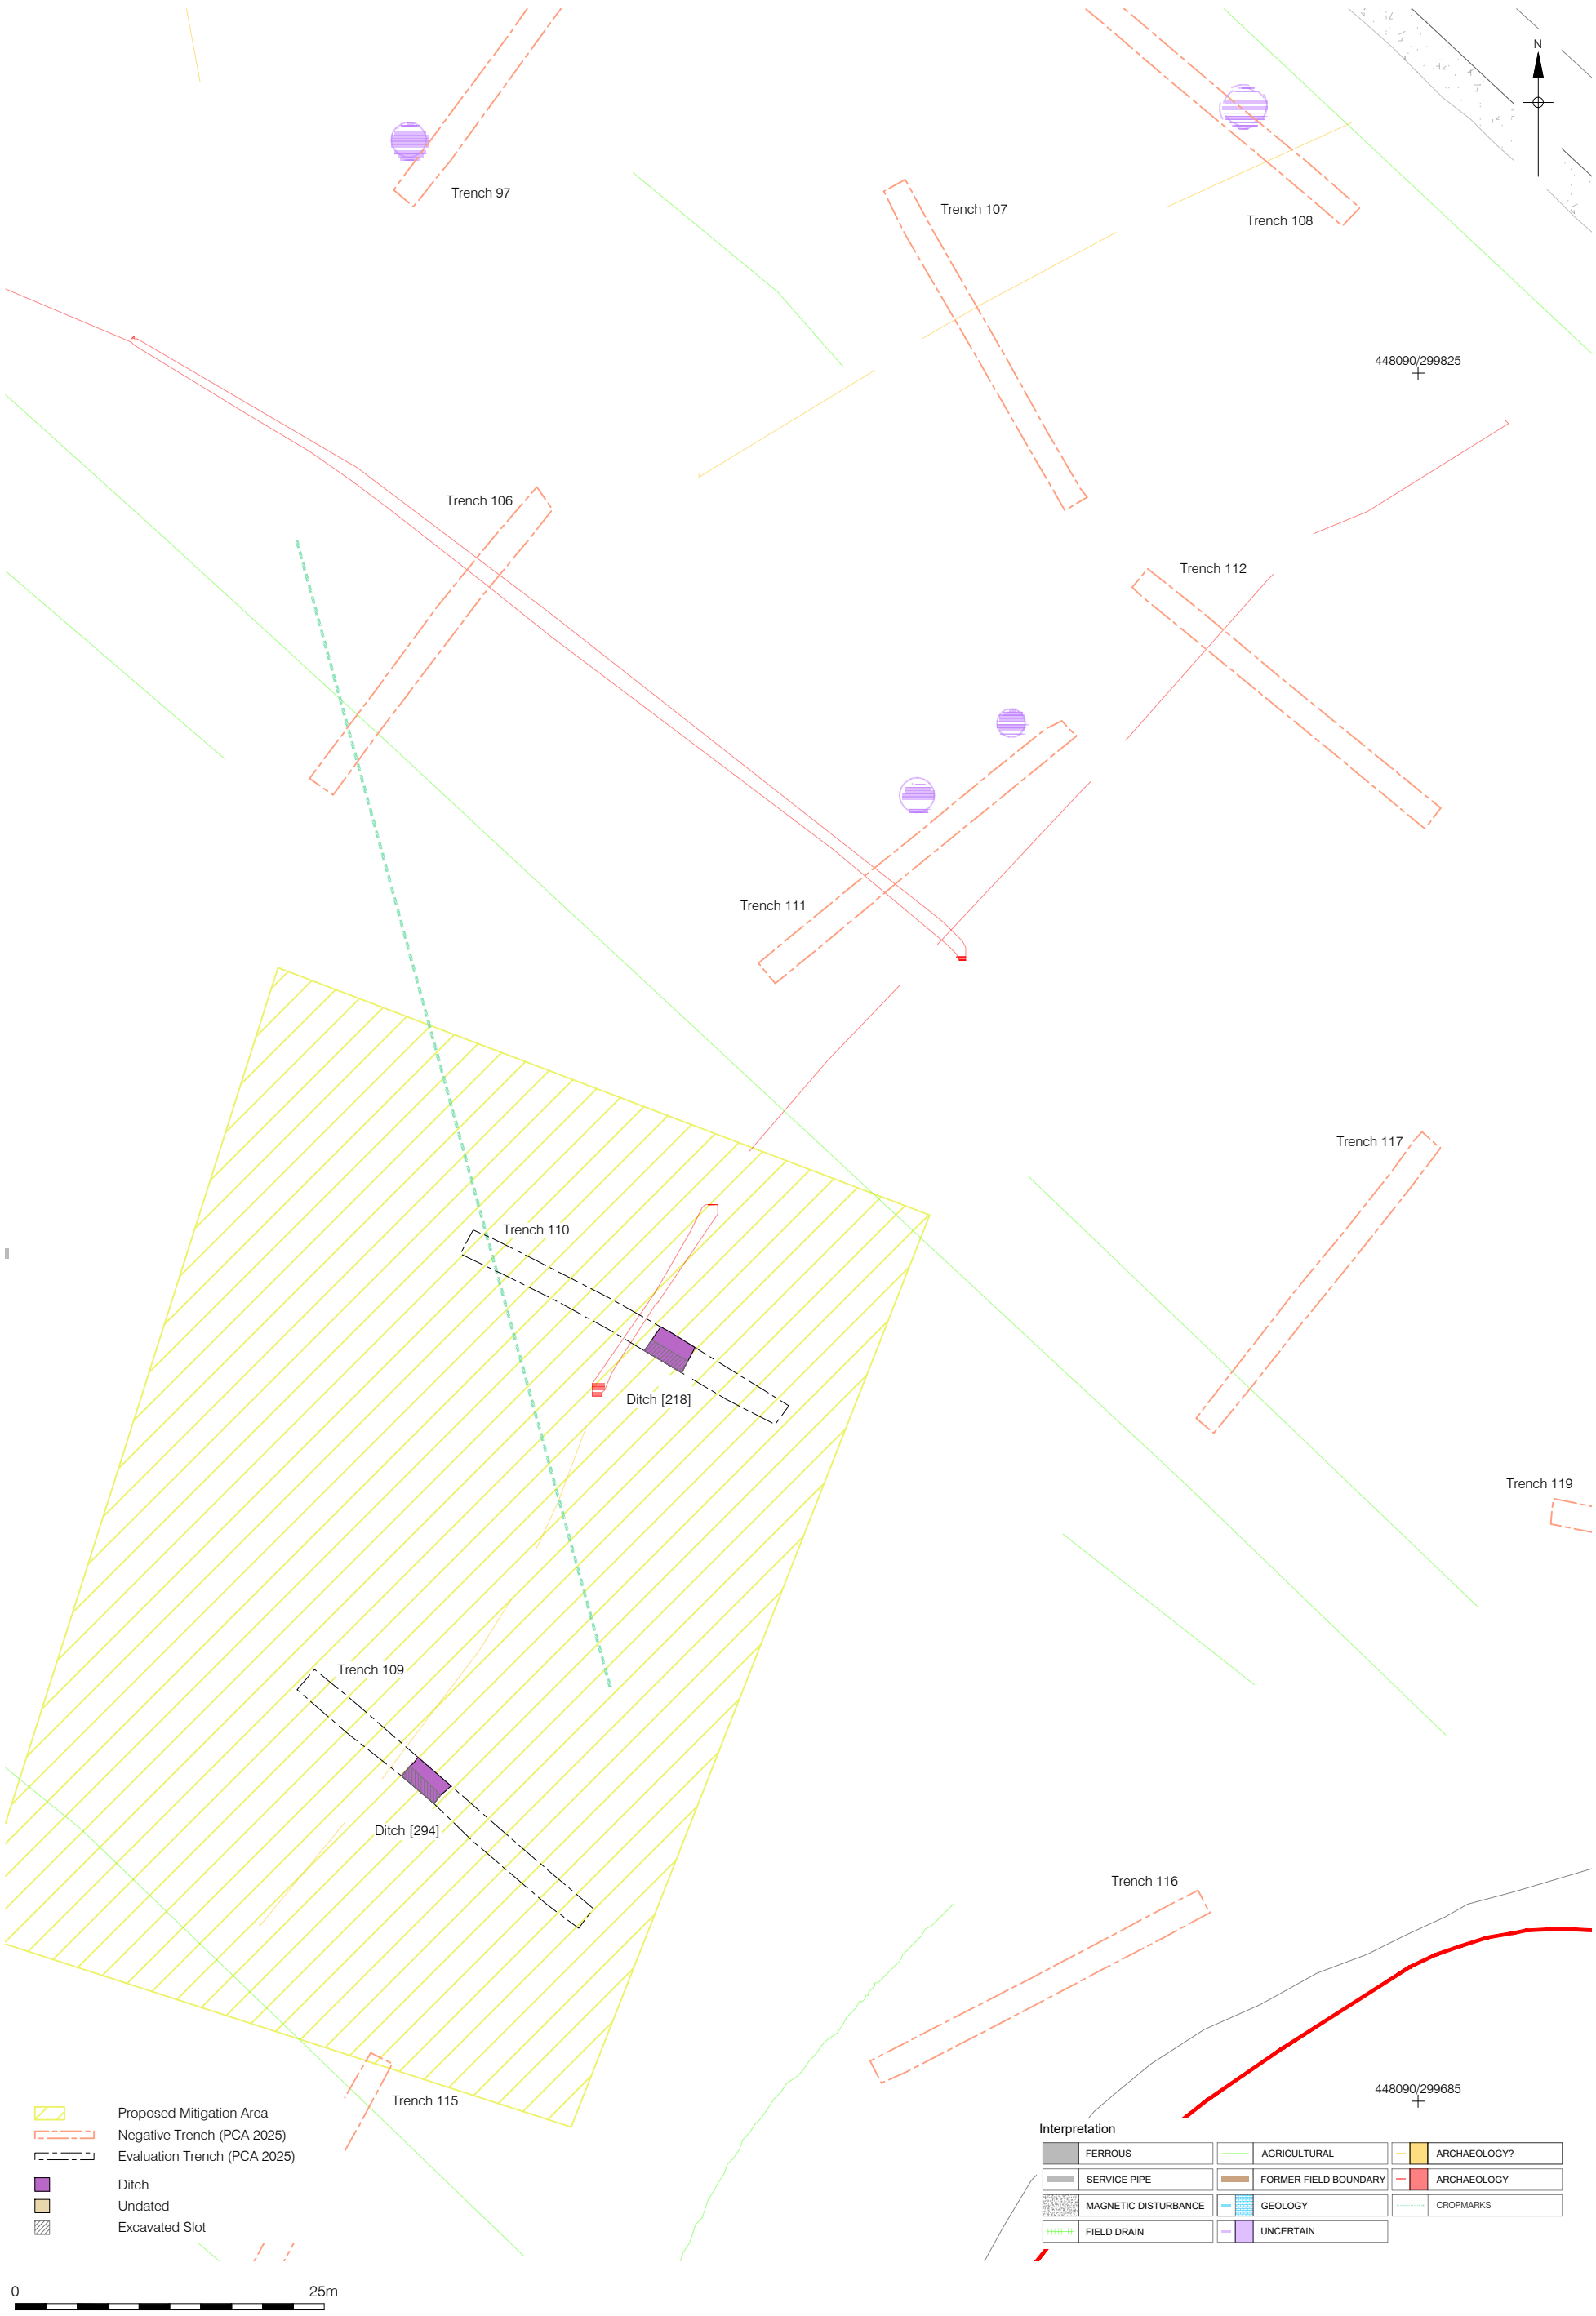
Figure 8  
Area 3 Detailed Plan of Trenches 109 and 110 Overlain on the Geophysical Survey Results  
1:500 at A3

4.3.11 The geophysical survey identified several linear features, mostly on a roughly NW-SE alignment within Areas 3 and 4, but these were largely proven to represent geological anomalies, or even the result of modern ploughing. The only exception to this was the NE-SW-aligned ditch excavated in trenches 109 [294] and 110 [218], which contained no datable finds.

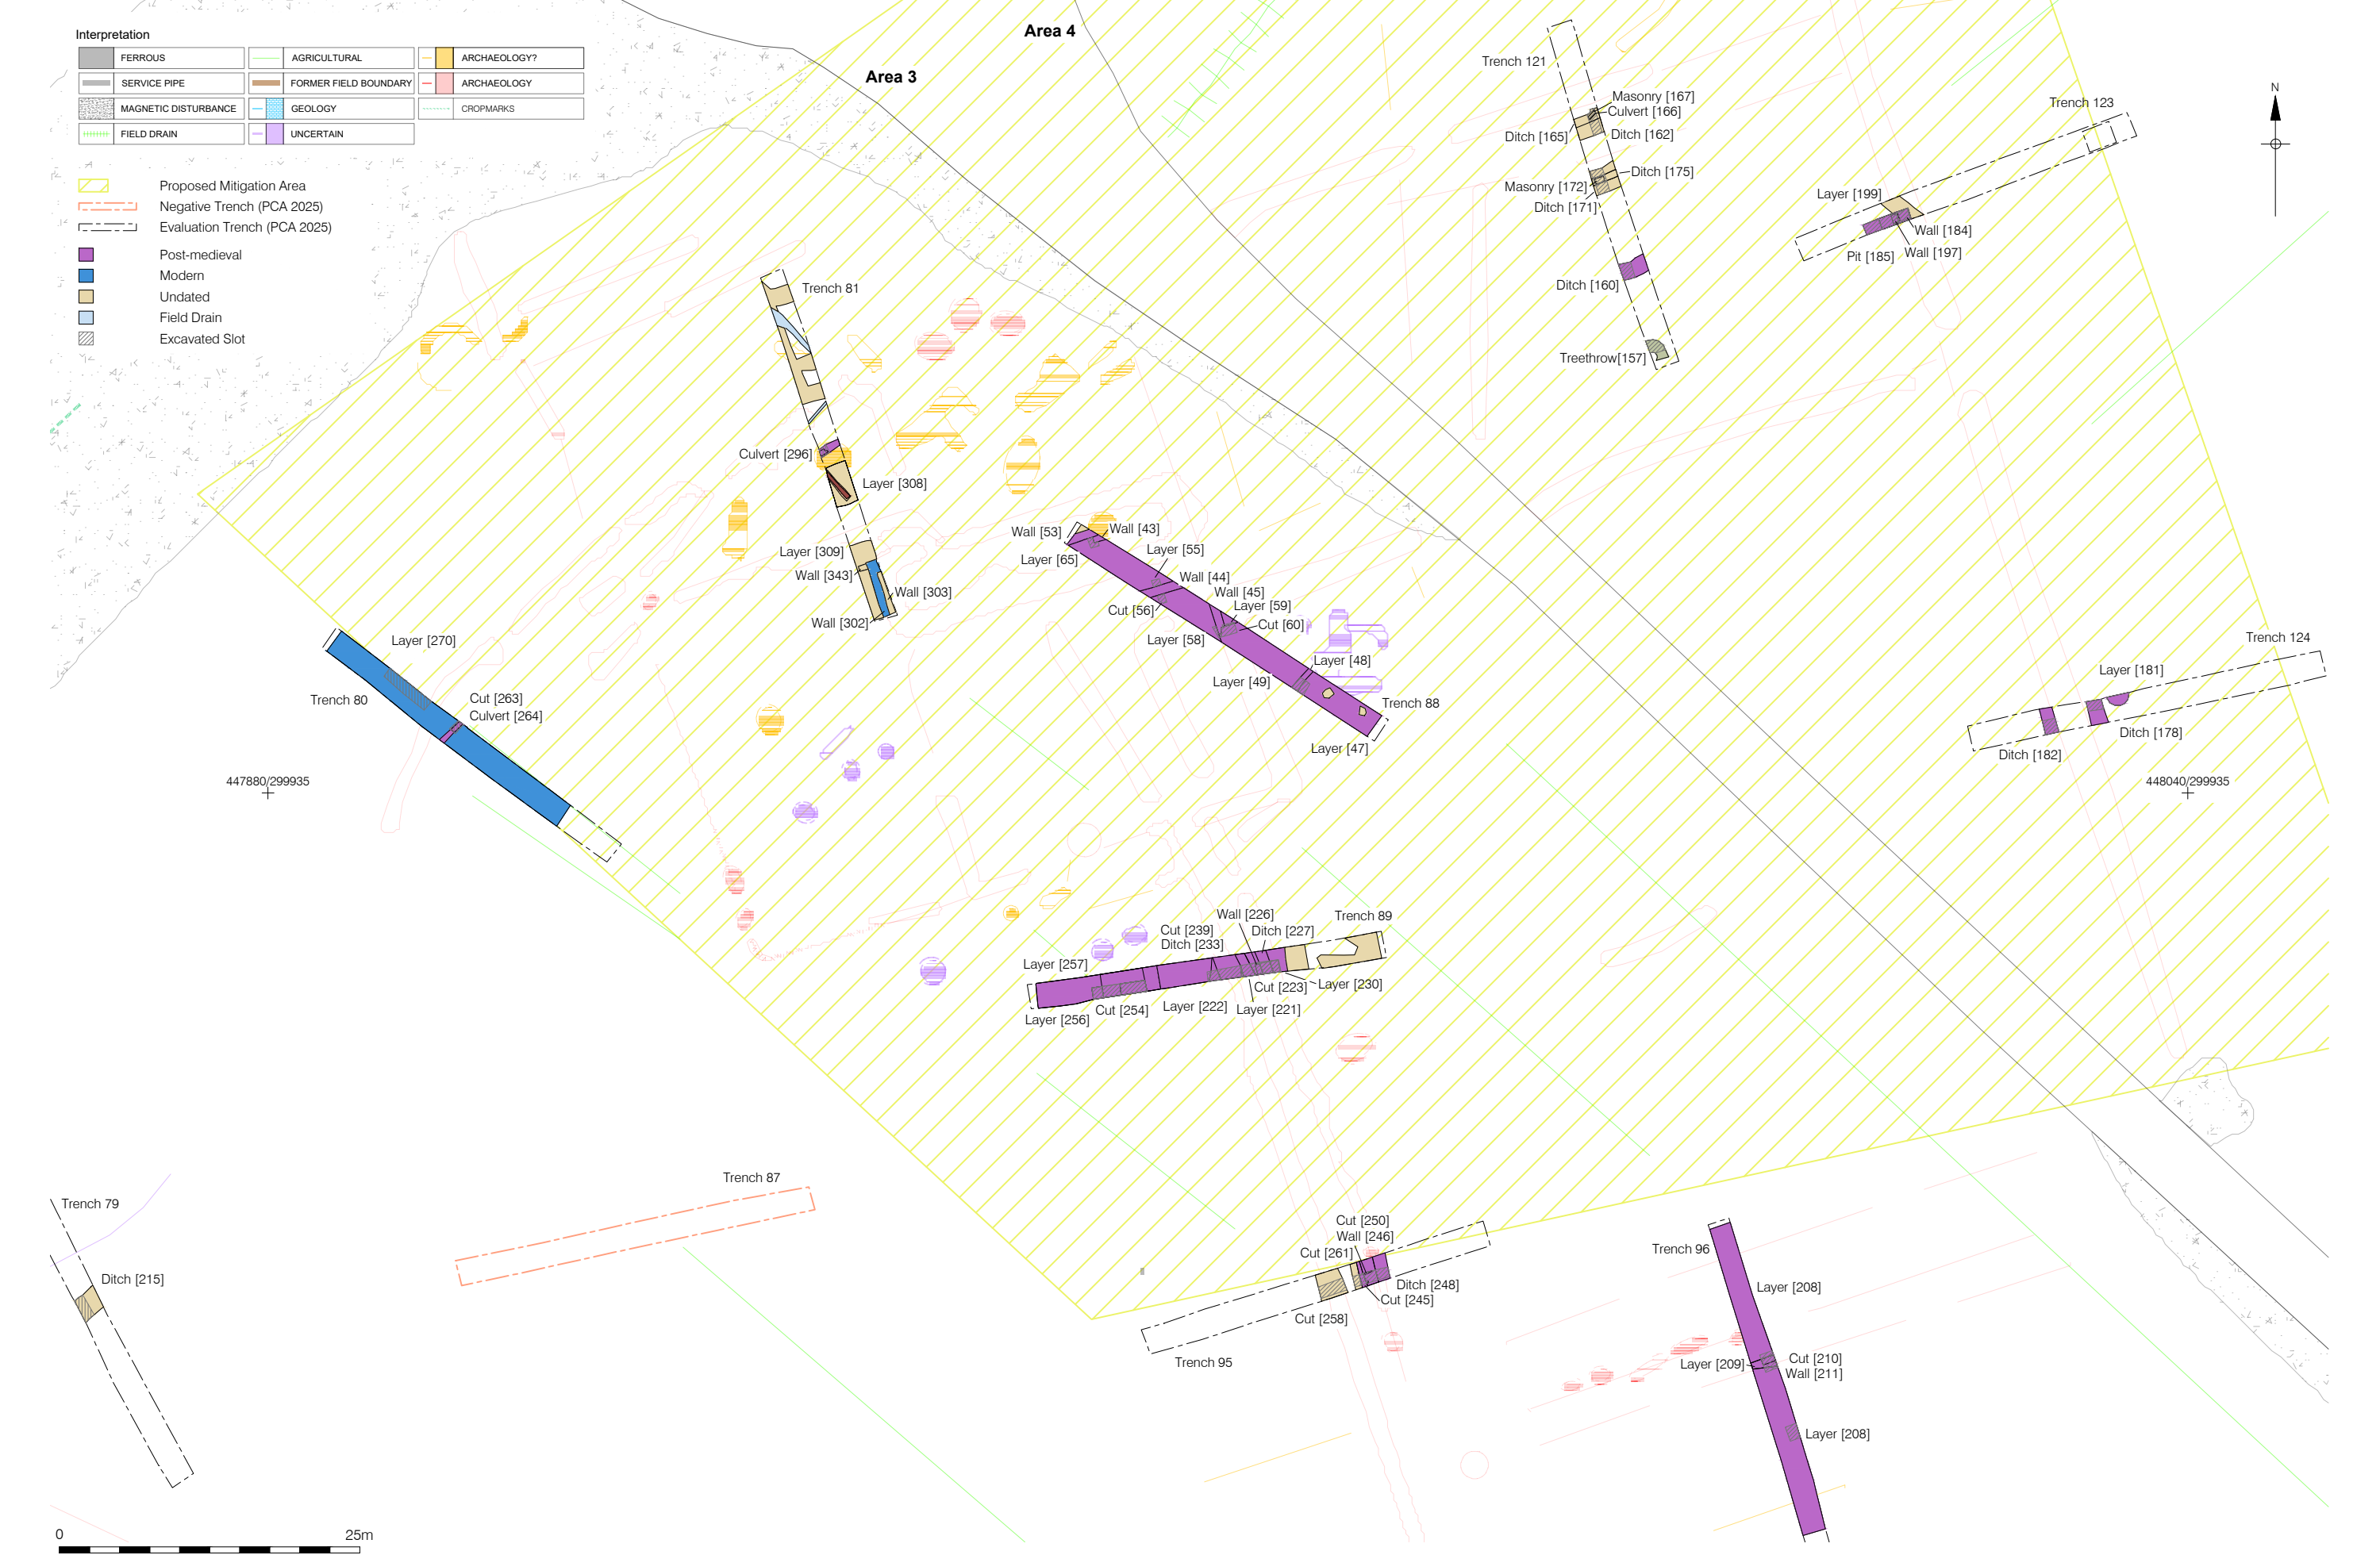
Figure 9  
Areas 3 and 4 Detailed Plan of Structural Remains Overlain on the Geophysical Survey Results  
1:500 at A3

4.3.14 The structural elements present within the north of Area 3 and North-west of Area 4 corresponded with the geophysical survey of the location of the former Tooley Hall and its associated gardens as depicted on the 1851 Tooley Tithe Map. However, the buildings appear much more expensive than those shown on the map. On this map within the Site, the hall buildings are shown as comprising a single sub-rectangular building approximately 30m in width, with narrow 'ranges' extending north. However, the archaeological evaluation identified further structural remains.

4.3.18 The plan of the pre-1800 hall that the ground truthing of the geophysical survey revealed was of a central rectangular building, with an enclosed area extending to its east likely forming a walled garden.

4.3.16 Deposits within trench 89 contained pottery of an early 17<sup>th</sup>-century date, as well as a crotal bell and iron key, all dating from the 15<sup>th</sup> to 17<sup>th</sup> centuries, which would suggest that the deposit was associated with the demolition of the original Tooley Hall before rebuilding in the early 19<sup>th</sup> century. A set of similar deposits was present within trench 80 and 96 which represent levelling/ terracing to the south and west of the new structure. Within trench 81 to the west of the known location of the 19<sup>th</sup>-century hall were several partly demolished and robbed-out walls sealed by a similar consolidation.

4.3.17 Trench 121 exposed two parallel robber trenches from which pottery dating 1600-1800 was recovered. Trench 123 contained a robbed-out wall aligned perpendicular to those in trench 121. A continuation south-east of the wall, as shown on the geophysical survey, was tested with Trench 124, and whilst no wall was present, two similar potential robber trenches were recorded.

4.3.19 Due to the active trackway existing between Areas 3 and 4, it was not possible to locate more than one trench within the location of the post-1800 Tooley Hall; trench 88 showed a continuation of the consolidation deposit associated with the demolition of the earlier hall, and the lower walls of basements associated with the post-1800 structure.
