**LAND AT CLUMP FARM,  
HINCKLEY ROAD,  
LEICESTERSHIRE LE9 7TJ:**

**ARCHAEOLOGICAL  
MANAGEMENT PLAN**

**PCA Report Number: R18365  
March 2026**

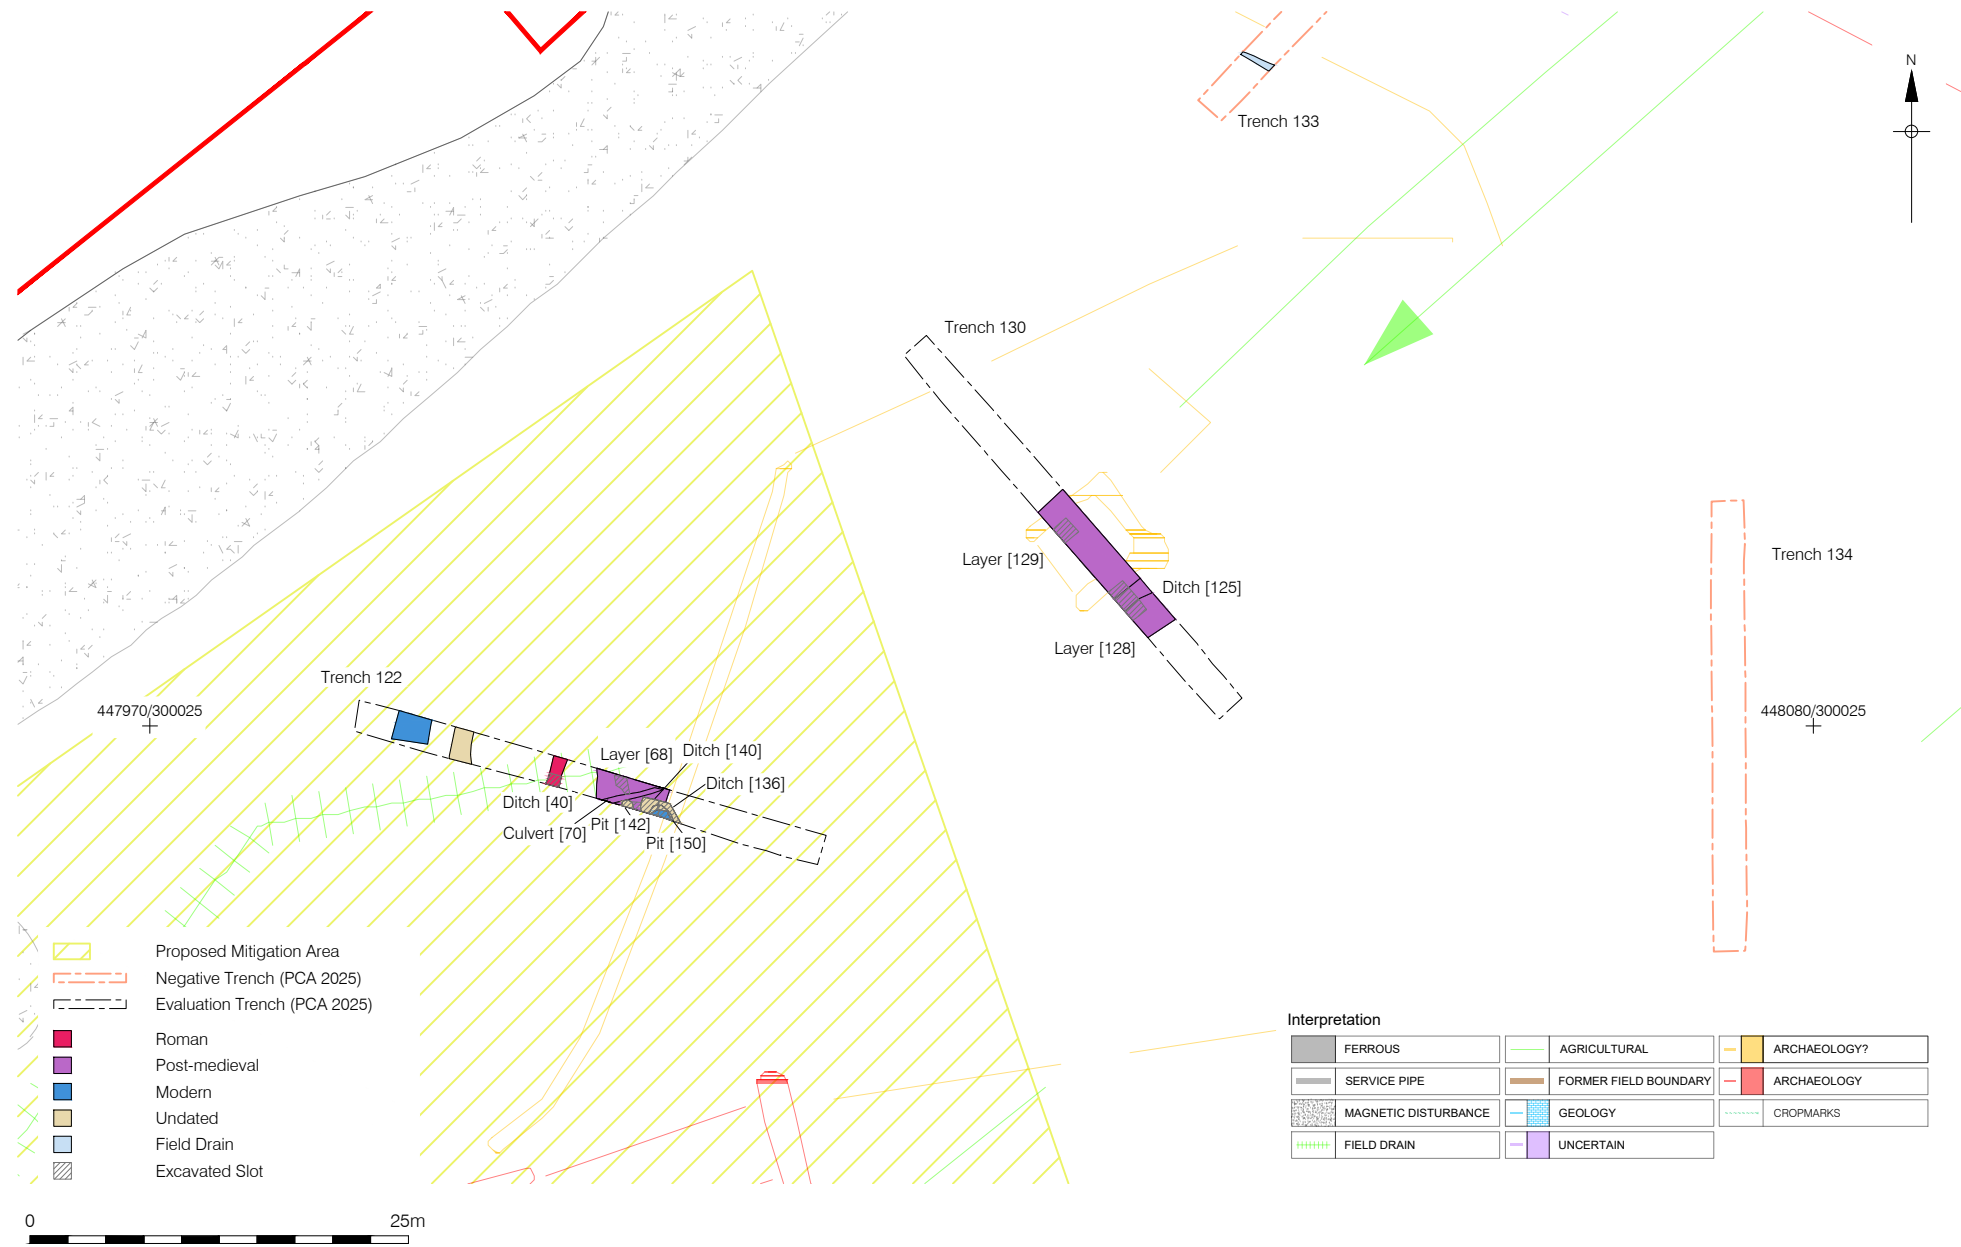
Figure 10  
Area 4 Detailed Plan of Trenches 122 and 130 Overlain on the Geophysical Survey Results  
1:500 at A4

4.3.20 Trench 130 was deliberately located to determine the nature of a squared feature identified on the previous geophysical survey (ASWYAS 2021), and which is recorded in the HER as being a possible Roman enclosure or mausoleum. Excavation revealed a deposit of post-medieval made ground containing 18-19<sup>th</sup> century bottle glass consistent with the

levelling deposits elsewhere before the construction of the new Hall in c1800. This was truncated by a robbed-out post-medieval wall, suggesting the structure to be an ancillary building associated with the new hall buildings, possibly a wall demarcating the southeastern boundary of the wooded landscaping shown on the tithe map.

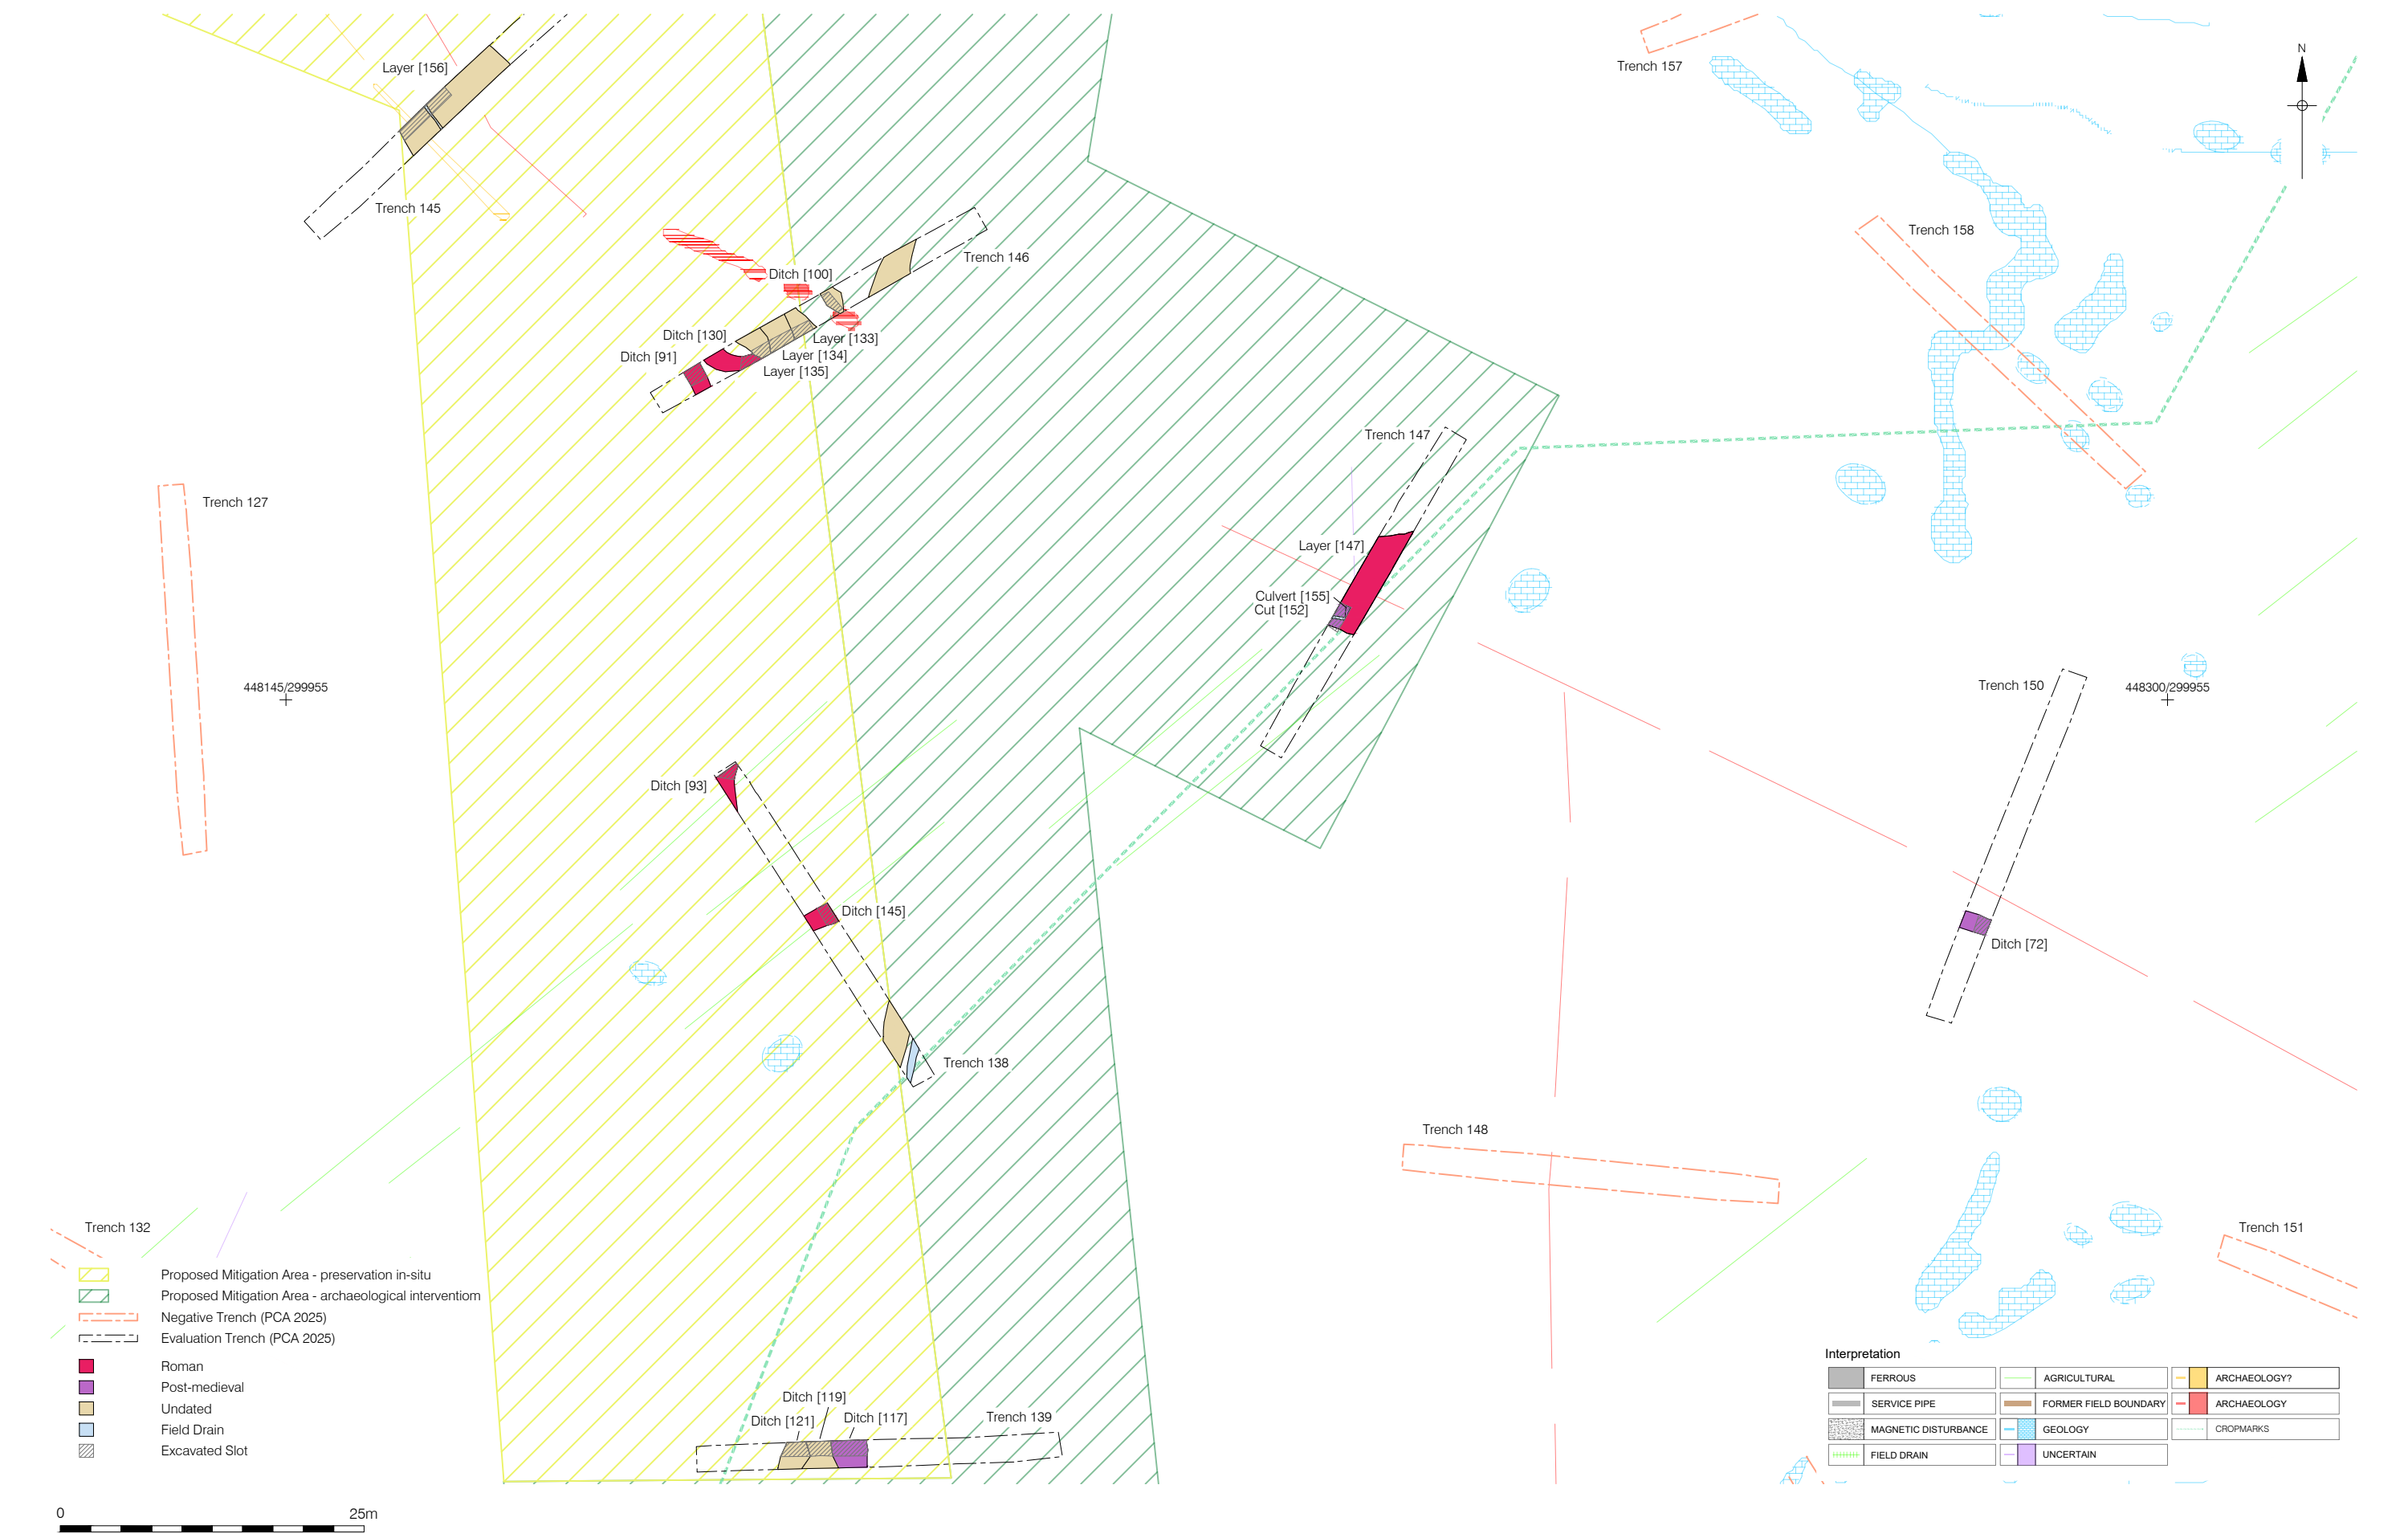
Figure 12  
Area 4 Detailed Plan of Trenches 138, 139, 145-147 and 150 Overlain on the Geophysical Survey Results  
1:500 at A3

- 4.3.1 The only features that could be reliably regarded as Roman were a linear feature [121] (trench 139), [93] (trench 138), [344] (trench 145), and [91] (trench 146), which ran broadly parallel the alignment of the post-medieval boundary recorded within trenches 139, 145, and 146.

- 4.3.2 It is likely that this ditch was part of a co-axial field system with perpendicular ditches, aligning roughly E-W present within trenches 138, 145, 146 and 155. Environmental samples from these features contained spelt, oats, and barley seeds in variable quantities, which were indicative of agricultural processing. The highest quantities of charred grains from ditch [144] within trench 155 suggest proximity to cereal processing activities.

- 4.3.3 A probable ring ditch, comprising of [130] and [100] identified within trench 146 was also identified, with environmental samples showing similar charred grains in smaller quantities.

- 4.3.6 A notable deposit of silty clay within a shallow hollow or depression was seen within Trenches 145, 146, and 147, potentially representing a NW-SE aligned paleochannel. Two of the fills of this feature, containing a possible iron knife as well as horse and cattle bones, as well as two sherds of 1st-century Samian ware. As no continuation of the feature was

4.3.9 The most archaeologically prominent former boundary ditch was located within Area 4, which was clearly defined on the geophysical survey and which was aligned broadly N-S, and which was depicted on the 1851 Tooley Tithe Map, and on later 19<sup>th</sup> and 20<sup>th</sup> century OS maps. A section of the ditch was recorded within trench 139 (as [117]) and recorded in plan within trenches 138, 146, and 154.
