**Archaeological Attendance and Recording (Watching Brief) at  
Bosworth 1485 Sculpture Trail (Site 5: 'Piecing together the Past'),  
Bosworth Battlefield Heritage Centre, Ambion Lane, Sutton Cheney, Leicestershire, CV13  
0AD**

ULAS Report No 2024-001

| Activity type | Watching Brief |

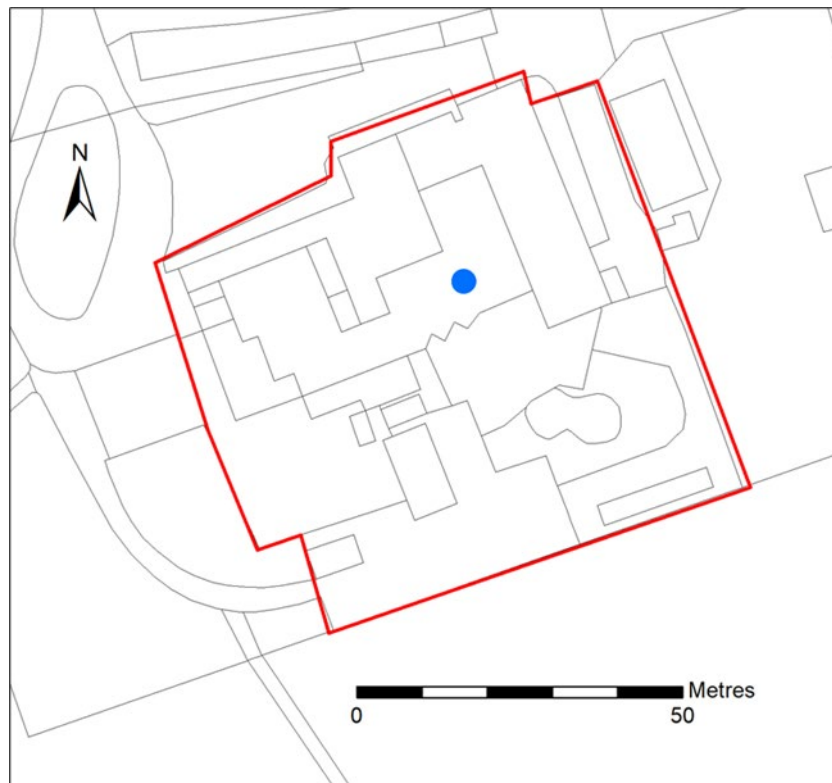
Figure 2: Detailed location plan showing proposals (provided by client)

The area of the proposals was within a brick paved courtyard of the Bosworth Battlefield Heritage Centre, adjacent to the 1485 Tithe Barn Restaurant (Figure 2-Figure 4).

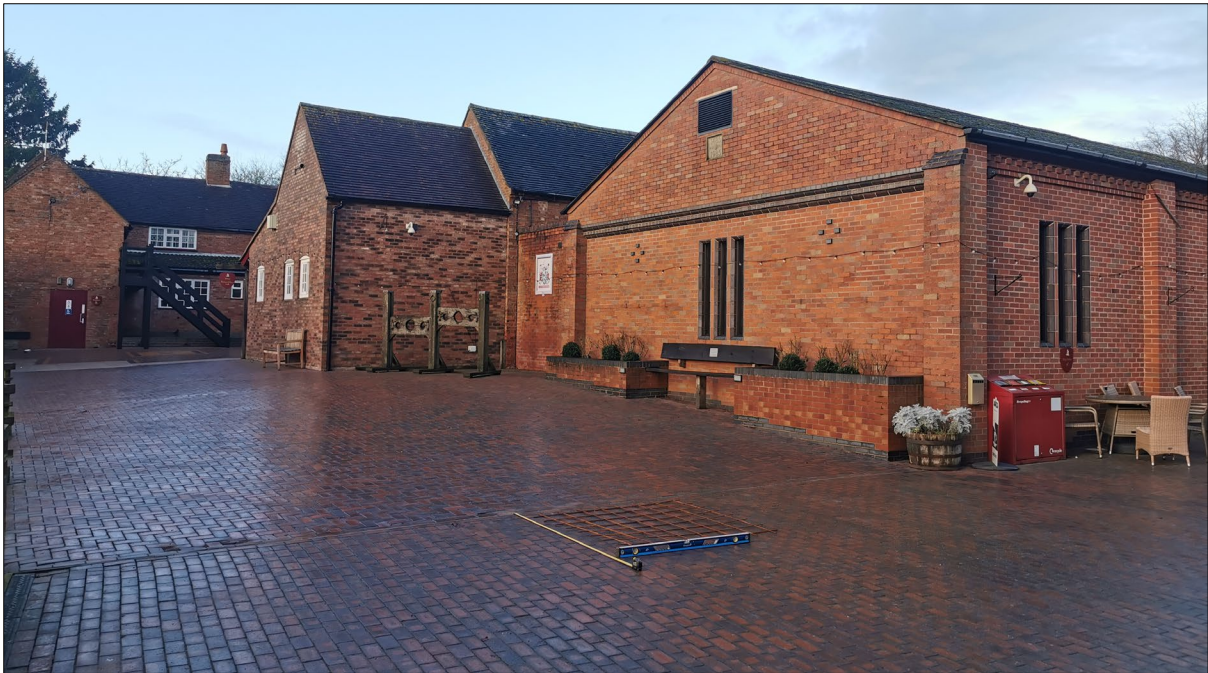
Figure 3: Area of proposals prior to groundworks commencing, looking north-west

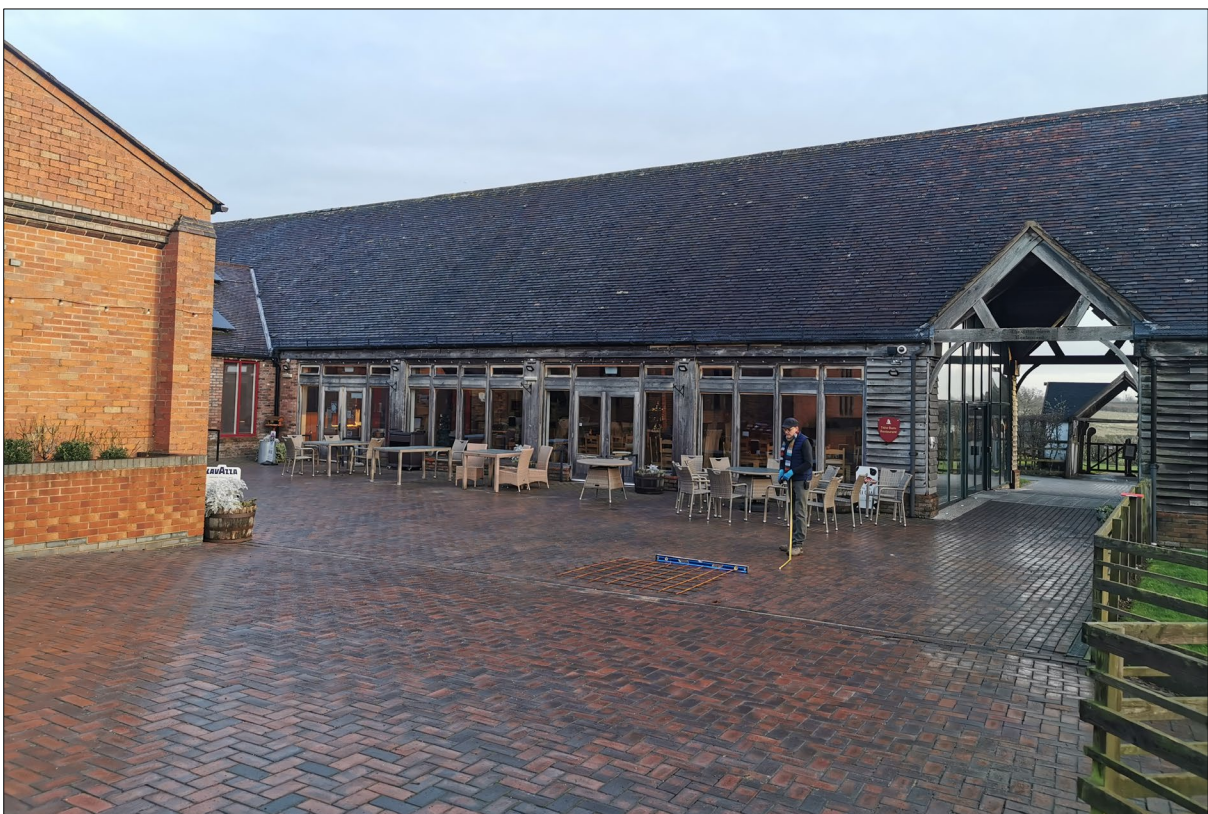
Figure 4: Area of proposals prior to groundworks commencing, looking north-east

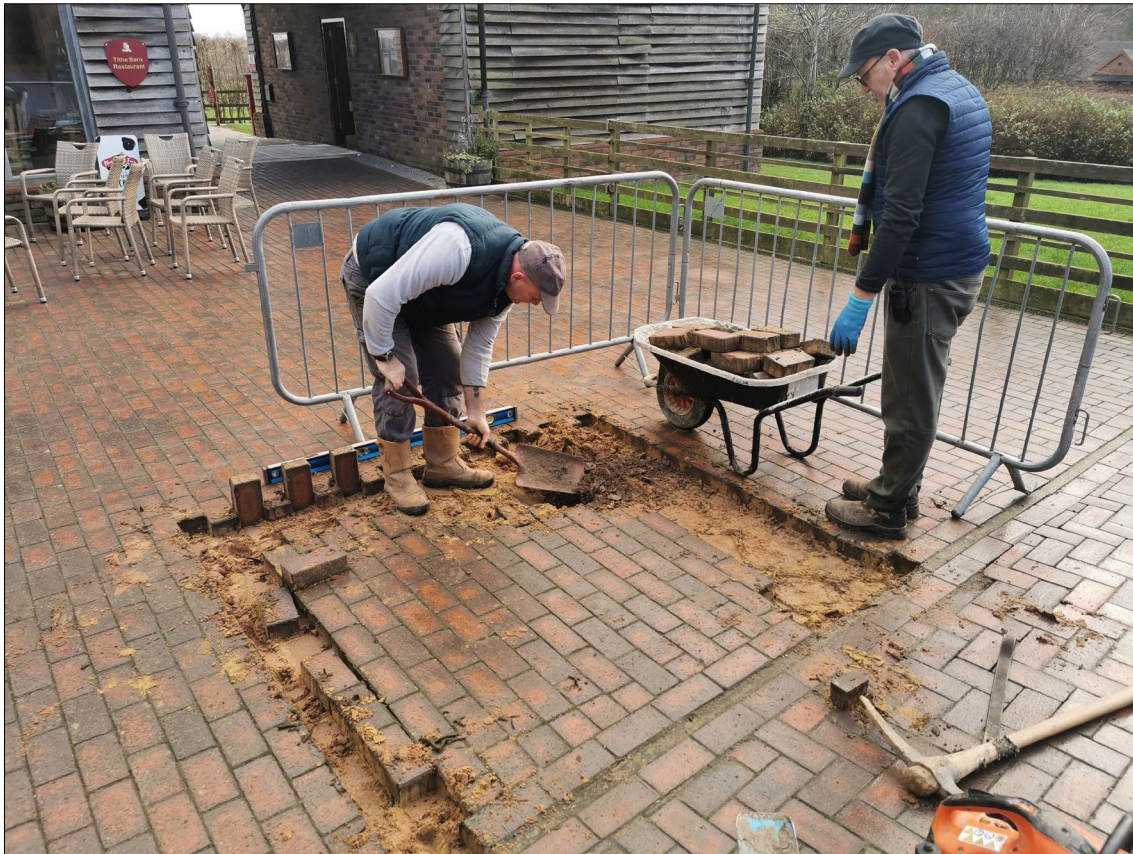
Due to minor alteration and reduction of the depth of the sculpture base foundation pit, the excavated pit measured 1.75m square and with a depth of 0.45m. After removal of the brick paving (0.08m deep), a sand blinding layer was first exposed with a depth of 0.05m (Figure 5). This overlaid a deposit of Type 1 aggregate, crushed hardcore. This aggregate deposit continued to the base of the foundation pit, i.e. at formation depth at 0.45m. At the base of the foundation pit, protruding through this material were a few fragments of modern building material, including fragments of concrete blocks and concrete paving slabs, and fragments of factory manufactured tile. This lower deposit of modern material was not exposed further, but this indicates either levelling of buildings here or that material was imported to site, presumably to raise ground levels. Metal detecting was not carried out on any of the excavated deposits as they consisted only of modern materials either brought in to site or of uncertain origin. No archaeological deposits were exposed and no artefacts were recovered during the work.

Figure 5: Exposing sand blinding below brick paving, looking south-east

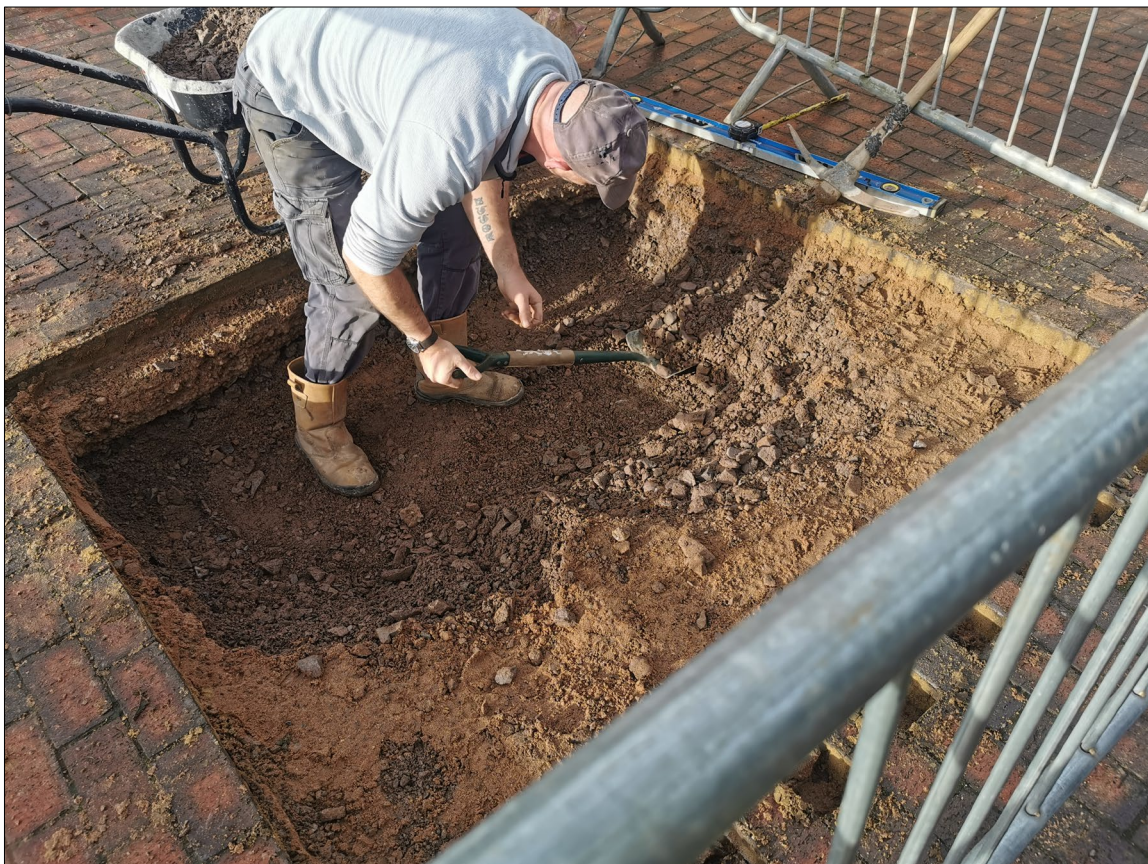
Figure 6: Excavating aggregate base, looking north-west

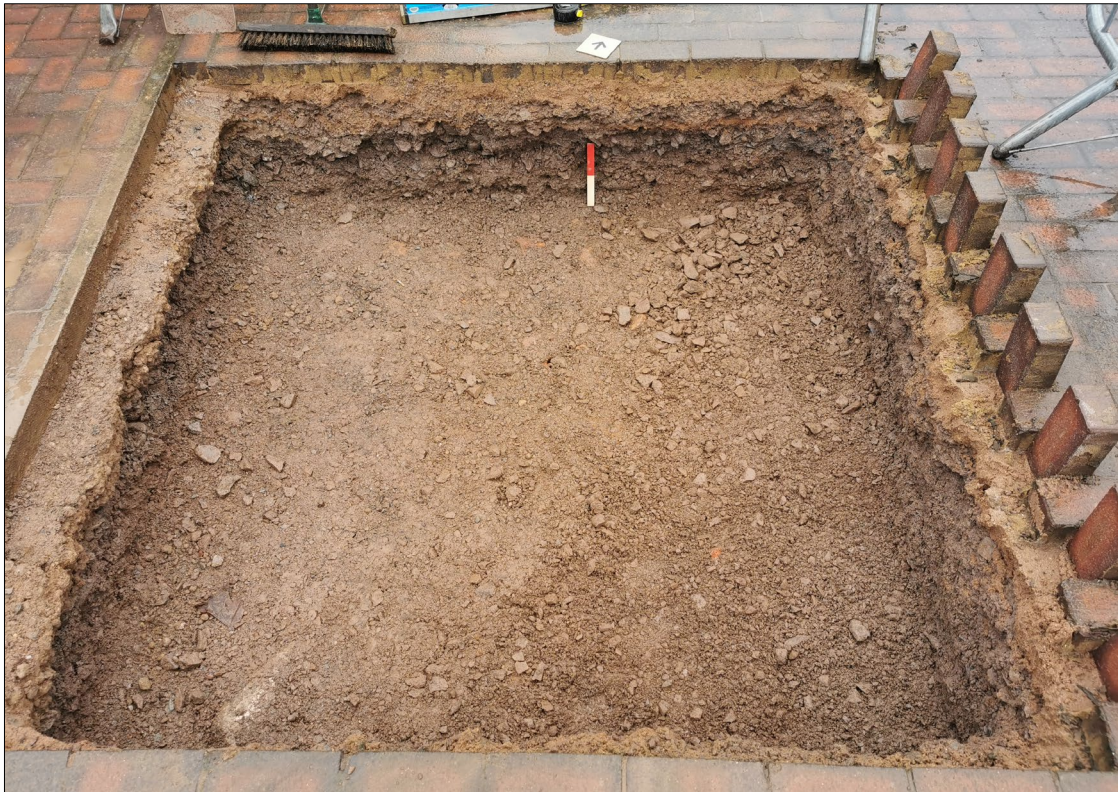
Figure 7: Excavated foundation pit, showing aggregate continuing below base, looking north (0.2m scale)

The excavated pit measured 1.75m square and with a depth of 0.45m, and was hand-dug. Only modern levels were exposed, consisting of made ground for the paved courtyard area. Below the formation depth were indications that modern demolition material was present, perhaps either from nearby structures or imported material. No archaeological deposits or artefacts were recovered during the work.
