Geotechnical &  
Environmental  
Consultants

Hinckley West  
Leicestershire

**Phase II Exploratory Investigation Report  
For  
Bloor Homes Midlands**

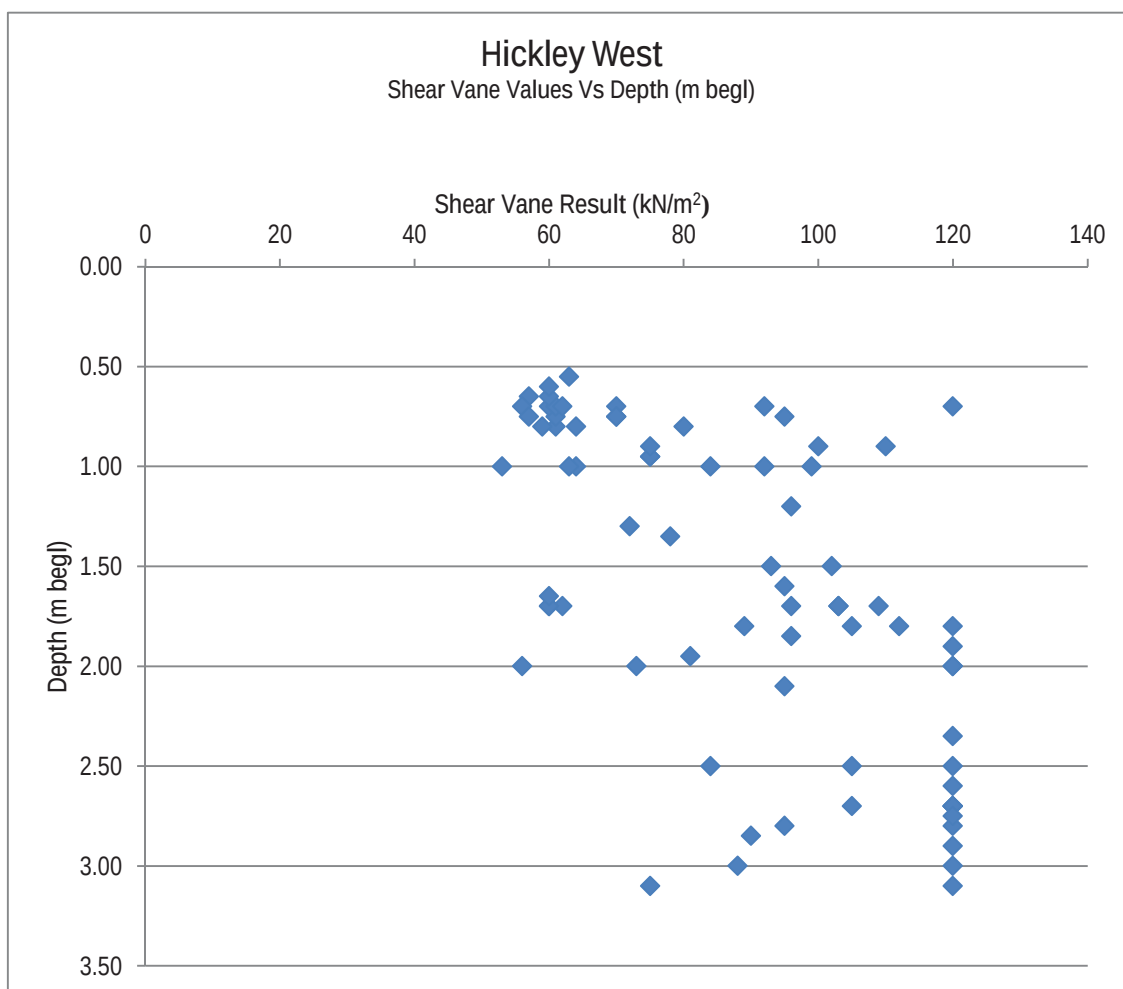
It should be noted that shear vane testing undertaken at depths greater than 1.00m was carried out ex-situ for health and safety reasons.

A graph showing shear vane results in relation to depth is presented on the next page.

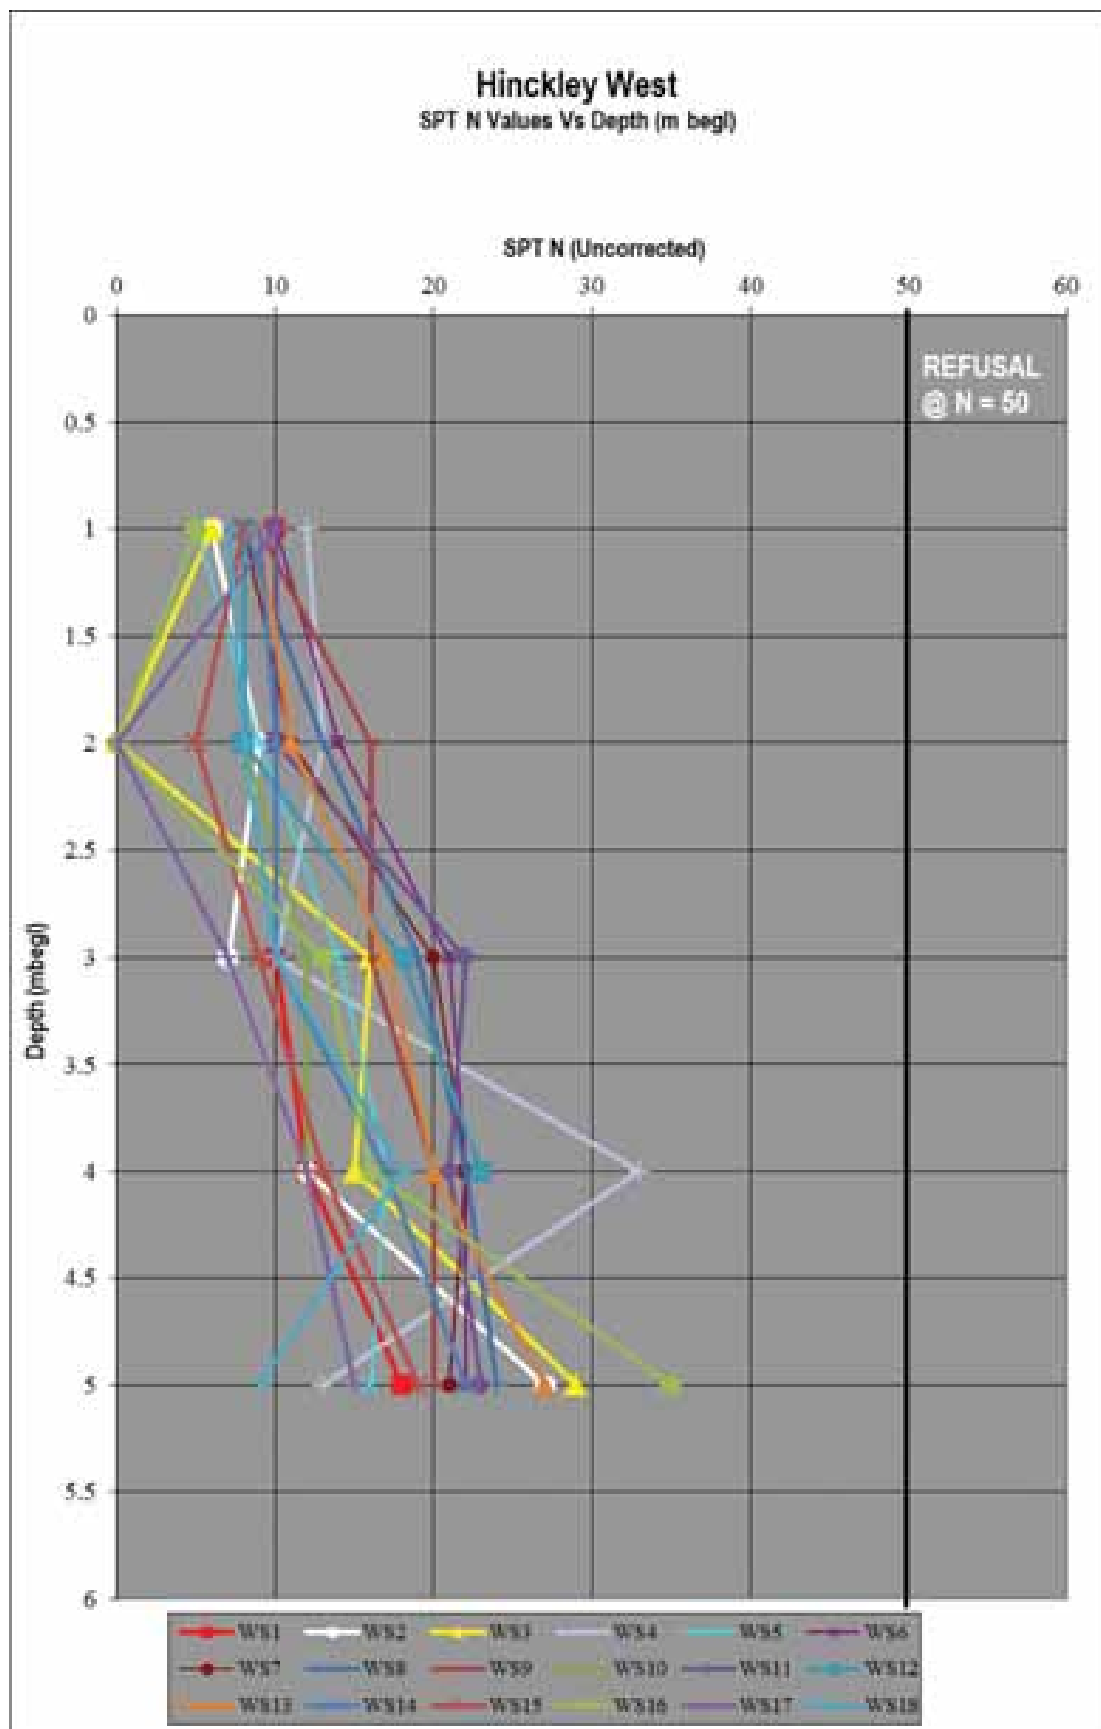
The results show the SPT 'N' values to generally increase with greater depth and are recorded on the logs in Appendix V

An SPT Vs Depth Chart of the data obtained from the boreholes advanced at the site is shown on the next page.

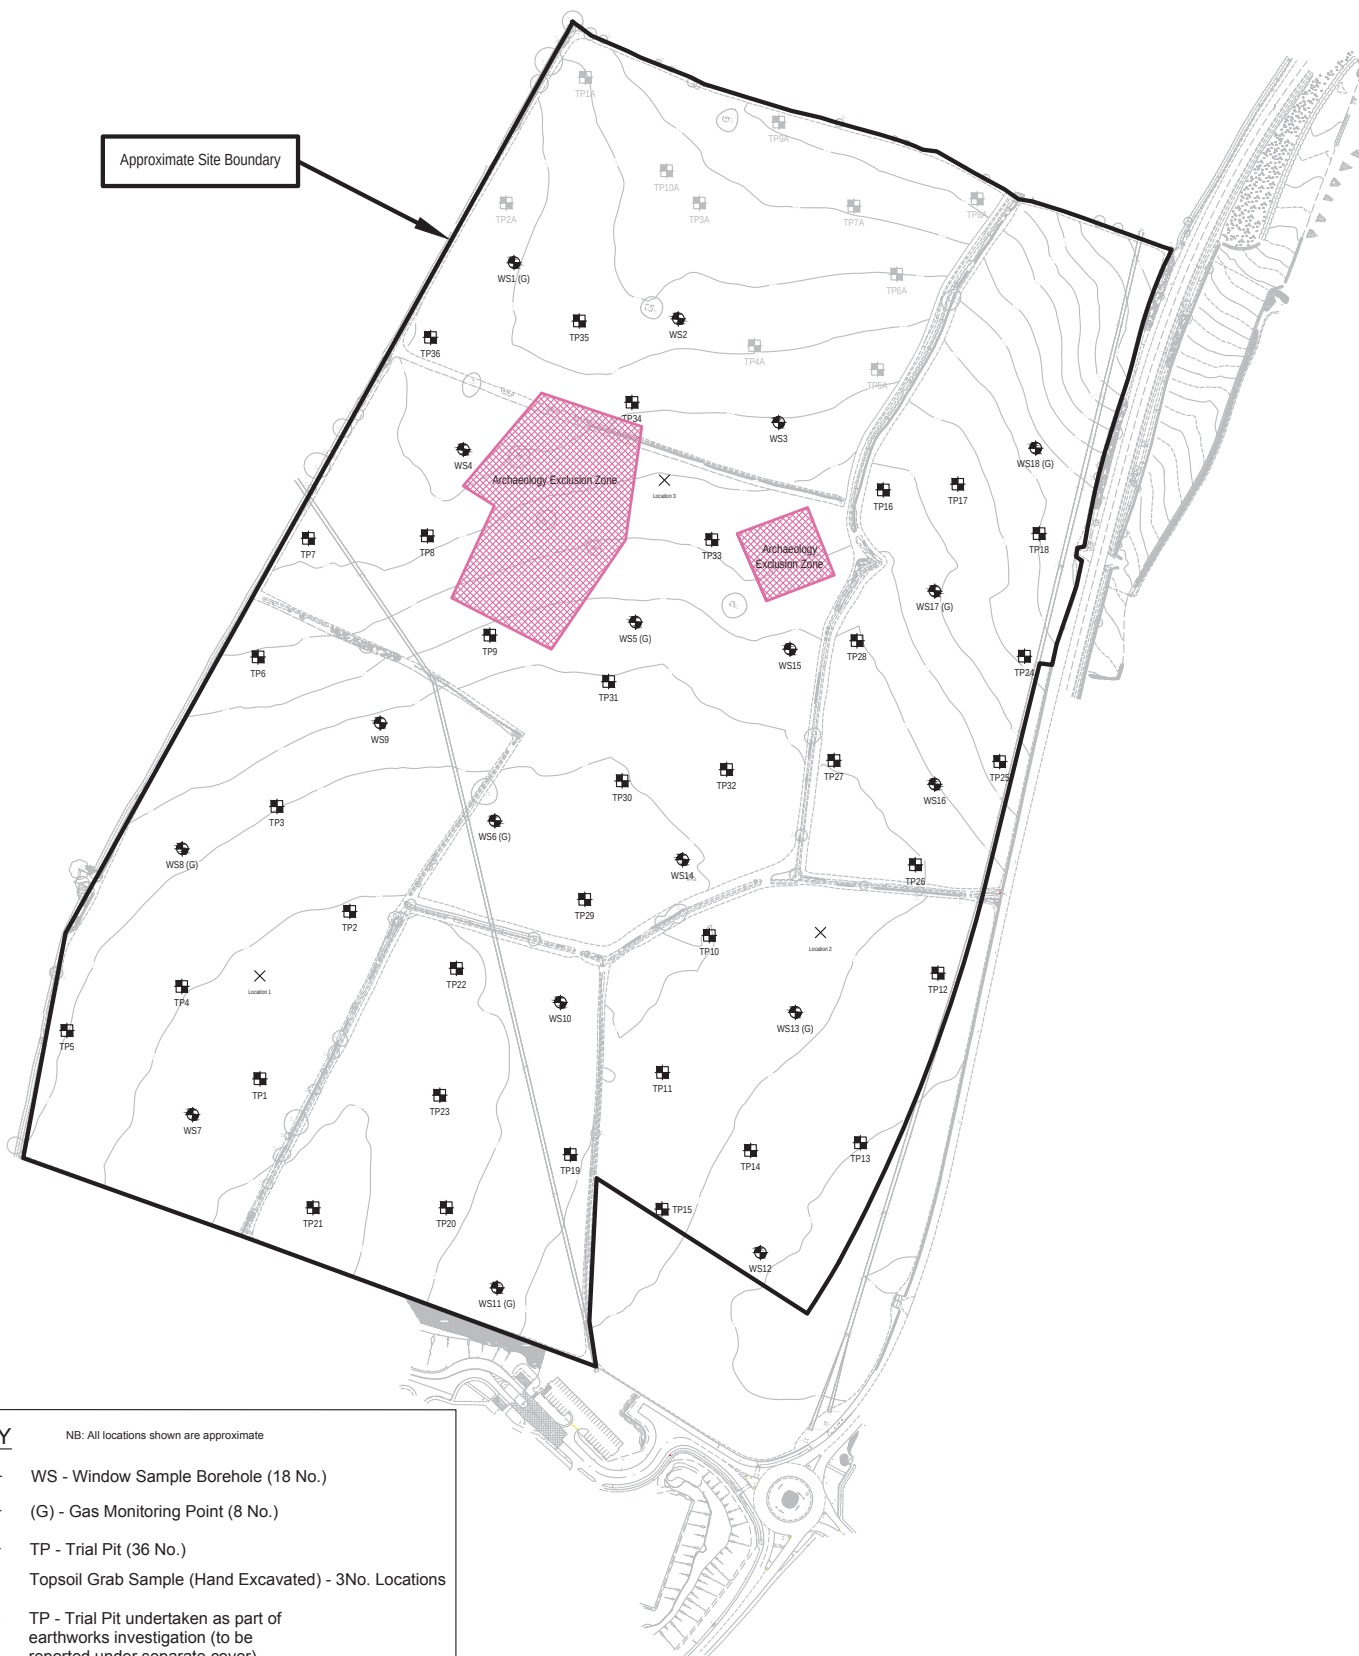
**Exploratory Hole Location Plan & GPS Co-ordinates  
(Figure No. D36147/04)**

The approximate locations of the exploratory holes are shown on the plan presented in Appendix IV (Figure No. D36147/04). Exploratory hole locations were positioned using a hand held GeoExplorer 5T GPS, with a claimed sub-metre accuracy of approximately 1m; accuracy subject to satellite coverage, line of-sight conditions etc. The GPS coordinates are presented on a separate sheet in Appendix IV. The exploratory hole logs are presented in Appendix V of this report.

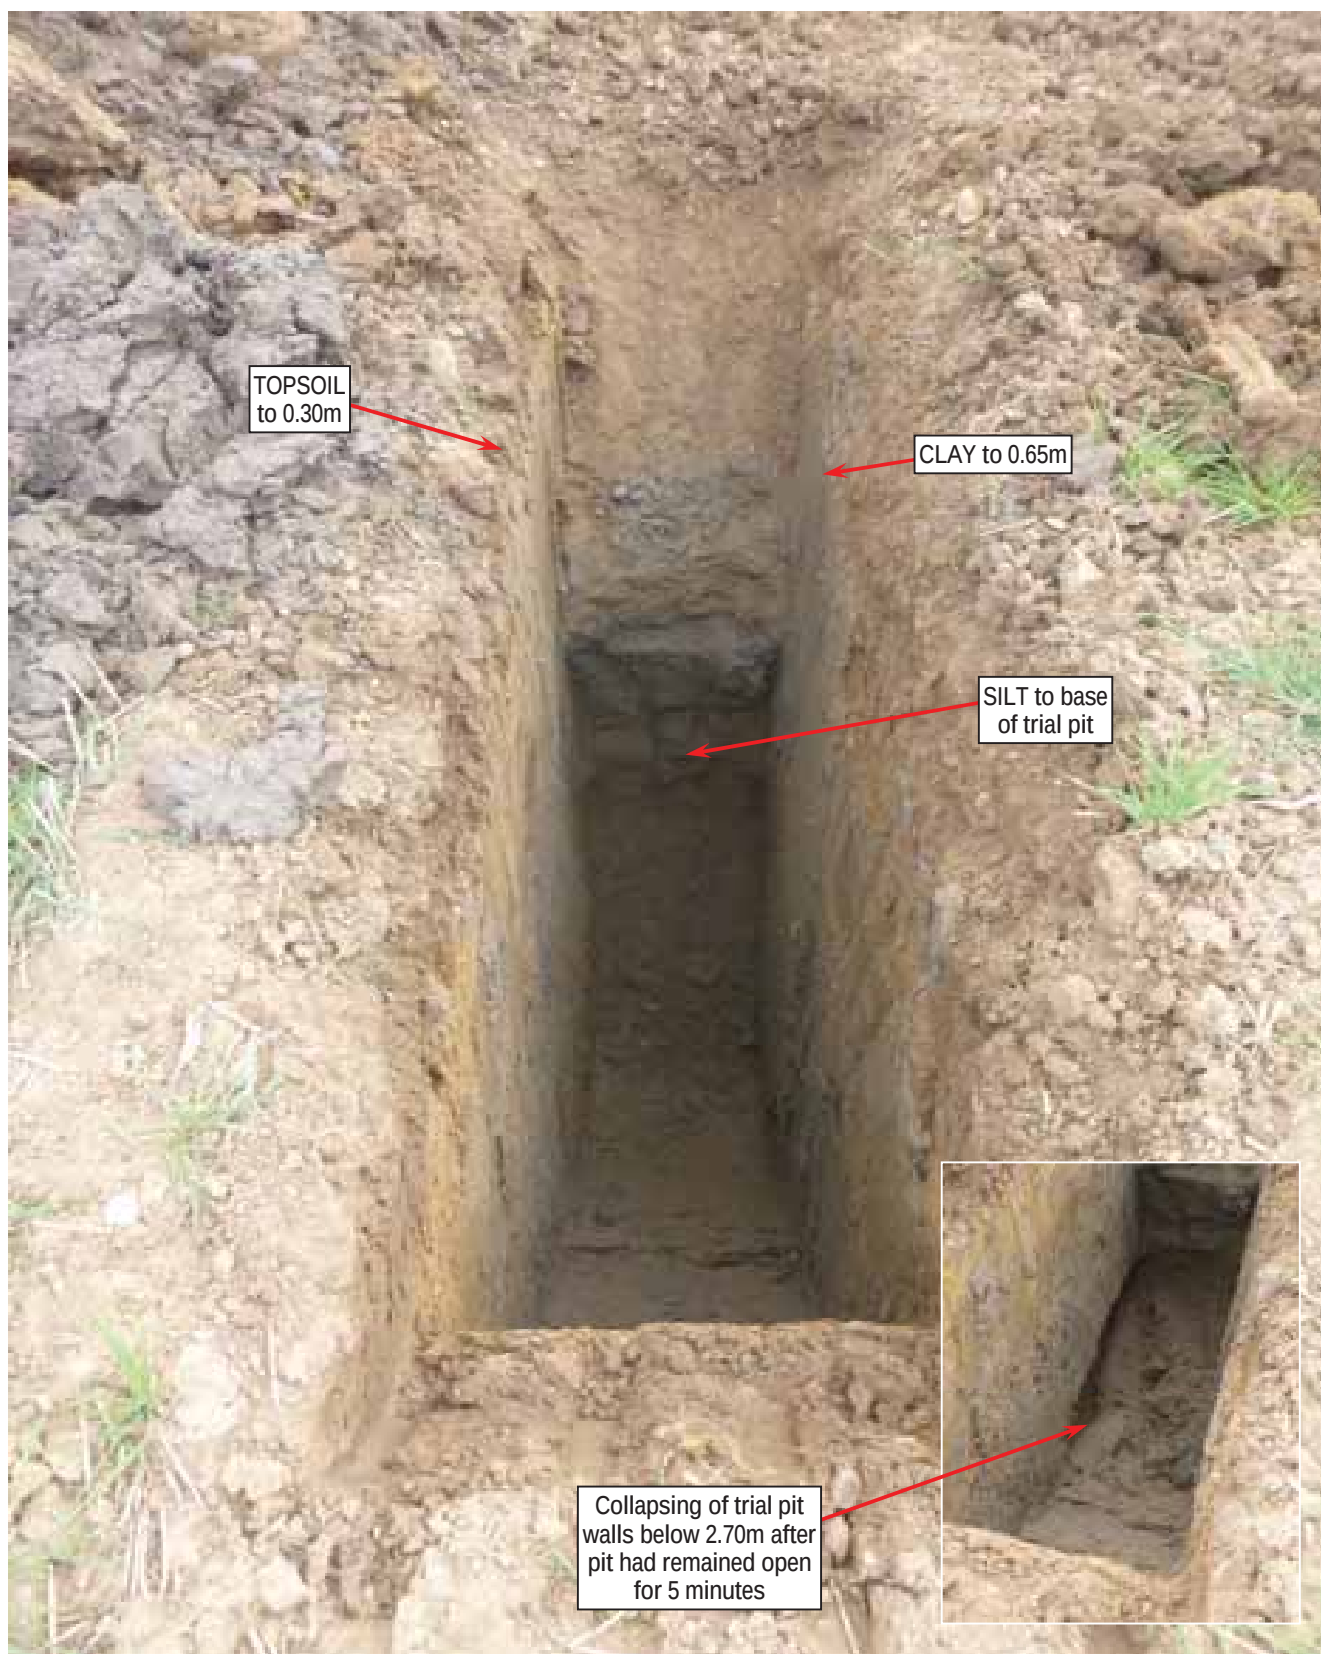
| Title | Completed Excavation (TP18) | Plate No. 4 | |

Collapsing of trial pit walls was only recorded in four locations, each time during excavations within the natural Silt strata. In TP18 and TP36 collapsing of the pit walls occurred after the pits had remained open for five minutes. Collapsing was recorded below a depth of 2.70m begl in TP18, and from between 1.50m and 2.80m begl in TP36. In TP18 the collapsing caused the undermining of shallower strata. In TP33 and TP35 collapsing occurred as the pits were being excavated; collapsing was recorded at depths in excess of 2.30m begl and in both cases caused the undermining of shallower strata. In TP18, TP33 and TP35, the collapsing appeared to be associated with groundwater seepages.

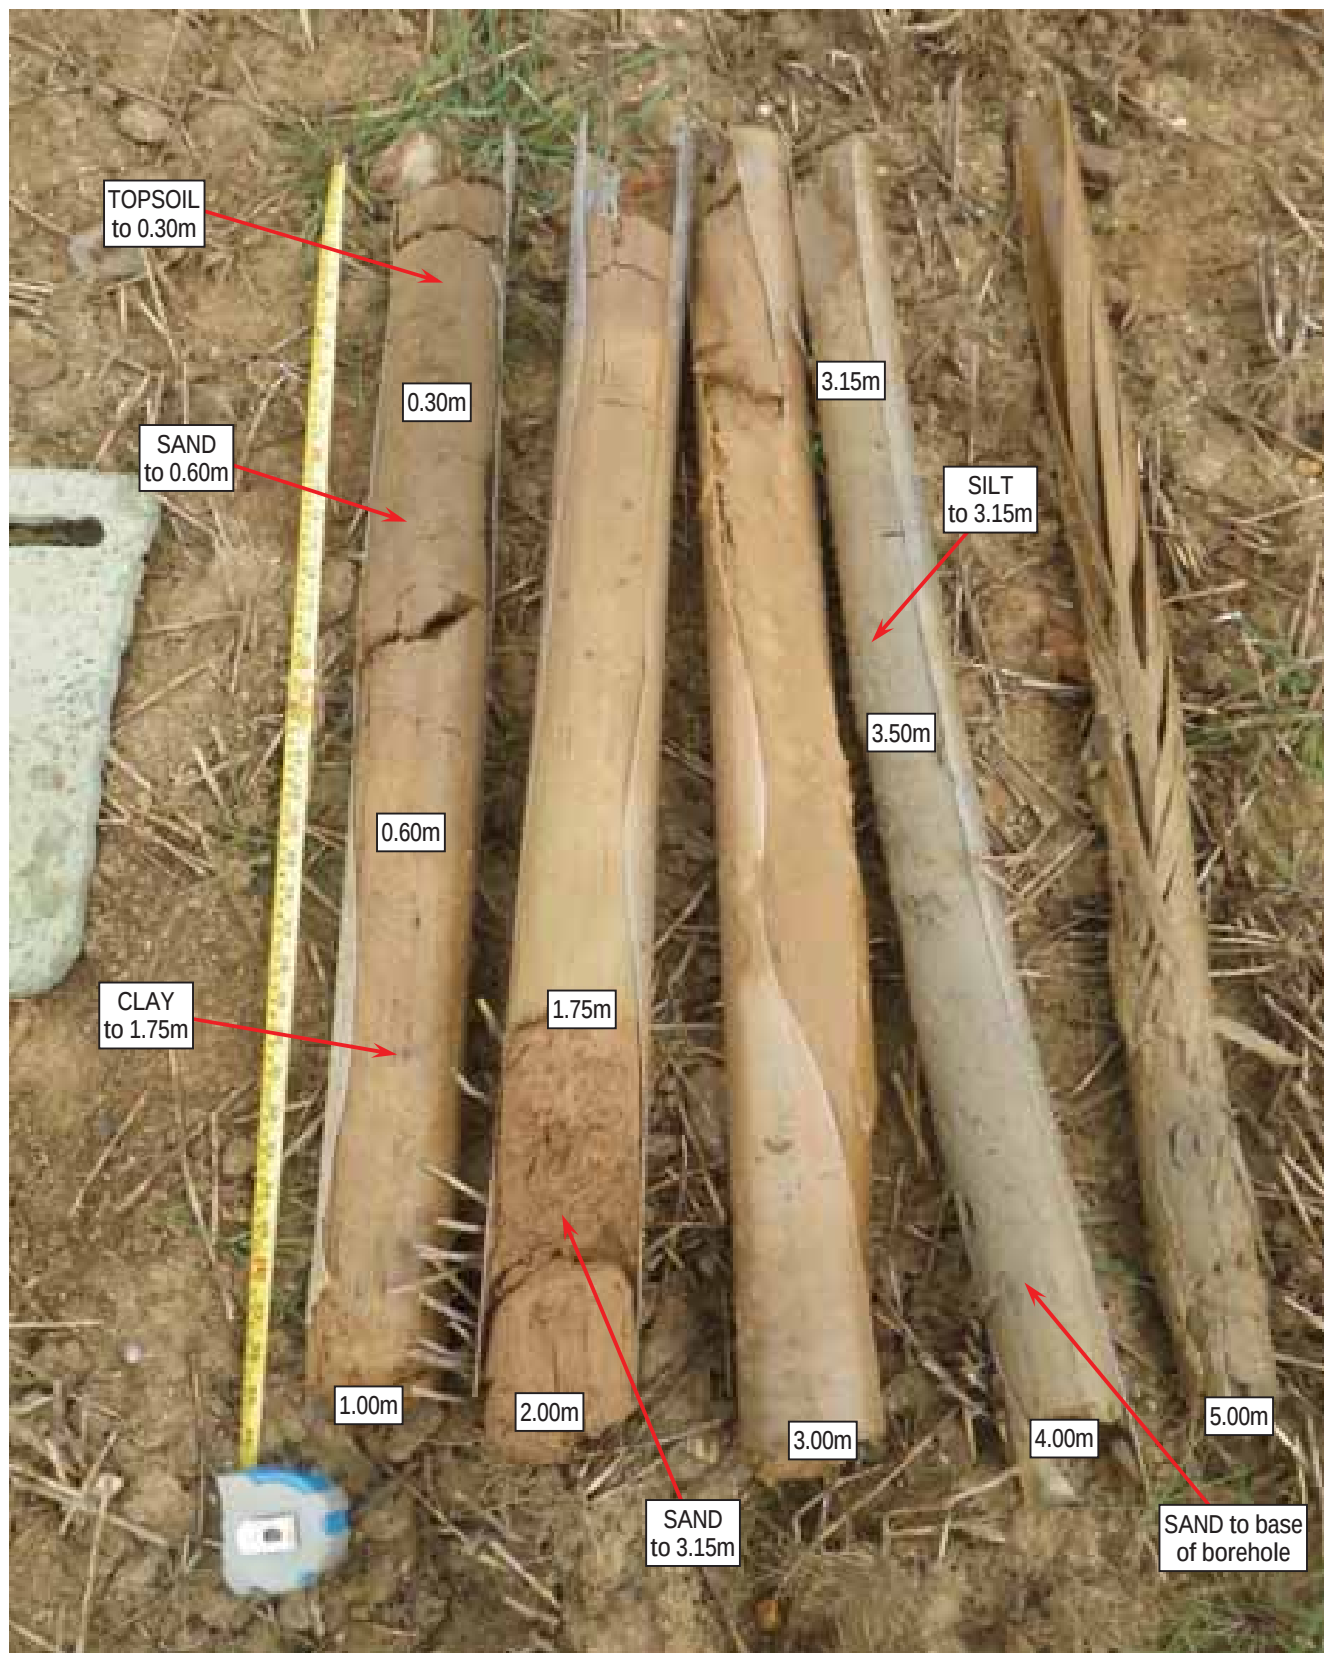
| Title | Recovered Cores from WS16 | Rev. | |

Medium dense (locally loose) fine to medium grained SAND was encountered in some northern areas of the site at variable depths either above, below or as bands within the Clay/Silt strata. In three of the window sample boreholes (WS3, WS16 and WS17) the Sand was recorded as very loose between approximate depths of 2.00m and 3.00m begl. Sand was also encountered as large pockets within the Clay strata in some southern areas of the site.

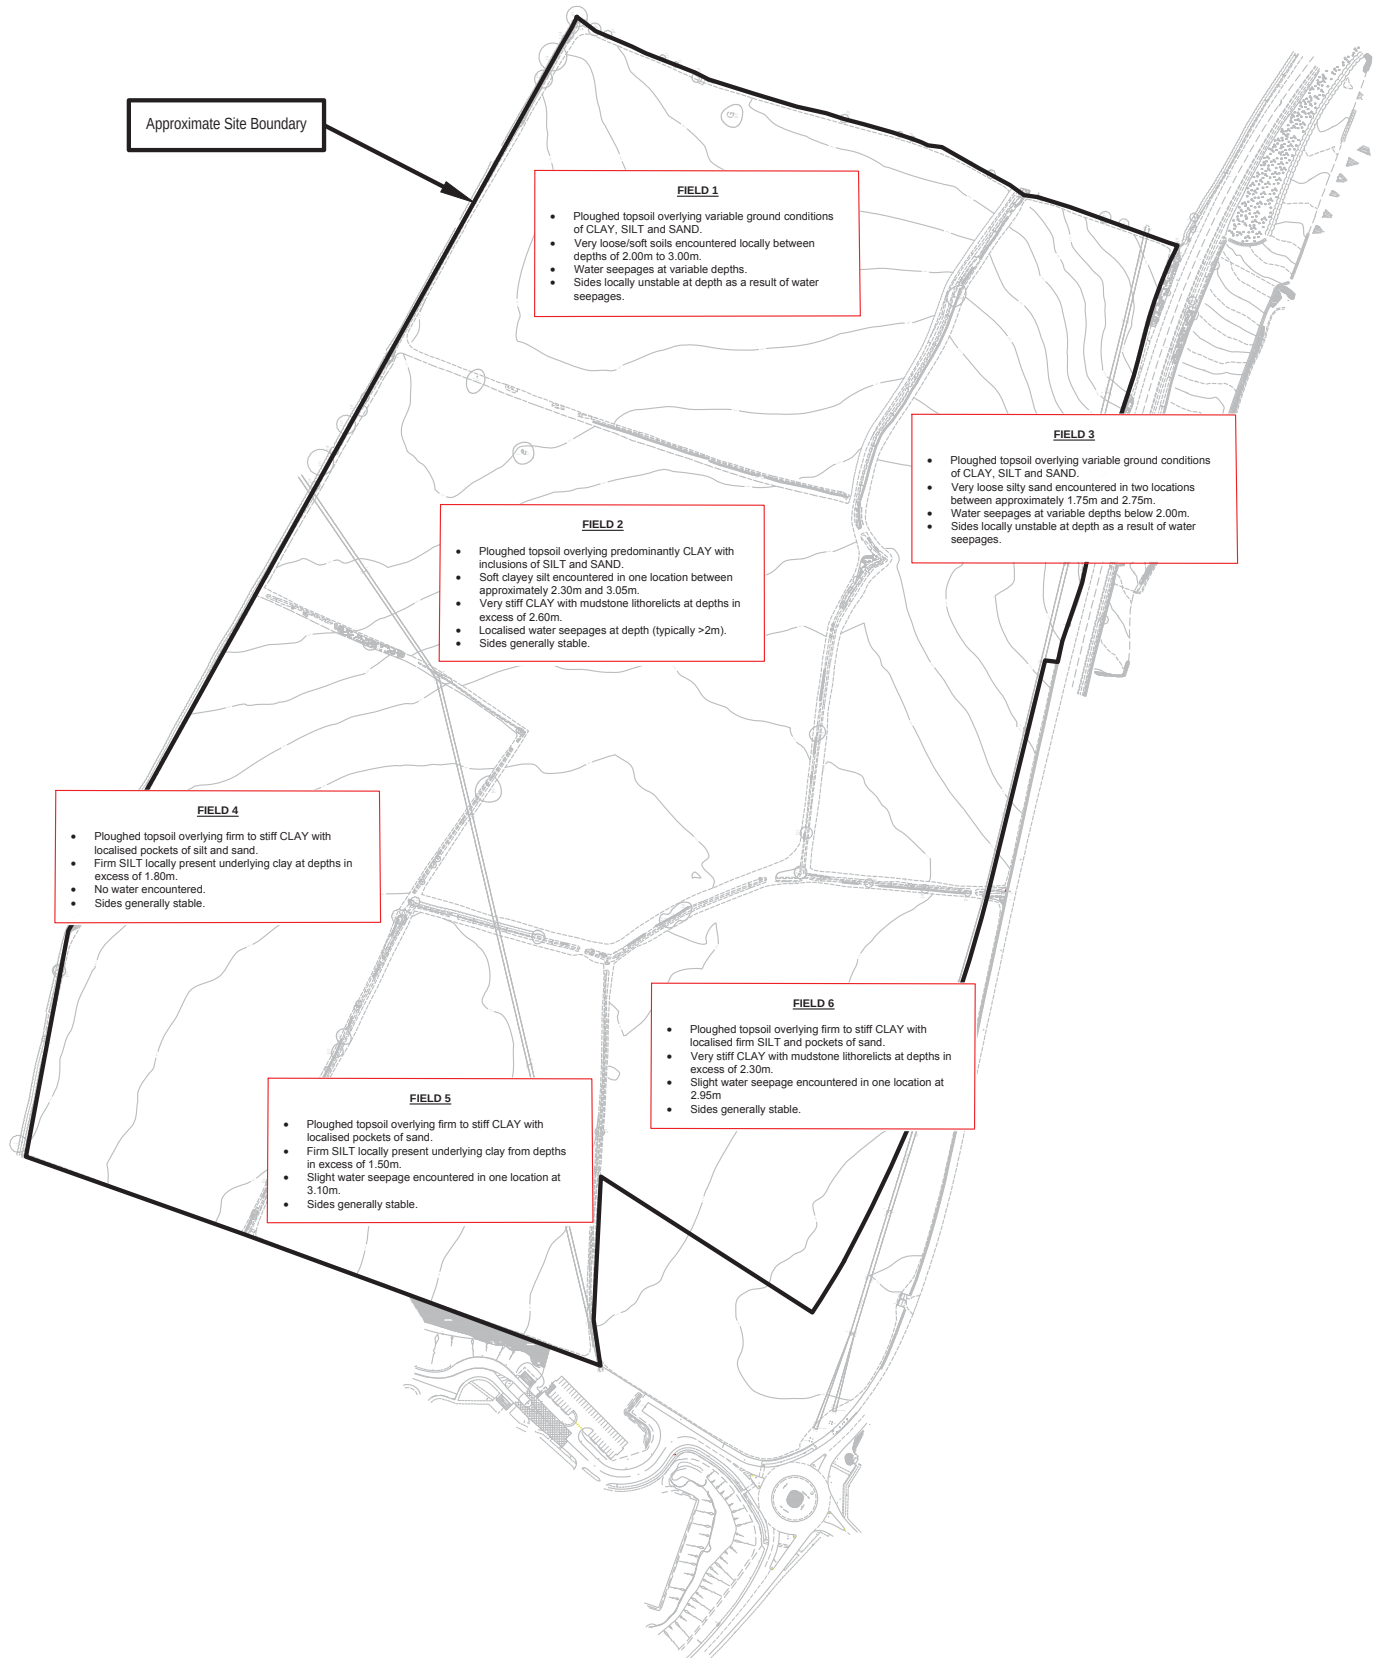
**Ground Conditions Plan  
(Figure No. D36147/06)**

| Ground Conditions | Reference should be made to the Ground Conditions Plan (Figure No. D36147/06), which is presented in Appendix XI of this report and summarises the ground conditions on a field by field basis. |

Reference should be made to the Ground Conditions Plan (Figure No. D36147/06), which is presented in Appendix XI of this report and summarises the ground conditions on a field by field basis.

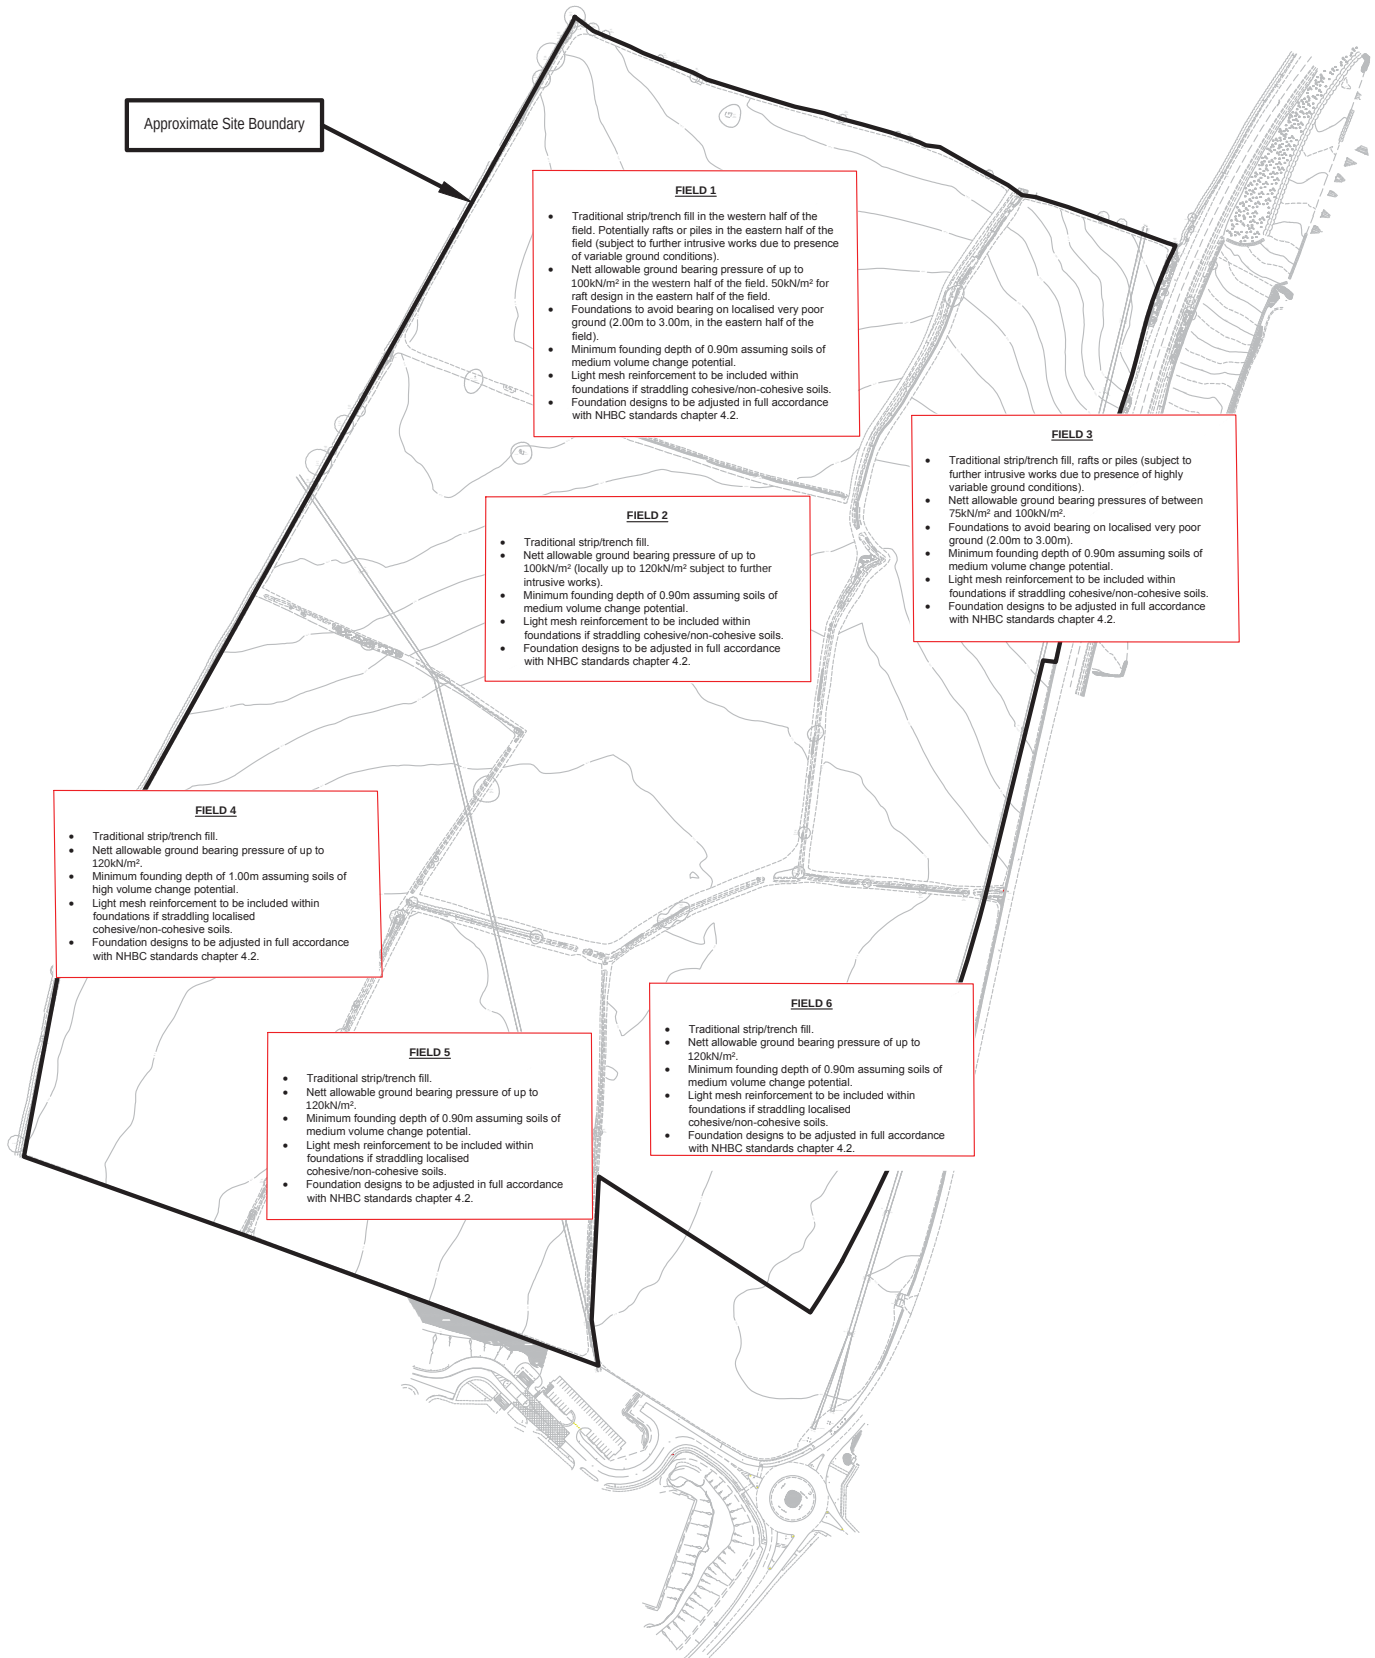
**Foundation Summary Plan  
(Figure No. D36147/07)**

| Foundation Design | A Foundation Summary Plan (Figure No. D36147/07), which summarises the foundation recommendations on a field by field basis, is presented in Appendix XII. |

The following foundation design recommendations comprise general advice for the entire site area. Based on the large size of the site (approximately 45Ha), a prudent developer may wish to commission parcel specific trial pitting and reports once the layout/development proposals, including levels, have been confirmed. In addition to the advice given below, a Foundation Summary Plan (Figure No. D36147/07), which summarises the foundation recommendations on a field by field basis, is presented in Appendix XII.

Foundations within cohesive soils may require localised deepening due to the influence of trees and hedgerows.
