## SOIL INFILTRATION CALCULATIONS FRONT SHEET

| <b>SCHEME</b> | Sketchley Grange, Burbage |
| <b>CLIENT</b> | Persimmon Homes (North Midlands) |
| <b>ASPECTS OF SCHEME TO BE DESIGNED</b> | Soil Infiltration Rate Testing |

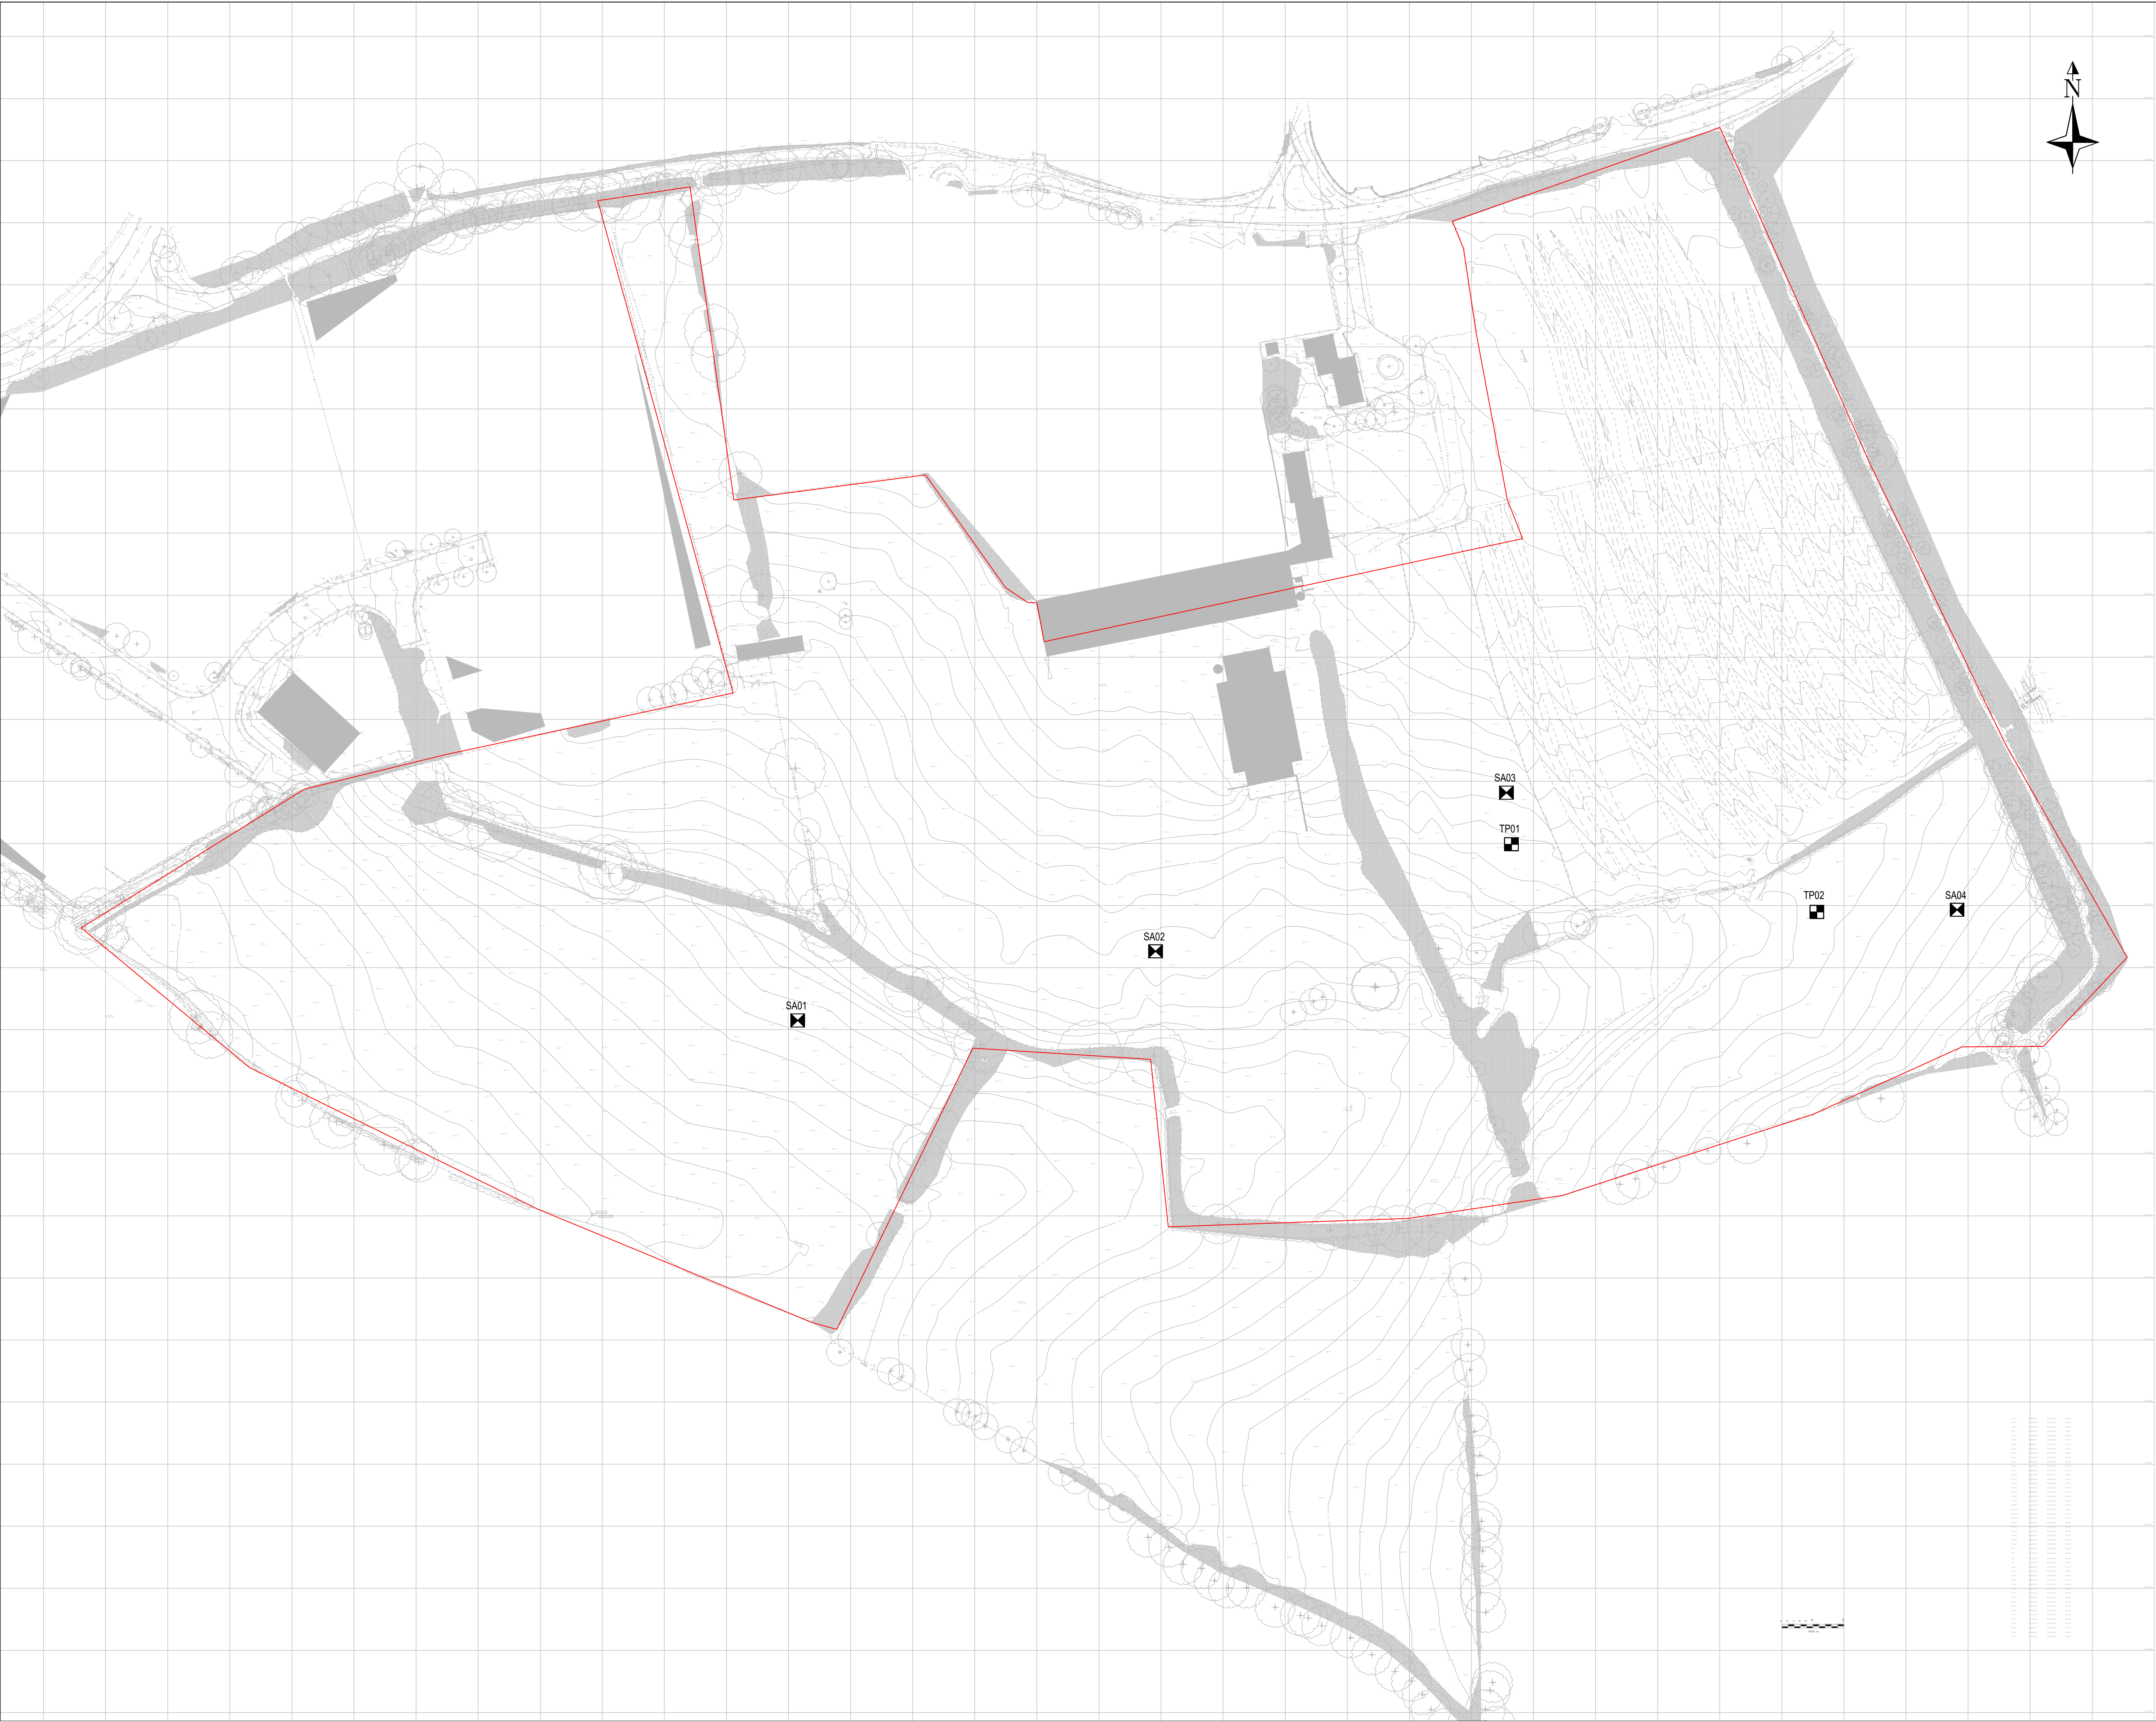
DRAWING NUMBER: 28959\_04\_140\_01

DRAWING TITLE: EXPLORATORY HOLE LOCATION PLAN

| Pages | Calculations | Checked by | Approved By | Date |
|---|---|---|---|---|
| 3 | Exploratory Hole Location Plan | CW | DT | 05.07.24 |

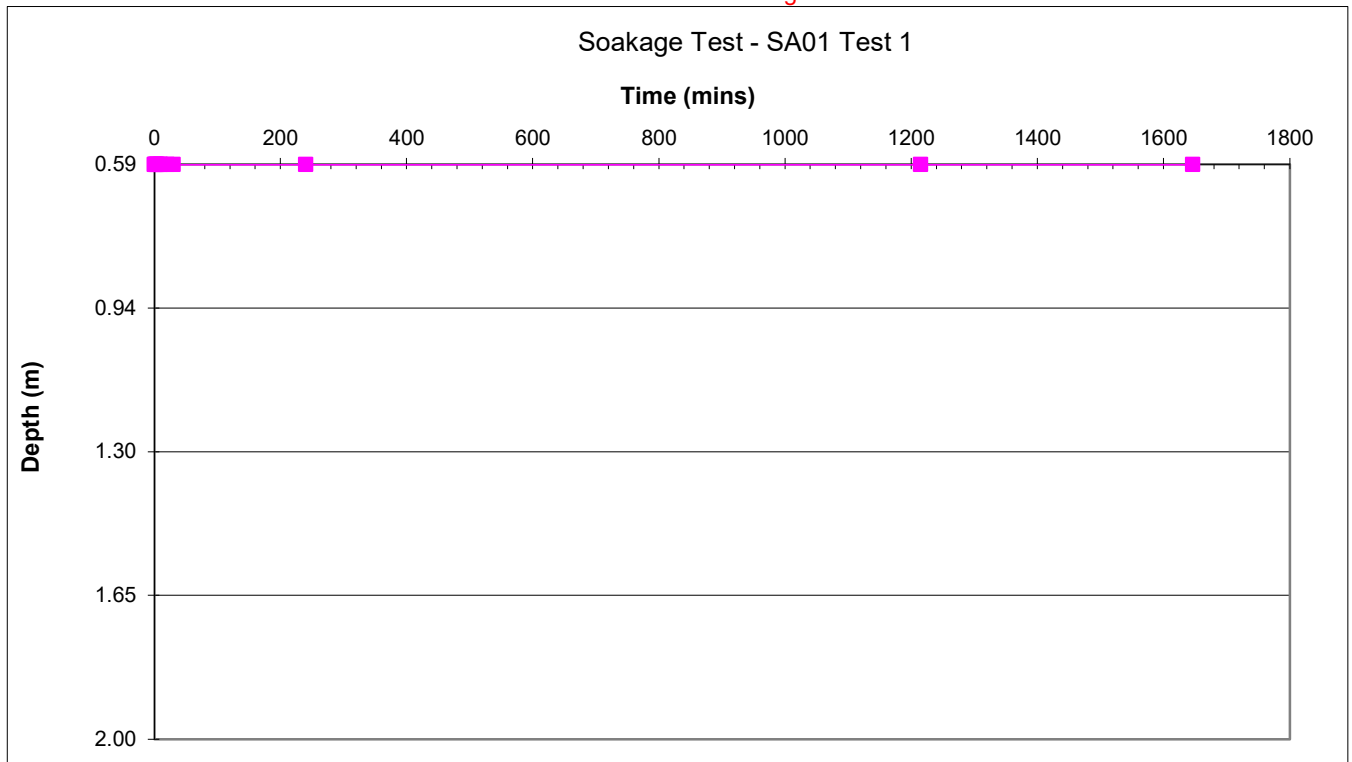
Soakaway pit ref. SA01 Test 1  
Length 1.70 m  
Width 0.45 m  
Depth 2.00 m  
Ground water level Not encountered  
Ground conditions 0.00-0.30m Light brown, slightly sandy, slightly gravelly clay TOPSOIL. Gravel comprises fine to coarse, subrounded to subangular, flint, quartzite and brick.  
0.30-2.00m Firm to stiff, blueish grey CLAY.

Insufficient soakage to derive an infiltration rate

| Pages | Calculations | Checked by | Approved By | Date |
|---|---|---|---|---|
| 4 | SA01 – Test 1 Insufficient soakage to calculate infiltration rate | | | |

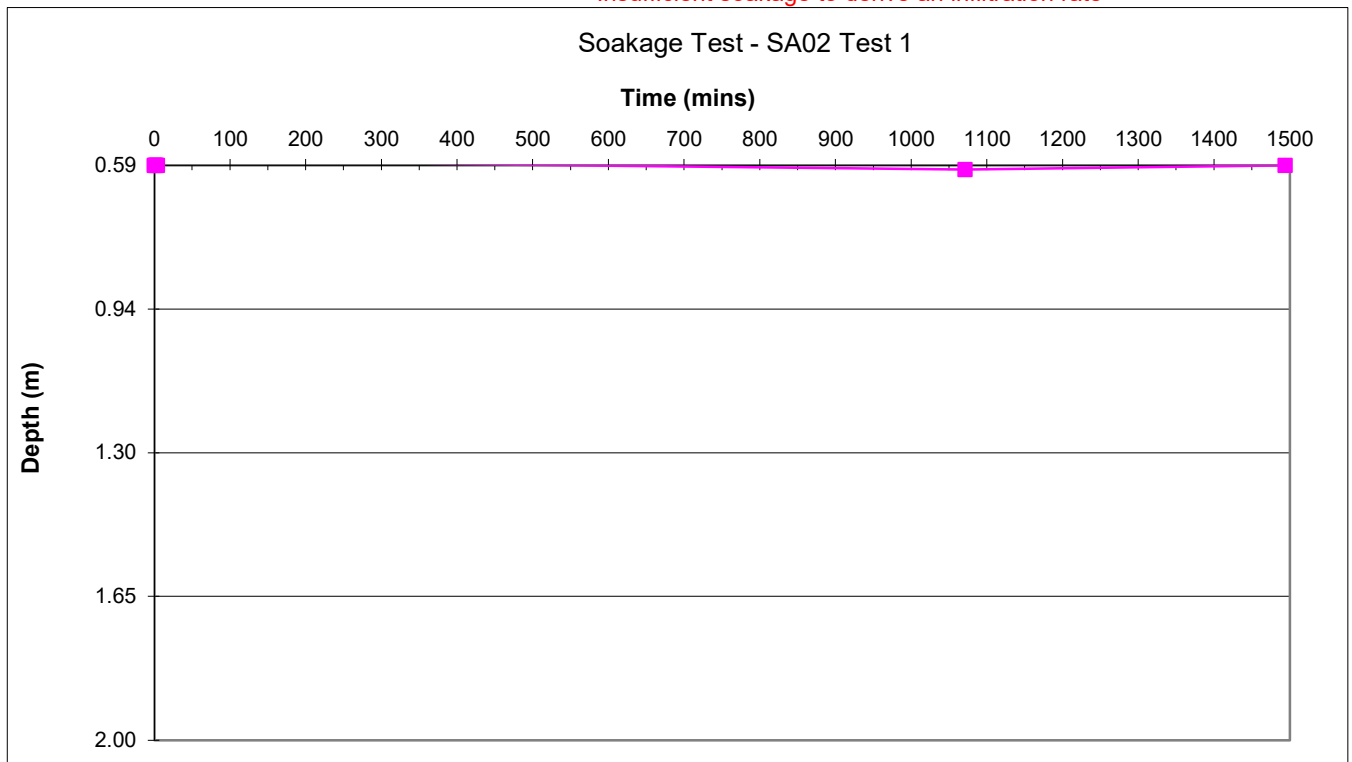
| <b>Soakaway pit ref.</b> | <b>SA02</b> | <b>Test 1</b> |

Insufficient soakage to derive an infiltration rate

| Pages | Calculations | Checked by | Approved By | Date |
|---|---|---|---|---|
| 5 | SA02 – Test 1 Insufficient soakage to calculate infiltration rate | | | |

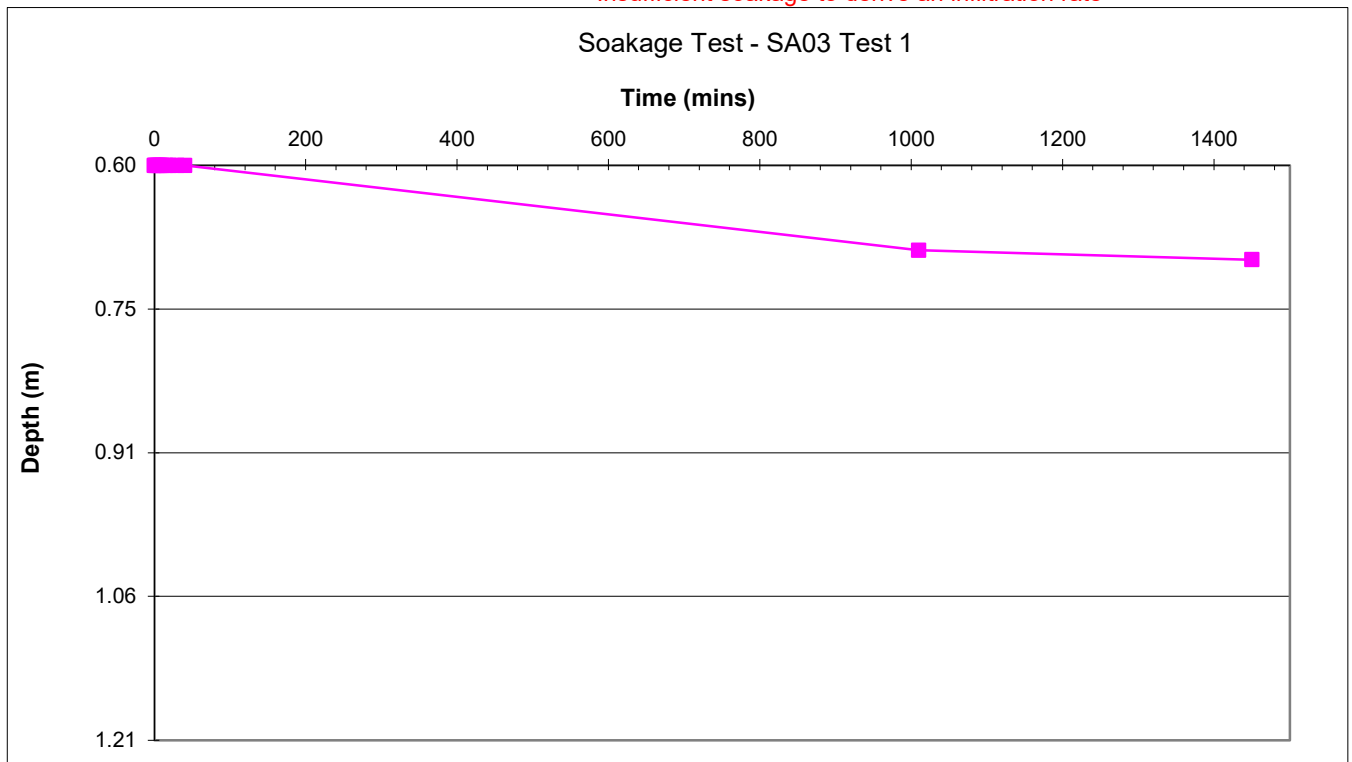
Soakaway pit ref. SA03 Test 1  
Length 2.40 m  
Width 0.45 m  
Depth 1.21 m  
Ground water level Not encountered  
Ground conditions 0.00-0.35m Grass onto brown, slightly sandy, slightly gravelly clay TOPSOIL. Gravel is fine to medium, subangular to subrounded flint and quartzite.  
0.35-1.30m Dark brown, clayey, silty SAND with occasional gravel of fine to medium, subrounded flint.

Insufficient soakage to derive an infiltration rate

| Pages | Calculations | Checked by | Approved By | Date |
|---|---|---|---|---|
| 6 | SA03 – Test 1 Insufficient soakage to calculate infiltration rate | | | |

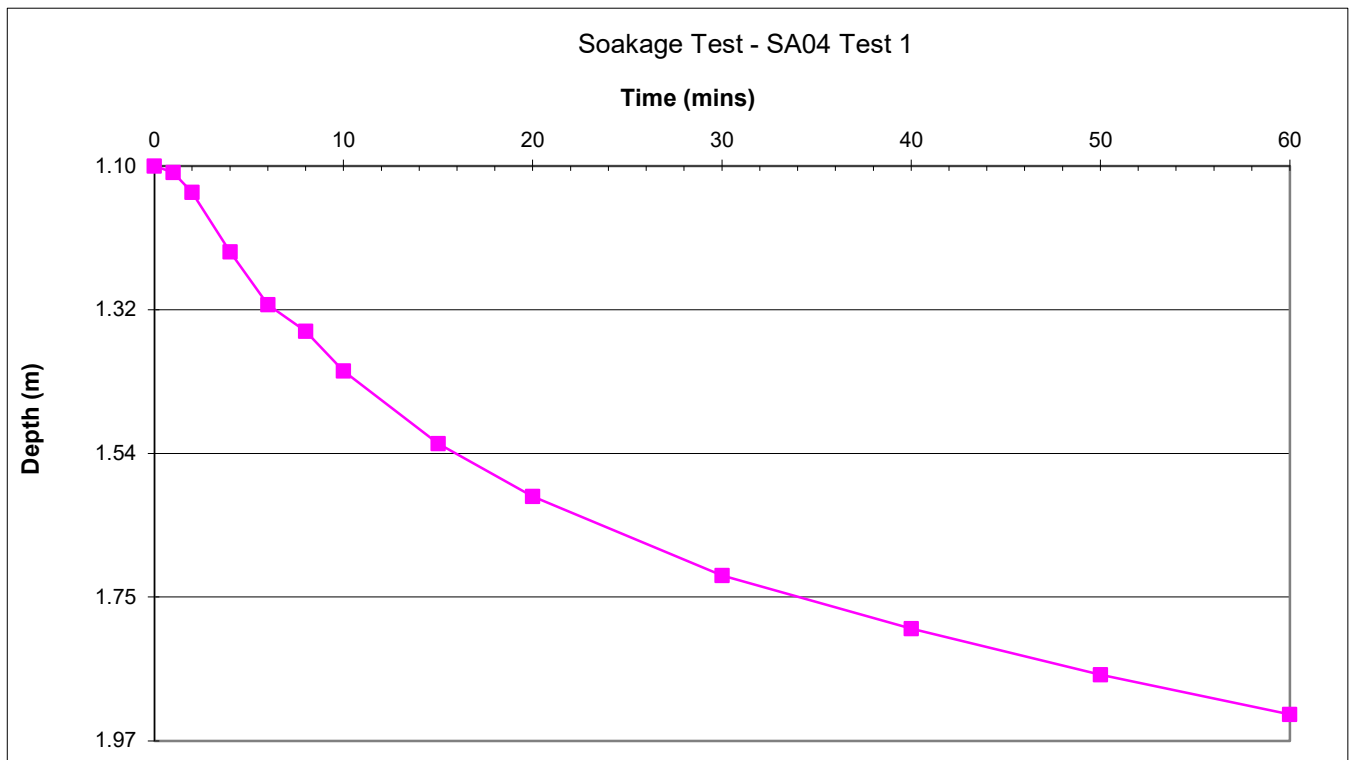
| Soakaway pit ref. | SA04 | Test 1 |

SOIL INFILTRATION RATE = 3.40E-05 m/s

| Pages | Calculations | Checked by | Approved By | Date |
|---|---|---|---|---|
| 7 | SA04 – Test 1 $3.40 \times 10^{-5}$ m/s | | | |

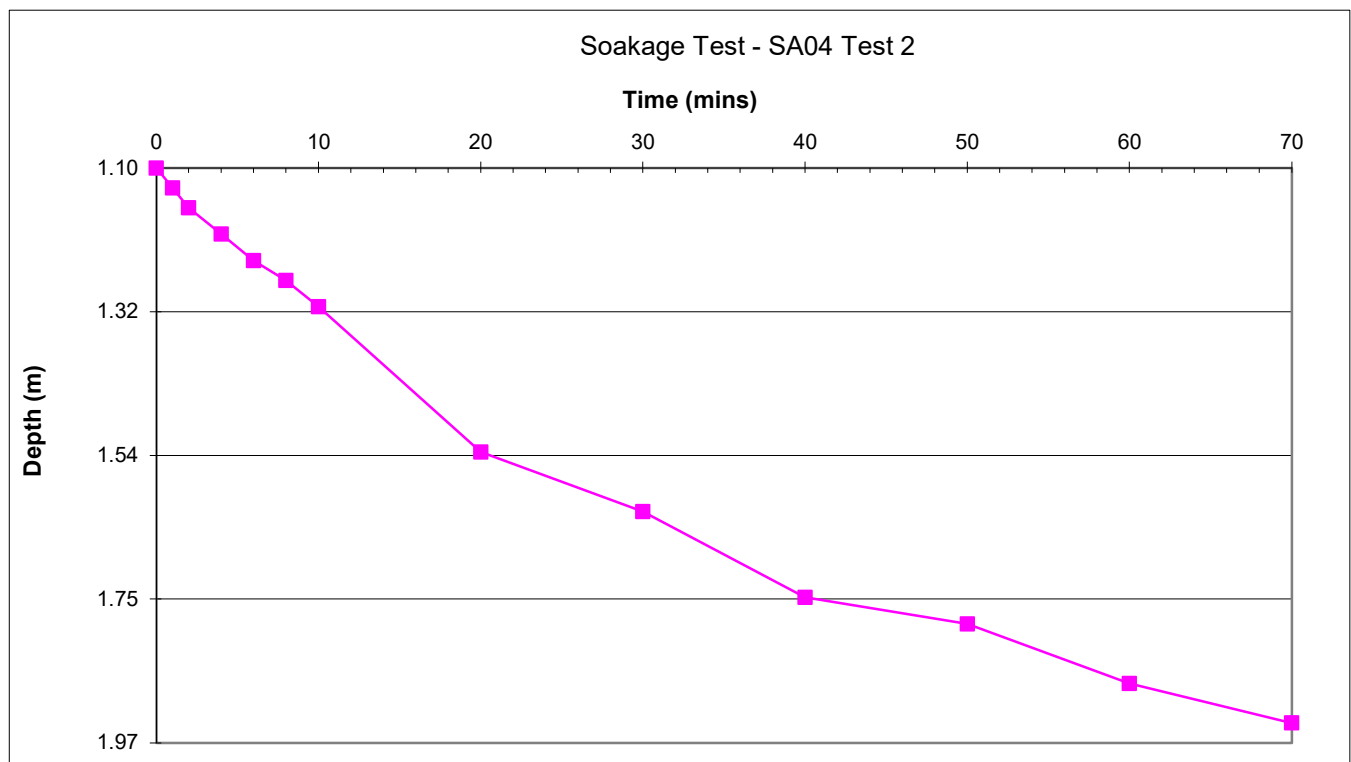
| Soakaway pit ref. | SA04 | Test 2 |

SOIL INFILTRATION RATE = 3.20E-05 m/s

| Pages | Calculations | Checked by | Approved By | Date |
|---|---|---|---|---|
| 8 | SA04 – Test 2 <b><math>3.20 \times 10^{-5}</math> m/s</b> | | | |

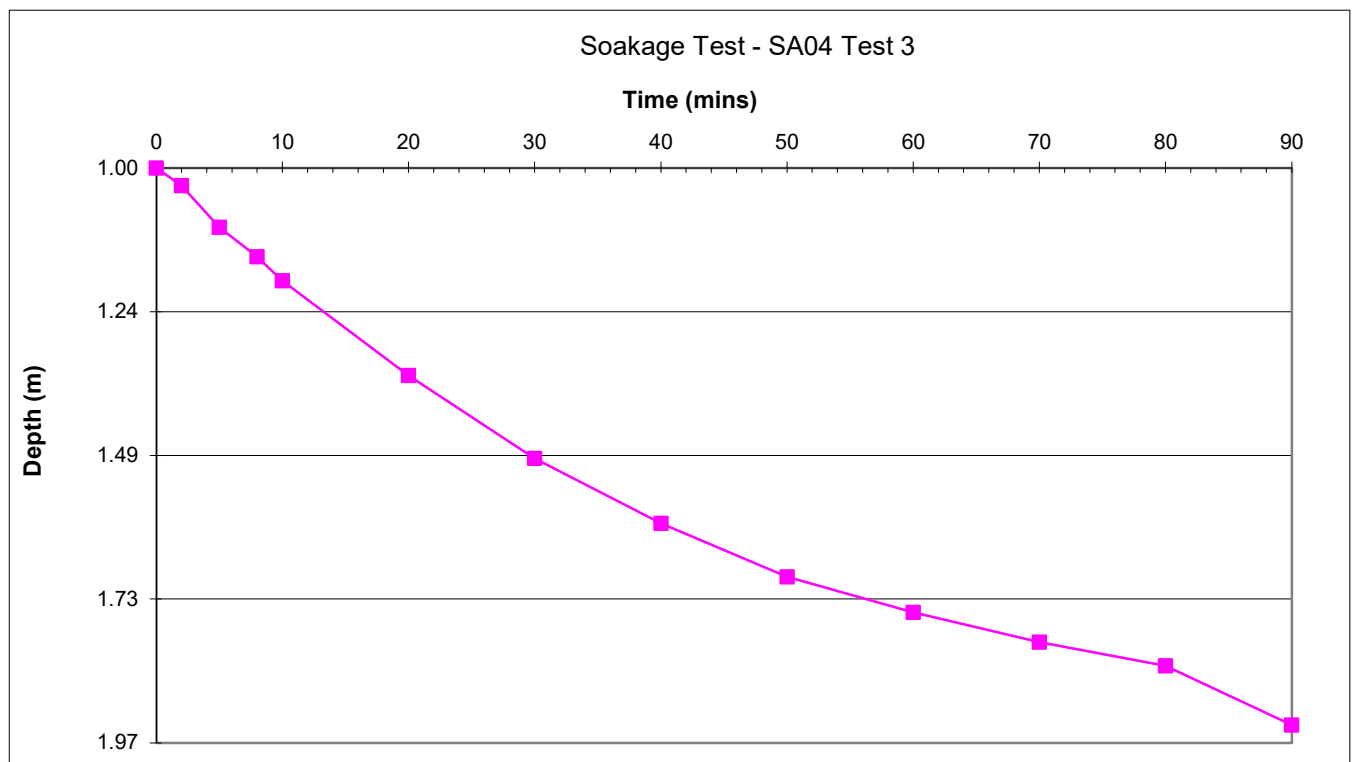
| Soakaway pit ref. | SA04 | Test 3 |

SOIL INFILTRATION RATE = 3.31E-05 m/s

| Pages | Calculations | Checked by | Approved By | Date |
|---|---|---|---|---|
| 9 | SA04 – Test 3 $3.31 \times 10^{-5}$ m/s | | | |
