Fort Estates Ltd

Crabtree Farm, Barwell

Arboricultural Method Statement and  
Tree Protection Plan

August 2023

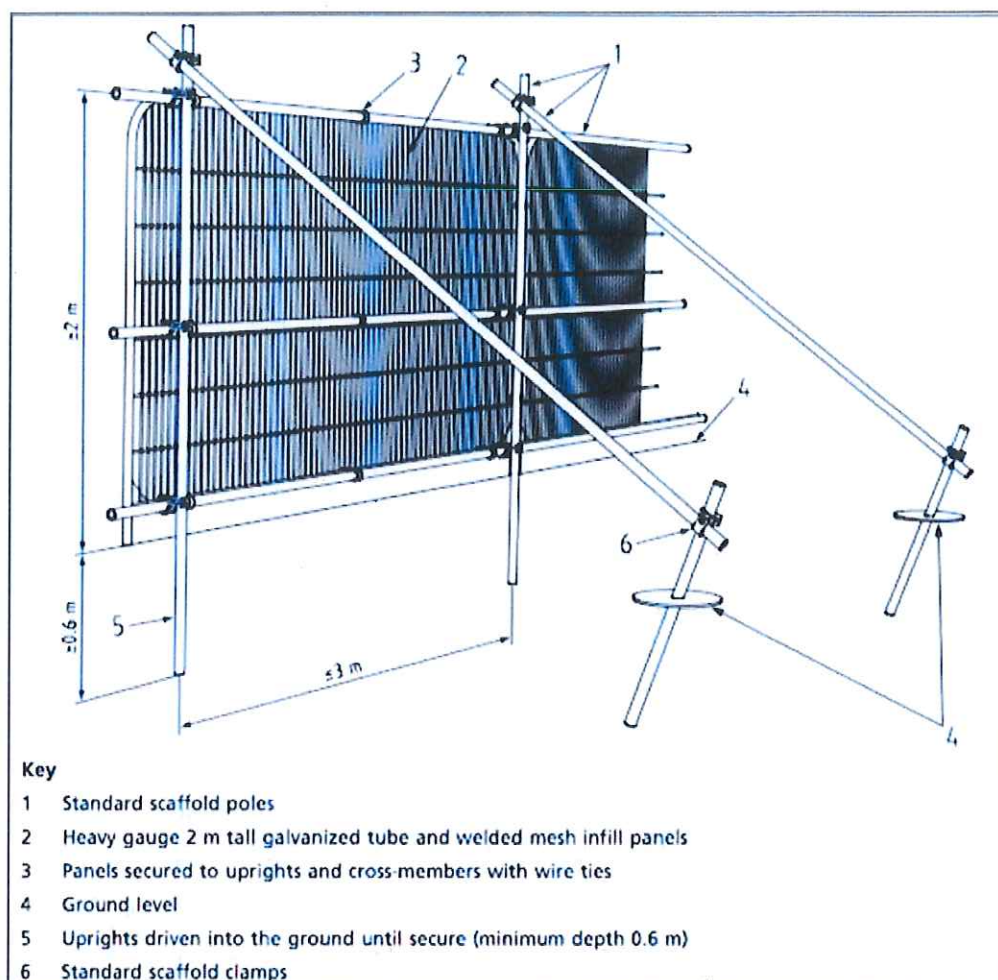
**Figure 1:** Default Specification for Protective Barrier (Tree Protection Fencing – TPF)  
 (Taken from Figure 2 of Section 6 BS5837:2012)

- 2.18 The default TPF specification (**Figure 1**) is a vertical and horizontal scaffold framework, braced to resist impacts. The vertical poles are driven securely into the ground with horizontal poles connected securely to the vertical sections. Bracing bars must then be securely attached to prevent movement of the structure if struck by machinery. Welded mesh panels are then securely attached to the scaffold framework. During installation it is important to consider the position of below ground services and structural roots, which must not be damaged. Where these constraints prevent the use of this specification, an alternative specification is provided in **Figure 2**.

- 2.19 Refer to **Figure 1** for the specification of the default Tree Protection Fencing.
- 2.20 It is the responsibility of everyone engaged in the construction process to respect the tree protection measures and observe the necessary precautions within and adjacent to them. In the event of any panel or support becoming damaged, this must be immediately reinforced by adding panels with the designs below as appropriate.

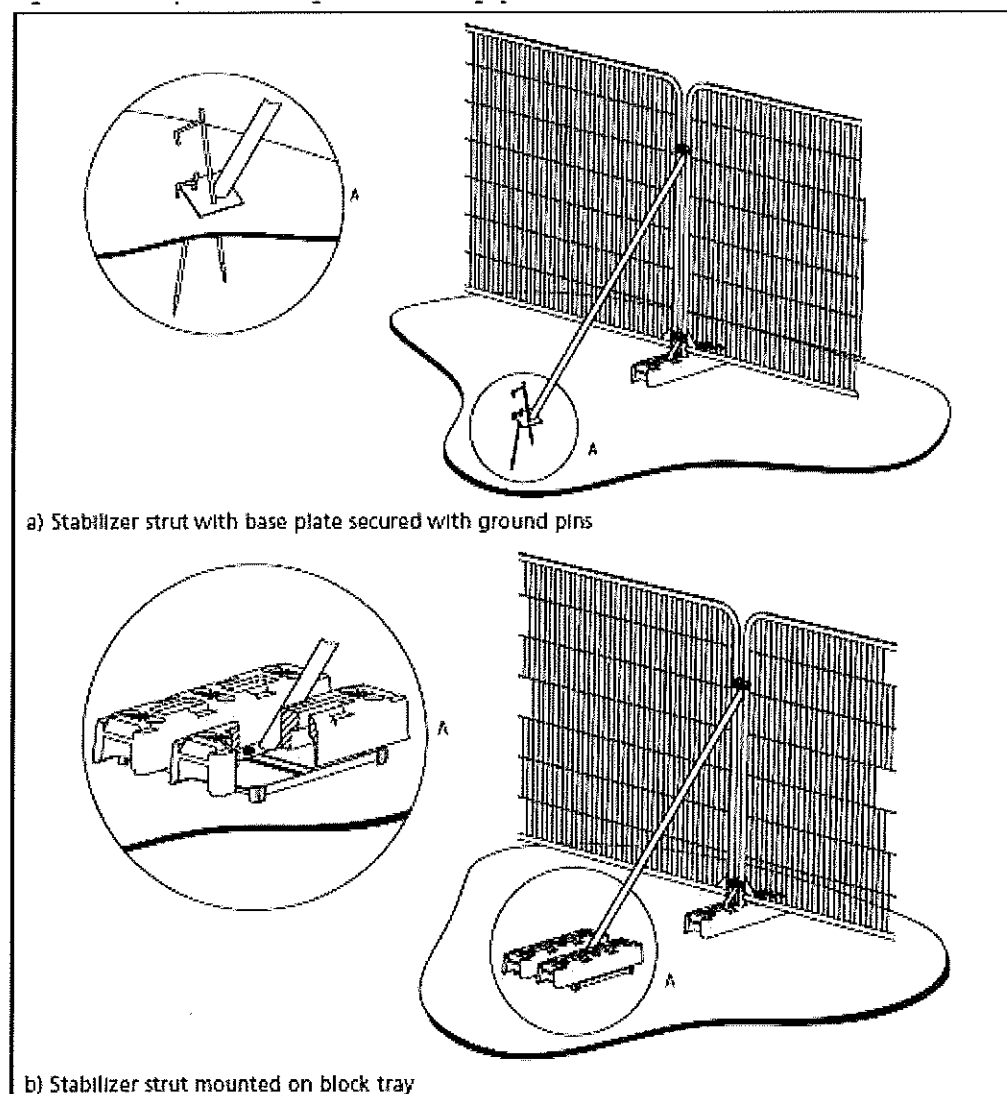
**Figure 2: Above Ground Stabilising Systems**

- 2.23 An alternative Tree Protection Fencing (TPF) design is shown on **Figure 2**.
- 2.24 2 metre tall welded mesh panels standing in rubber or concrete feet joined using a minimum of two anti-tamper couplers installed so they can only be removed from inside the protected area. The fence couplers should be at spaced least 1 metre apart, but uniformly across the whole barrier. These panels must be supported within the protected area with struts attached to a base plate secured by ground pins as per **Figure 2**.
- 2.25 Where the fencing is installed above retained hard surfacing and / or it is otherwise not feasible to use ground pins (e.g. due to underlying services or structural roots), the struts can be mounted on a block tray as per **Figure 2**.

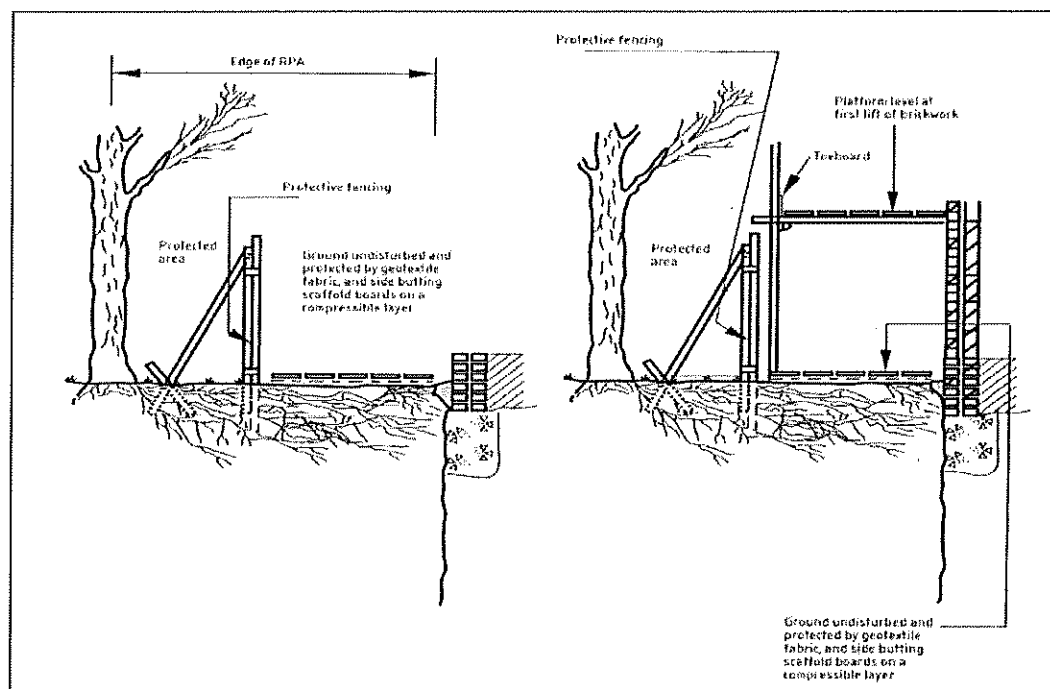
**Figure 3:** Default Specification for the installation of scaffolding within RPAs

- 2.26 Should scaffolding be required within any of the RPA's, appropriate ground protection should be installed; such protection must be strong enough to support any predicted load and resist compaction and soil damage.
- 2.27 The primary method of protecting the ground when erecting scaffolding within RPA is by installing geotextile fabric and side butting scaffolding boards on a compressible layer such as bark chippings on a geotextile membrane.
- 2.28 The scaffolding may be erected first with the uprights placed on spreader boards and the ground protection installed around the uprights.
- 2.29 The boarding will be left in place until the building works are finished.

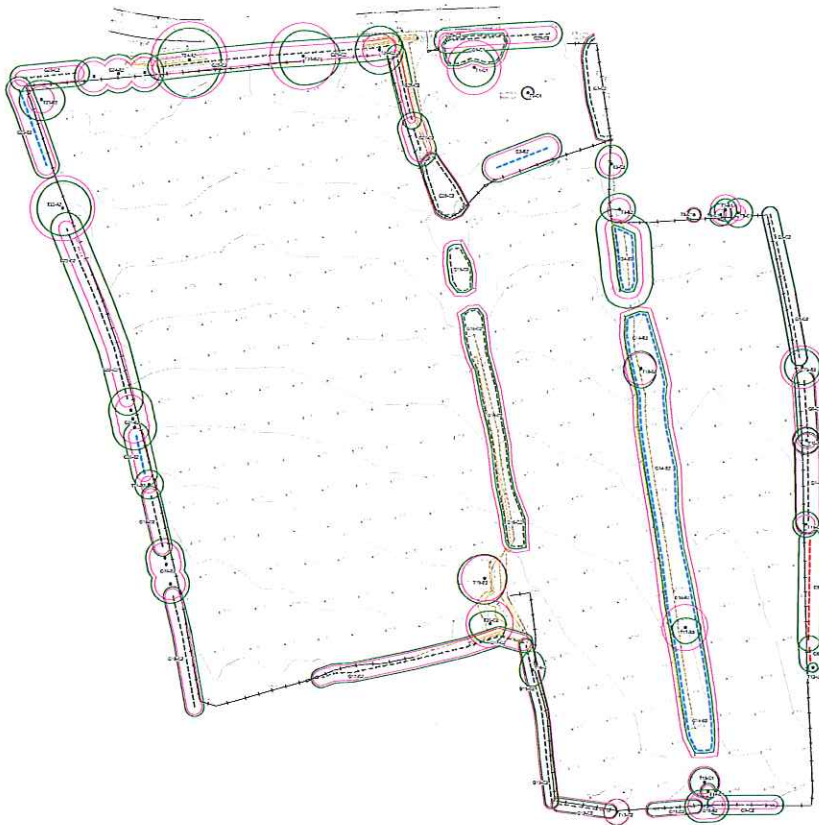
Tree Constraints Plan  
 showing tree categories  
 and risk protection  
 zones.
