Former Leisure Centre, Hinckley 2025

Heritage and Archaeology Assessment

March 2025

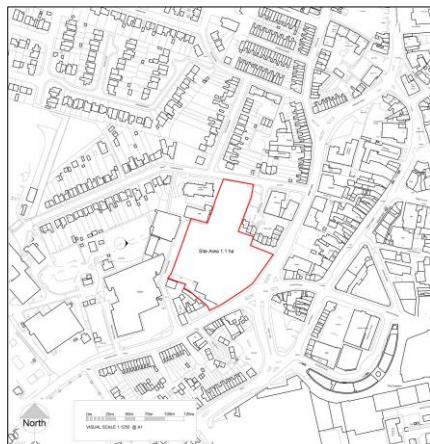
Extent of existing planning permission

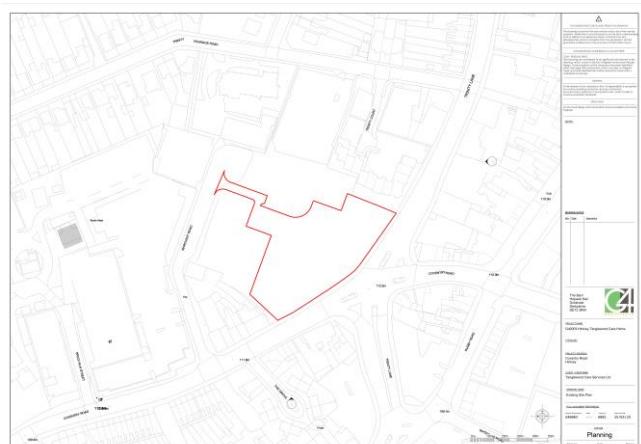
Extent of present application

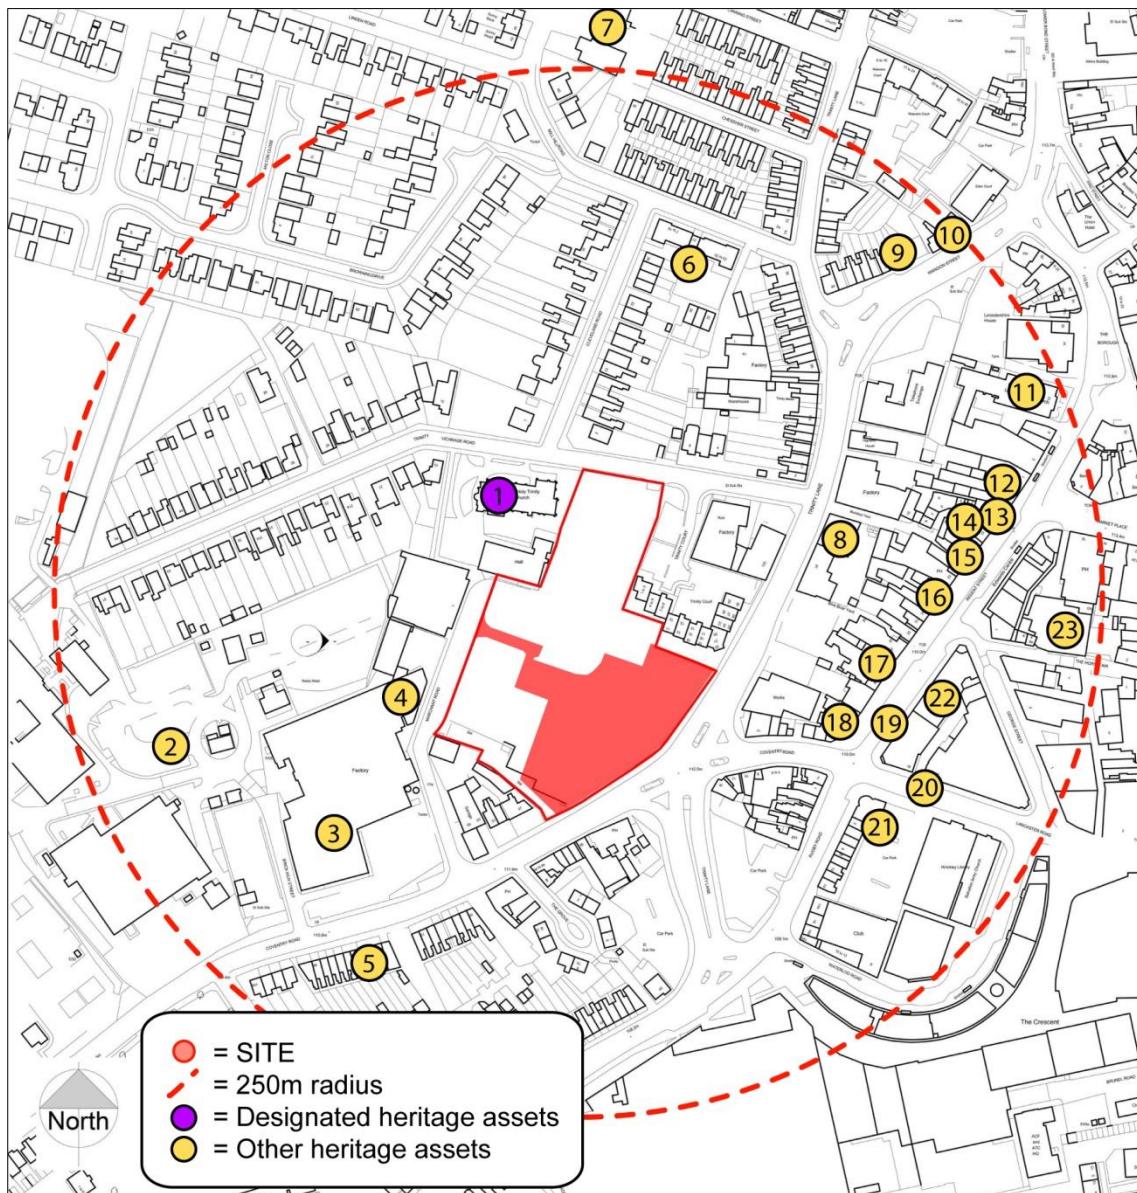
Location of gazetteer entries – Present application in red shading. Red line shows existing planning permission

1 - church (grade II listed building); 2 - gasworks; 3 - hosiery factory; 4 - windmill; 5 - Roman coins; 6 - 1916 factory; 7 - windmill (SM); 8 - archaeological investigation; 9 - archaeological investigation (SM); 10 - seventeenth century building; 11 - 1860s church; 12 - sixteenth century building; 13 - archaeological investigation; 14 - site of medieval house; 15 - sixteenth century building; 16 - eighteenth century building; 17 - medieval? building; 18 - eighteenth century building; 19 - road remains? quern?; 20 - cobbled surface; 21 - 1920s cinema; 22- 1930s hosiery factory; 23 - 1930s ballroom

4.01 This chapter lists the archaeological investigations and heritage assets (sites, findspots and buildings/structures of archaeological or historical interest) recorded in the Leicestershire and Rutland Historic Environment Record (HER) and in other sources that are likely to be informative about the history and significance of the site. These comprise the records within a c250m radius of the approximate centre of the site. Where possible the relevant HER or other identifying number is given. The location of the recorded sites are plotted on the figure below the table.

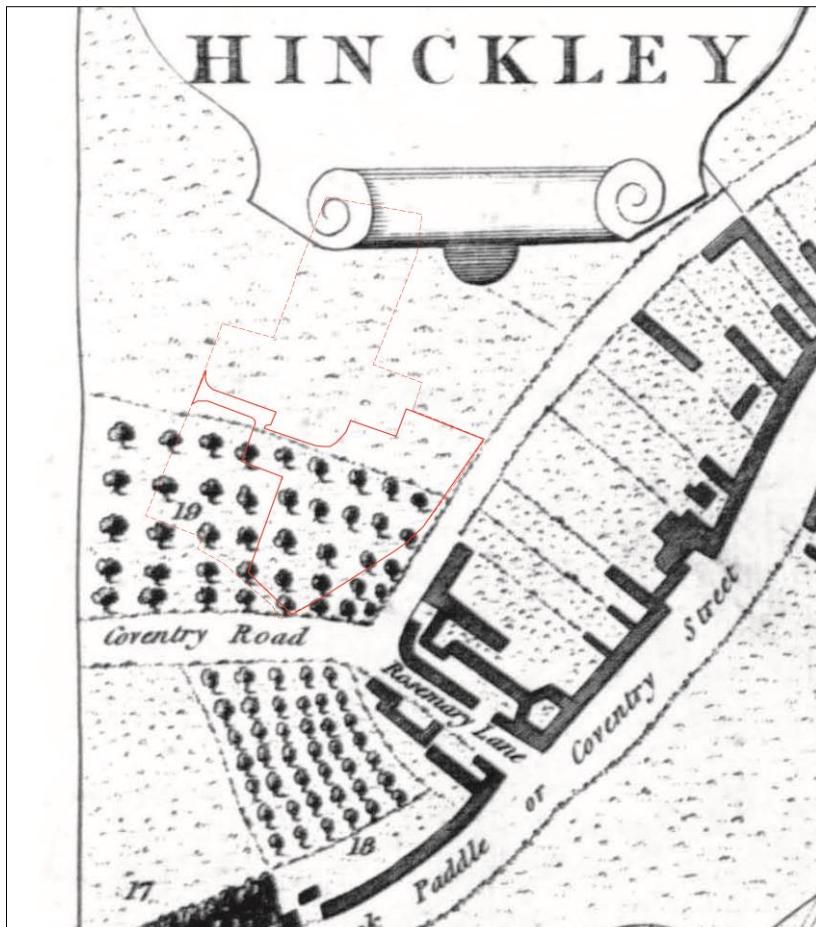
1782 town map of Hinckley (site location approximate) Present application solid red line, existing planning permission shown as dashed line

5.01 The earliest map available is the 1782 town plan of Hinckley, which shows the site to be in agricultural land with no buildings shown. The caption for the '19' marked on the map in the south part of the site reads 'Gardens planted with fruit trees'. The site remained undeveloped at the time of the 1914 Ordnance Survey 2" to 1 mile preliminary survey map.

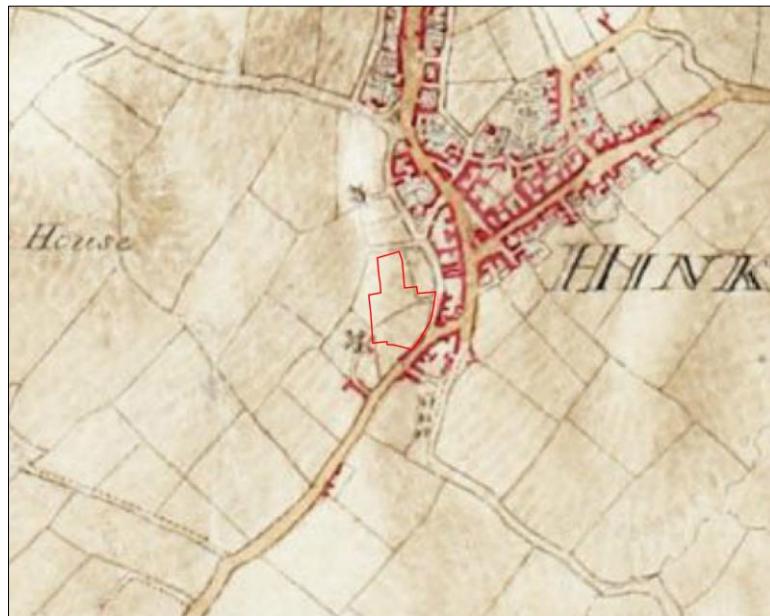
1814 Henry Stevens map for the Ordnance Survey 2" to 1 mile (site location approximate)

5.02 The first buildings on the site are shown on the 1818 tithe apportionment map, a range of buildings on the Coventry Road frontage. By comparison with the later Ordnance Survey maps, these were probably a smithy and adjacent buildings, possible stables. The Trinity Church, the neighbouring malthouse (later labelled as 'warehouse') and the Trinity Vicarage had yet to be built on the site. These buildings are all shown on the 1889 Ordnance Survey map with the bulk of the site still shown as agricultural or garden land.

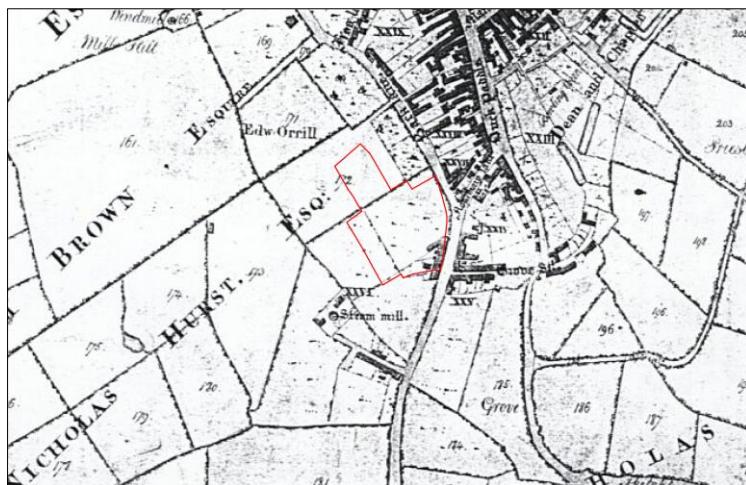
1818 Tithe apportionment map (site location approximate) Present application solid red line, existing planning permission shown as dashed line

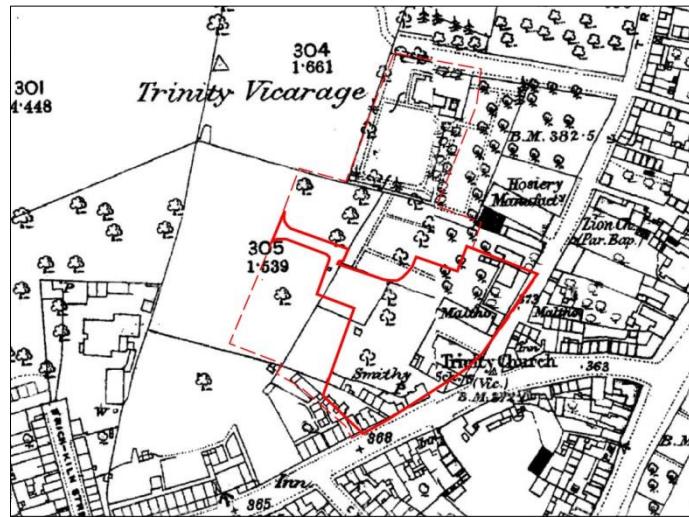
1889 Ordnance Survey (1:2500) Present application solid red line, existing planning permission shown as dashed line

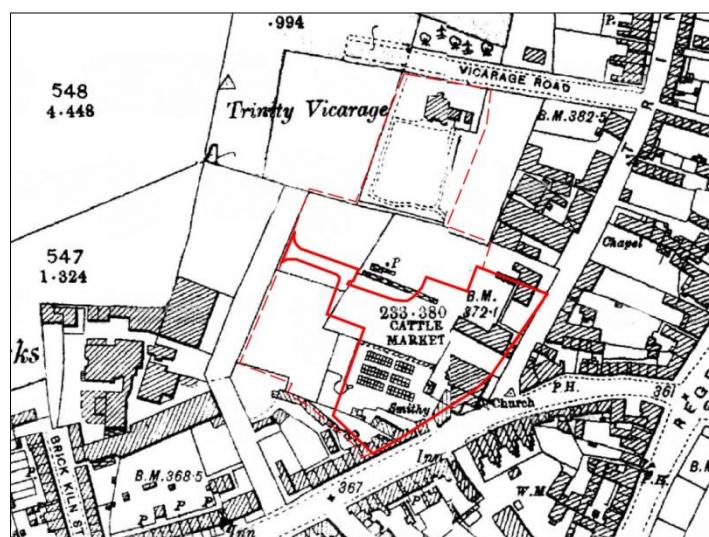
1903 Ordnance Survey map (1:2500) Present application solid red line, existing planning permission shown as dashed line

5.03 In the period between the 1889 map and the 1903 map a cattle market was established in the southern part of the site, initially with a walled area enclosing a series of pens on the 1903 map, with the addition of a number of covered buildings by the time of the 1924 map. In 1903 Trinity Church (within the site) was still labelled 'church' but by the time of the 1924 map - the present-day Church of the Holy Trinity having been built in 1909-10 - the former Trinity Church had become a hall.

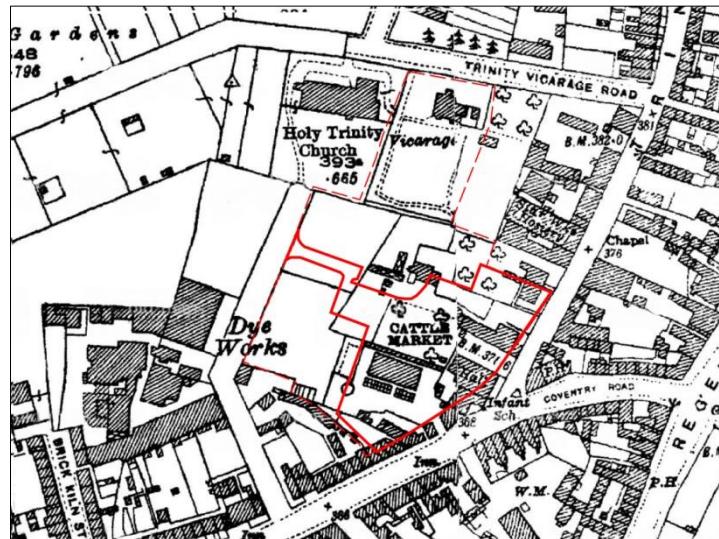
1924 Ordnance Survey map (1:2500) Present application solid red line, existing planning permission shown as dashed line

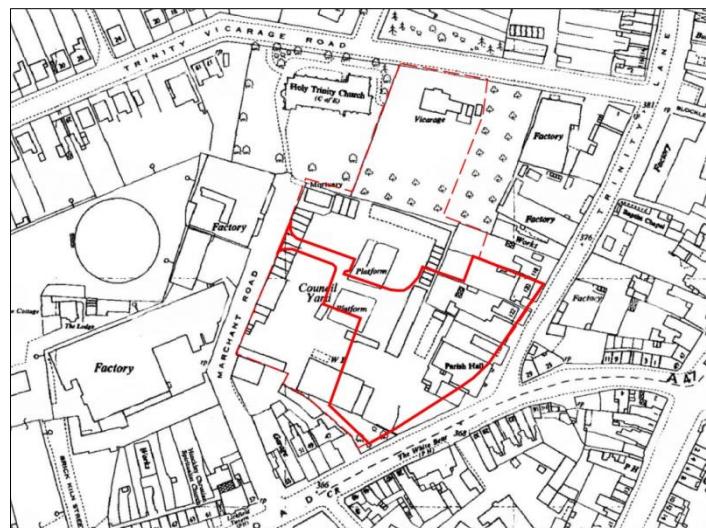
1961 Ordnance Survey map (1:2500) Present application solid red line, existing planning permission shown as dashed line

5.04 The site changed in the middle part of the twentieth century, with the cattle market being replaced by the council depot. The smithy and possible stable had also been removed by this time. The gasworks to the west of the site had been constructed and the hosiery factory to the southwest had reached its full extent.

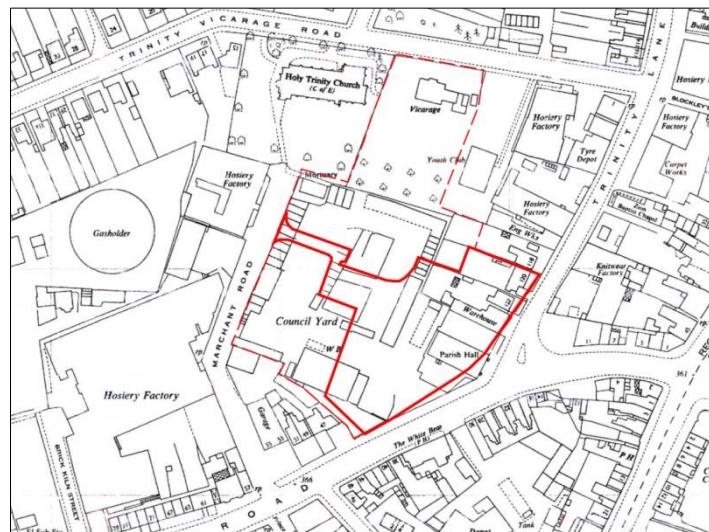
1966 Ordnance Survey map (1:1250) Present application solid red line, existing planning permission shown as dashed line

5.05 Between the 1966 map and the present-day, the site changed out of all recognition. The former leisure centre was built in the mid-1970s, necessitating the demolition of the former Trinity Church (Trinity Hall), the warehouse to its north (formerly a malthouse) and all traces of the previous cattle market and council depot. Presumably it was around this time that the former Trinity Vicarage in the north part of the site was demolished and the extant church hall to the south of the present-day Church of the Holy Trinity was built.

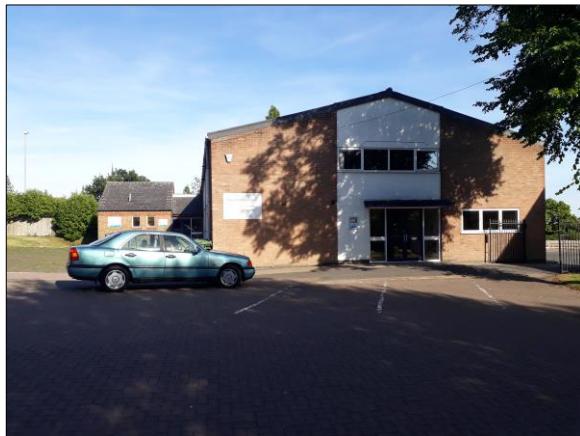
Plate 1: The 1960s/70s church hall to the south of the Church of the Holy Trinity, looking east

7.12 To the south of the church a substantial church hall was constructed after 1966 (**Plate 1**). The effect of this large building is to screen the church from the proposed development site to the south/southeast. To the east of the east end of the church is a fence and a substantial hedge screen which serves to screen the church from the northern part of the site. The effect of these blocking elements is that a visitor to the church cannot see the site of the proposed development, the only exception being through a narrow gap between the church hall and the neighbouring building to the southwest (**Plate 2**).

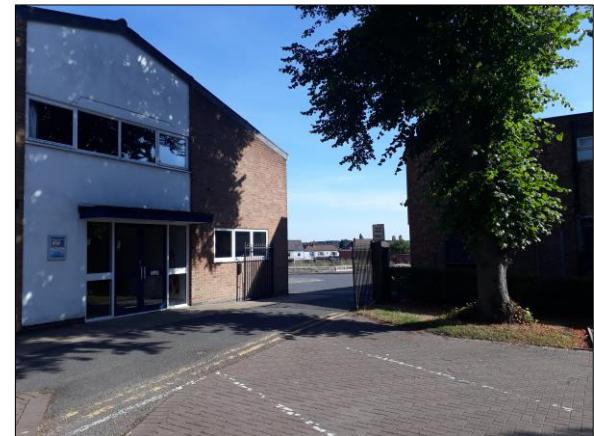
Plate 2: Looking southeast past the 1960s/70s church hall towards the site

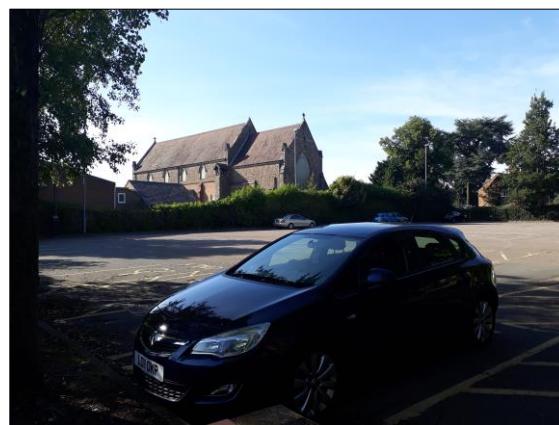
Plate 3. Looking northwest towards the church from the car park in the north part of the site

7.13 Views of the church's upper parts are possible from various parts of the proposed development site but these are limited. The most valuable views are primarily from the car park in the northern part of the site towards the eastern end (**Plate 3**). Views from the southern part of the site and the roadside of Coventry Road are of less value, and in both cases the 1960s/70s church hall blocks clear views (**Plates 4-5**).

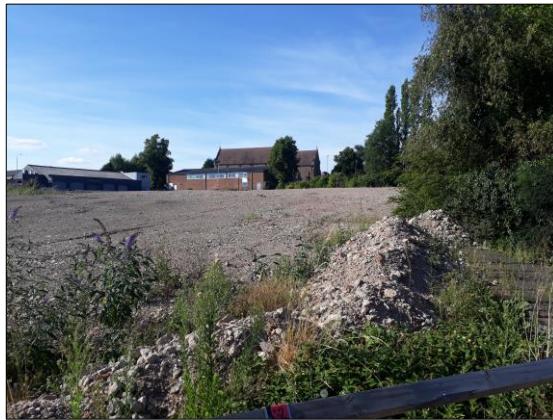
Plate 4: Looking towards the church and church hall from the southern part of the site

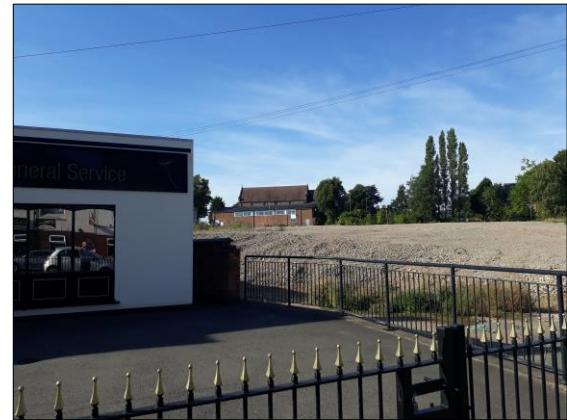
Plate 5: Looking towards the church and church hall from Coventry Road across the site

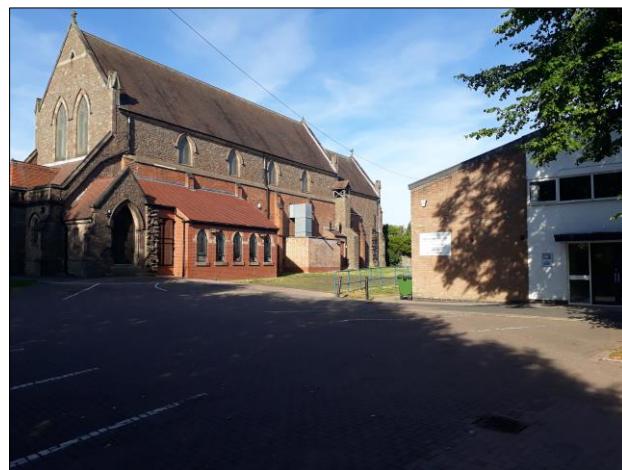
Plate 6: The unfinished southern elevation of the church with unsympathetic brick additions

7.15 In modern times (after 1966) the elevation has seen two phases of unsympathetic brick extension, totally out of keeping with the rubble stone exterior and in contrast with the sympathetic western extension built in the 1930s (**Plate 6**).
