**Arboricultural  
Impact Assessment  
and  
Method Statement  
for  
11 Sapcote Road  
Burbage**

30<sup>th</sup> January 2026

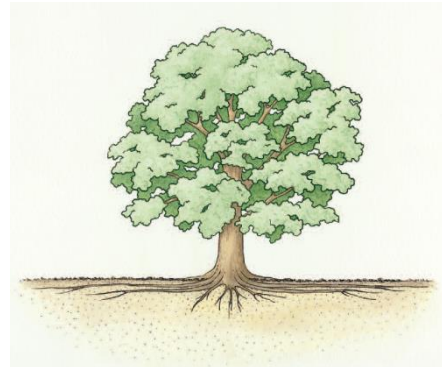
**Trees have relatively shallow but wide spreading roots<sup>6</sup>.**

Roots grow predominantly near the soil surface – 90% or more of all roots, and virtually all of the large structural supporting roots, are within 60cm of the surface of the ground. Although they may be deeper within the dense mass of roots and soil close to the base of the tree it is uncommon for roots to penetrate to a depth greater than 2 metres<sup>7</sup>.

Within a short distance of the stem the roots are highly branched so as to form a network of small-diameter woody roots that typically extend radially for a distance much greater than the height of the tree, except where impeded by unfavourable conditions. All parts of this system bear a mass of fine, non-woody absorptive roots.

The root system does not generally show the symmetry seen in the branch system. Roots proliferate wherever they encounter favourable soil conditions which is why the greatest root concentration is found close to the soil surface where the soil is loosest, and water, oxygen and nutrients are most readily available. As far as these conditions allow, the root system tends to develop sufficient volume and area to provide physical stability.

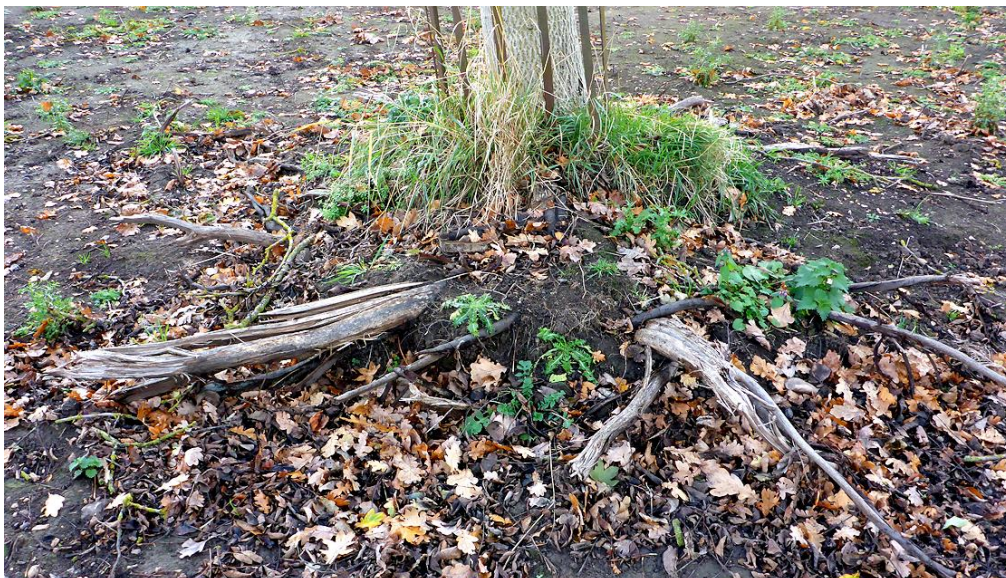
**Walnut roots smashed by an excavator.**

During construction damage is often sustained when digging foundations or trenches for services. Surface roots are at risk when laying driveways, hardstanding and landscaping. Damaged roots are an entry point for infection and if a root is cut completely the tree loses a proportion of its capacity to take up water and minerals, store energy for the winter and weakens its anchorage in the ground.

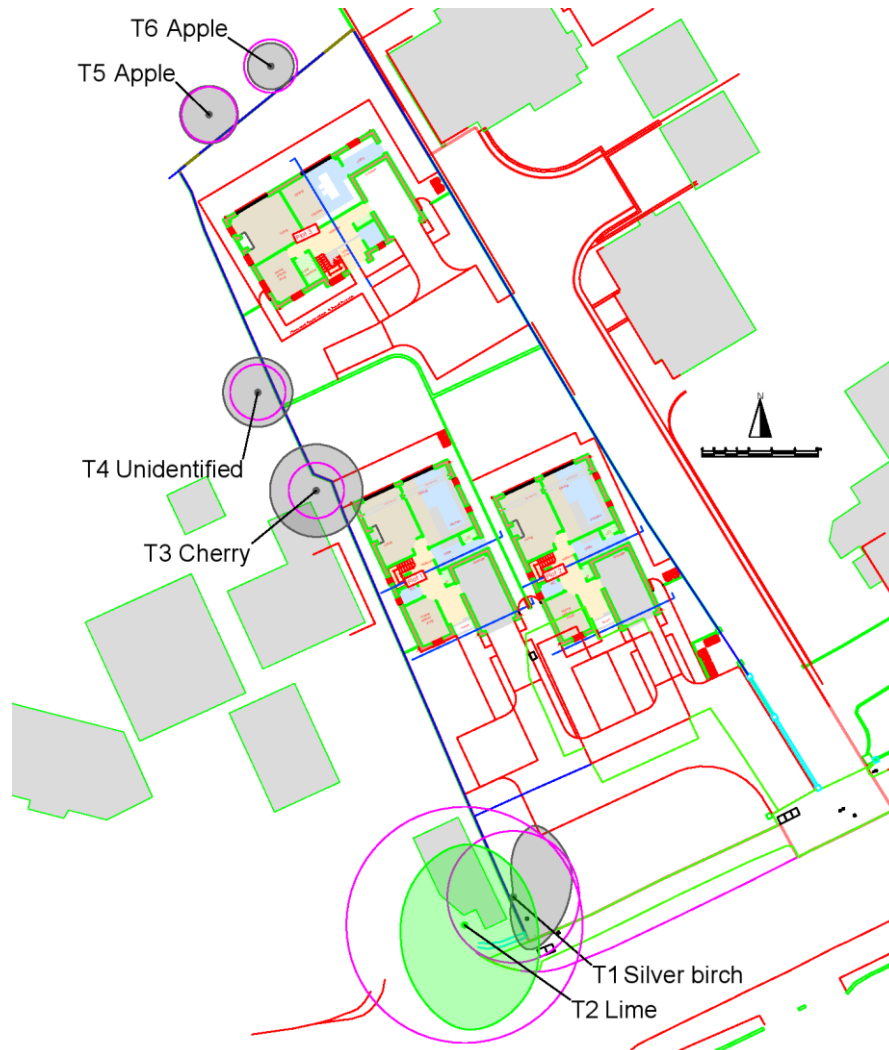
All the existing trees will be retained as shown in the plan below.

**Root protection areas shown in magenta.**

The footprint of the development is outside of the root protection area of the retained trees so there is no requirement for specially engineered foundations.

Hard surfacing (driveways, parking, paths) within the root protection area will be installed using a no-dig, load-spreading geocell.

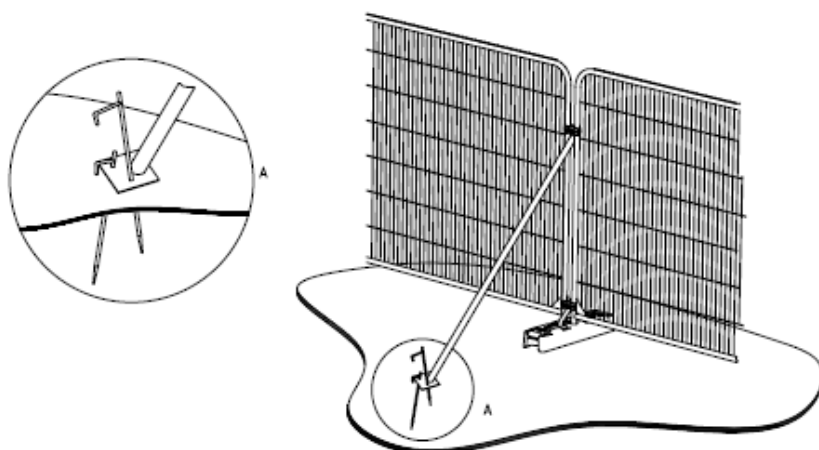
a) Stabilizer strut with base plate secured with ground pins

Before any development commences, protective barriers will be installed to protect the trunks and lower limbs of the trees and to exclude construction from the root protection area. The position for the barrier is shown in an A1 size 1:200 scaled tree protection plan “11 Sapcote Road, Burbage AIA-A1 TPP.pdf”, a section of which is shown overleaf. The radius of the RPA for each tree is shown in the Survey Schedule and on the tree protection plan. Where trees overhang it may be necessary to increase the extent of the tree protection barriers to contain the canopy where it could be damaged by machinery or vehicles. Due to surveying limitations, discrepancies may exist in the relative position of features on the plan, therefore all measurements for RPAs should be taken directly from the trees themselves.

Examples of suitable protective barriers are shown below.

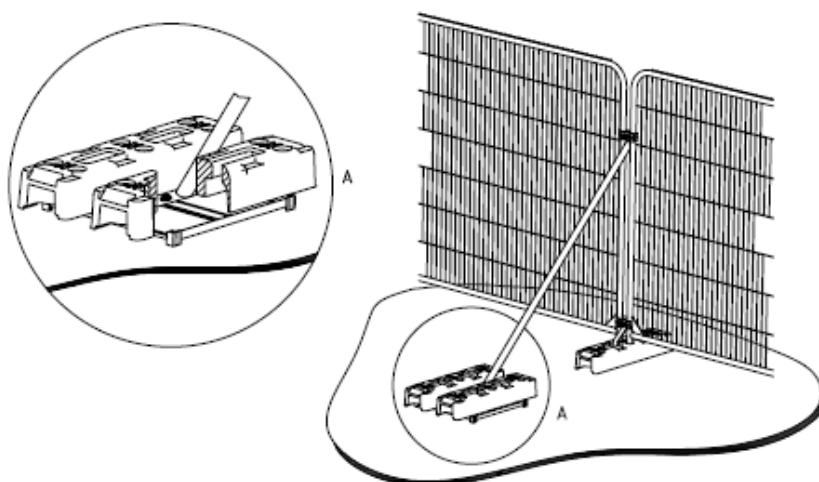
b) Stabilizer strut mounted on block tray

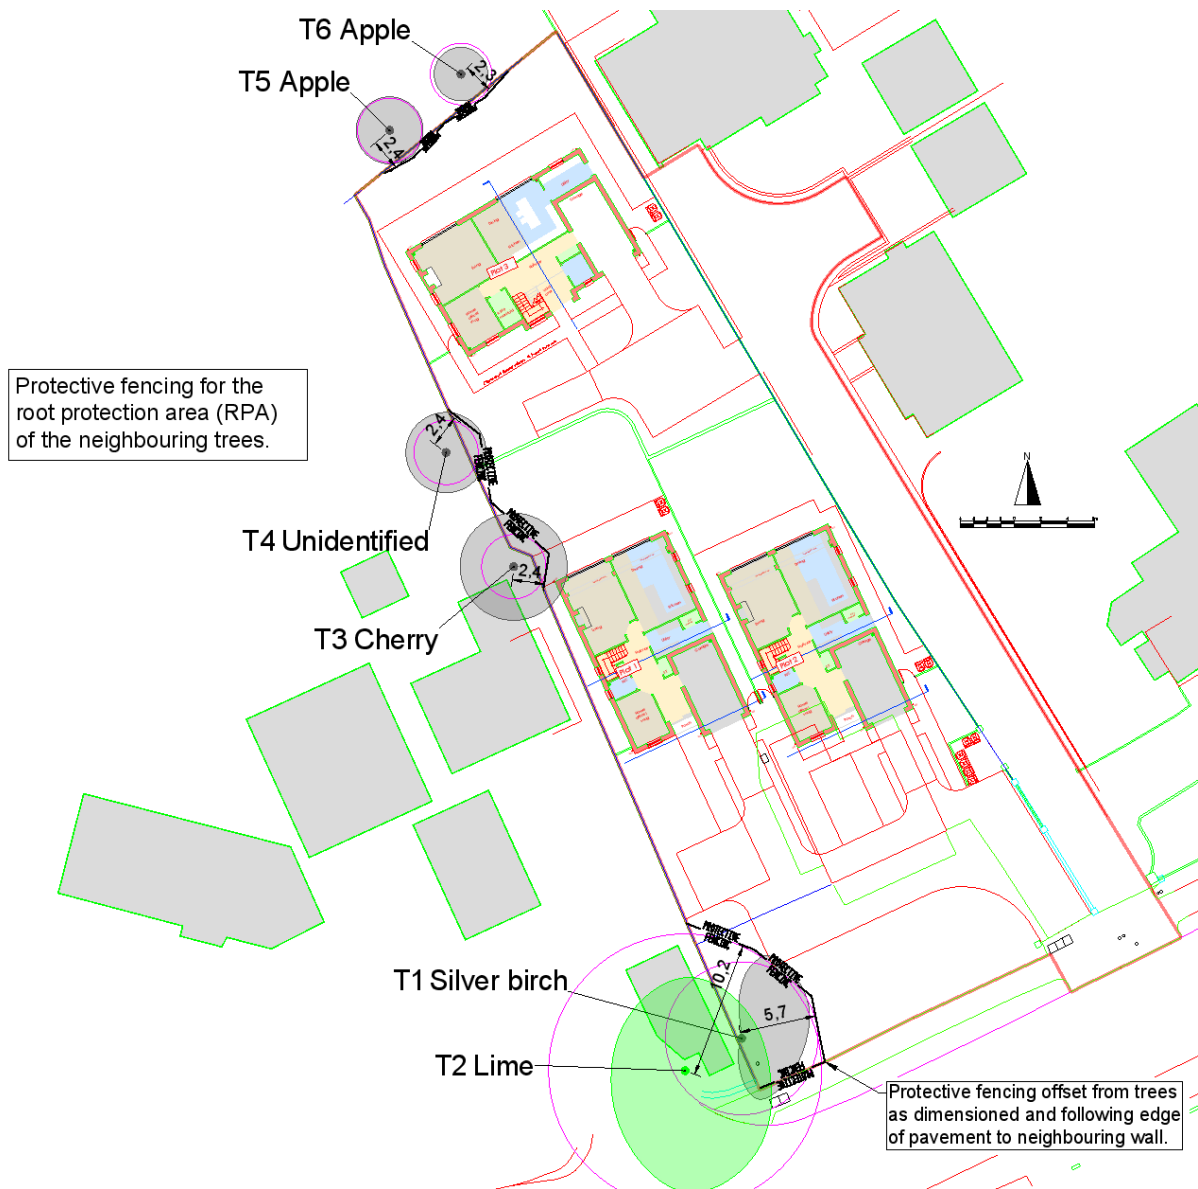
Extract from the tree protection plan showing siting of protective fencing.

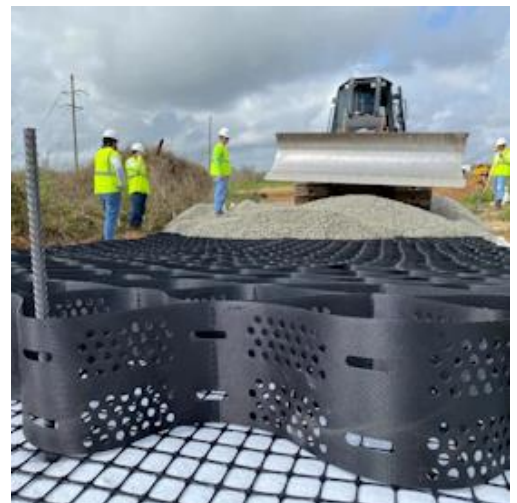
- ① Porous/permeable wearing course
- ② Separation geotextile (100-300g/m<sup>2</sup>)
- ③ HDPE geocell filled with aggregate
- ④ Base geotextile (300g/m<sup>2</sup> min.)
- ⑤ Existing subgrade

A cellular confinement system is a series of geocells arranged in a honeycomb-like formation that is combined with an underlying geotextile and angular stone to spread loads in such a way as to minimise compaction of underlying soil. Wearing surface options include porous asphalt, permeable block paving and loose or resin-bound gravel.

When cellular confinement systems or ‘geocells’ are used to protect tree root zones the central concept is that they are installed above ground and this normally results in a surface that is around 150mm above the existing ground level for footpaths, and in excess of 300mm above for roads and driveways. Careful consideration may need to be given to matching the raised level with existing surfaces and a sectional drawing can be useful.

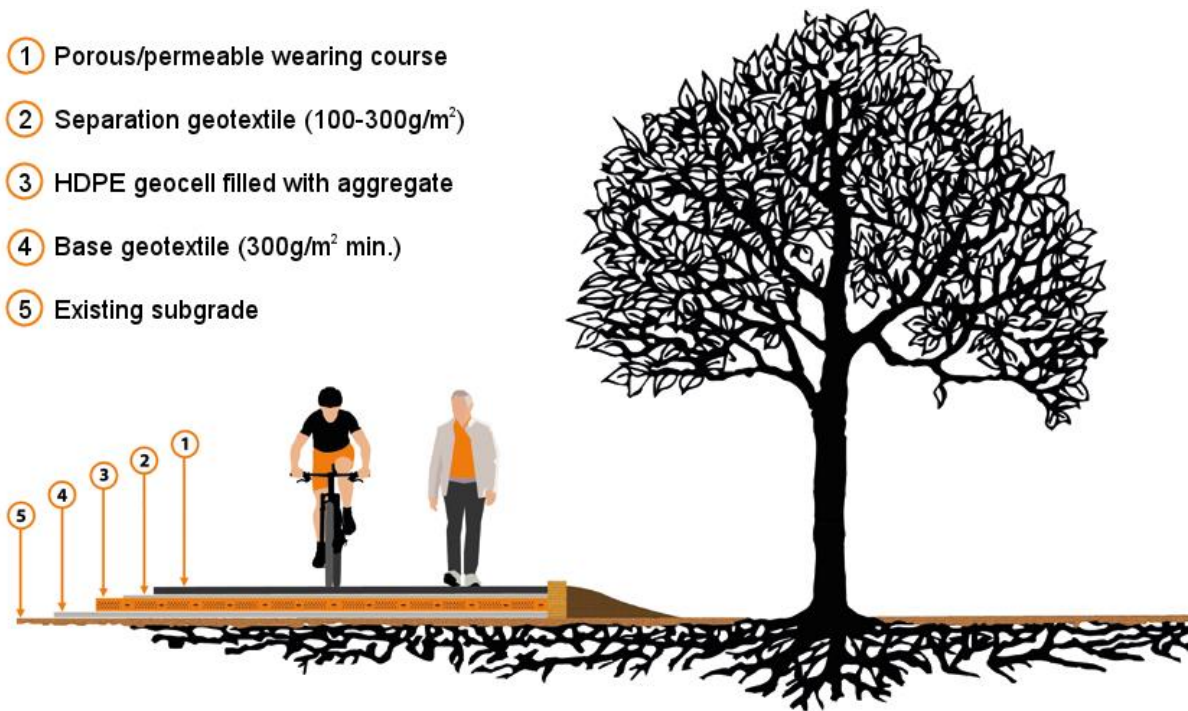
## **The basic approach to using cellular confinement systems for ground protection near trees<sup>5</sup>.**

A suitably qualified technician should specify the appropriate depth of geocell to use and this will depend on the bearing capacity and the strength of the soil.

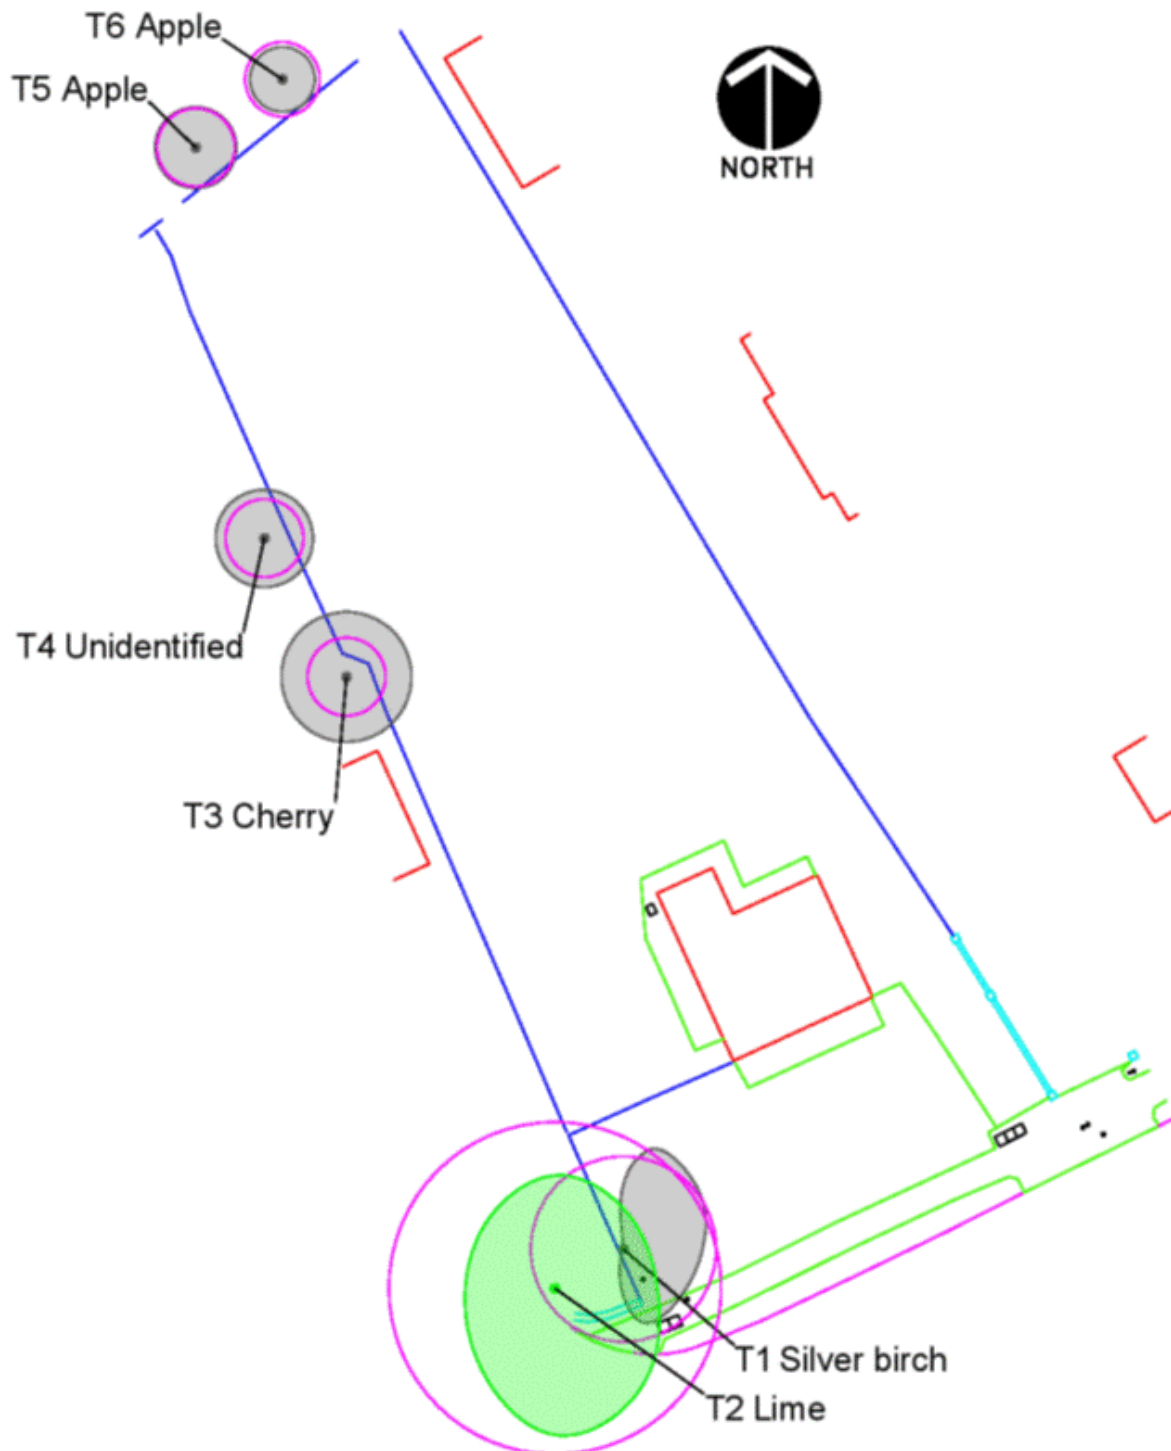
## Tree Survey Plan

Shaded outline shows tree canopy graded in accordance with BS5837; RPA shown in magenta. The position of the trees is not intended to infer ownership which should be clarified before any tree work is carried out.

This tree plan is also supplied as an AutoCAD dwg file, XREFerenced to the topographical model. The tree geometry including the canopy and RPA are stored as layers that can be easily imported and overlaid onto a design layout to produce a tree constraints plan. Note: the CAD drawing units are metres.
