# Markfield Commercial Development Cliffe Hill Farm, Markfield Leicestershire

## *Archaeological Evaluation*

CA Project: MK1399  
CA Report: MK1399\_2  
Accession number: X.A12.2026

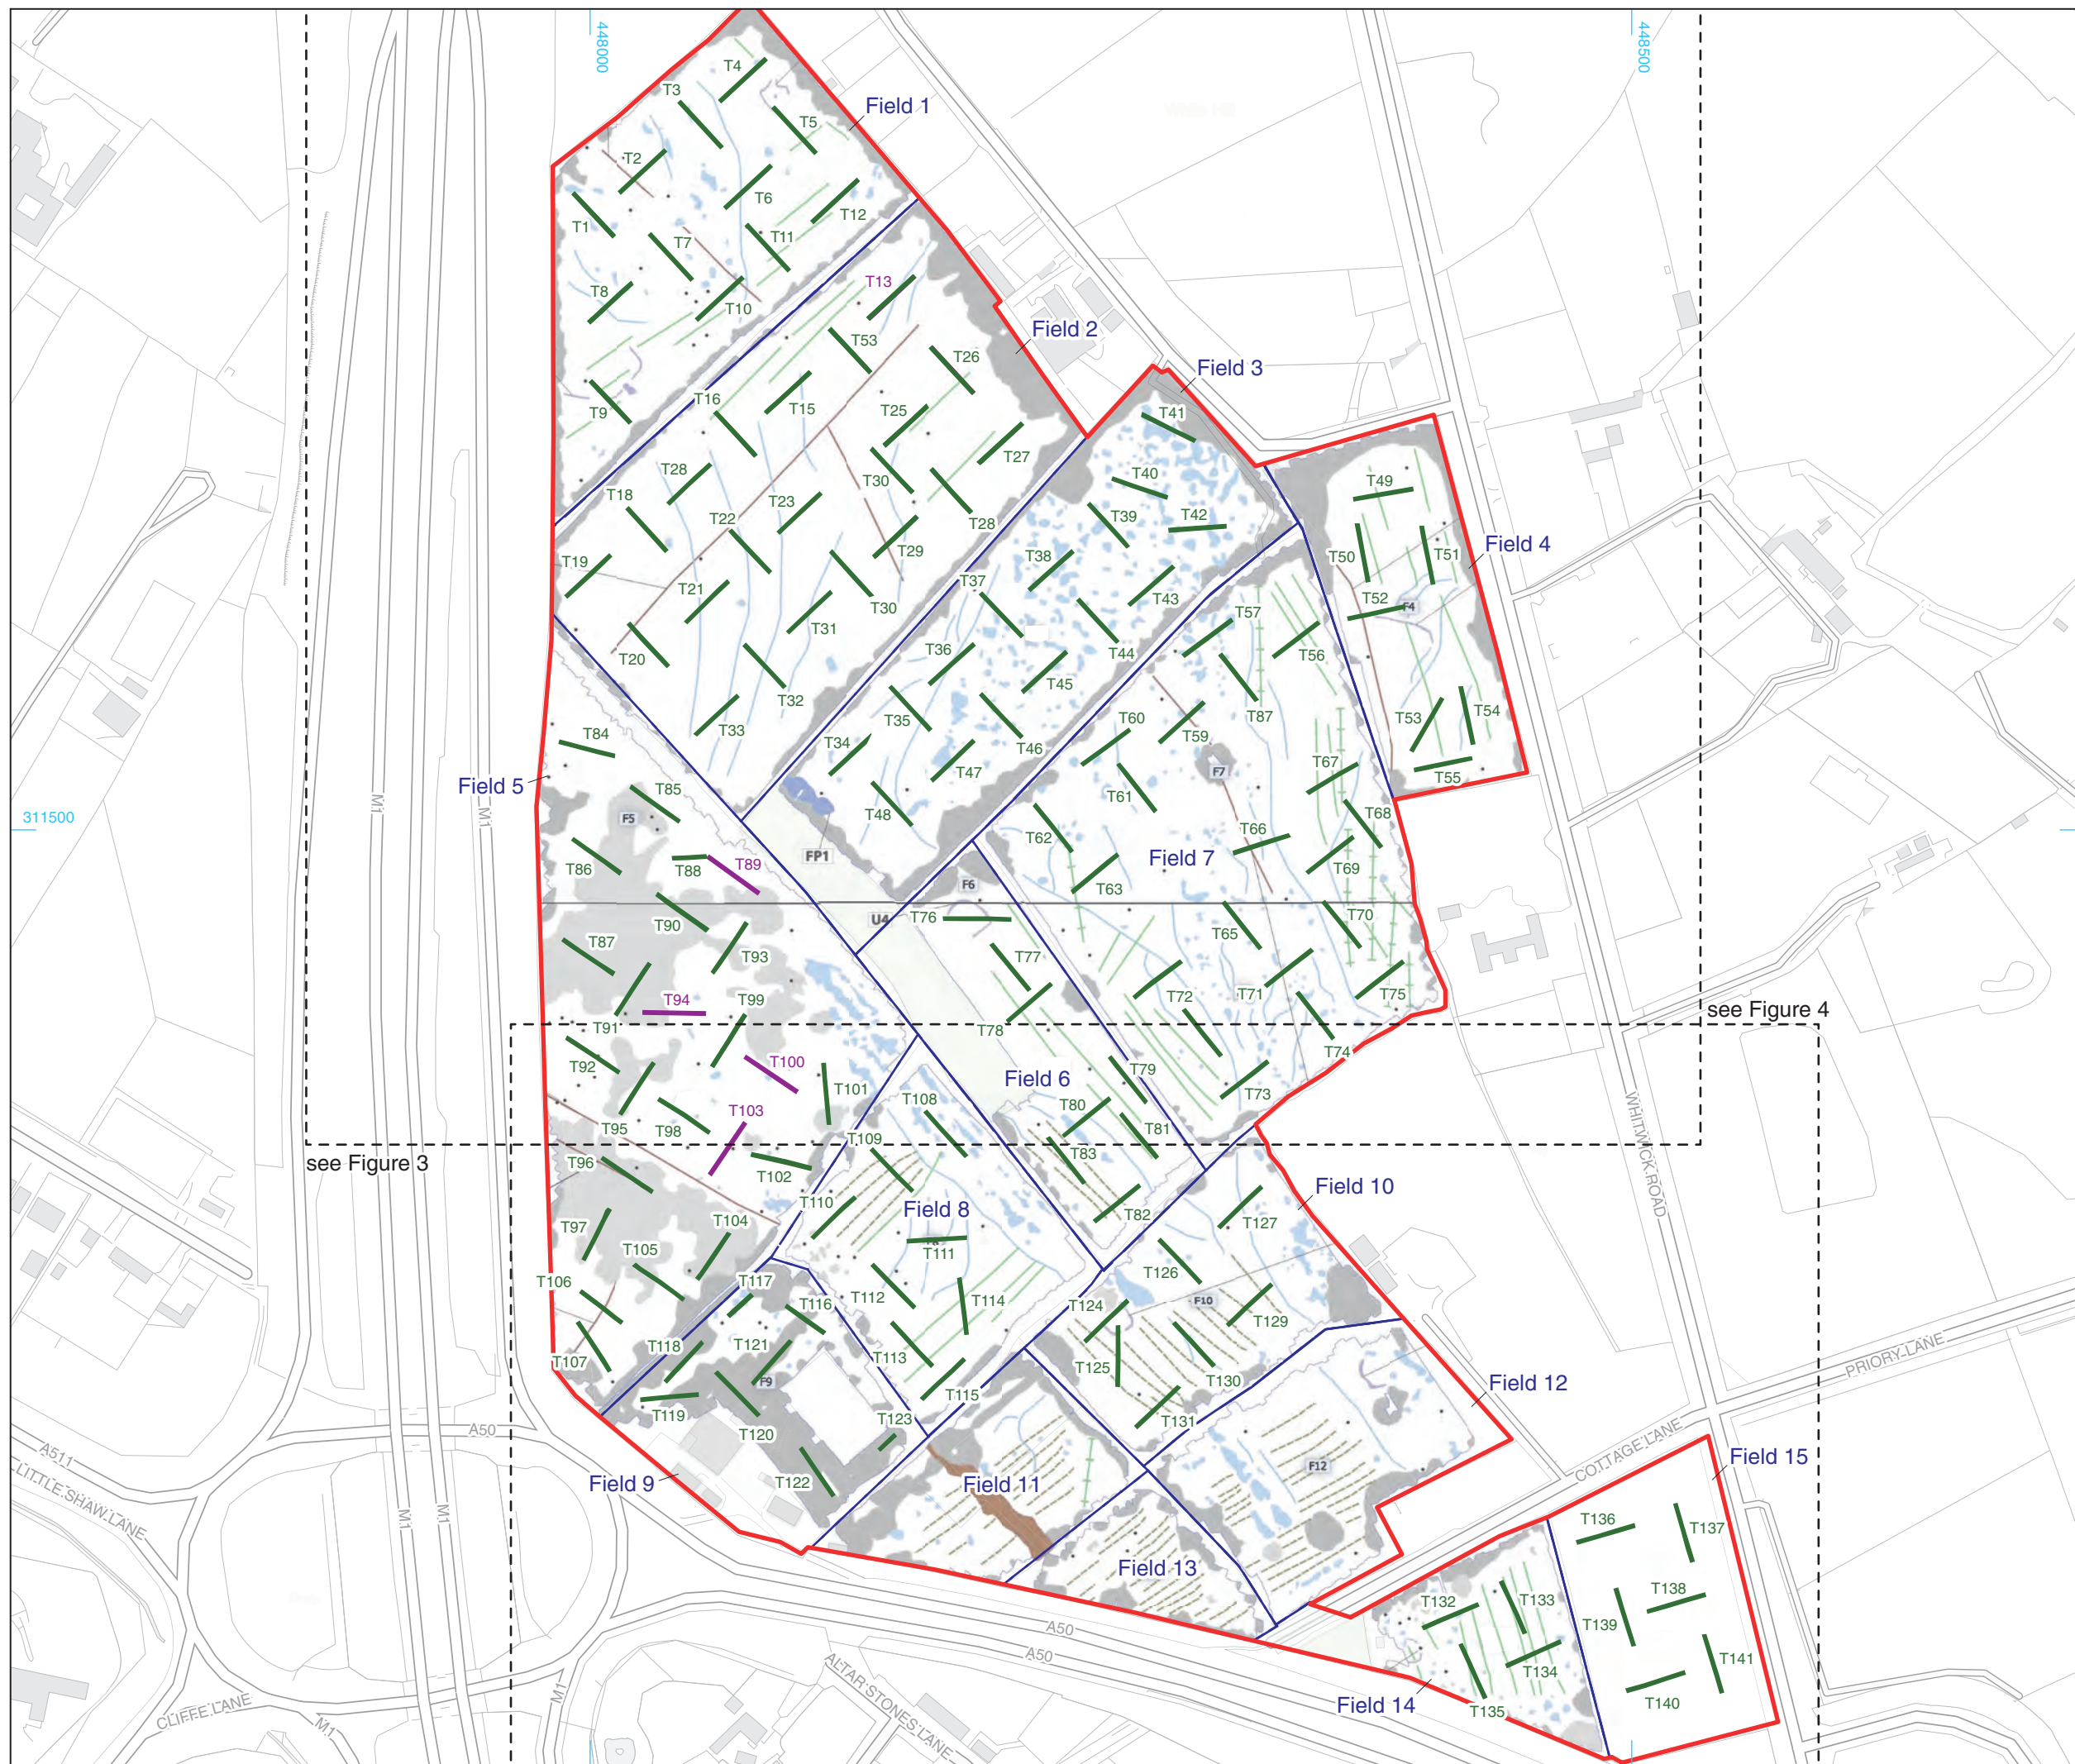
| DRAWN BY<br>CHECKED BY<br>PM | AW<br>HK<br>AS | PROJECT NO.<br>DATE<br>SCALE@A3 | MK1399<br>05/08/2026<br>1:3000 | FIGURE NO.<br><b>2</b> |

**FIGURE TITLE**  
Trench location plan showing  
geophysical survey results

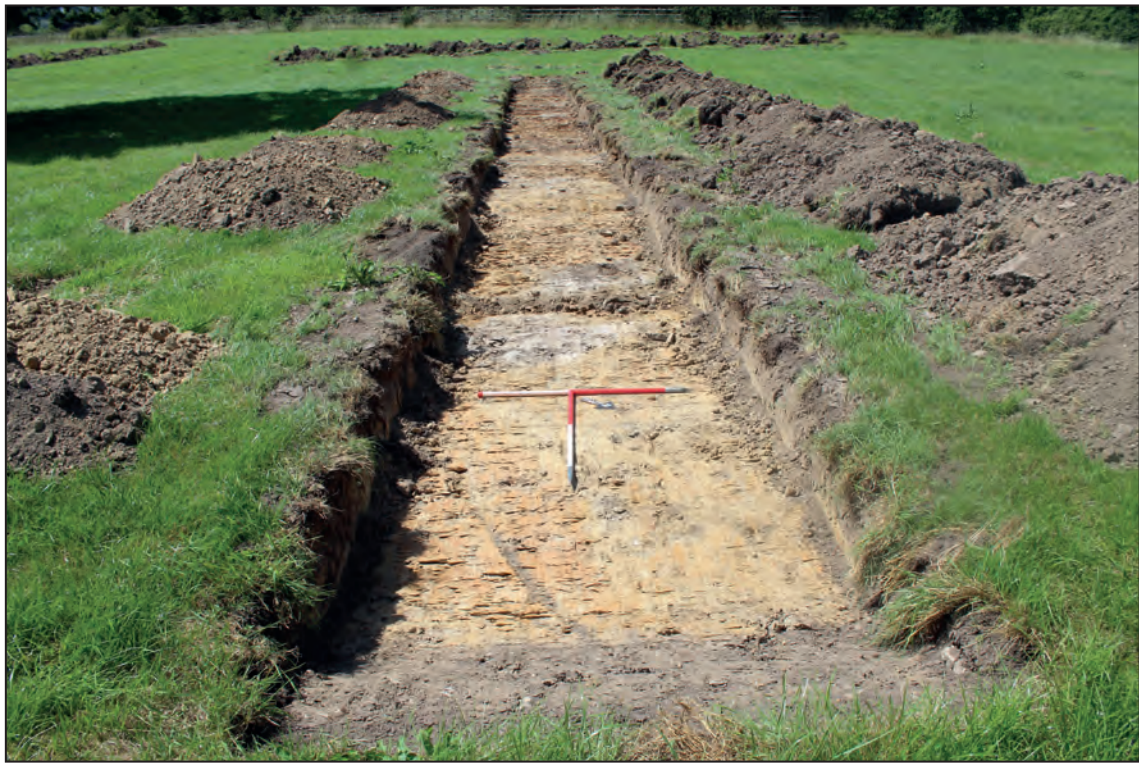
Trench 2, looking south-west (1m scales)

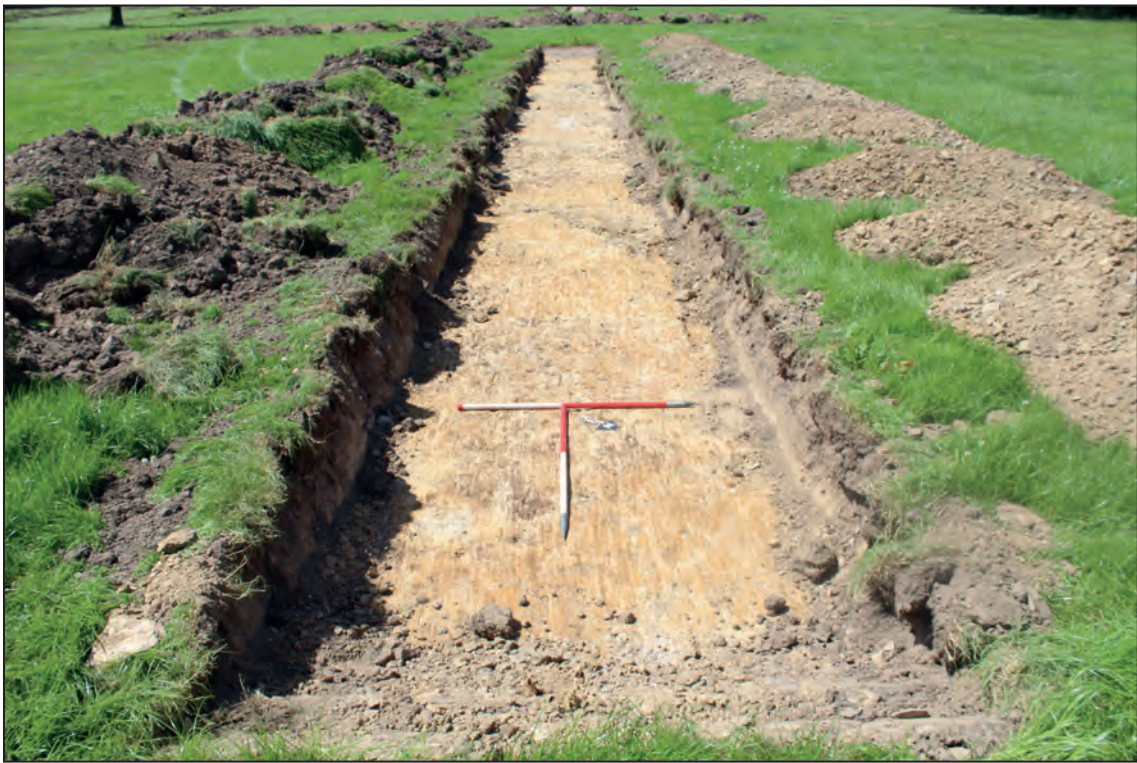
Trench 13, looking south-west (1m scales)

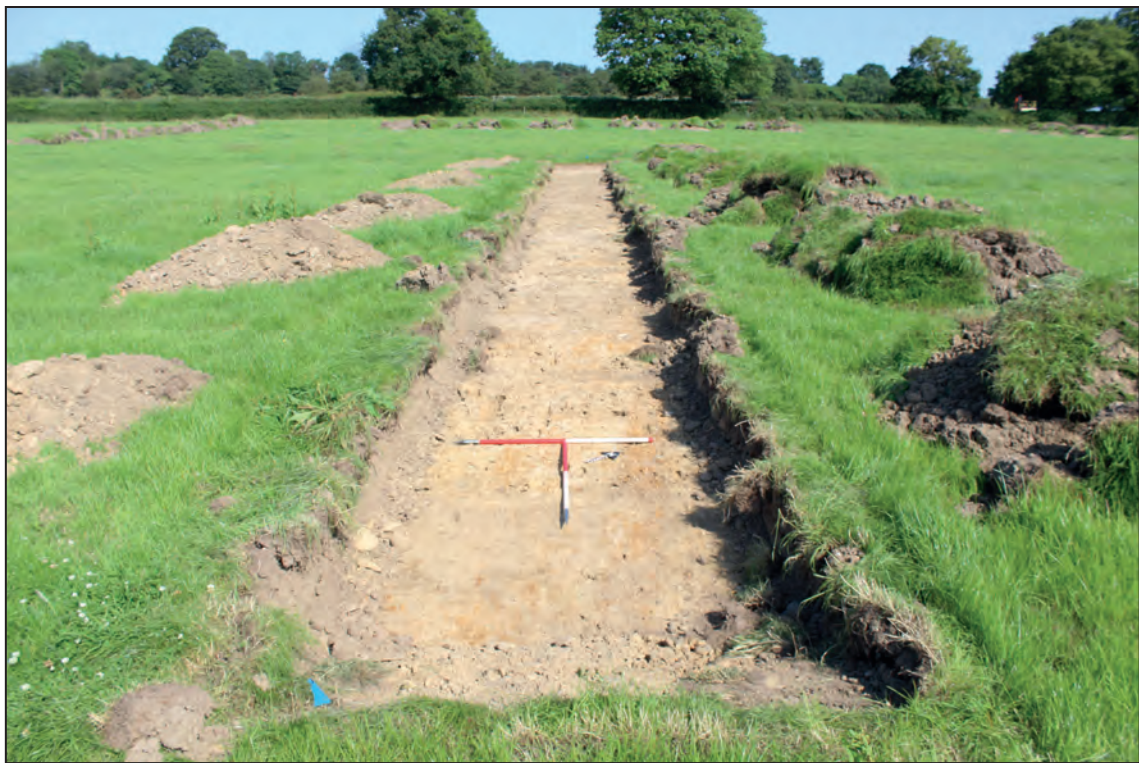
Trench 22, looking north-west (1m scales)

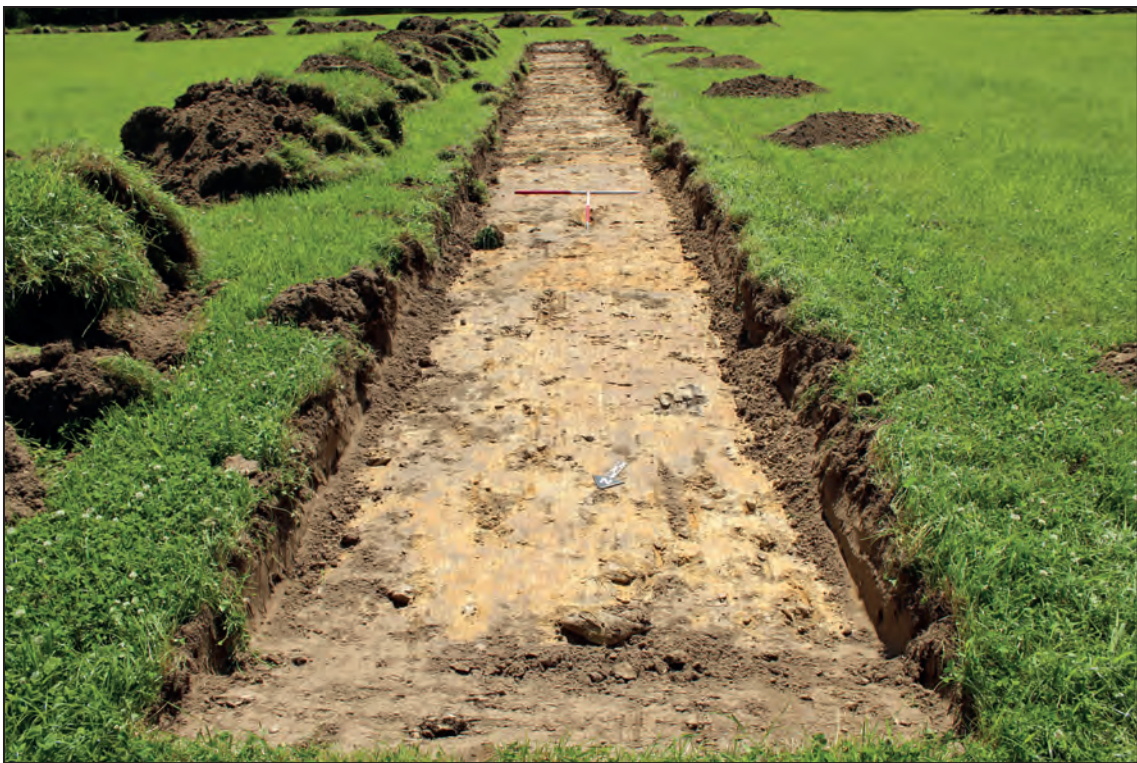
Trench 65, looking south-east (1m scales)

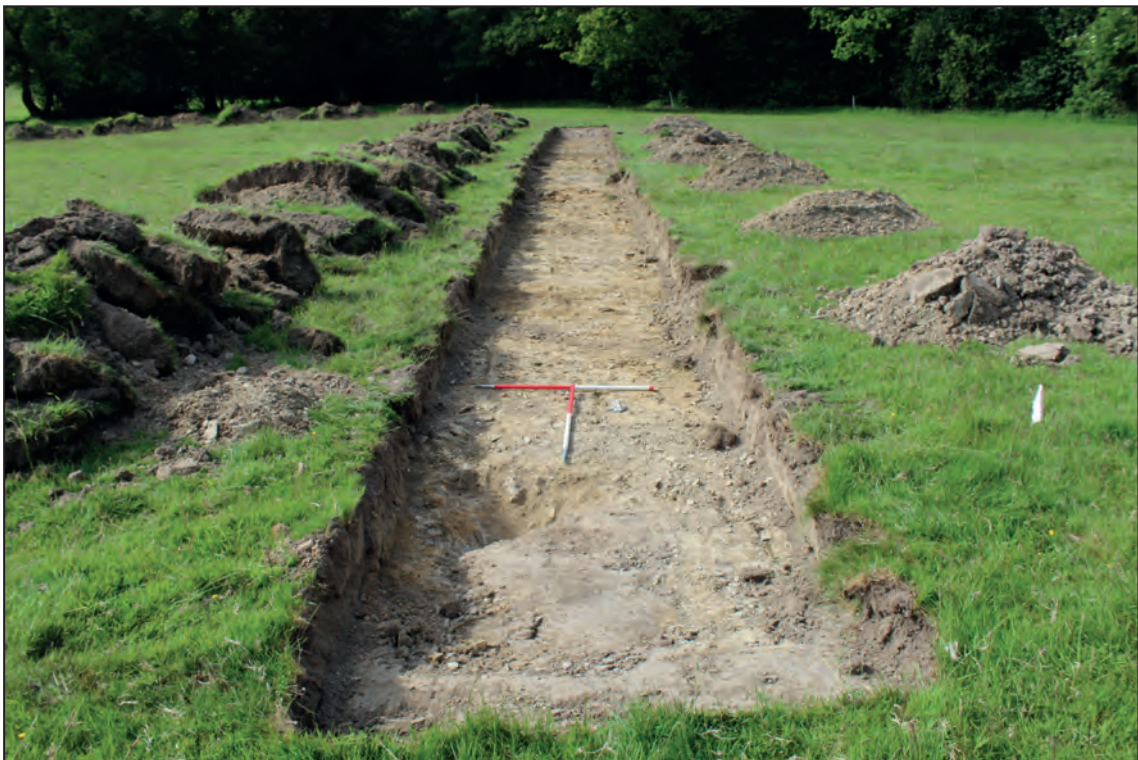
- 5.3. Most trenches (1–28, 30–52, 54–70, 72, 74–123, 126–134 and 136–141) were devoid of any archaeological features or deposits and will not be discussed further. Features were tested in trenches 124 and 125 but deemed to be of natural origin and recorded as probable tree bowls/ rooting. A layer initially recorded in Trench 85 was subsequently identified as the first exposure of the extensive made ground deposits noted above.

Trench 125, looking south (1m scales)

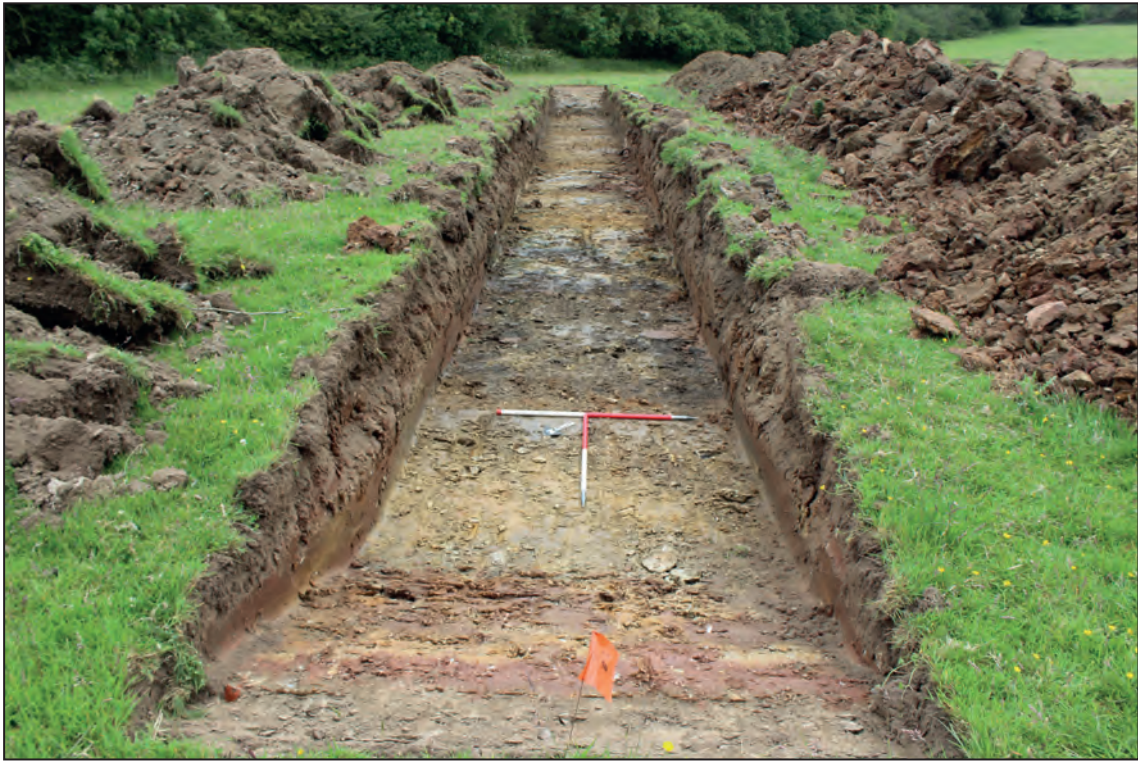
- 6.3. A notable aspect of the evaluation was the presence of extensive made-ground deposits in a number of trenches in the southwest part of the site, in trenches 84-88, 90, 93, 98, 99, 101, 102, 104, 105 and 107. These deposits, often exceeding 1m in thickness, consisted of mixed clays, granite boulders, limestone rubble and redeposited soils. In some trenches, such as Trenches 87, 90, 93 and 98, the made ground was sufficiently deep (2m+) that the natural substrate was not encountered. Buried soil horizons beneath the made ground were only encountered in Trench 101, the topsoil having been removed in all other trench locations in this part of the site prior to the importation of the material used to raise the ground levels. No archaeological features were found associated with any made-ground deposits, their composition and distribution suggesting large-scale recent activity most likely associated with the construction of the adjacent M1 motorway and Junction 22 roundabout rather than any historic land use.

Trench 84, looking south-east (1m scale)

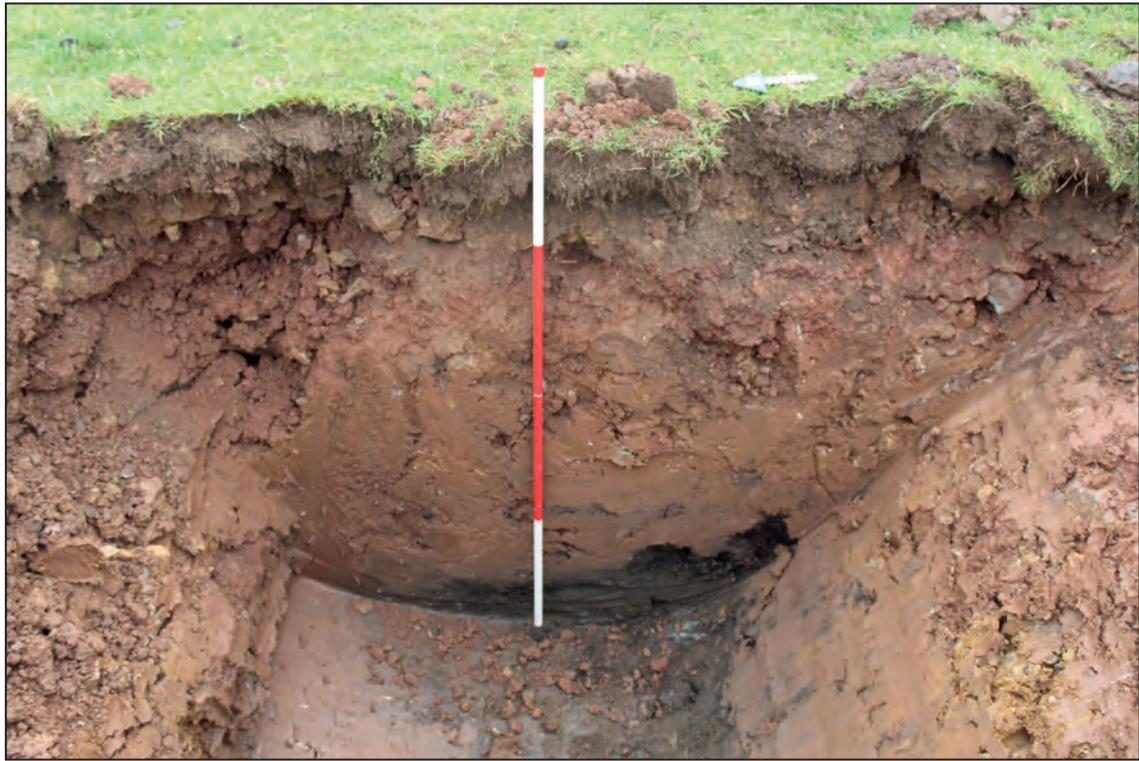
Trench 90, looking east ( 2m scale)

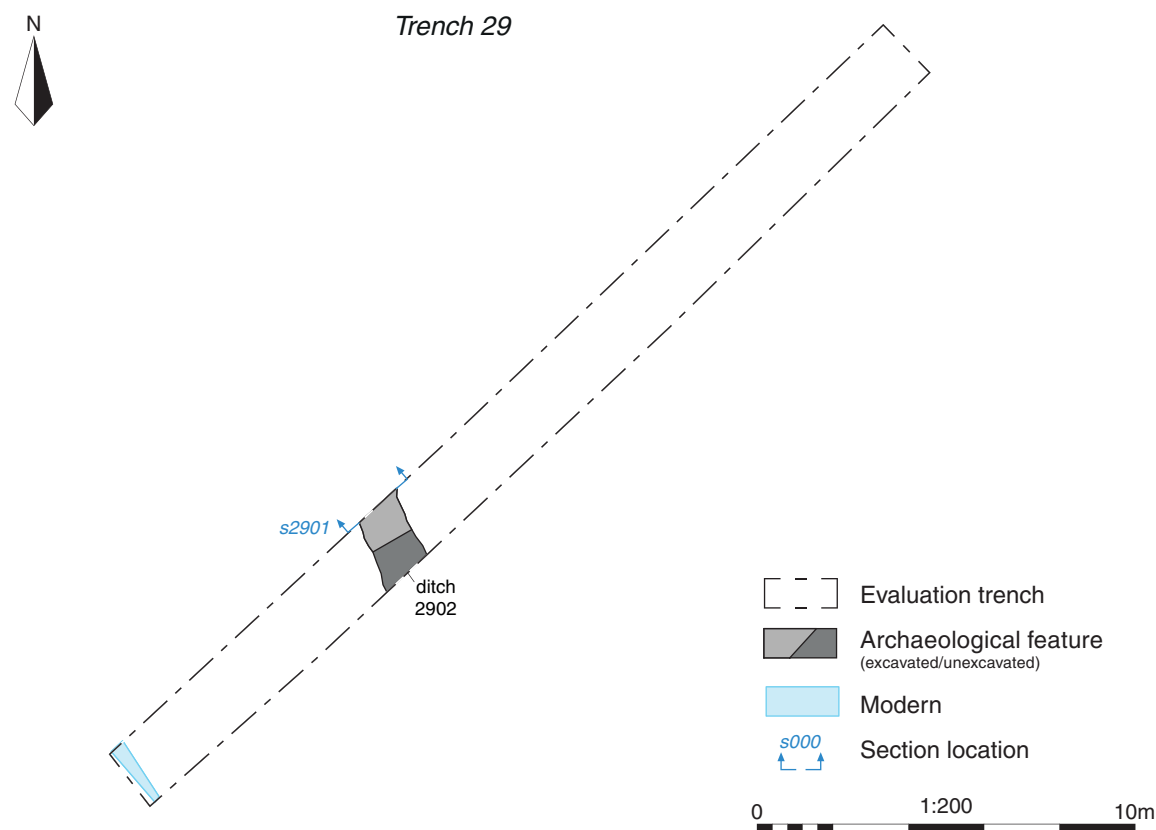
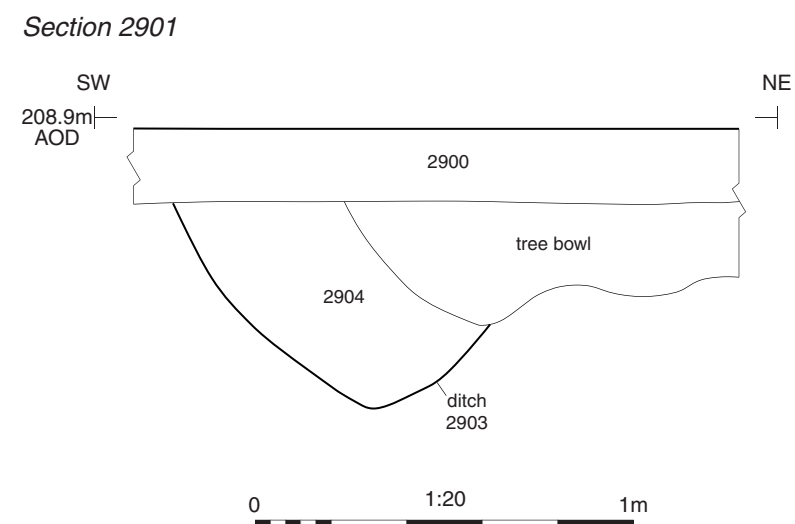
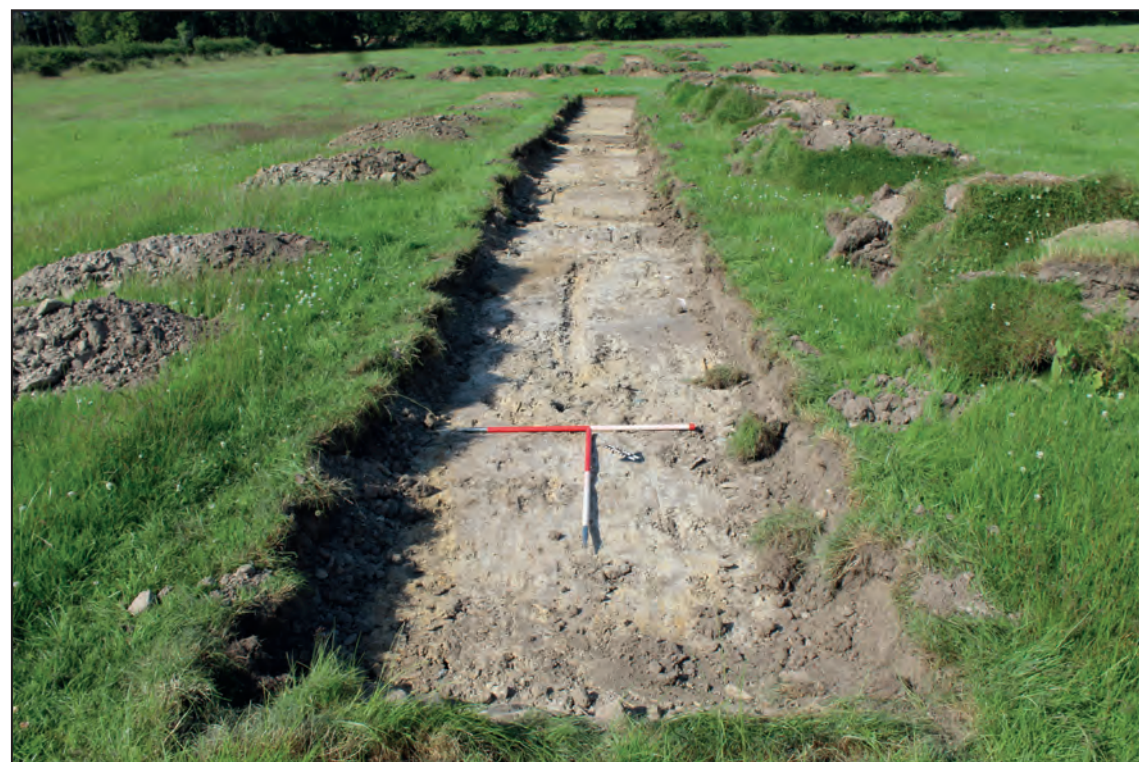
| DRAWN BY<br>CHECKED BY<br>PM | AW<br>HK<br>AS | PROJECT NO.<br>DATE<br>SCALE@A3 | MK1399<br>05/08/2026<br>1:200, 1:20 | FIGURE NO.<br><b>9</b> |

Trench 29, looking south-west (1m scales)

**FIGURE TITLE**  
**Trench 29: plan, section and  
 photographs**

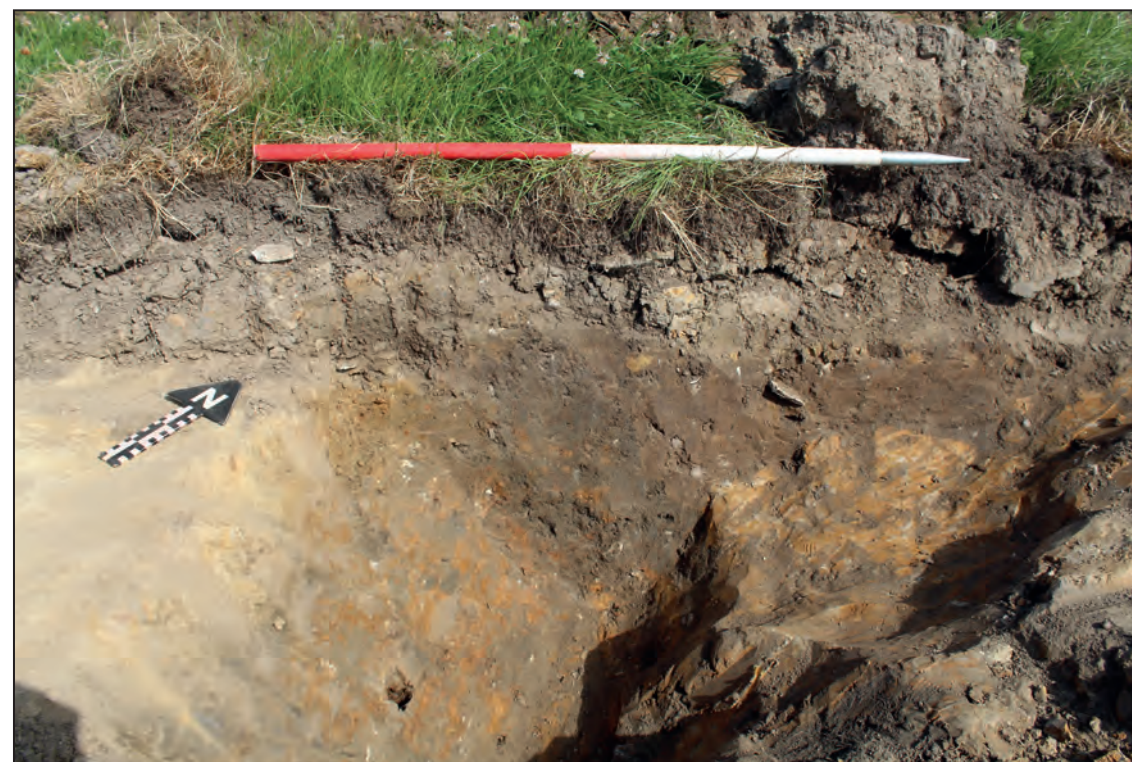
- 5.4. North-west/south-east aligned post-medieval field boundary ditch 2903 measured 0.6m wide and 0.5m deep, with moderately sloping concave sides and a concave base. It corresponds with a boundary depicted on 19th-century mapping and had

been partially truncated by a later tree bowl. The single fill, 2904, consisted of a friable mid orange-brown silty clay with minimal stone inclusions. No artefacts were recovered.

Ditch 2903, looking north-west (1m scale)

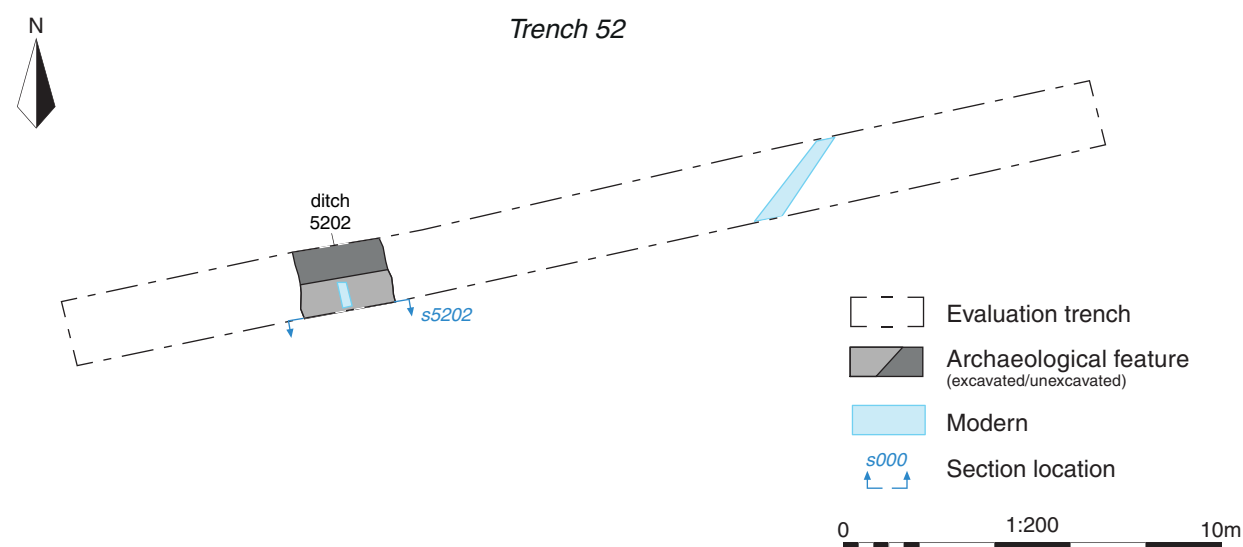
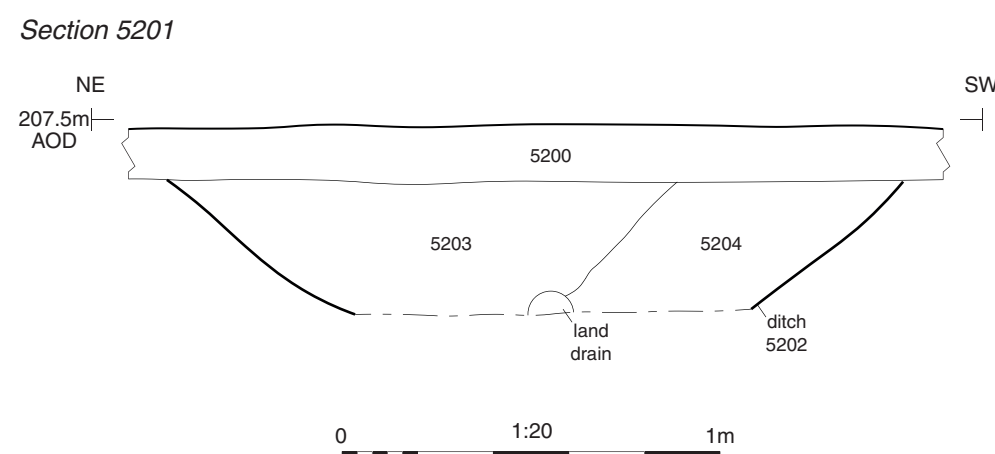
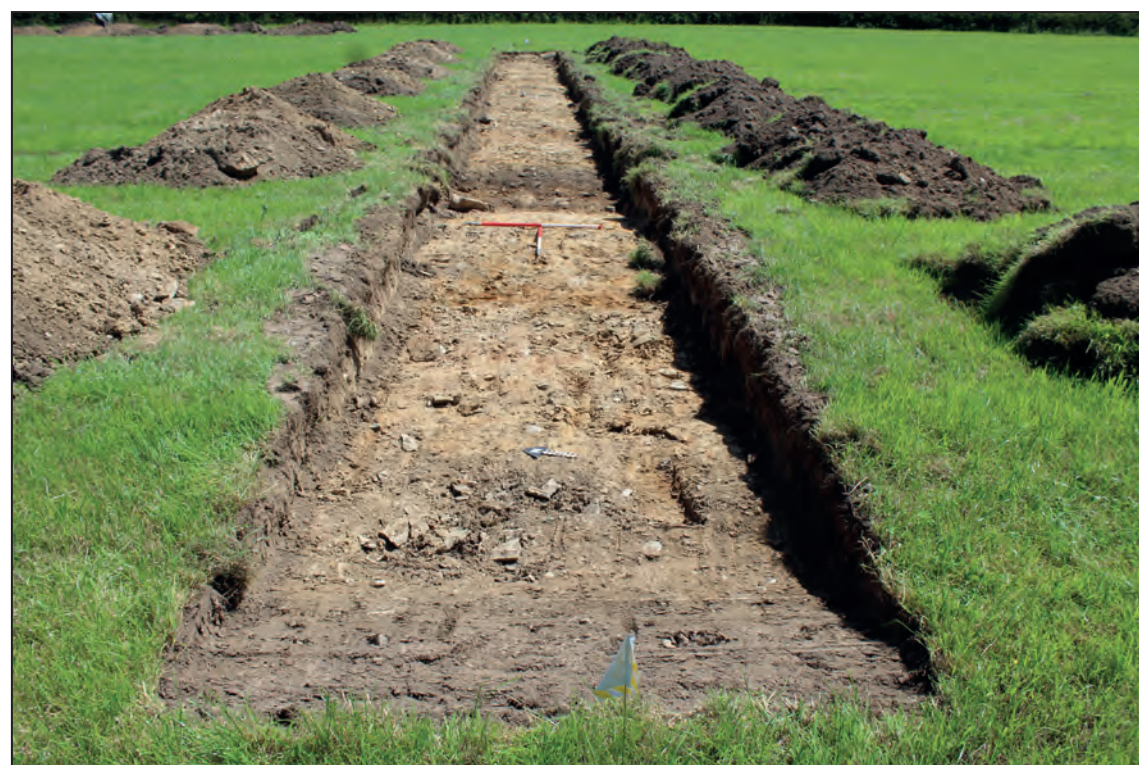
| DRAWN BY<br>CHECKED BY<br>PM | AW<br>HK<br>AS | PROJECT NO.<br>DATE<br>SCALE@A3 | MK1399<br>05/08/2026<br>1:200, 1:20 | FIGURE NO.<br><b>10</b> |

Trench 52, looking north-east (1m scales)

**FIGURE TITLE**  
 Trench 52: plan, section and  
 photographs

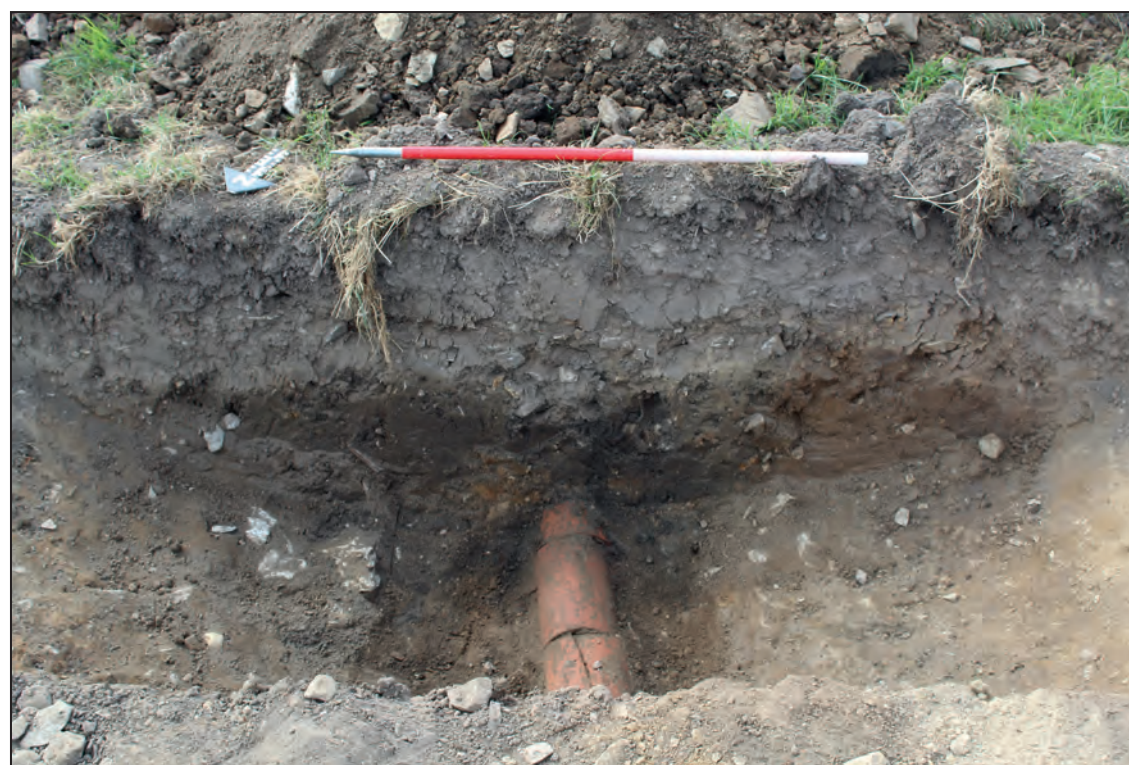
- 5.5. A historic field boundary ditch (5202) was present, measuring 1.94m wide and 0.35m deep, with steep sloping sides and a concave base. A ceramic land drain was present within the ditch. Two deliberate backfill deposits were recorded: 5203, a dark brownish grey clay silt with frequent large angular stones, and 5204, a light brown grey clay silt with frequent angular and sub-angular stones. These deposits likely represent deliberate backfilling of the ditch associated with the process of field amalgamation/ enlargement in the 20th century. No artefacts were recovered

Ditch 5202, looking south-east (1m scale)

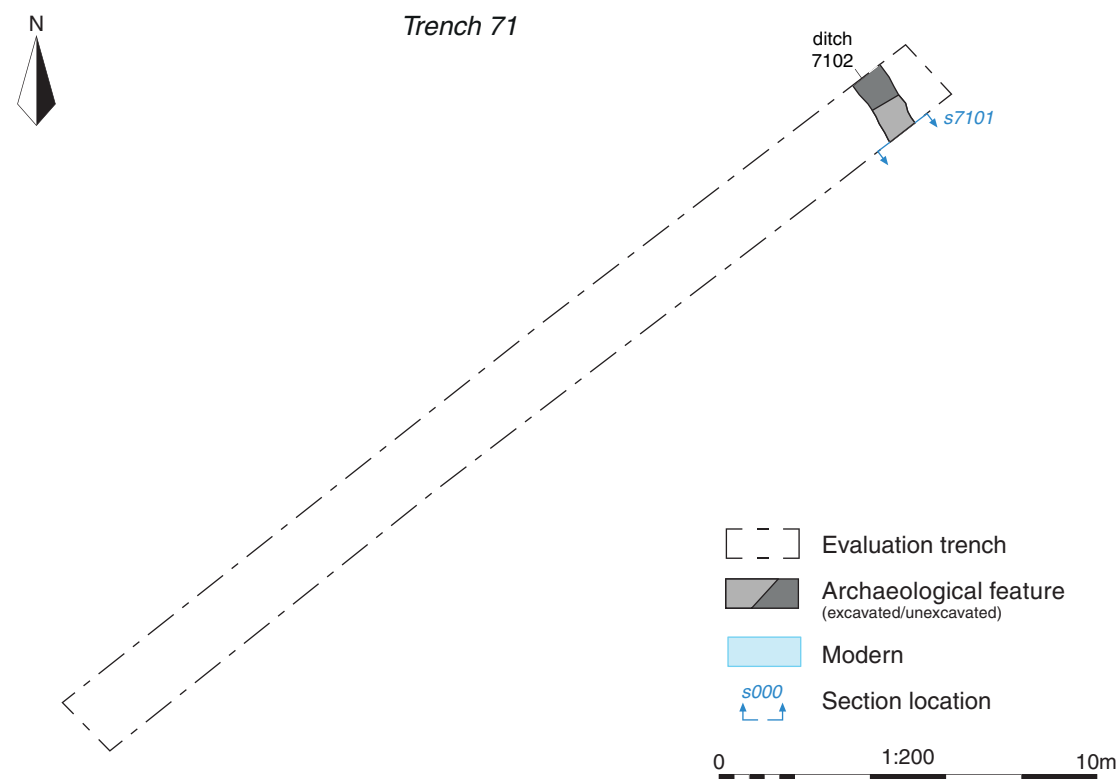
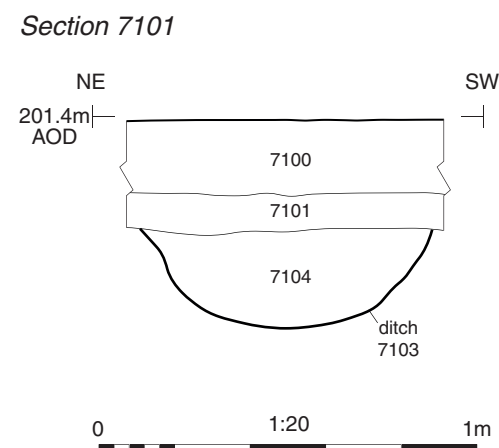
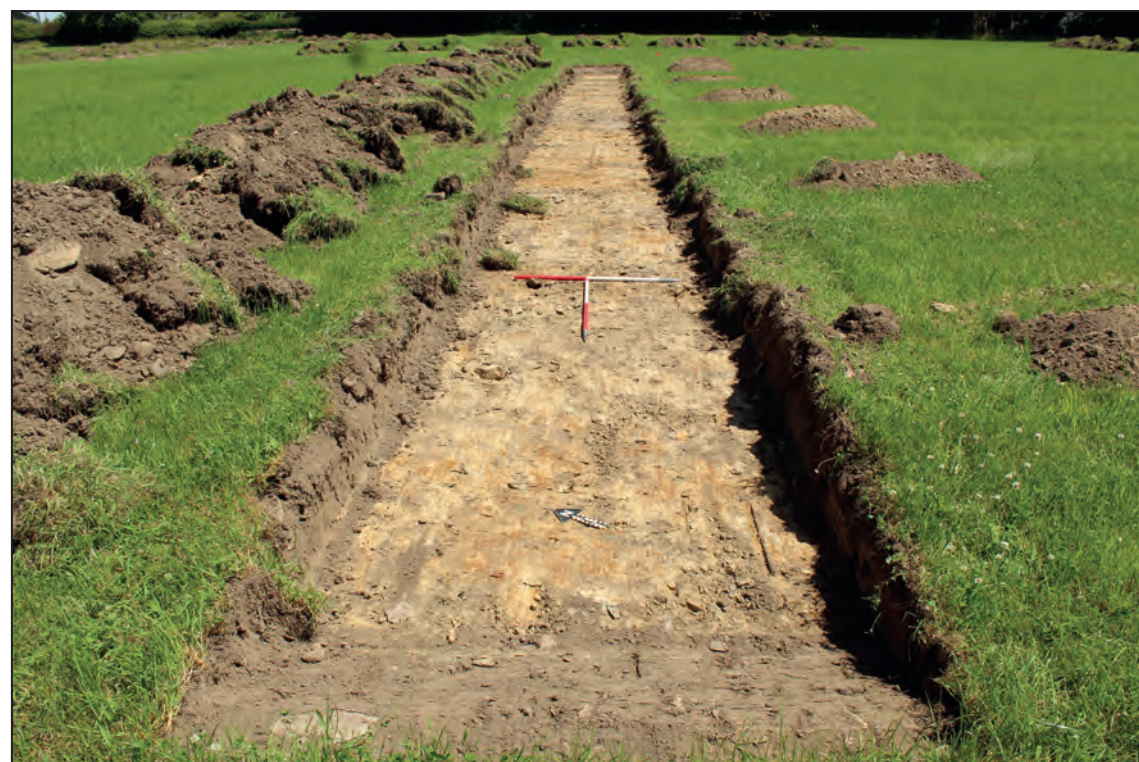
| DRAWN BY<br>CHECKED BY<br>PM | AW<br>HK<br>AS | PROJECT NO.<br>DATE<br>SCALE@A3 | MK1399<br>05/08/2026<br>1:200, 1:20 | FIGURE NO.<br><b>11</b> |

Trench 71, looking north-east (1m scales)

**FIGURE TITLE**  
**Trench 71: plan, section and  
 photographs**

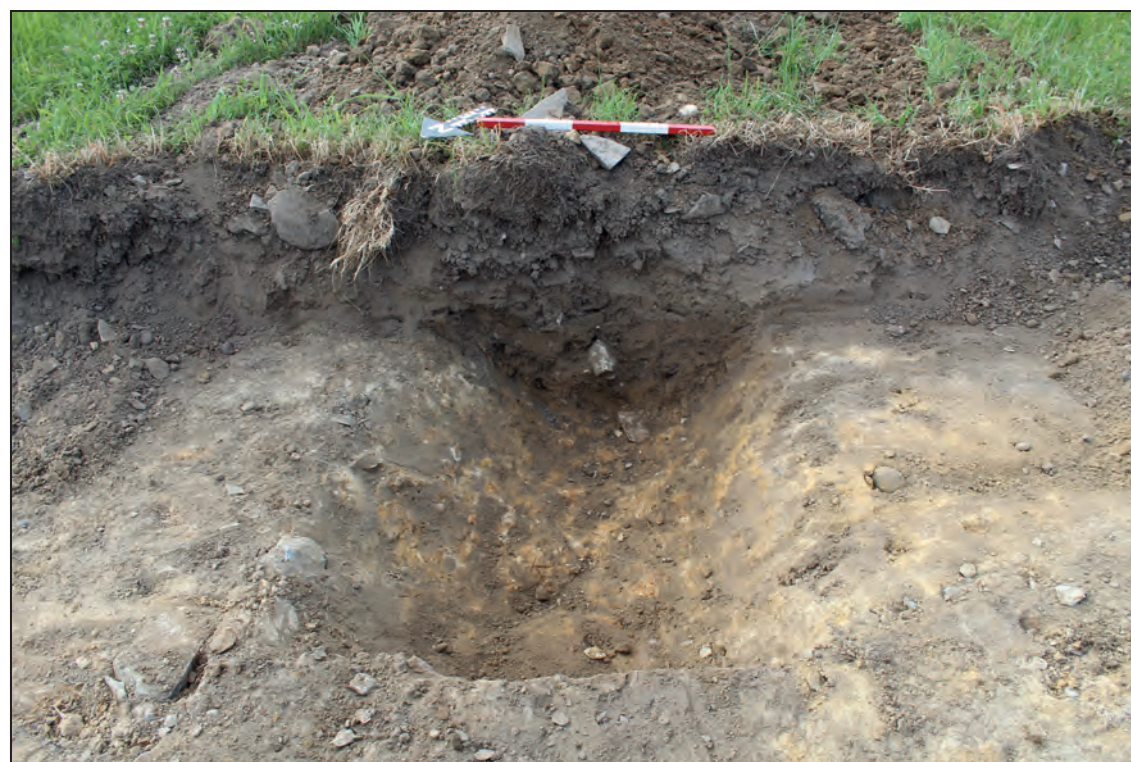
- 5.6. A modern boundary ditch, 7103, was present, measuring 0.76m wide and 0.27m deep, with steep concave sides and a shallow concave base. The fill, 7104, comprised a friable mid brown-grey silty clay with occasional small stone fragments. No artefacts were recovered.

Ditch 7103, looking south-east (0.5m scale)

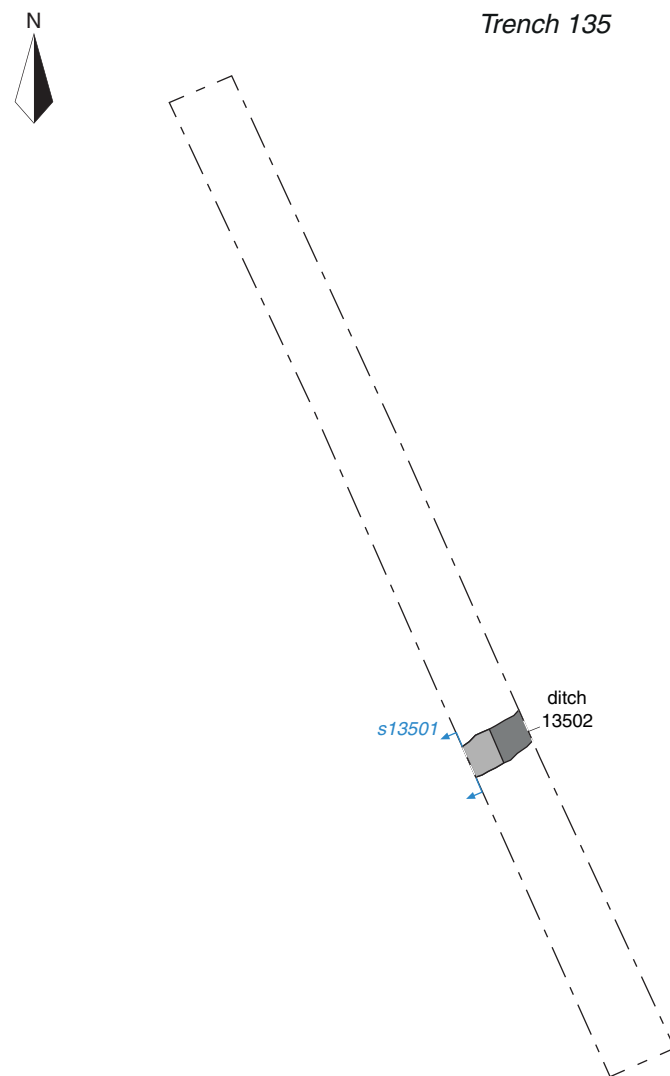
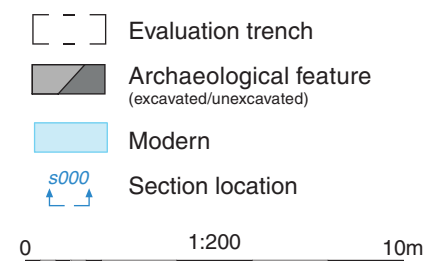
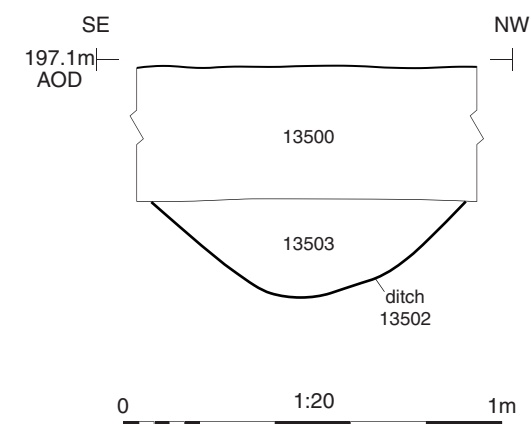
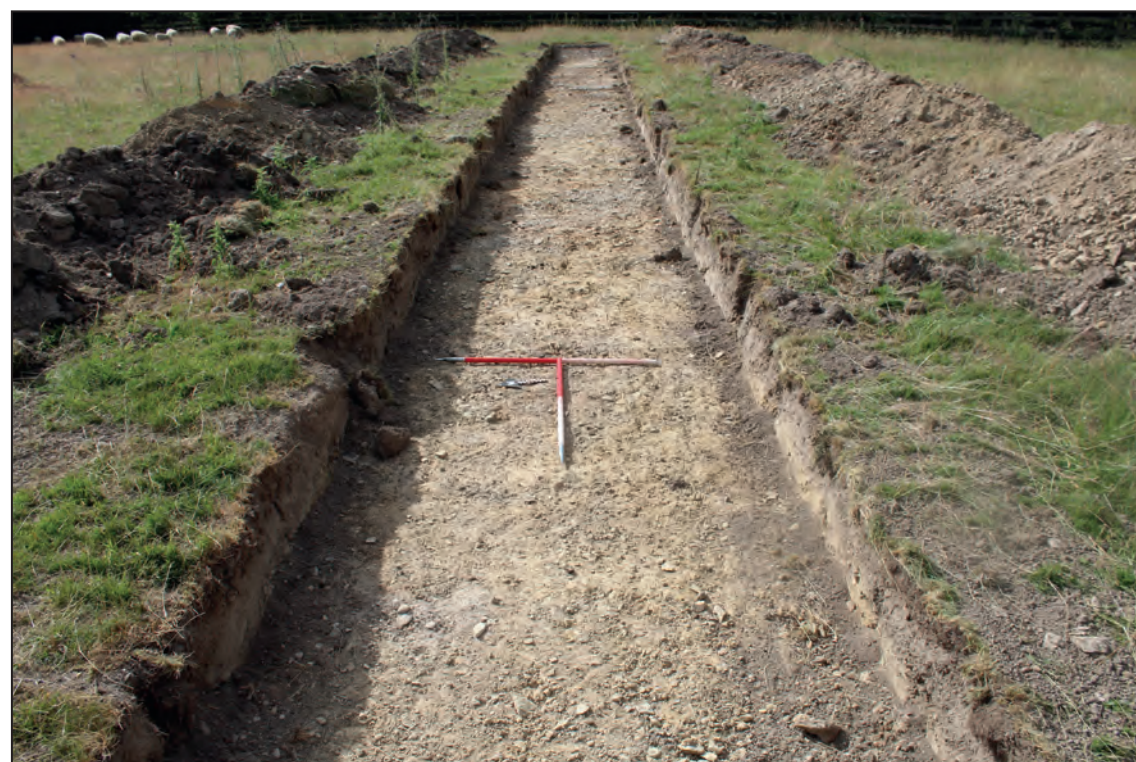
**Section 13501**

Trench 135, looking south-east (1m scales)

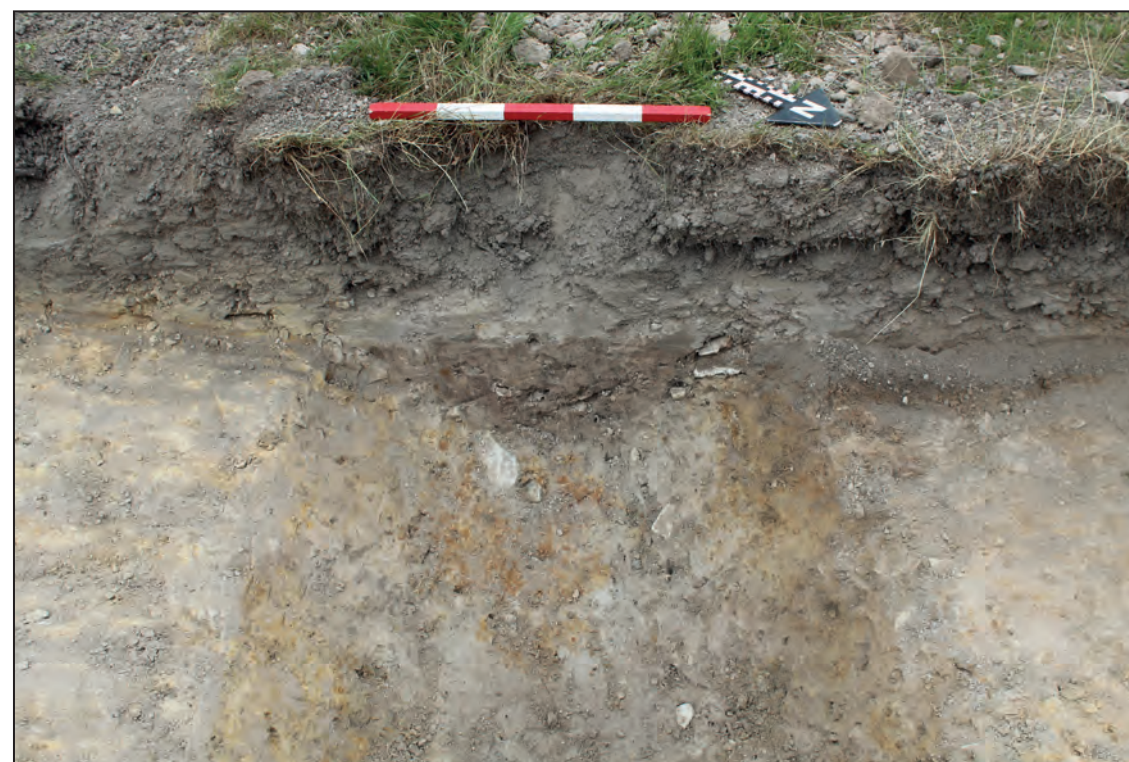
- 5.7. A shallow post-medieval boundary ditch, 13502, was present, measuring 0.82m wide and 0.26m deep, with shallow concave sides and rounded base. The fill, 13503, comprised a light brown-grey silty clay with very occasional stone fragments. No artefacts were recovered.

Ditch 13502, looking south-west (0.5m scale)
