# East Lodge

*163 The Park, Market Bosworth, Leicestershire, CV13 0LP.*

Historic Building Recording (level 3).

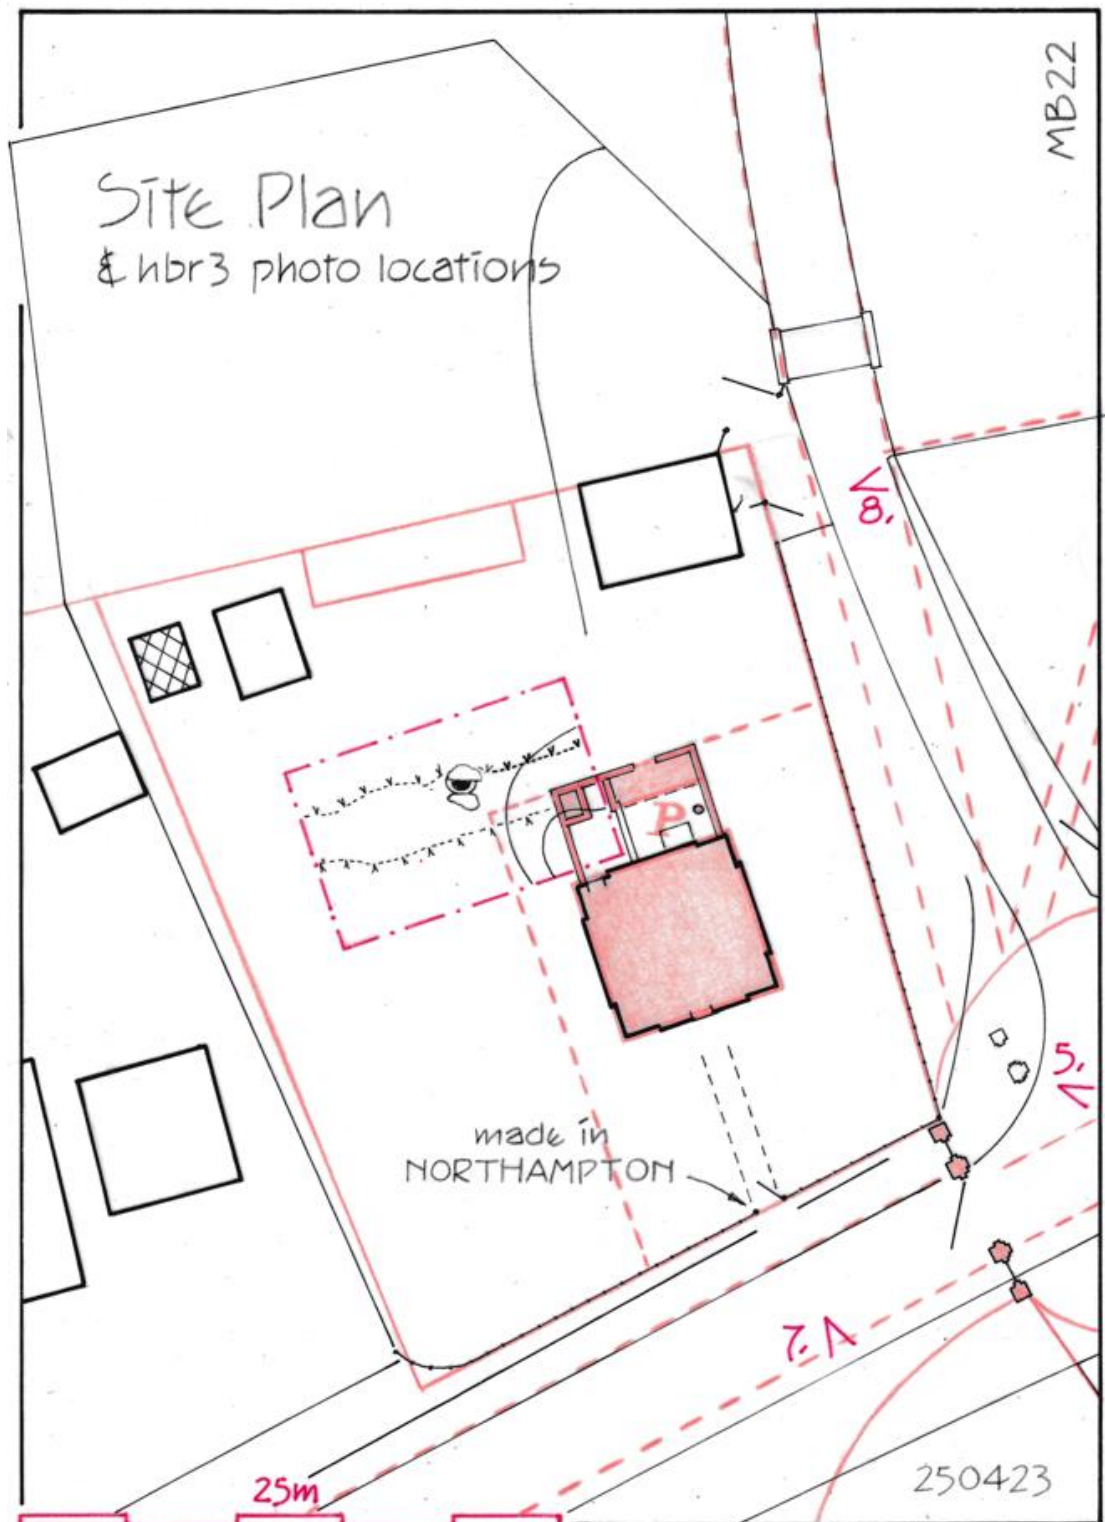
Fig 4: Site Plan showing OS 1903 features in *pink*, including kitchen yard outhouses, site of pump, and original site of Park Gate.

When the utility room was added, the old WC was incorporated into the scheme and refitted completely, and the old back-gate was replaced by a new door. The coalhouse/woodshed was demolished but the enclosing wall was just reduced, opening this prospect of the house, with a new entry being cut through the north wall for access. Both outhouses were under pent roofs, and concealed from view, presumably so as not to mar the splendour of the lodge with service

buildings. There is no evidence for the site of the pump that was located on the east side of the yard.

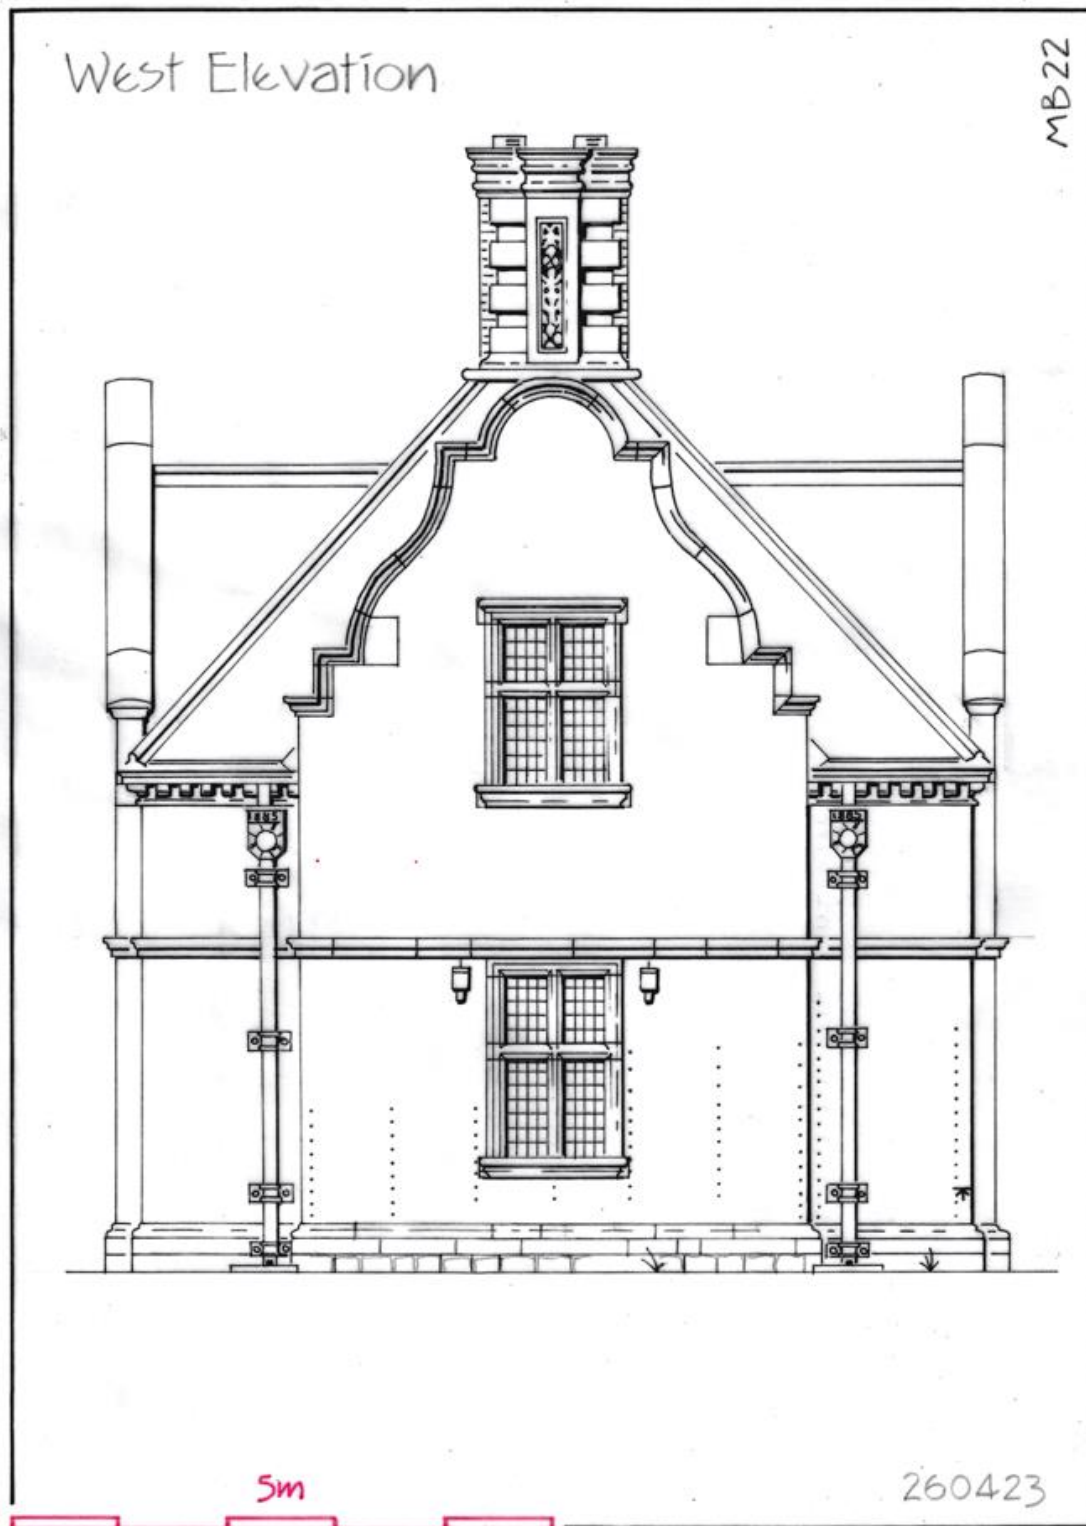
Fig 9: West elevation of lodge. Note the dated RWP hoppers, dated 1885.

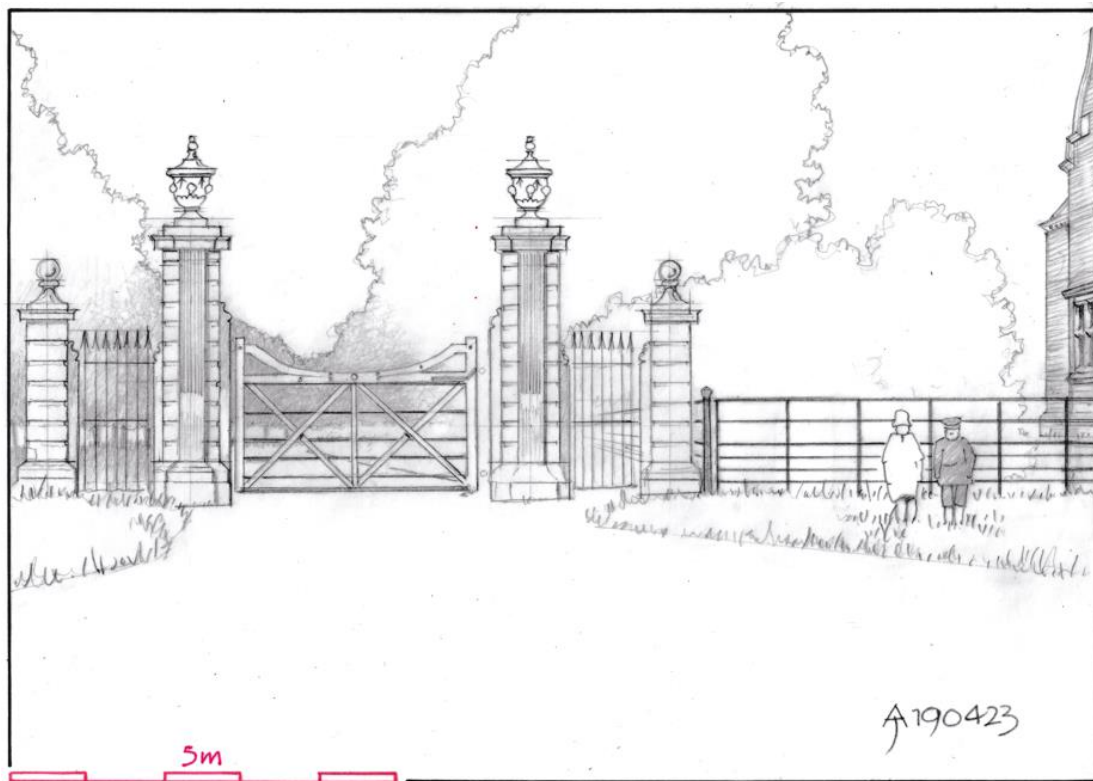
*Fig 11: East elevation of the park gateway and avenue beyond, showing original positions of piers based on an old photograph.*

The four piers forming the gateway ([mle12162](#)) to the park are constructed of rusticated limestone ashlar are Grade II listed and in a C17 style but probably late C19 construction (1885). The taller inner piers have fluted applied shafts with scrolled volutes on inner face with ramified capping urns above the cornice, the smaller outer piers are similarly detailed, but surmounted with ball finials. An old photograph shows the piers, with main gate and side

railings, in their original position. They were relocated further apart and forward as part of a road widening scheme. The side gates of iron and the central single iron gate and fittings are lost.

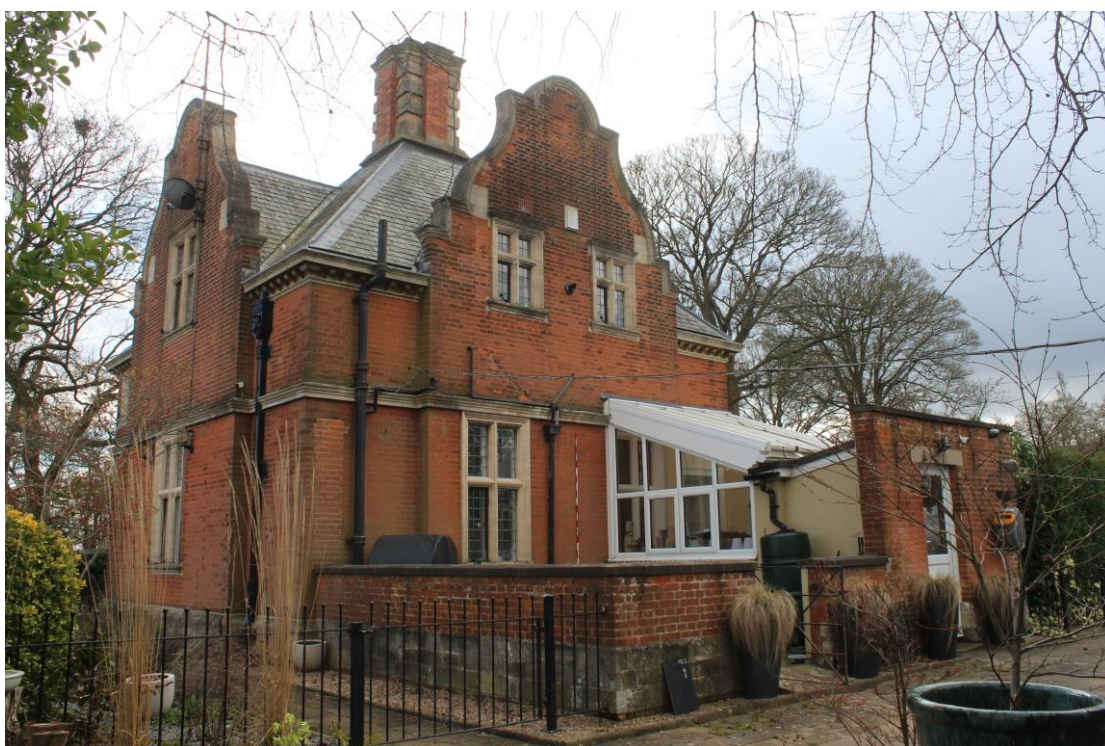
*Plate 3: View from northeast, note the repaired brickwork following the removal of kitchen-yard wall around northeast corner. The rendered wall is the surviving west wall of the coal-shed.*

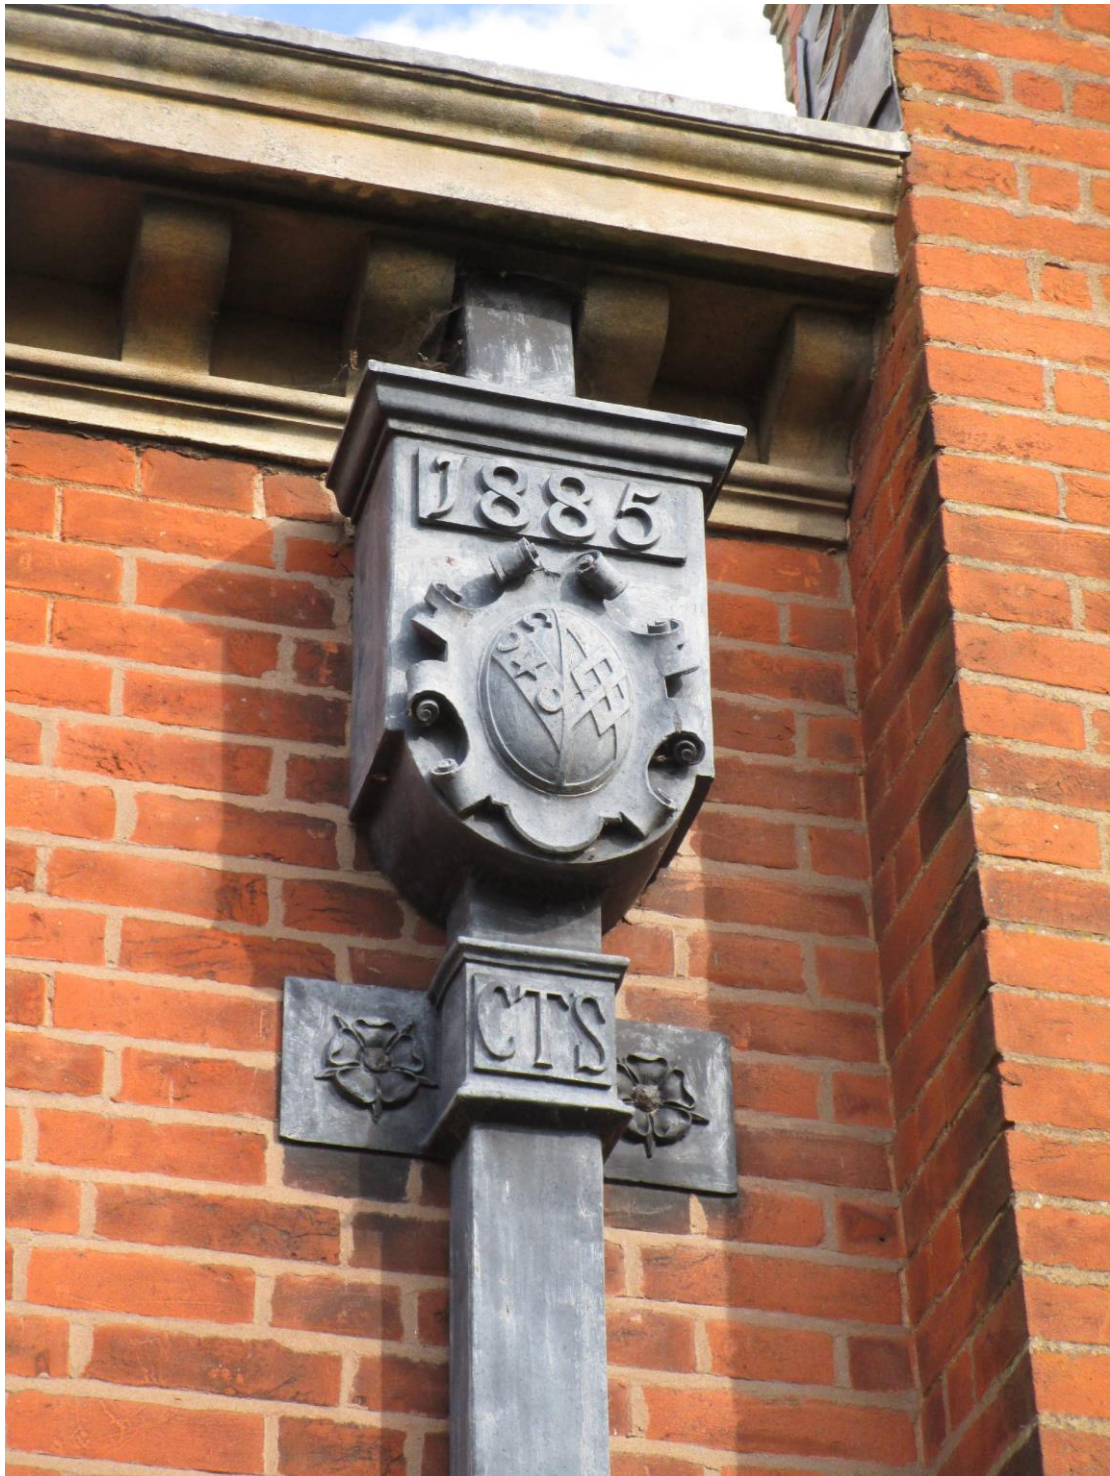
*Plate 6: View of hopper and rainwater pipe detail.*

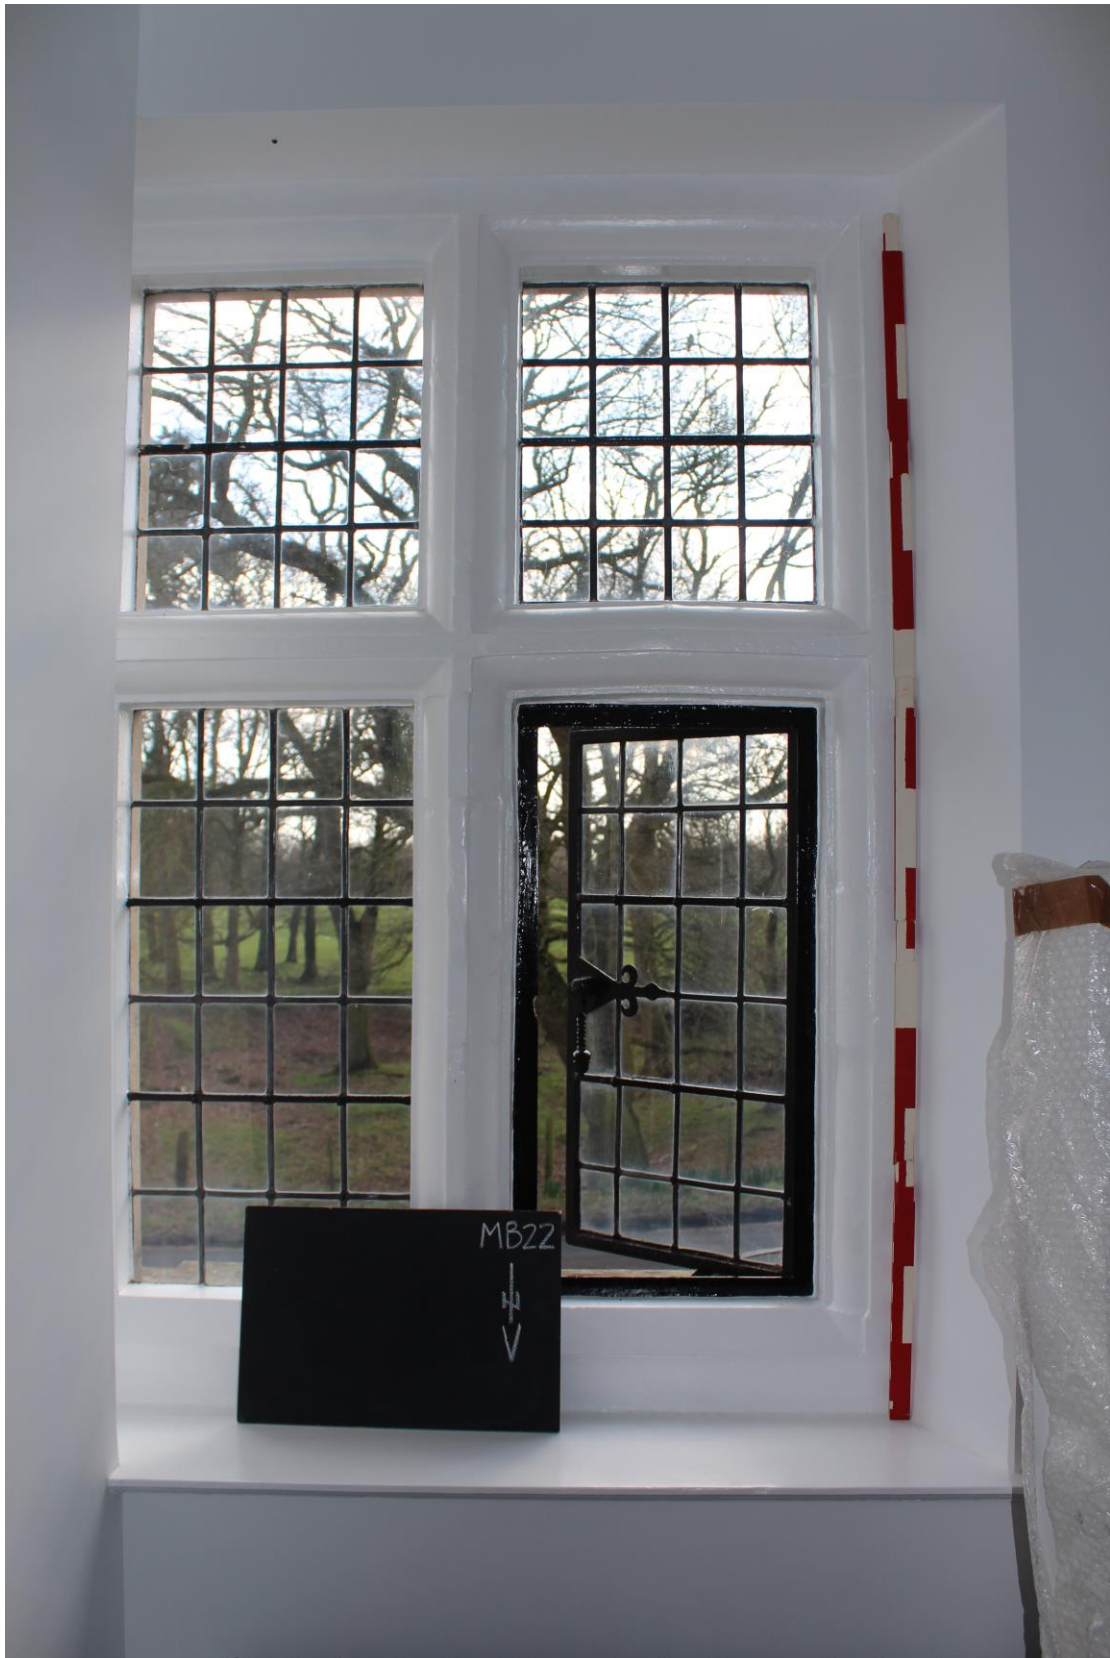
*Plate 9: A 1st floor at the front partially blocked by an internal wall but preserving the symmetry of the front elevation.*

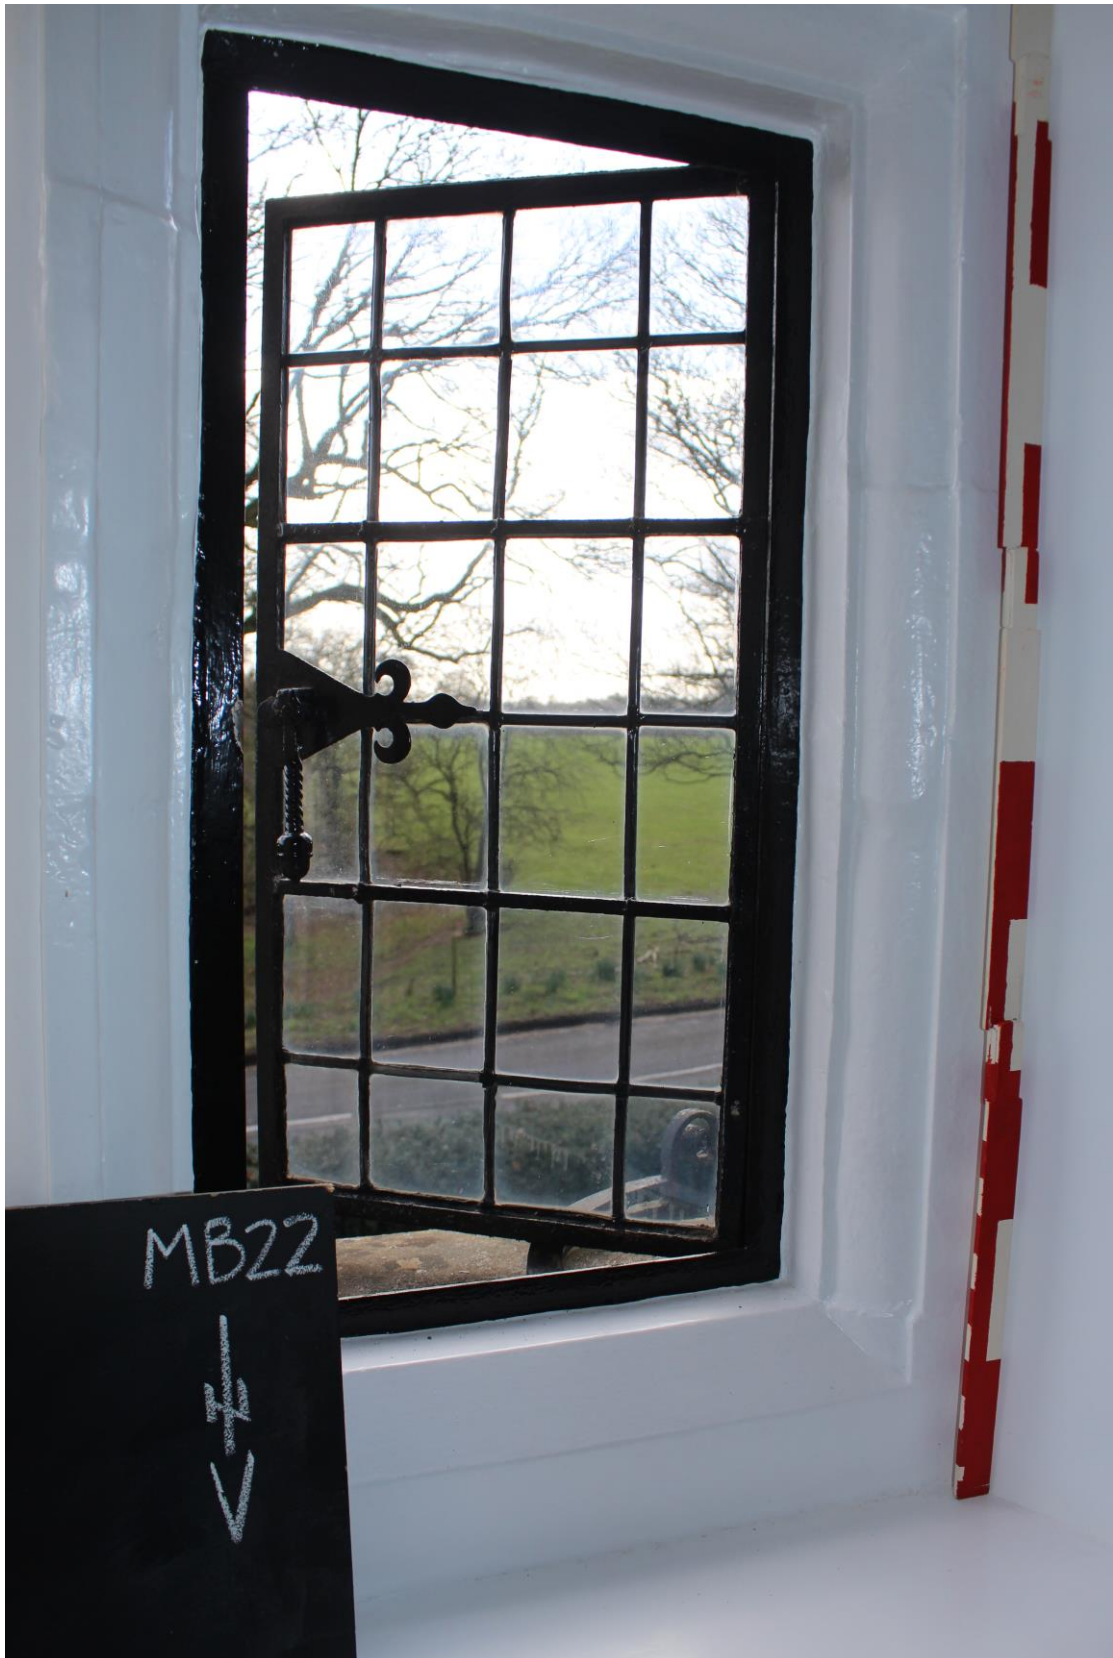
*Plate 10: Detail of window's iron fittings and furnishings.*

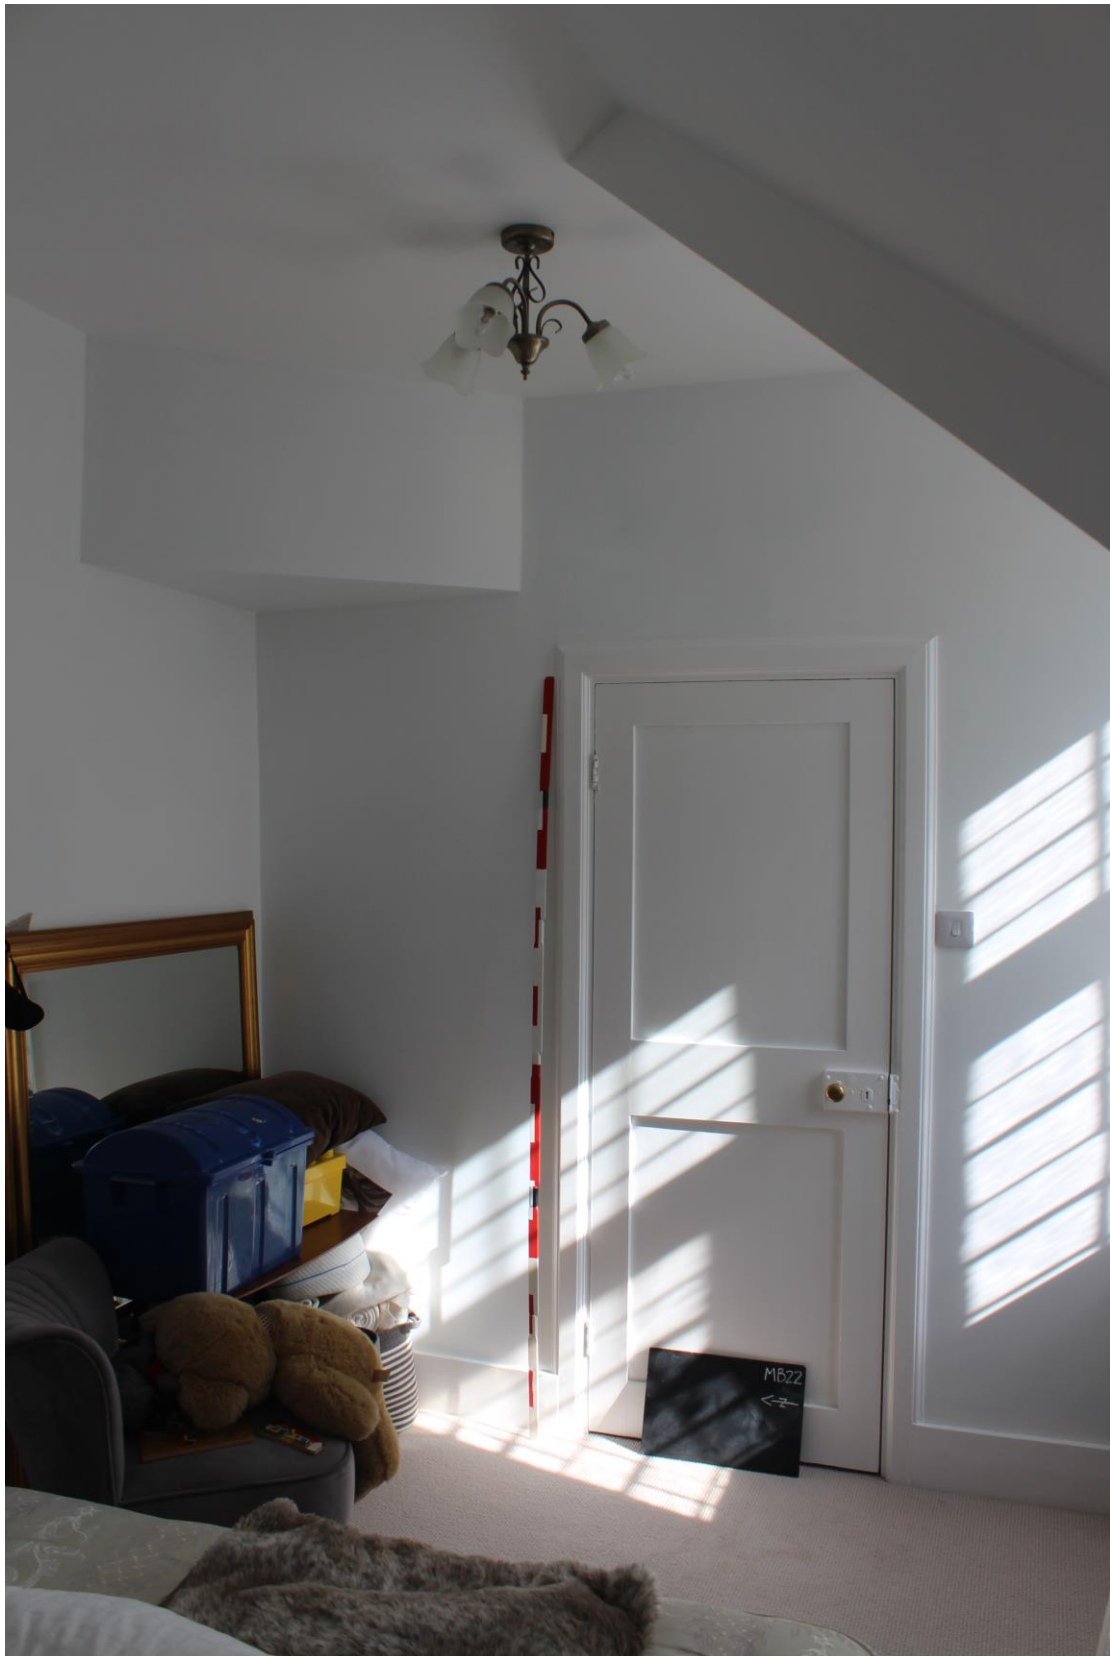
*Plate 11: Possible evidence for a small corner fireplace removed during modernisation.*

Fireplaces are replaced often to reflect changes in domestic comfort and there are no original fireplaces on the ground floor, in the dining-room there is a modern reproduction and in the former parlour the fireplace has been panelled over, replacing another modern reproduction. The site of the kitchen chimney can be seen with part of the flue in the corner boxed in well above head-height. On the first floor there are two small fireplaces; simple stone piers and lintel chamfered on the inner and outer arises, terminating in flat stops. One retains its original iron grate and the other, in the bathroom, has been converted for storage. In the front bedroom a triangular boxing-in above head-height suggests the former presence of a small corner fireplace.

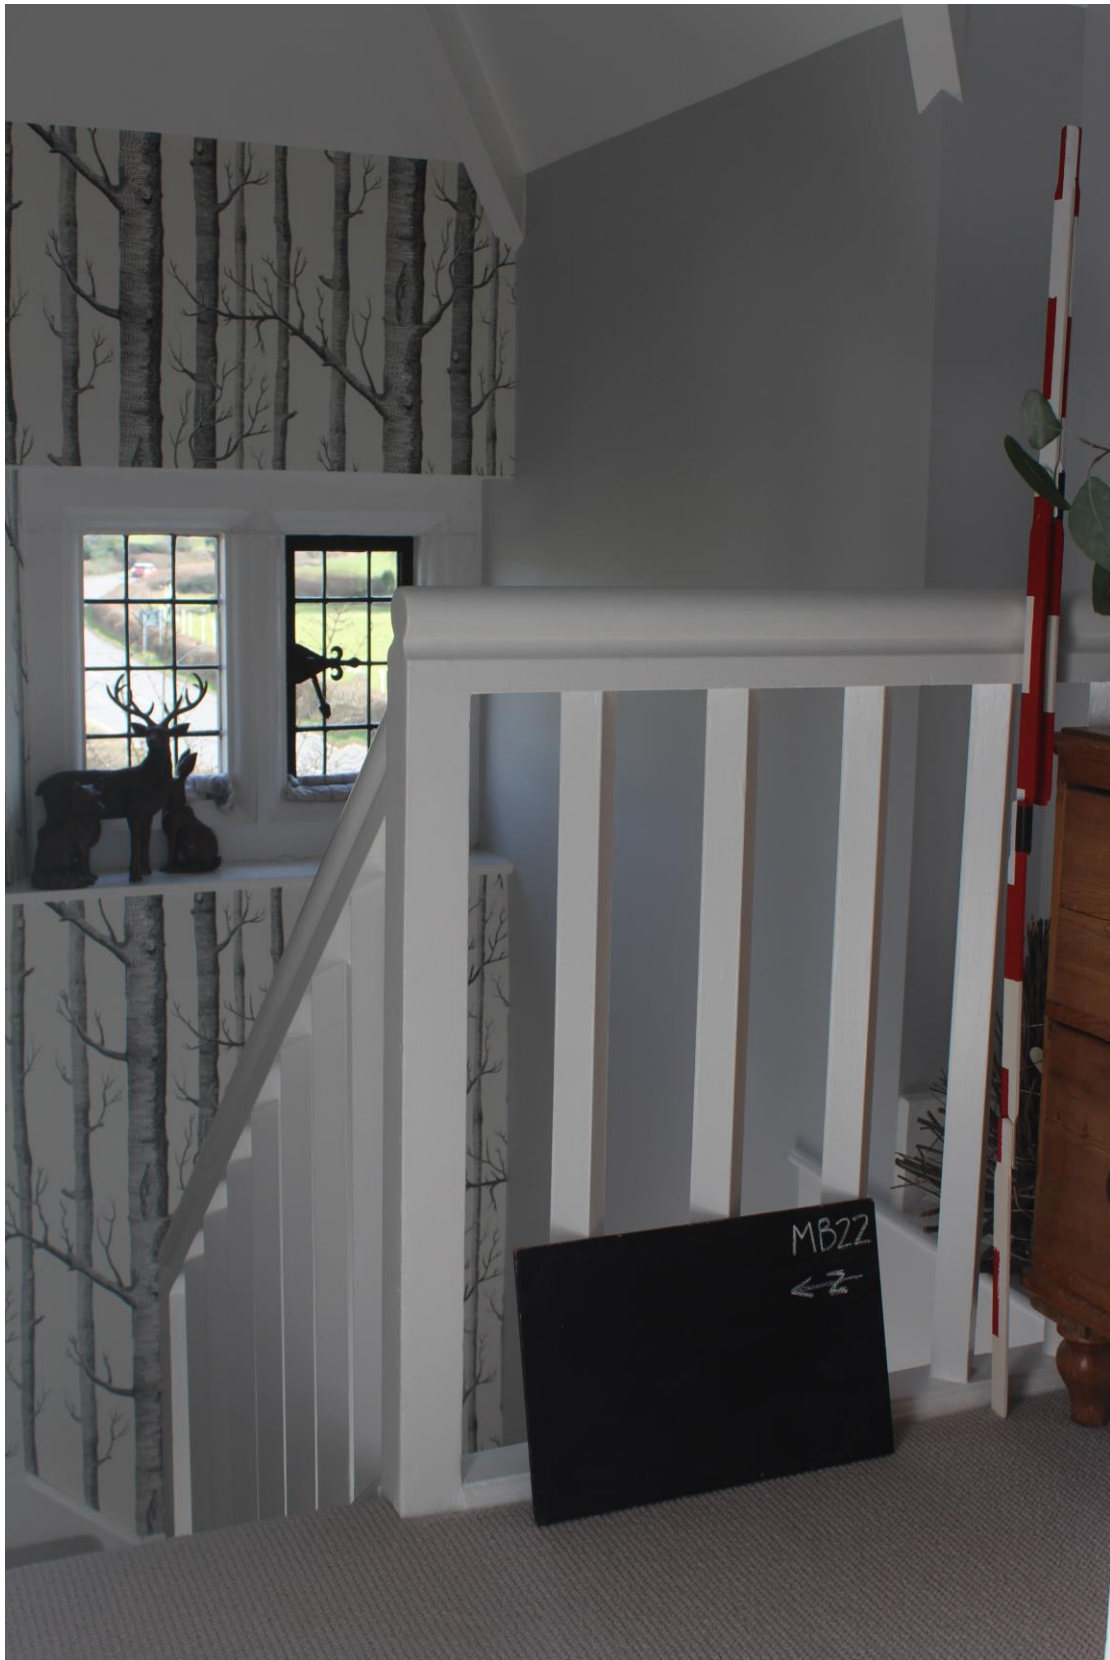
*Plate 12: A view to the southeast at the landing, showing the simple balustrade and the small window which from the outside is the only compromise to the building's symmetry.*

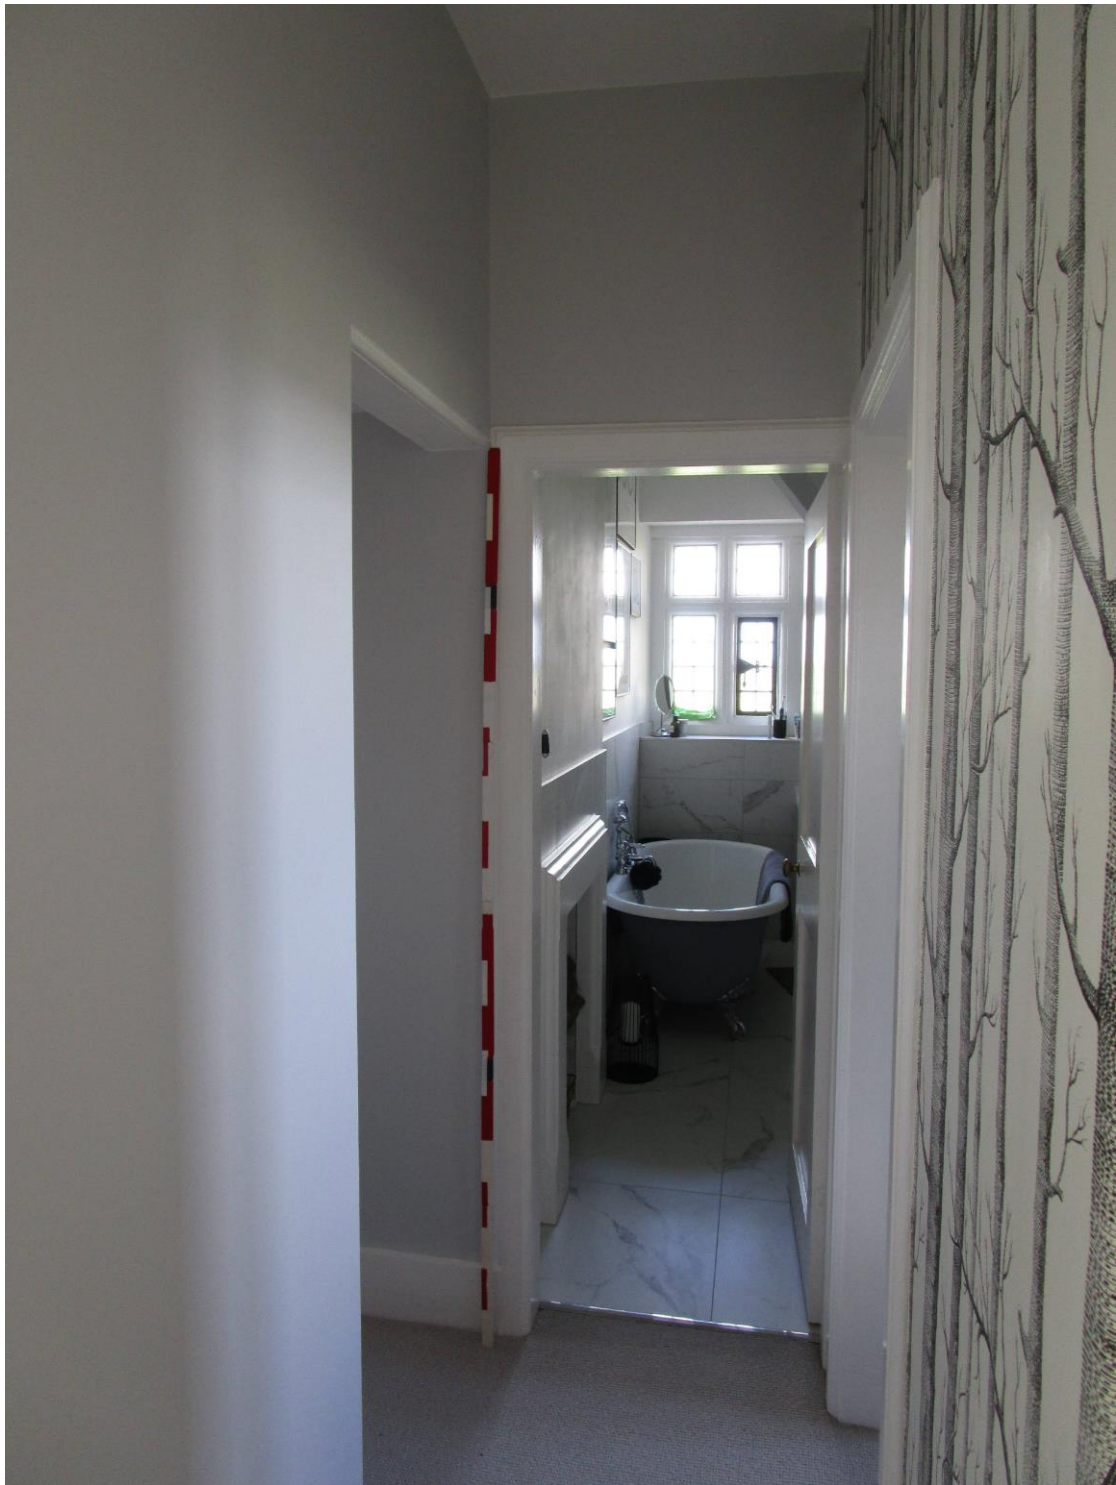
*Plate 13: View along 1st floor corridor to the bathroom and the remains of an original fireplace.*

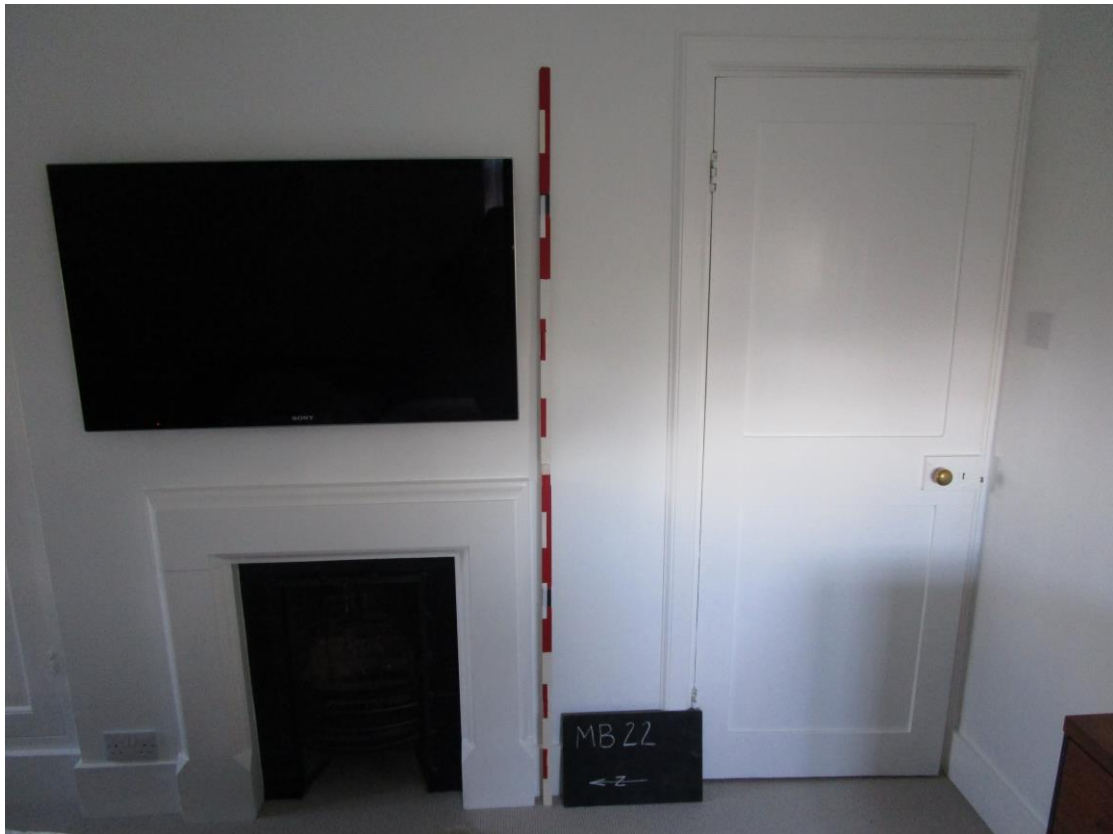
*Plate 14: 1st floor fireplace and door; both original features.*

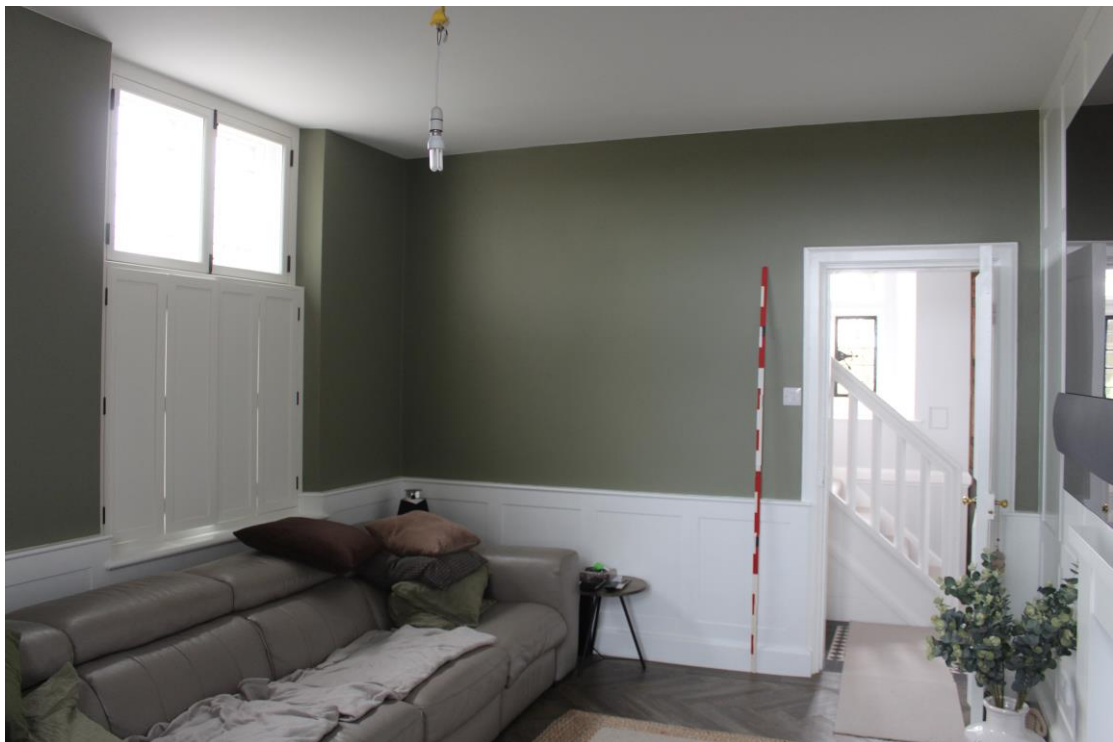
*Plate 15: The former parlour, the dado-panelling and window shutters are modern features, and the fireplace which replaced the original, on the right, has been panelled over.*

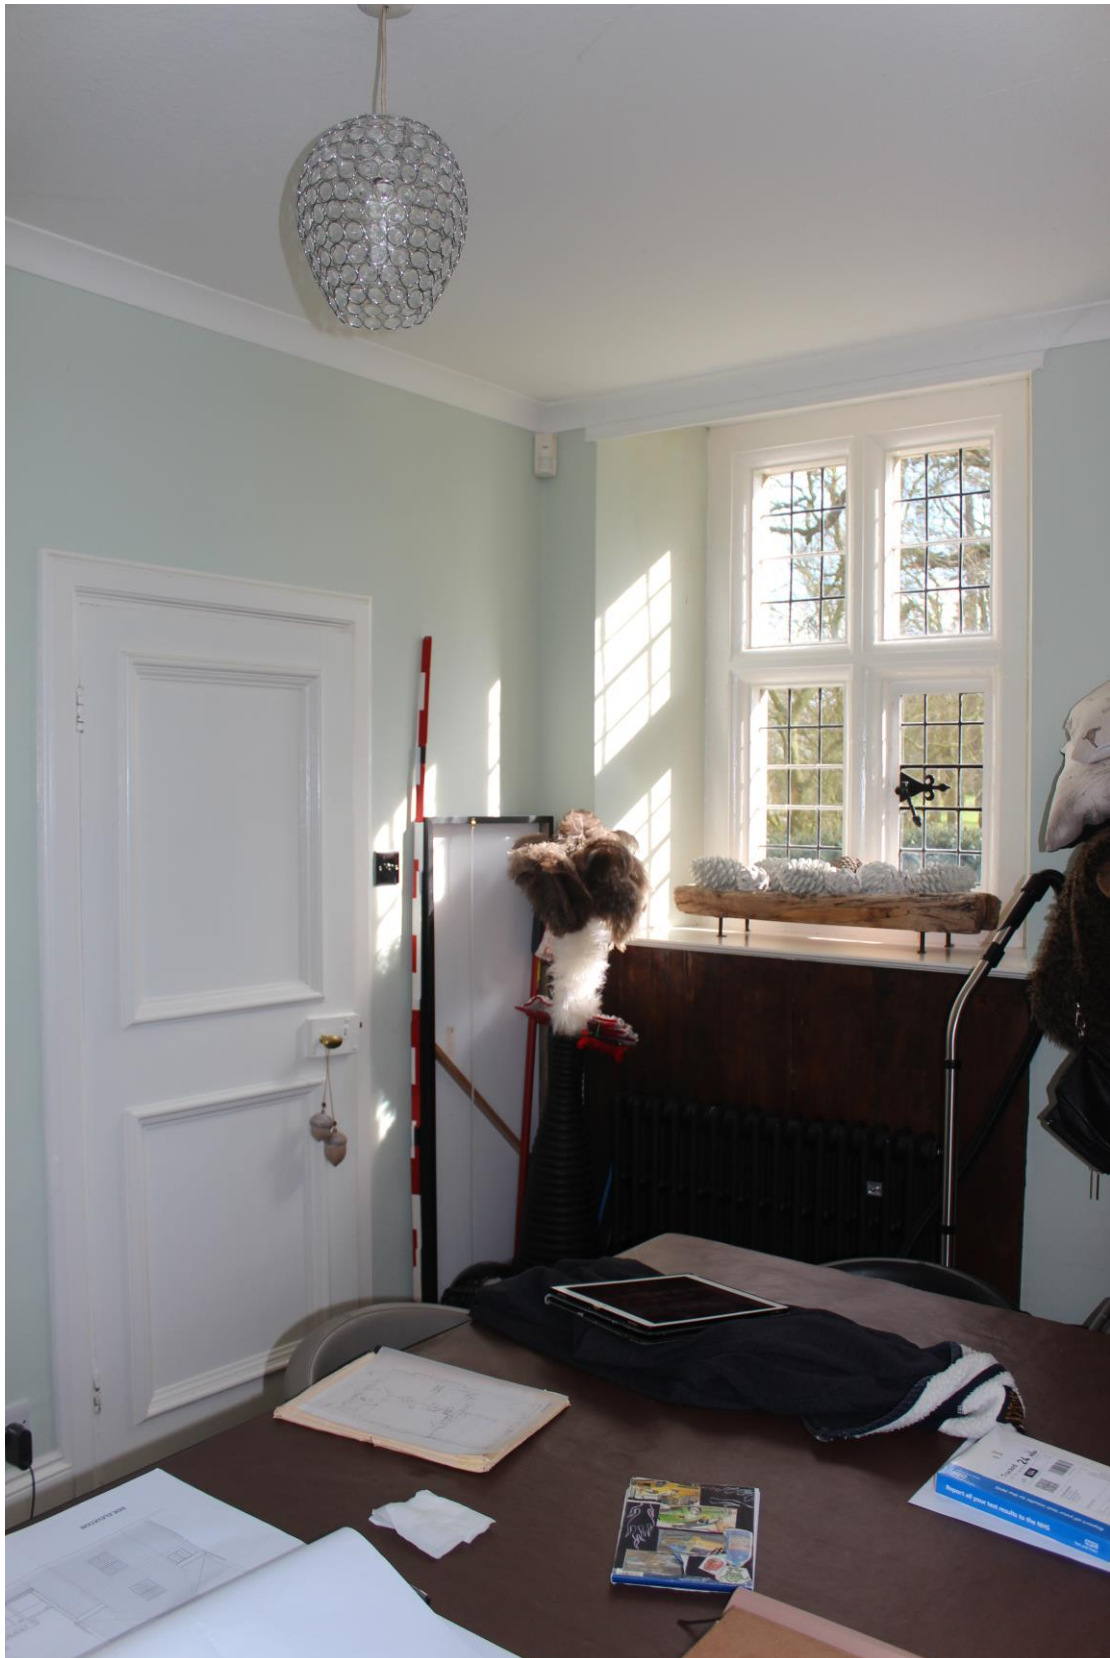
*Plate 16: The dining room, showing a heavily moulded two-panel door, contrasting with the utilitarian doors on the 1st floor.*

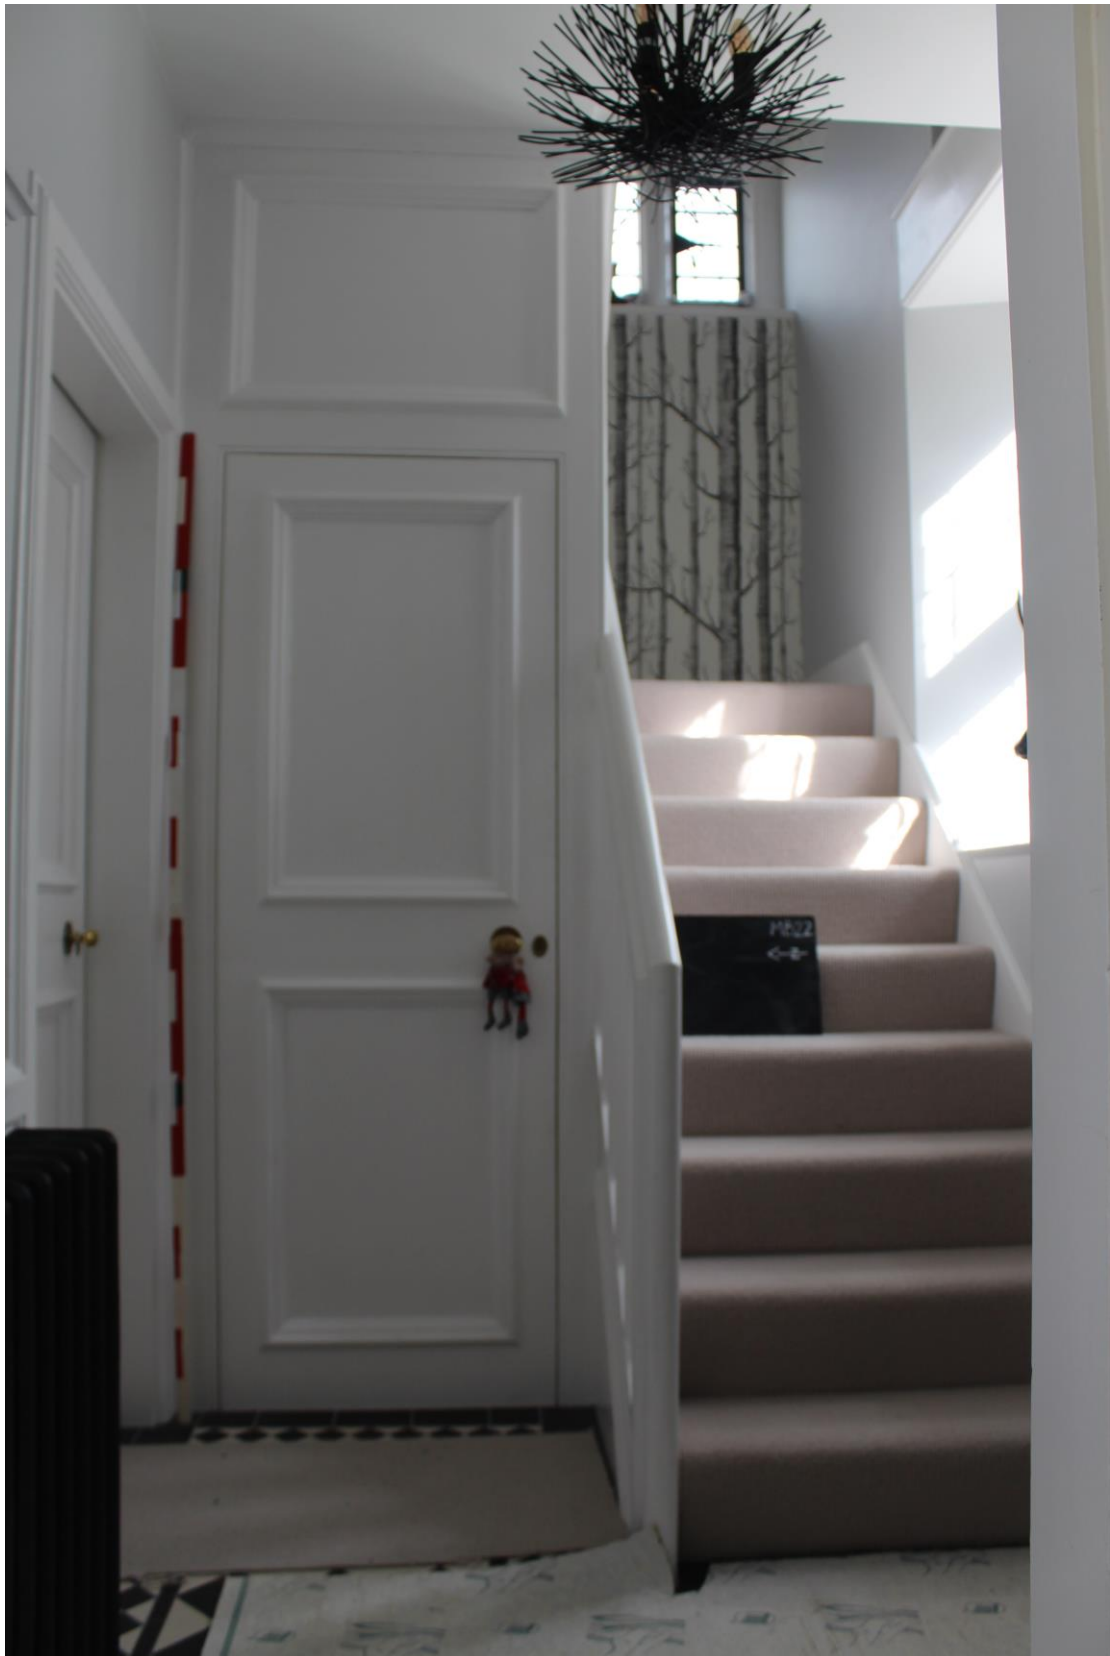
*Plate 17: The entrance hall with numerous original details, the tiled floor however is modern as are the C19 style radiators throughout*
