# East Lodge

*163 The Park, Market Bosworth, Leicestershire, CV13 0LP.*

Historic Building Recording (level 3).

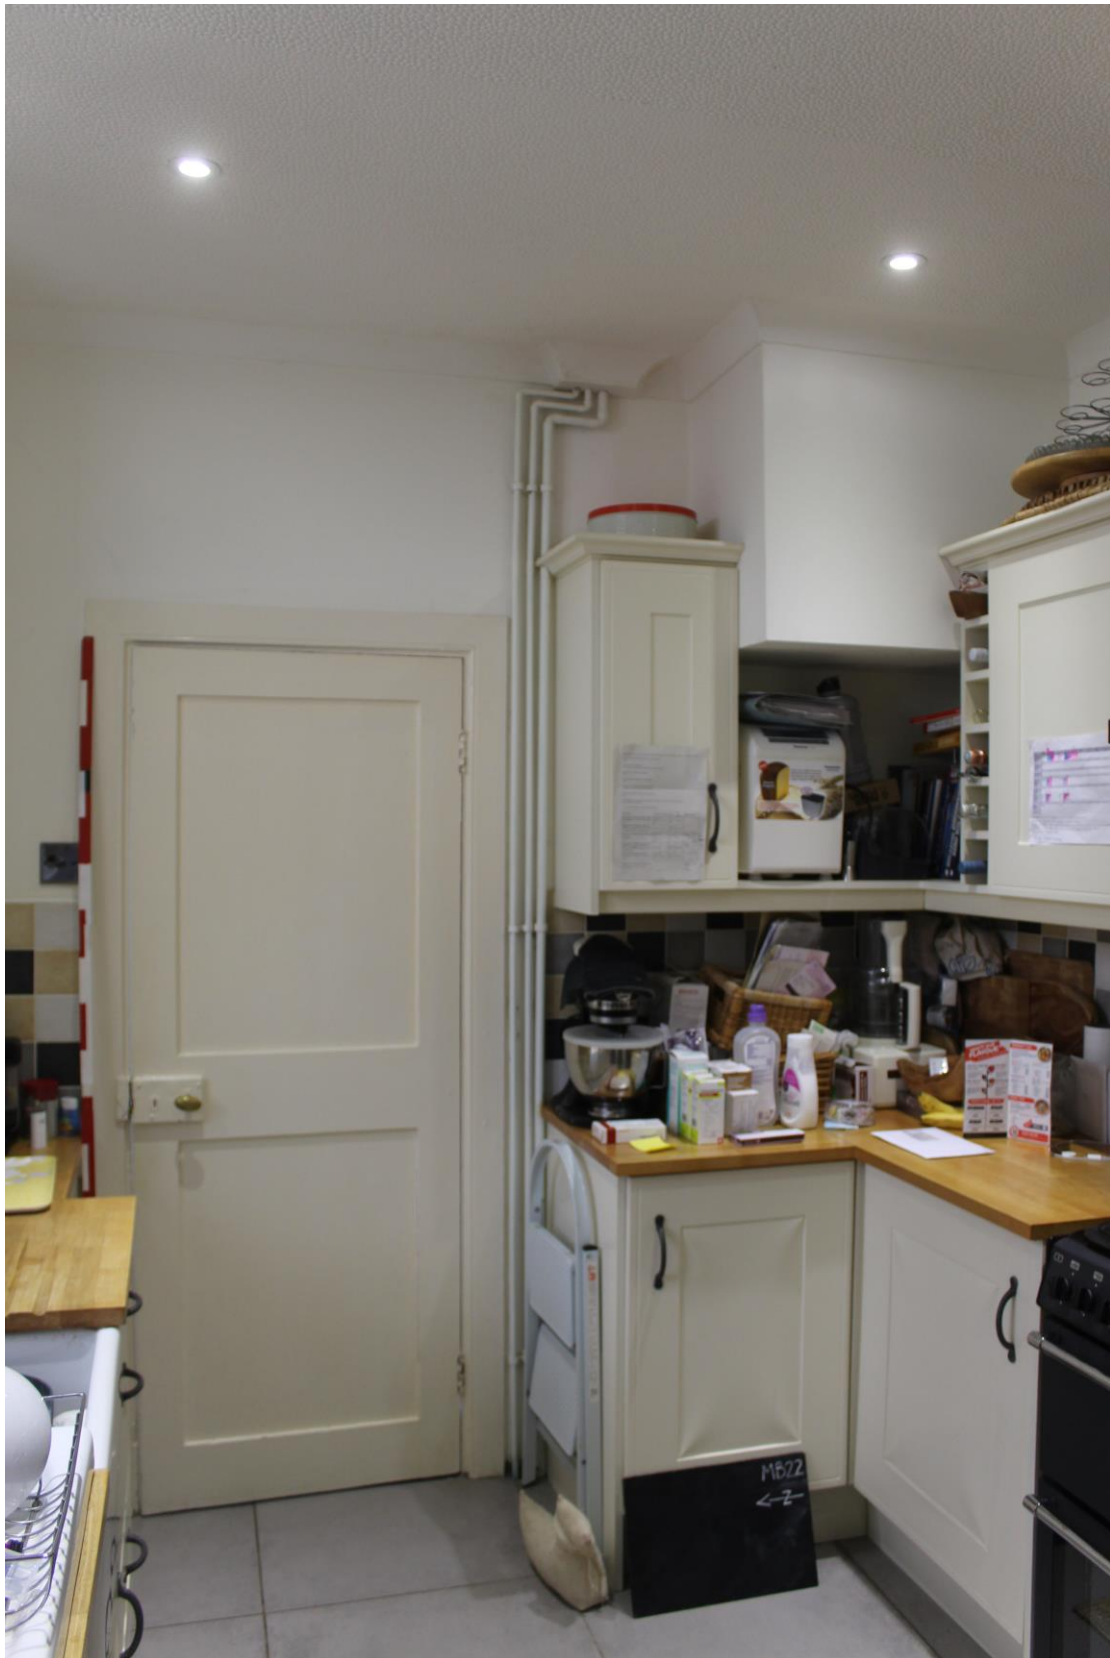
*Plate 18: The kitchen showing an original utilitarian door and what appears to be the remains of a chimney flue over the site of a probable range.*

Fireplaces are replaced often to reflect changes in domestic comfort and there are no original fireplaces on the ground floor, in the dining-room there is a modern reproduction and in the former parlour the fireplace has been panelled over, replacing another modern reproduction. The site of the kitchen chimney can be seen with part of the flue in the corner boxed in well above head-height. On the first floor there are two small fireplaces; simple stone piers and lintel chamfered on the inner and outer arises, terminating in flat stops. One retains its original iron grate and the other, in the bathroom, has been converted for storage. In the front bedroom a triangular boxing-in above head-height suggests the former presence of a small corner fireplace.

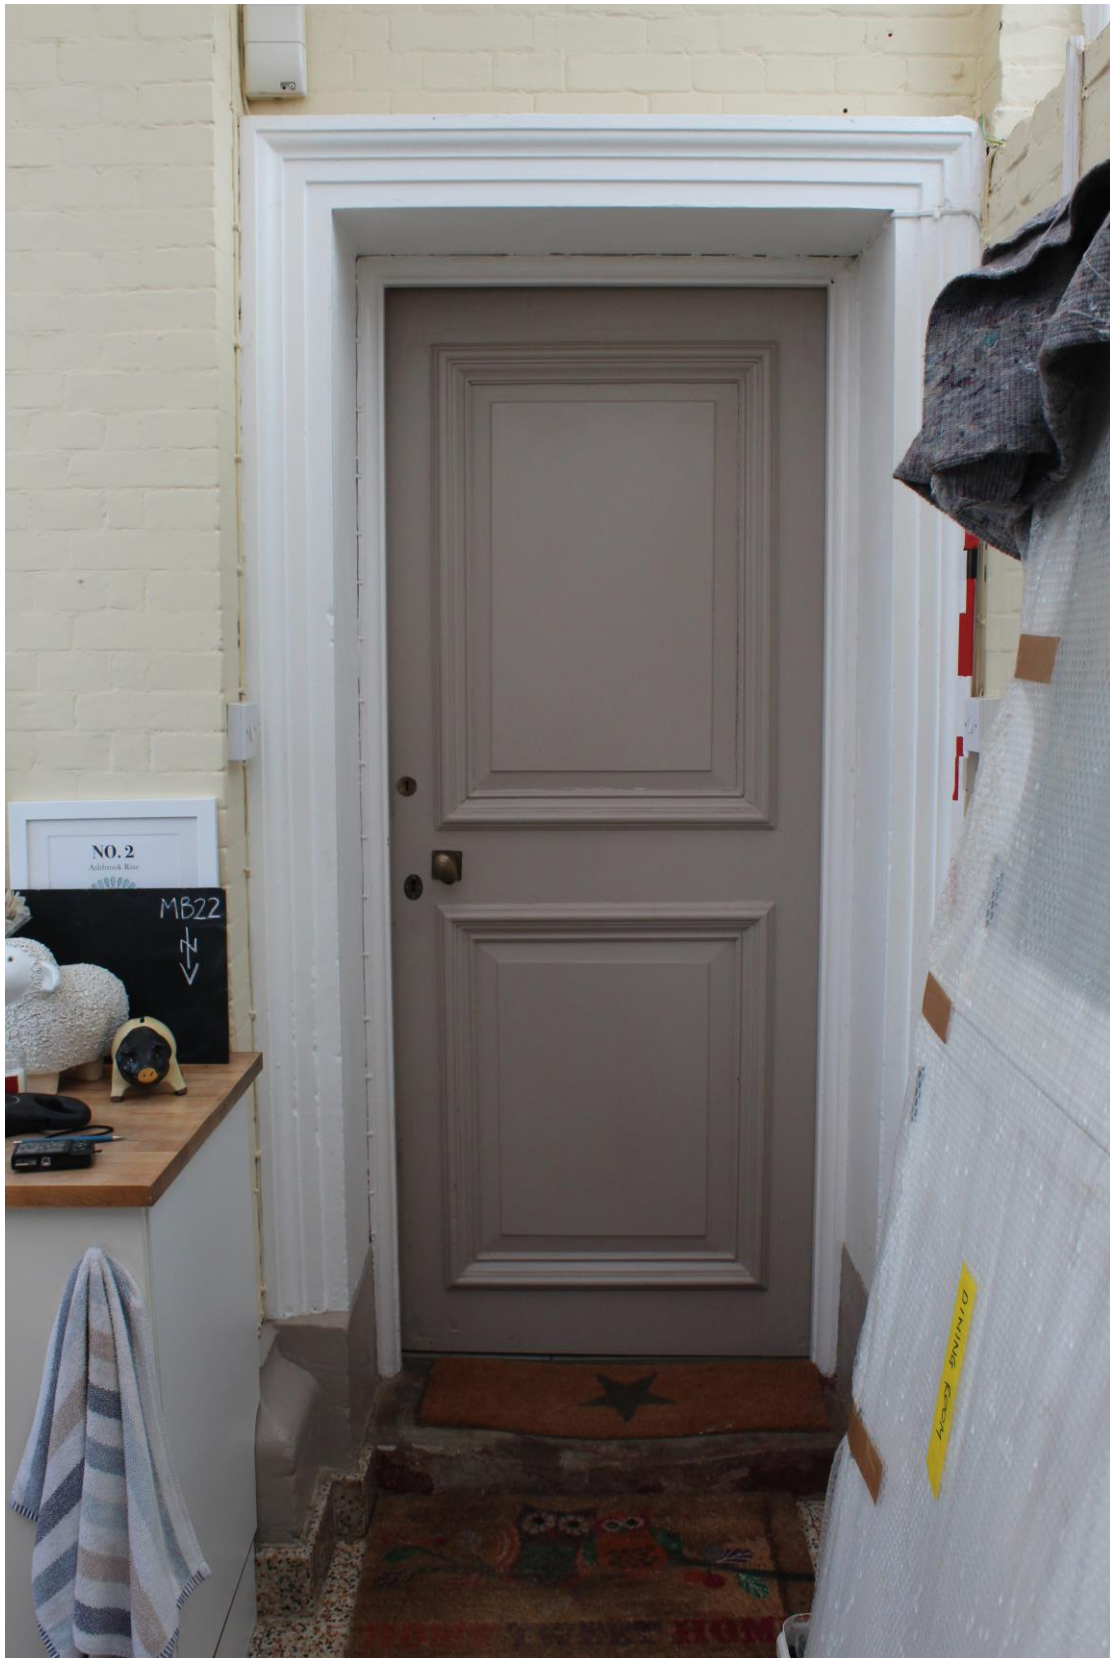
*Plate 19: The former backdoor, note the worn step. The part of the original kitchen-yard here was roofed over and incorporated the old WC in modern times to provide a laundry and utility room. The doorway from the yard to the garden beyond was retained in the scheme as the existing backdoor.*

When the utility room was added, the old WC was incorporated into the scheme and refitted completely, and the old back-gate was replaced by a new door. The coalhouse/woodshed was demolished but the enclosing wall was just reduced, opening this prospect of the house, with a new entry being cut through the north wall for access. Both outhouses were under pent roofs, and concealed from view, presumably so as not to mar the splendour of the lodge with service

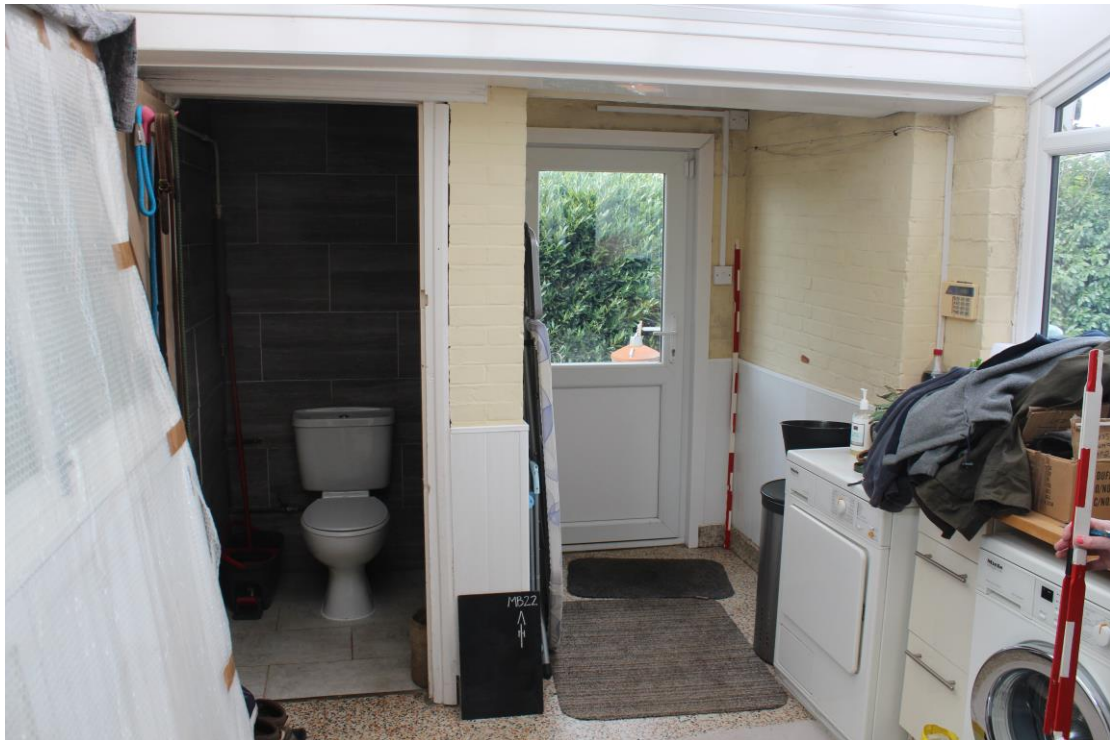
*Plate 20: The utility room showing the modernised WC, the wall to the right of the backdoor is the west wall of the lost woodshed/coalhouse.*

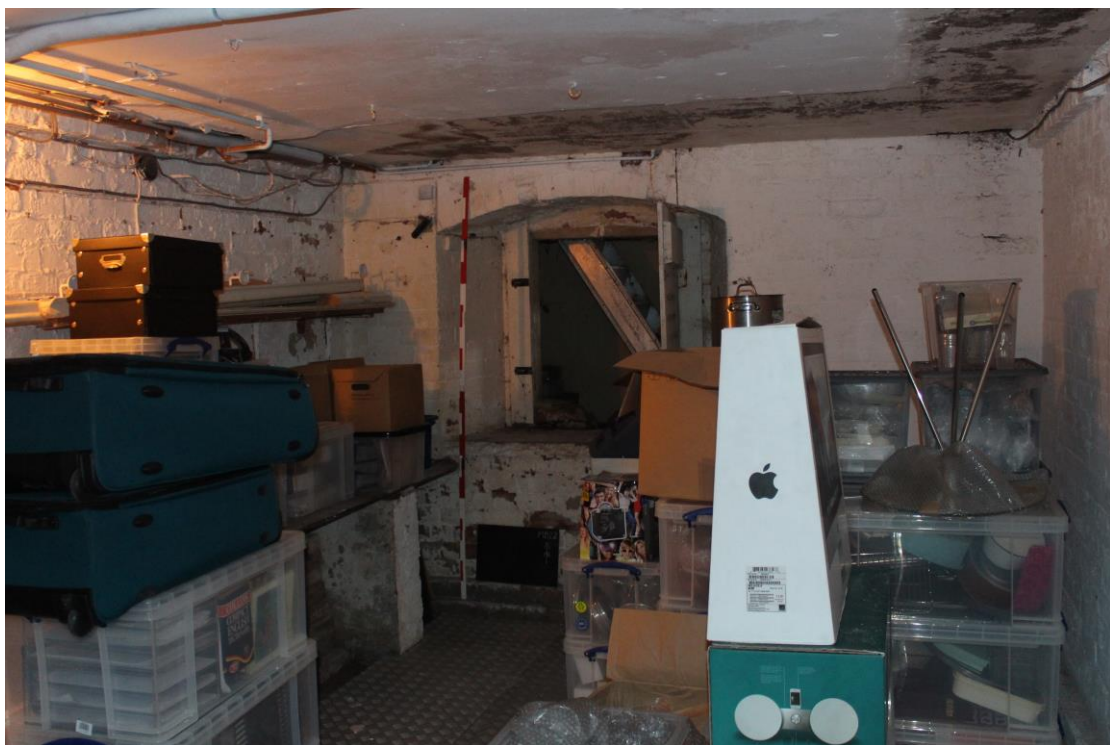
*Plate 21: The cellar, showing the slate cold-shelf and the masonry of the casement window. The mullion was removed, a simple doorway added, and a short ladder inserted into the lightwell to provide external access.*

The cellar is accessed from the front hallway through a heavily moulded door like the others here, to the parlour and to the dining-room, and there is a matching moulded panel above it. The stone casement-window at the far end, looking out to a light-well, has had its mullion removed to provide external access and a rude boarded door has been inserted. The central slab of slate-shelf, supported on brick walls, has been removed to provide access to the modern boiler set into an original recess. Both heads of recess and window rere-arch have segmental-heads.
