Hinckley West  
Leicestershire

**Phase II Exploratory Investigation Report  
For  
Bloor Homes Midlands**

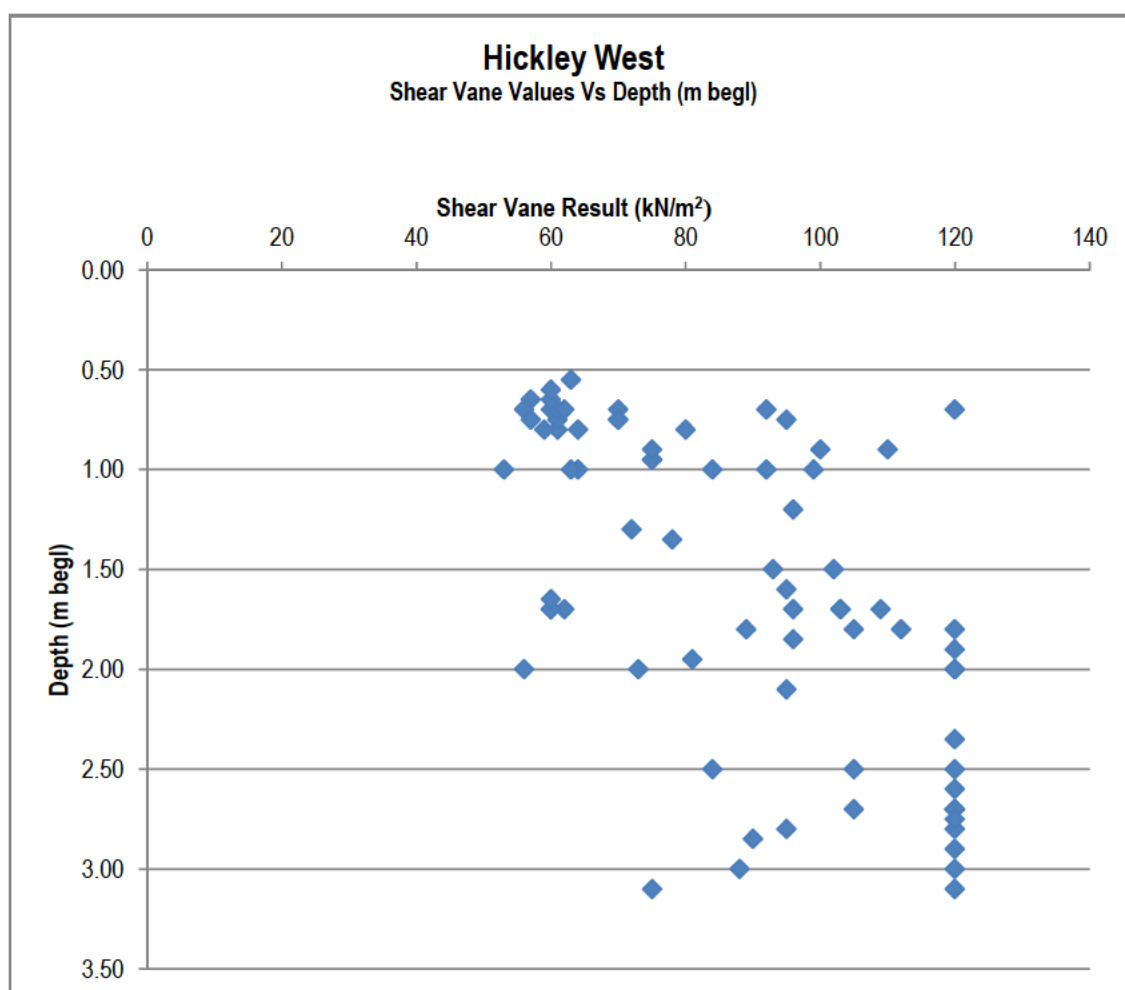
It should be noted that shear vane testing undertaken at depths greater than 1.00m was carried out ex-situ for health and safety reasons.

A graph showing shear vane results in relation to depth is presented on the next page.

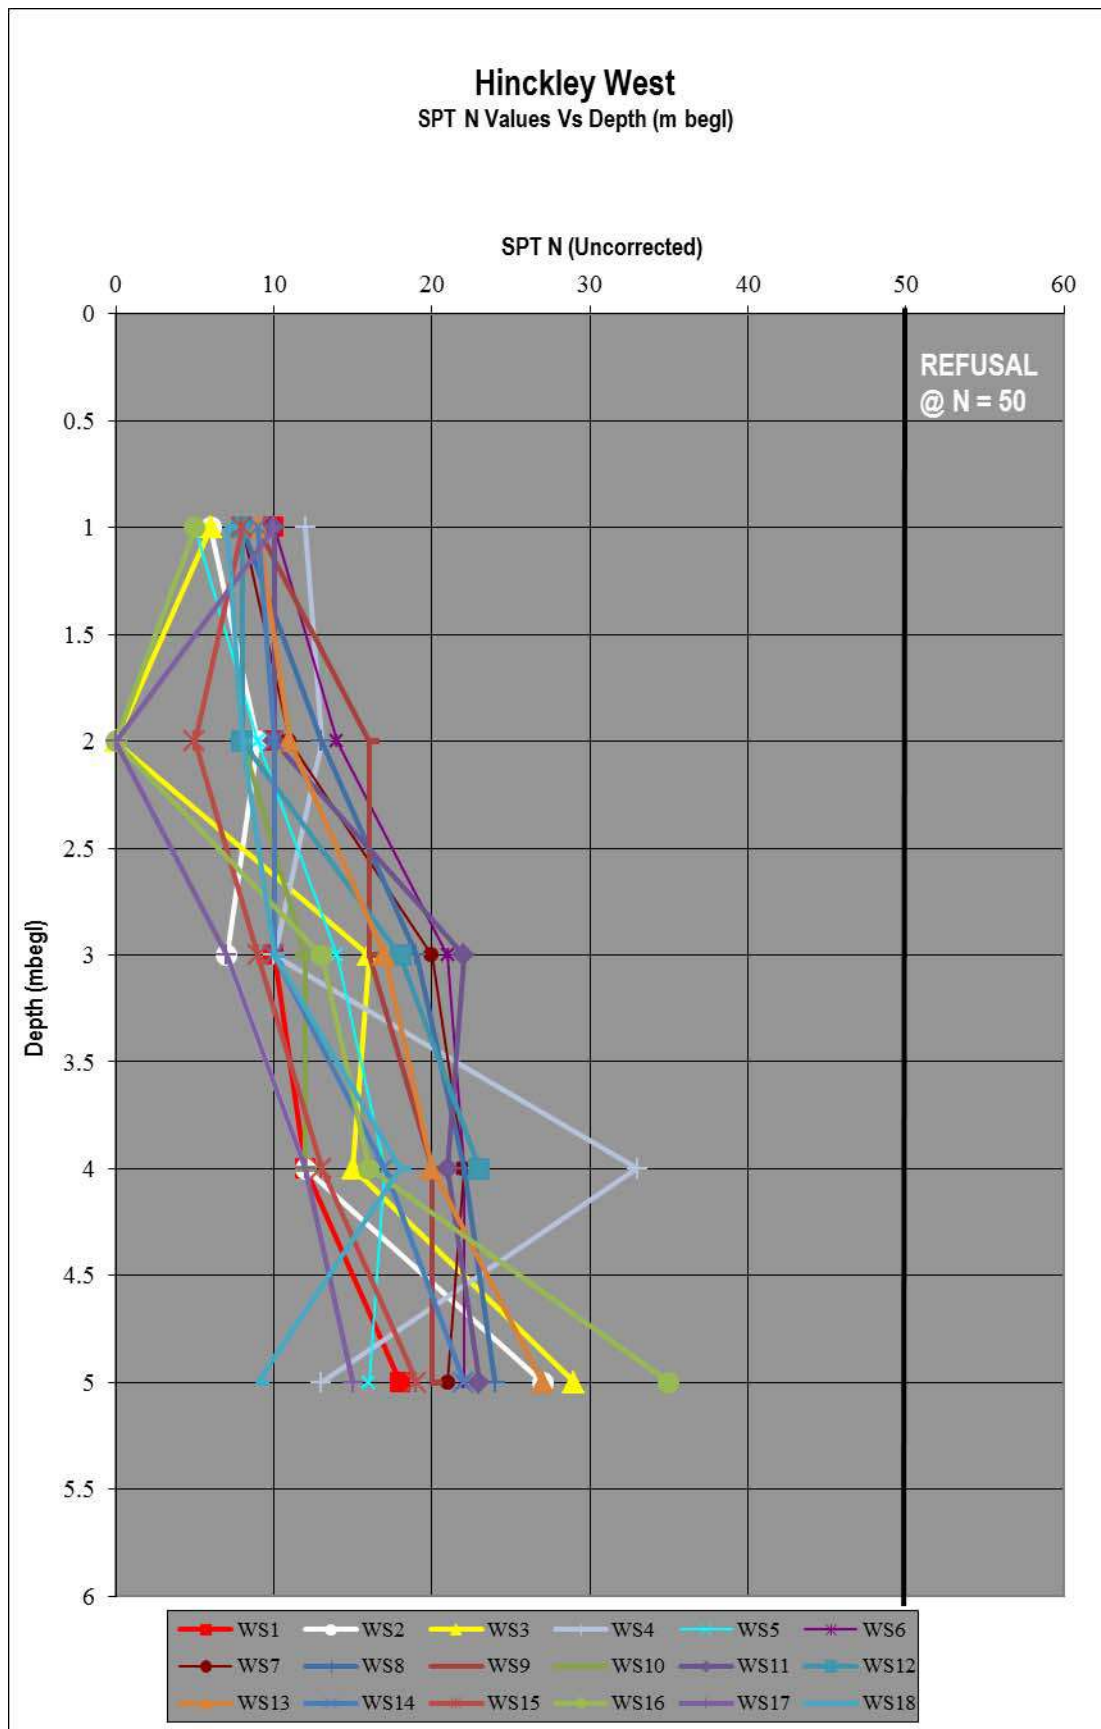
The results show the SPT 'N' values to generally increase with greater depth and are recorded on the logs in Appendix V

An SPT Vs Depth Chart of the data obtained from the boreholes advanced at the site is shown on the next page.

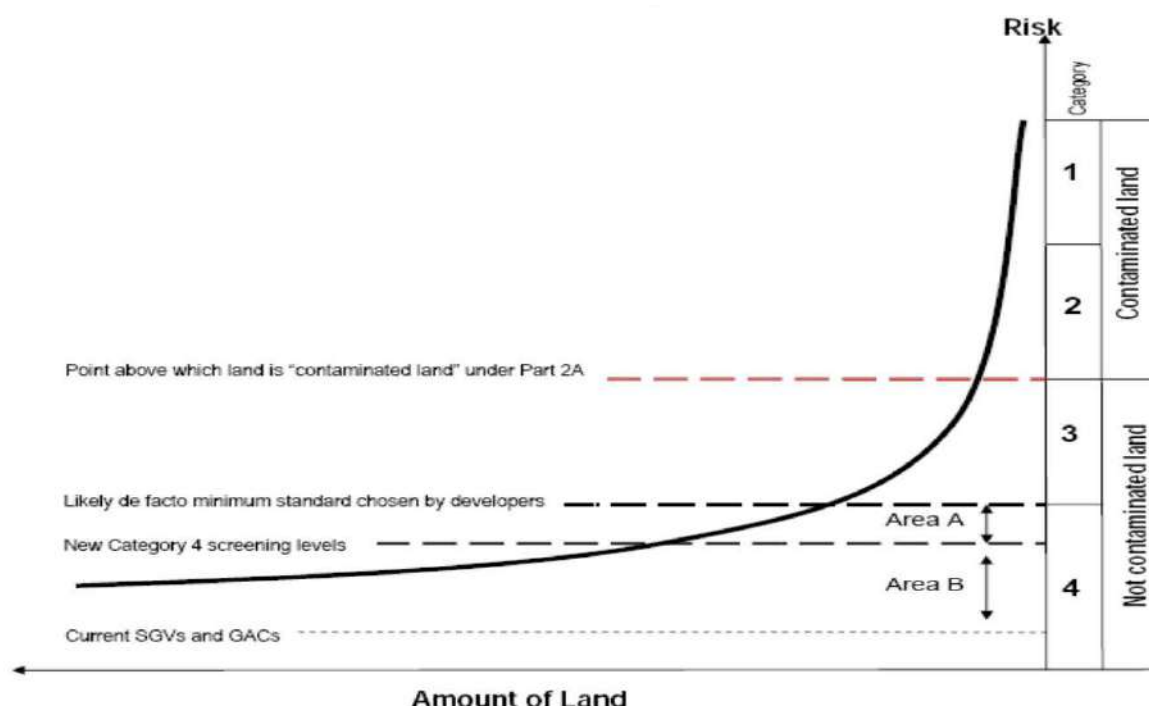
The foregoing categories are depicted in diagrammatical form in the following graph (taken from Defra publication SP1010):

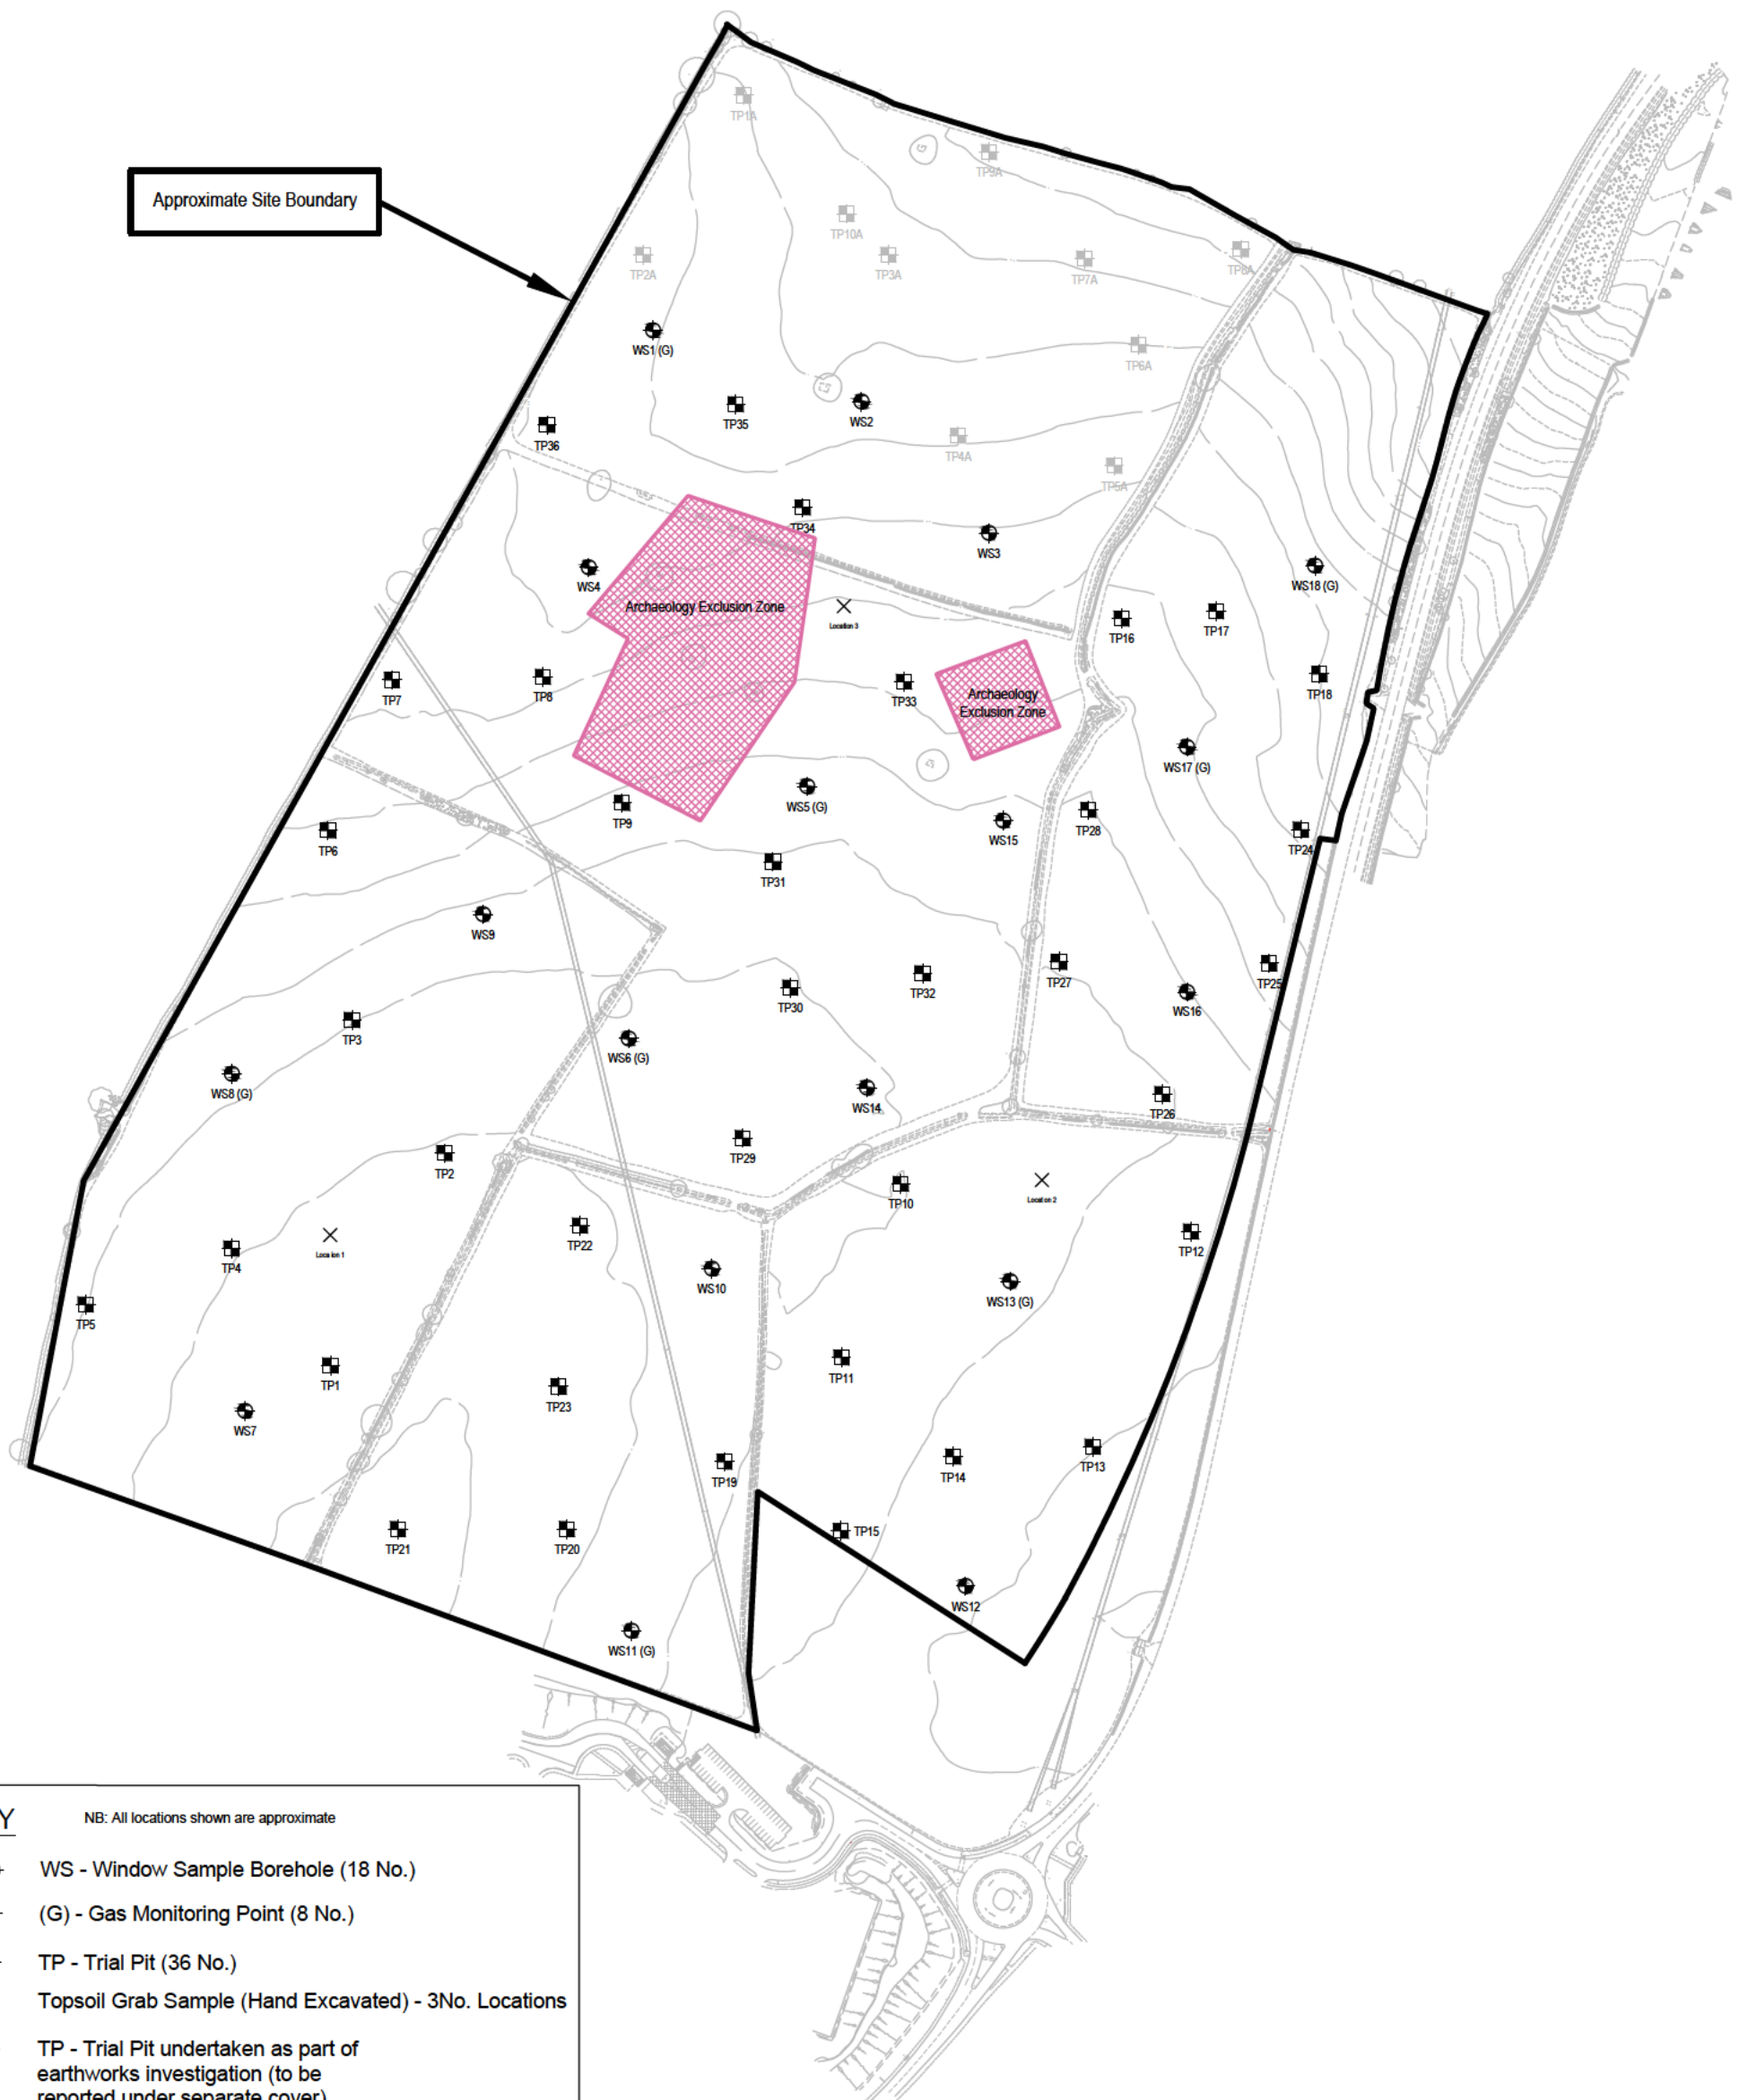
**Exploratory Hole Location Plan & GPS Co-ordinates  
(Figure No. D36147/04)**

The approximate locations of the exploratory holes are shown on the plan presented in Appendix IV (Figure No. D36147/04). Exploratory hole locations were positioned using a hand held GeoExplorer 5T GPS, with a claimed sub-metre accuracy of approximately 1m; accuracy subject to satellite coverage, line of-sight conditions etc. The GPS coordinates are presented on a separate sheet in Appendix IV. The exploratory hole logs are presented in Appendix V of this report.

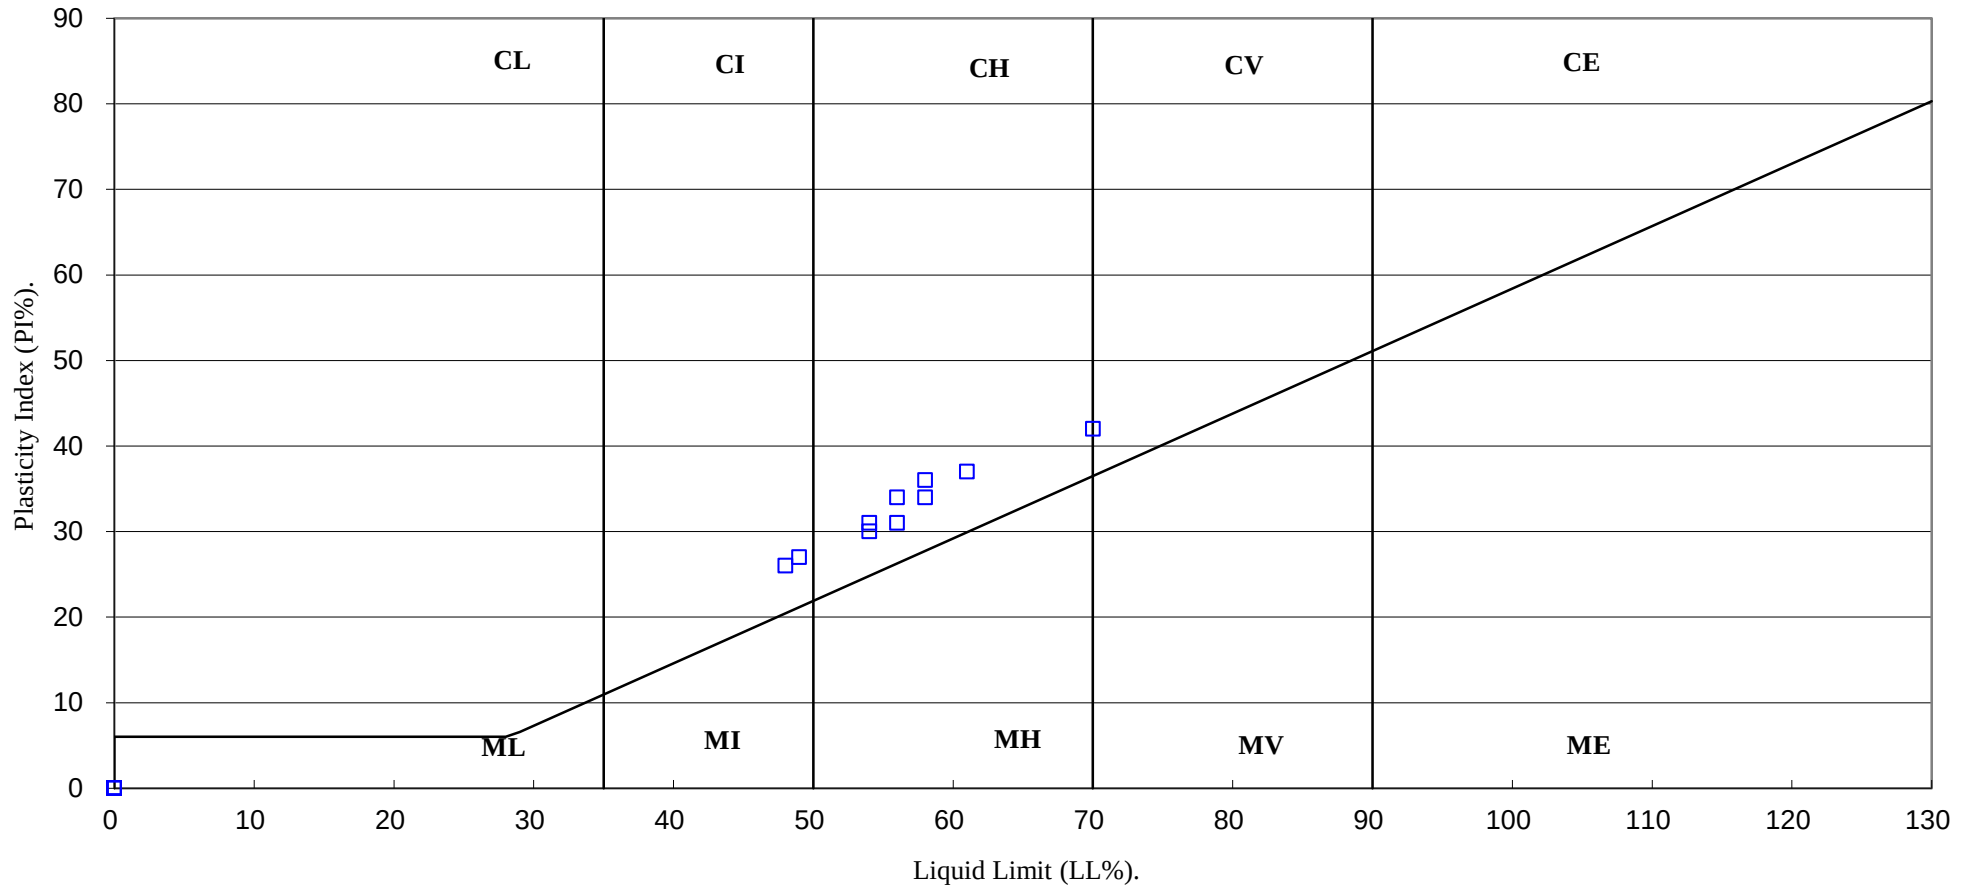
# PLASTICITY CHART FOR CASAGRANDE CLASSIFICATION.

(BS5930 :2015)

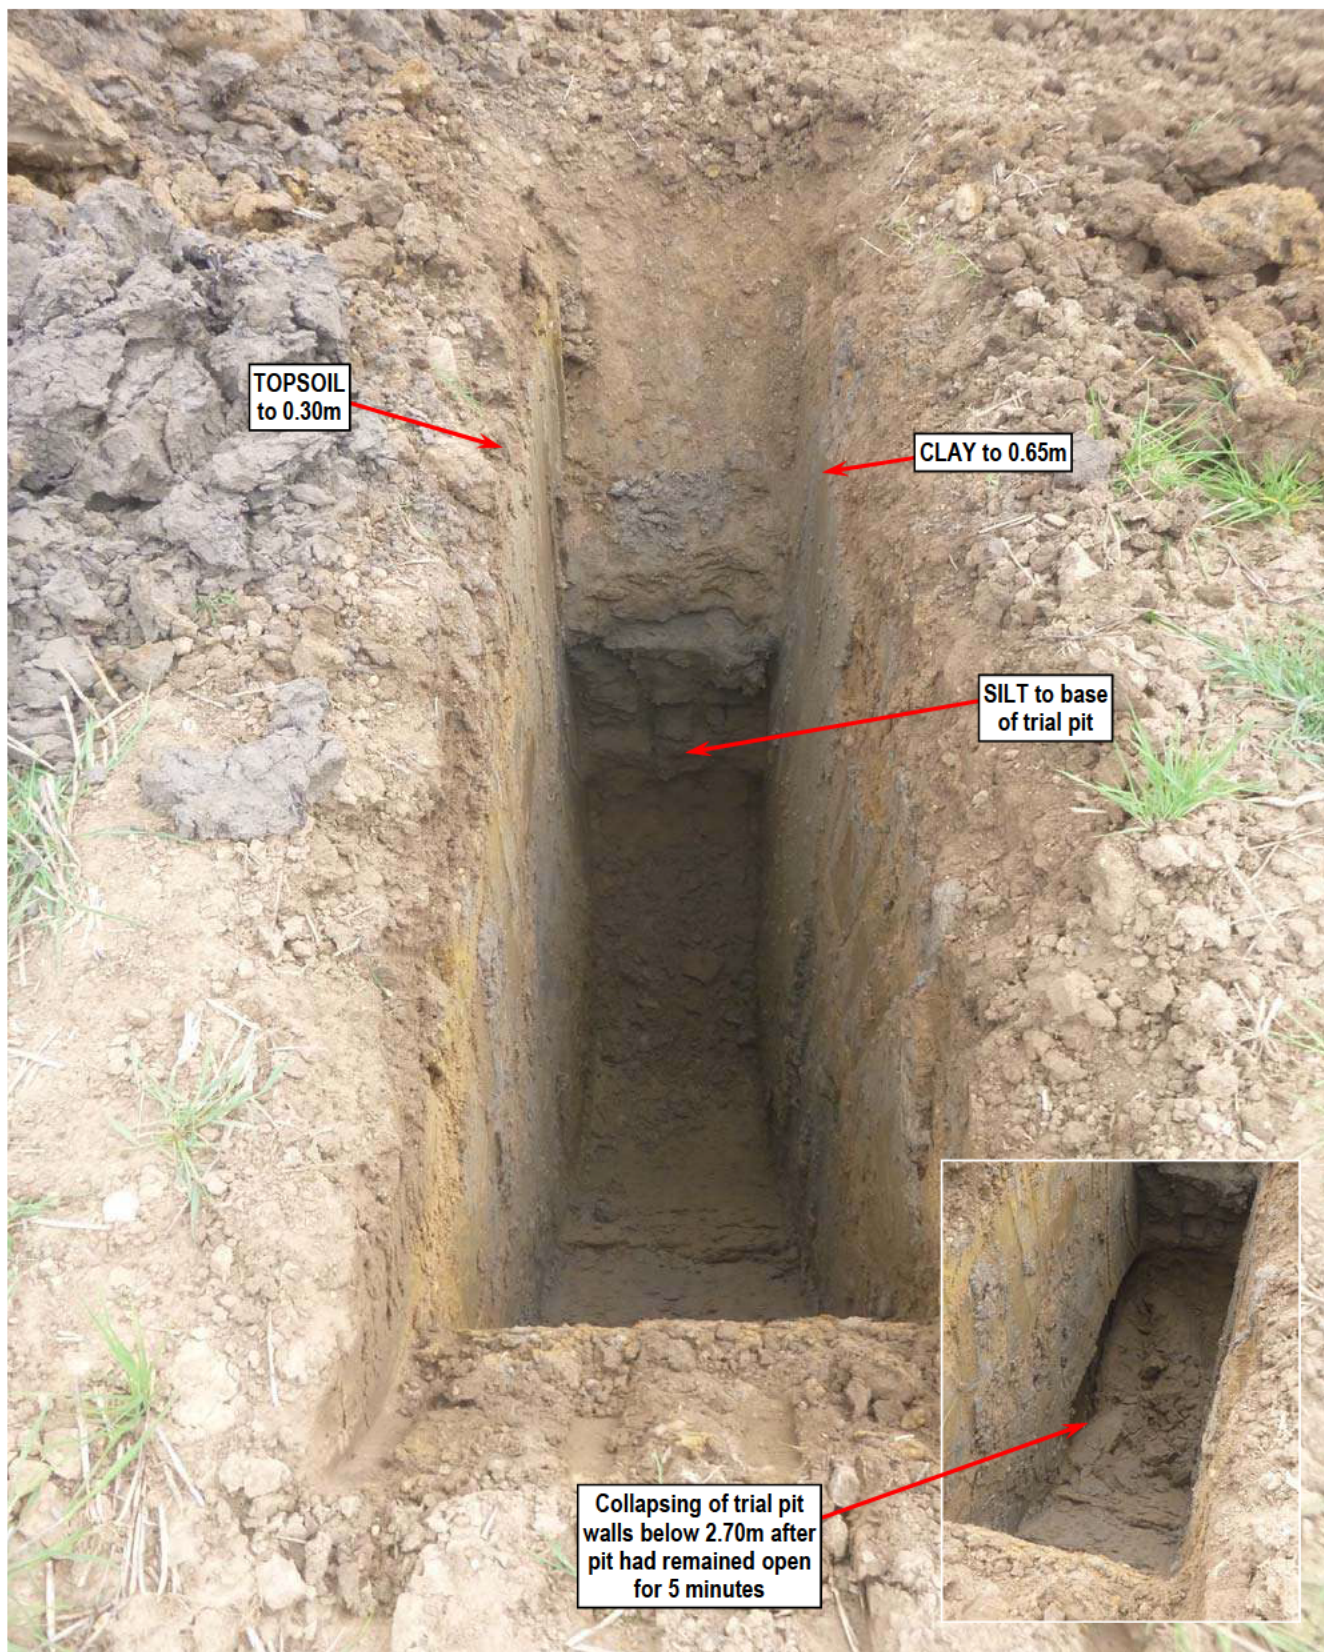
| Title | Completed Excavation (TP18) | Plate No. 4 | |

Collapsing of trial pit walls was only recorded in four locations, each time during excavations within the natural Silt strata. In TP18 and TP36 collapsing of the pit walls occurred after the pits had remained open for five minutes. Collapsing was recorded below a depth of 2.70m begl in TP18, and from between 1.50m and 2.80m begl in TP36. In TP18 the collapsing caused the undermining of shallower strata. In TP33 and TP35 collapsing occurred as the pits were being excavated; collapsing was recorded at depths in excess of 2.30m begl and in both cases caused the undermining of shallower strata. In TP18, TP33 and TP35, the collapsing appeared to be associated with groundwater seepages.

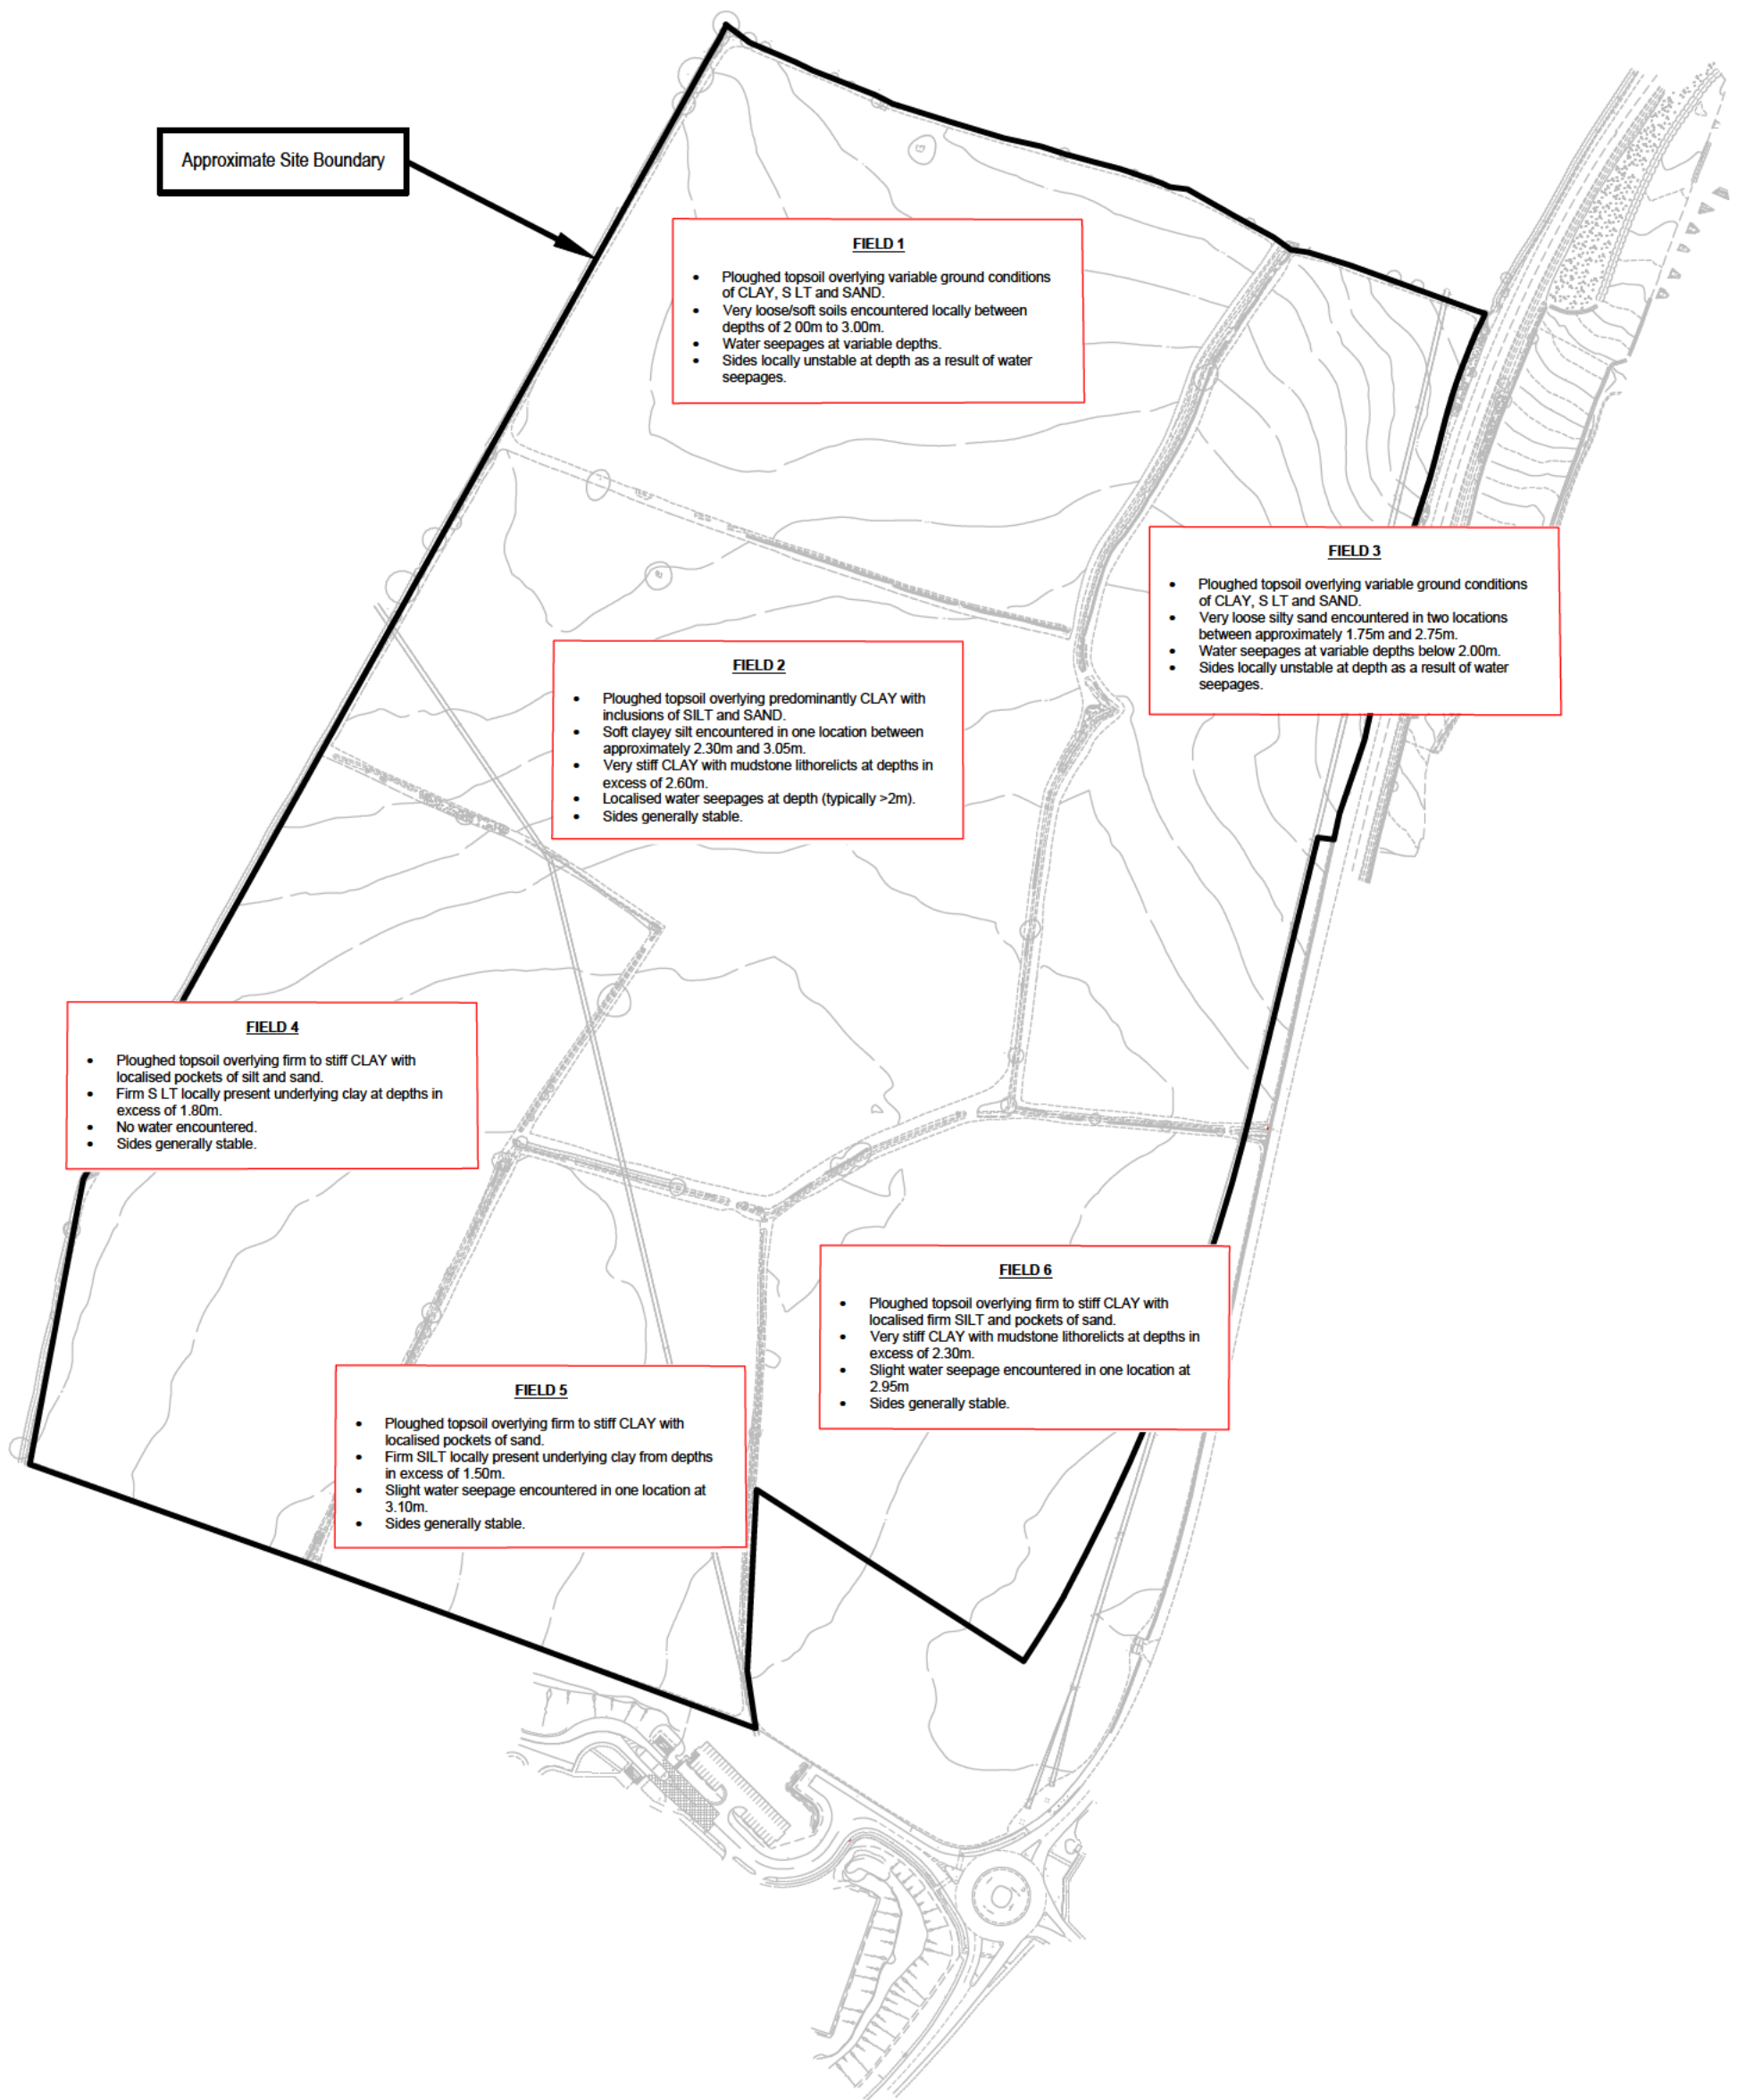
**Ground Conditions Plan  
(Figure No. D36147/06)**

| Ground Conditions | Reference should be made to the Ground Conditions Plan (Figure No. D36147/06), which is presented in Appendix XI of this report and summarises the ground conditions on a field by field basis. |

Reference should be made to the Ground Conditions Plan (Figure No. D36147/06), which is presented in Appendix XI of this report and summarises the ground conditions on a field by field basis.

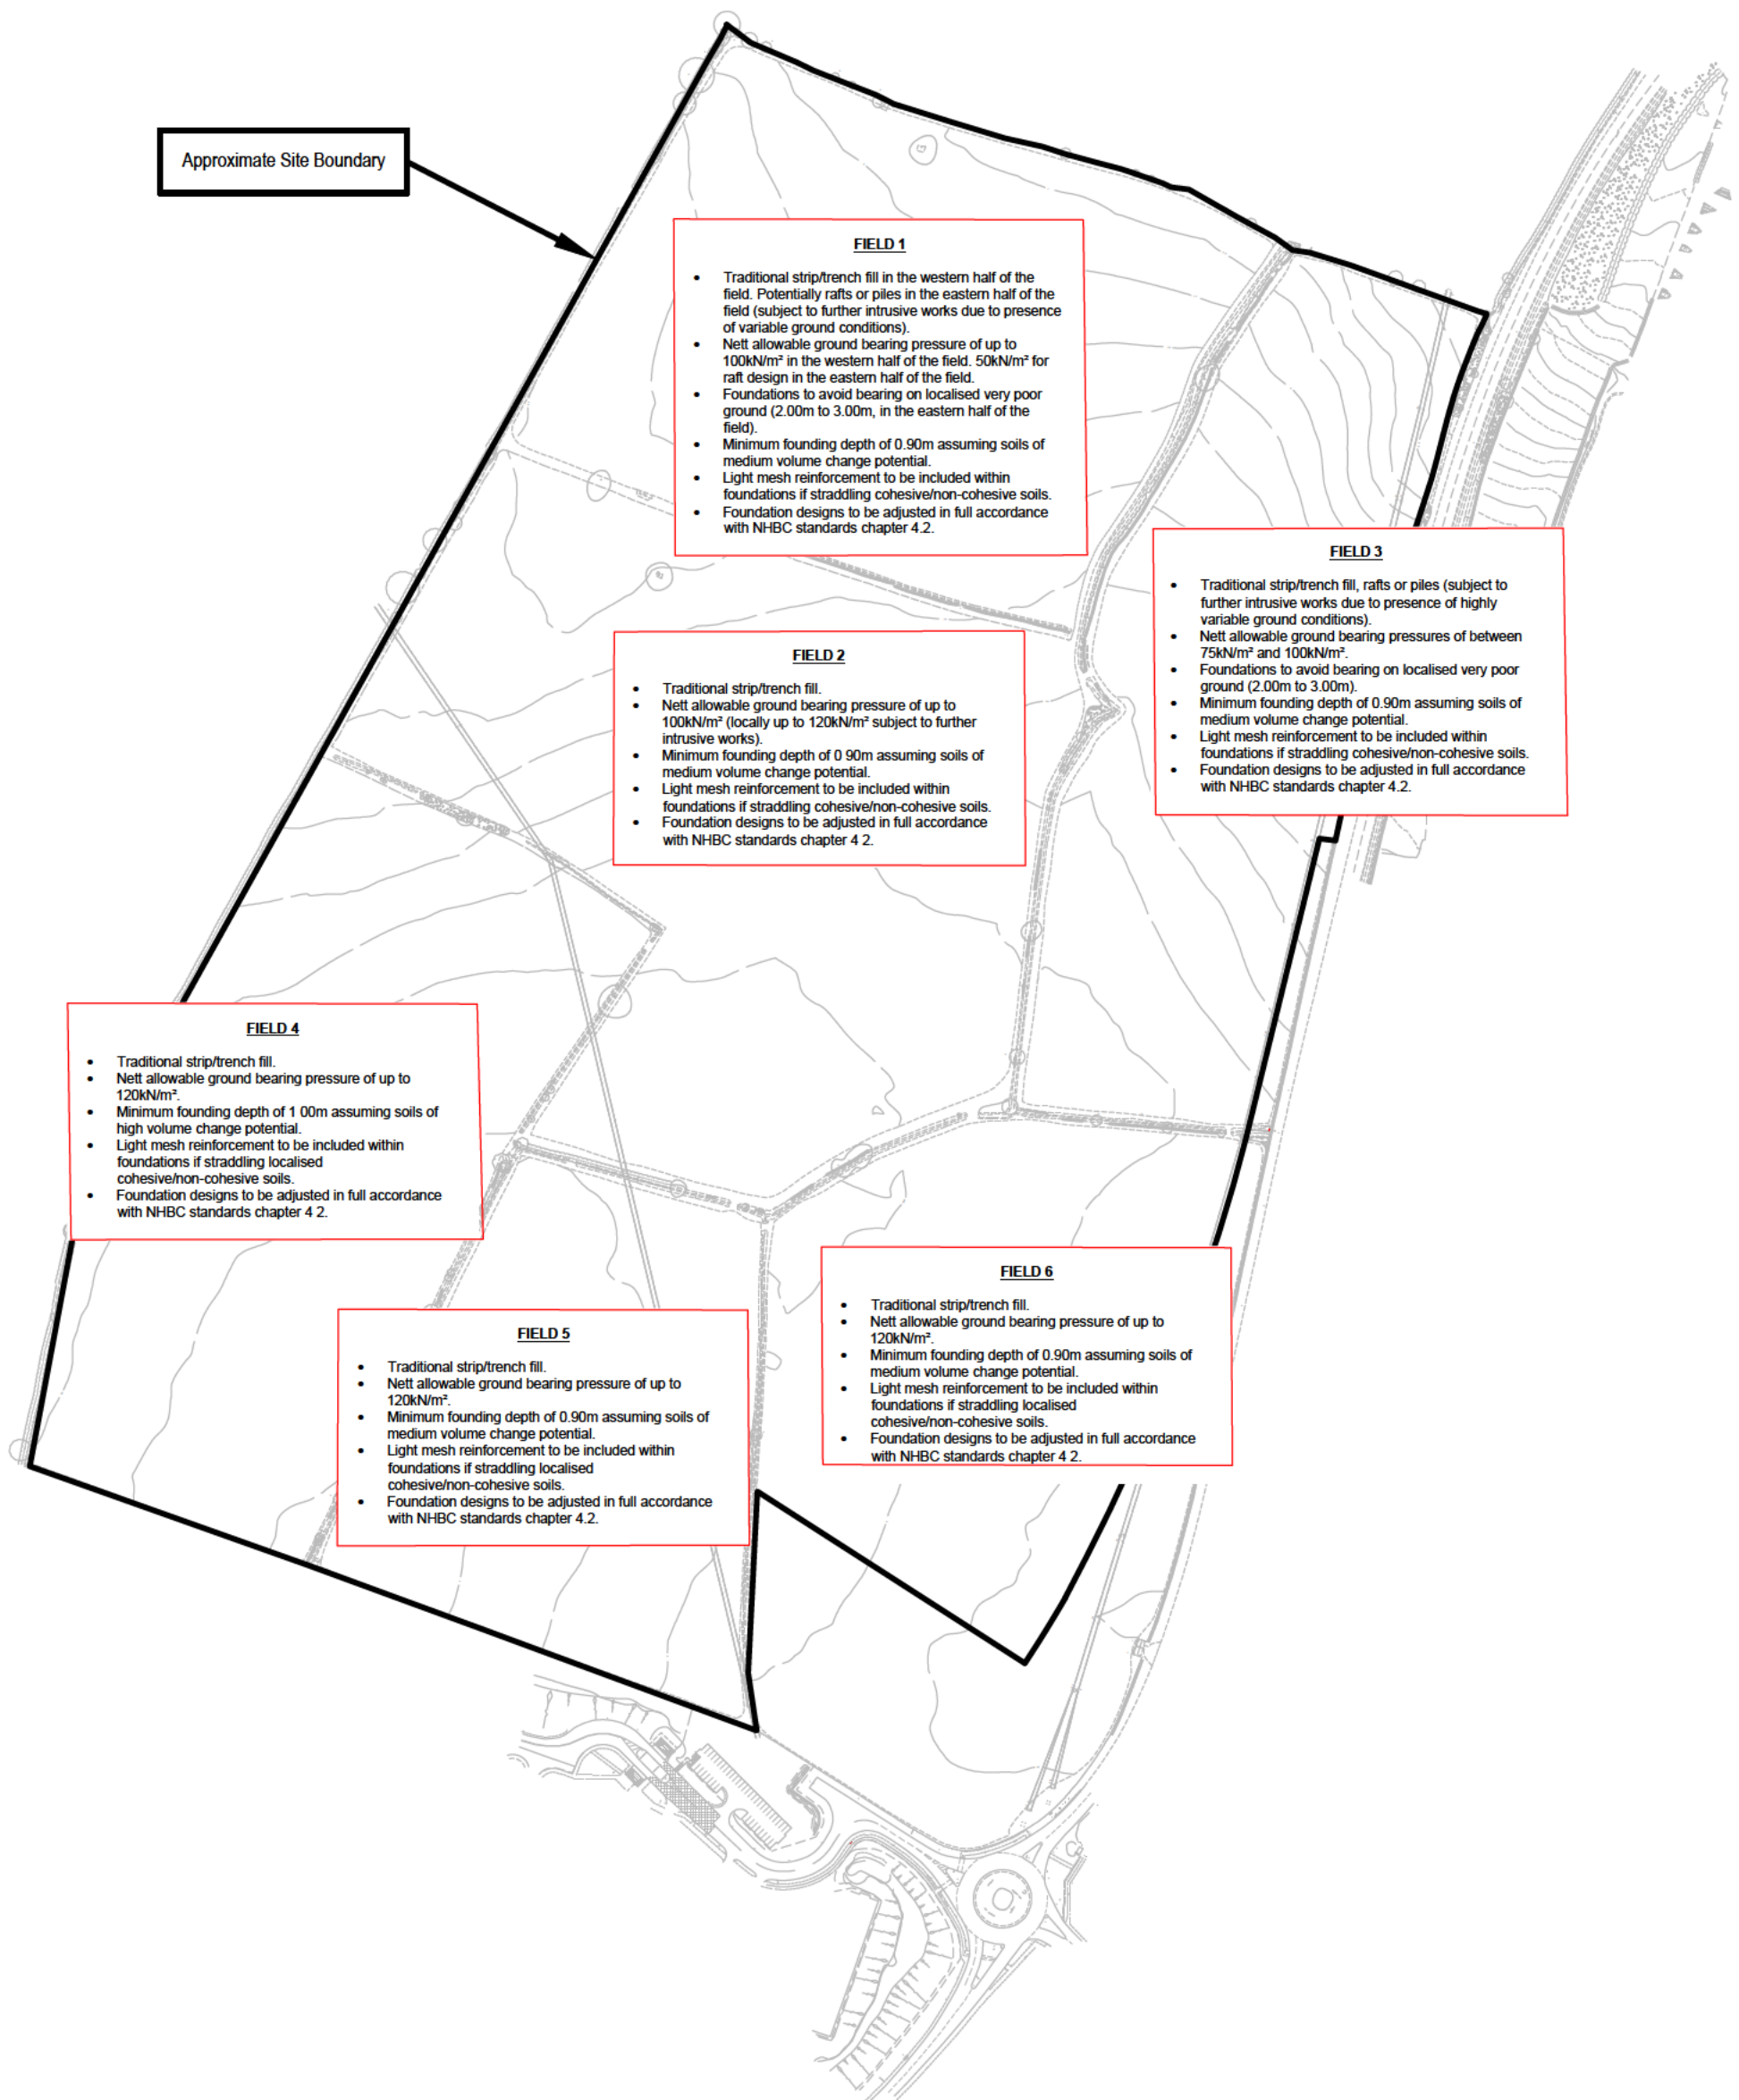
**Foundation Summary Plan  
(Figure No. D36147/07)**

| Foundation Design | A Foundation Summary Plan (Figure No. D36147/07), which summarises the foundation recommendations on a field by field basis, is presented in Appendix XII. |

The following foundation design recommendations comprise general advice for the entire site area. Based on the large size of the site (approximately 45Ha), a prudent developer may wish to commission parcel specific trial pitting and reports once the layout/development proposals, including levels, have been confirmed. In addition to the advice given below, a Foundation Summary Plan (Figure No. D36147/07), which summarises the foundation recommendations on a field by field basis, is presented in Appendix XII.
