**RODGERS LEASK  
ENVIRONMENTAL**

Kirkby Road, Desford  
Infiltration Test Factual Report

Project: Kirkby Road, Desford

**INTRUSIVE LOCATION PLAN -  
SOAKAWAY TESTING**

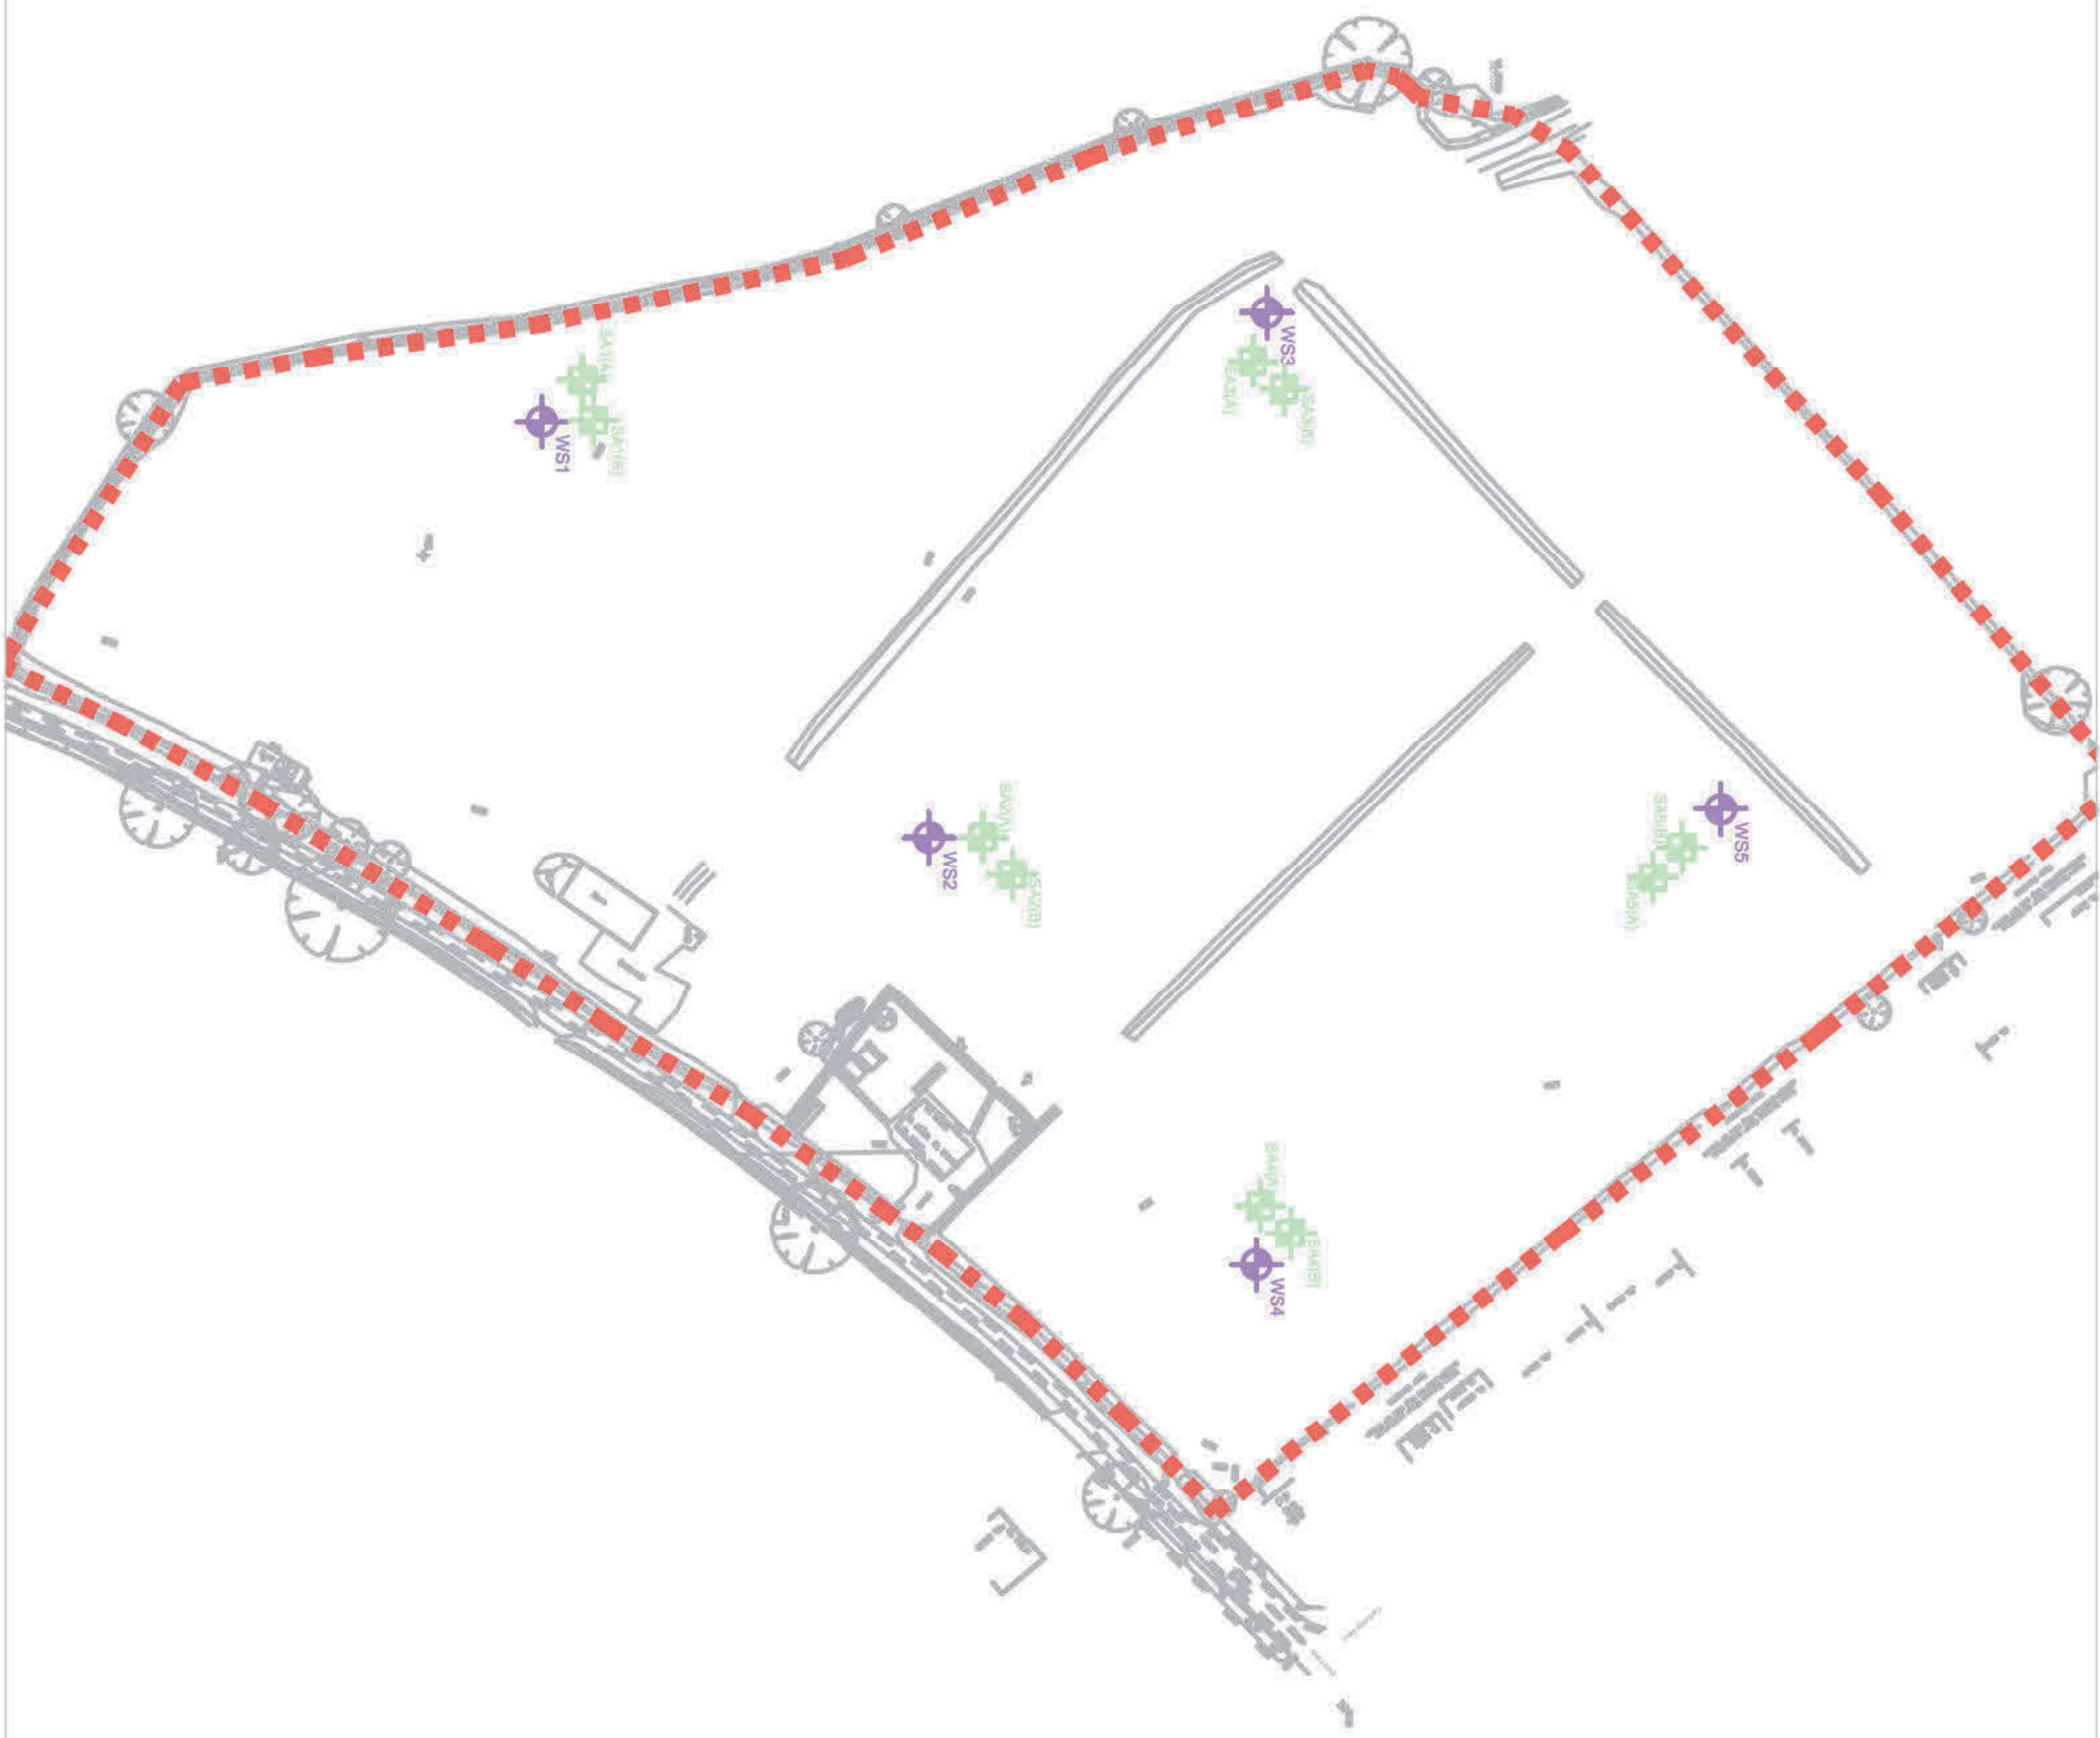
RLL, undertaking civil drainage assessment for the site provided the preferred locations for the TP's. The locations of the TP's are indicated on RLE Drawing No. P14-310-003 contained in Appendix B of this report.
