Barwell Capitol  
Barwell East

Hinckley Road, Barwell

Arboricultural Method Statement and  
Tree Protection Plan

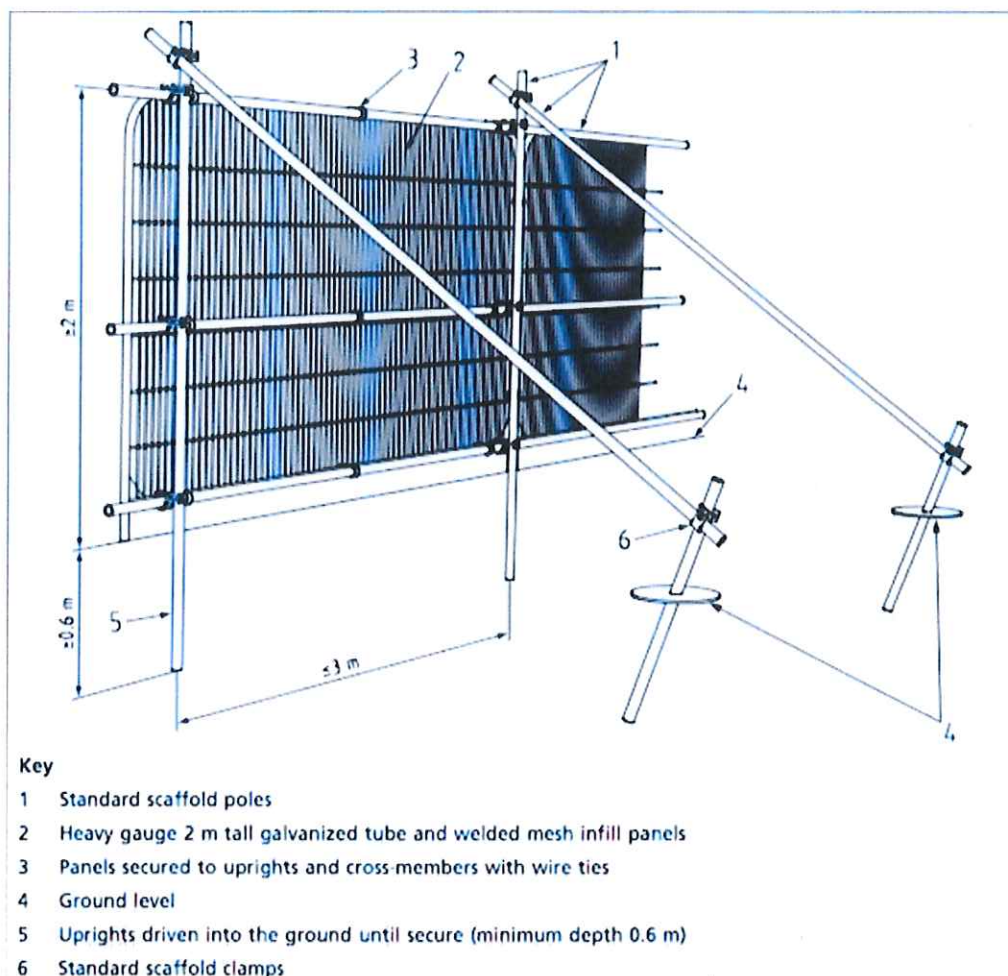
- 2.35 **Figure 1.** Default Specification for Protective Barrier (Tree Protection Fencing – TPF) (Taken from Figure 2 of Section 6 BS5837:2012)

- 2.31 The default TPF specification (**Figure 1**) is a vertical and horizontal scaffold framework, braced to resist impacts. The vertical poles are driven securely into the ground with horizontal poles connected securely to the vertical sections. Bracing bars must then be securely attached to prevent movement of the structure if struck by machinery. Welded mesh panels are then securely attached to the scaffold framework. During installation it is important to consider the position of below ground services and structural roots, which must not be damaged. Where these constraints prevent the use of this specification, an alternative specification is provided in **Figure 2**.

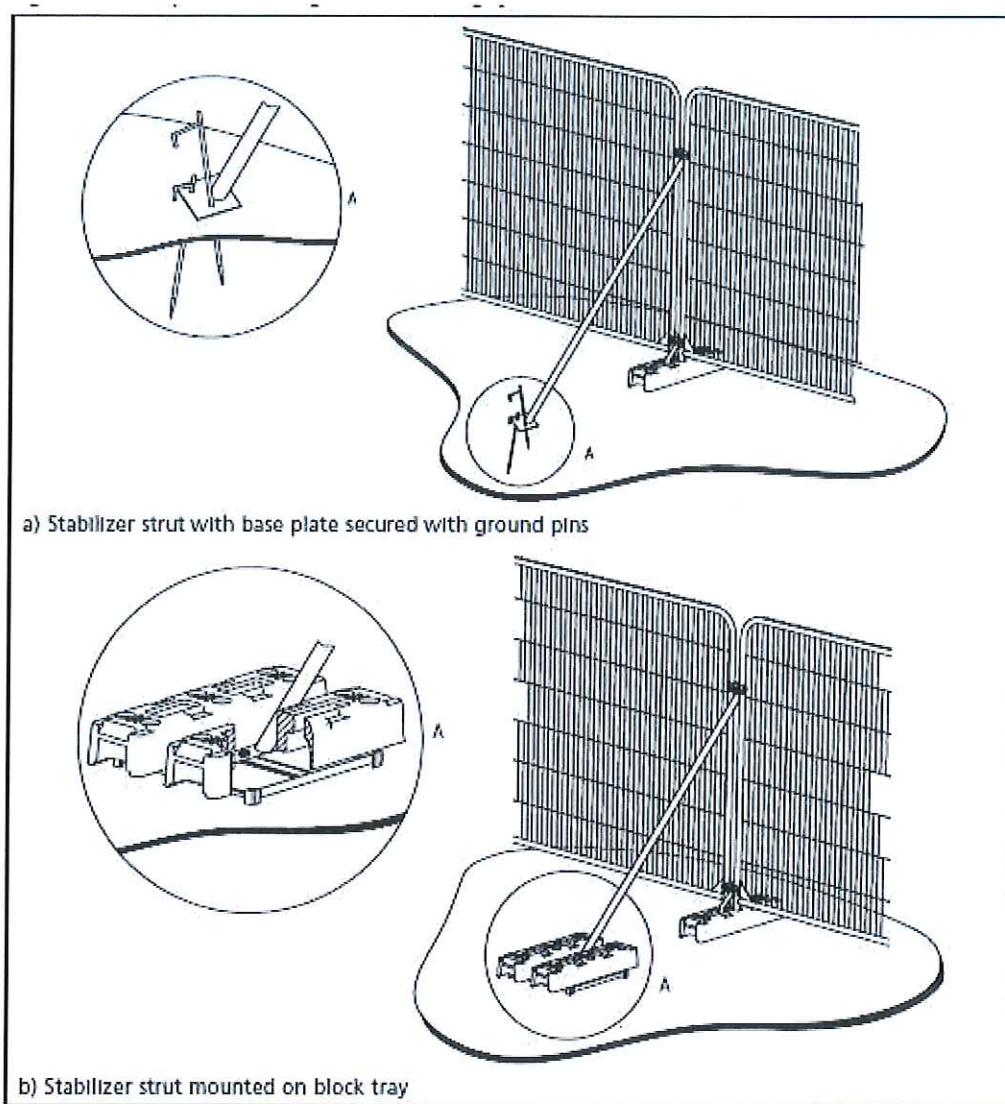
2.39 **Figure 2.** Above Ground Stabilising Systems

- 2.36 An alternative Tree Protection Fencing (TPF) design is shown on **Figure 2.**
- 2.37 2 metre tall welded mesh panels standing in rubber or concrete feet joined using a minimum of two anti-tamper couplers installed so they can only be removed from inside the protected area. The fence couplers should be at spaced least 1 metre apart, but uniformly across the whole barrier. These panels must be supported within the protected area with struts attached to a base plate secured by ground pins as per Figure 2.

- 2.38 Where the fencing is installed above retained hard surfacing and / or it is otherwise not feasible to use ground pins (e.g. due to underlying services or structural roots), the struts can be mounted on a block tray as per Figure 2.

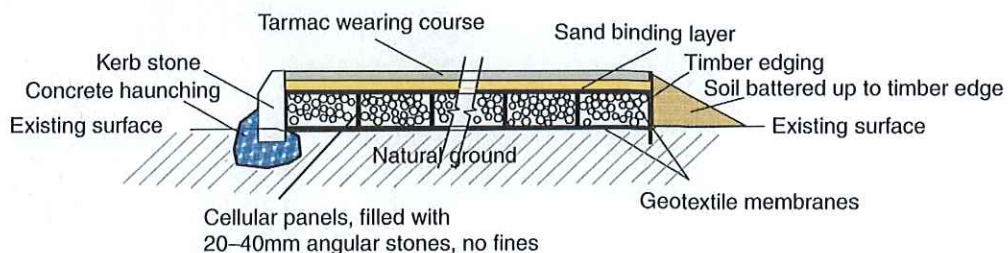
**Figure 3.** Example Cellular Confinement System (Cox 2011)

- 2.56 The final surface may then be either permeable tarmac, block paviors with an appropriate binding layer such as sand or loose material such as gravel or bark chip to allow continual movement of air and water through the surface to the soil volume below.

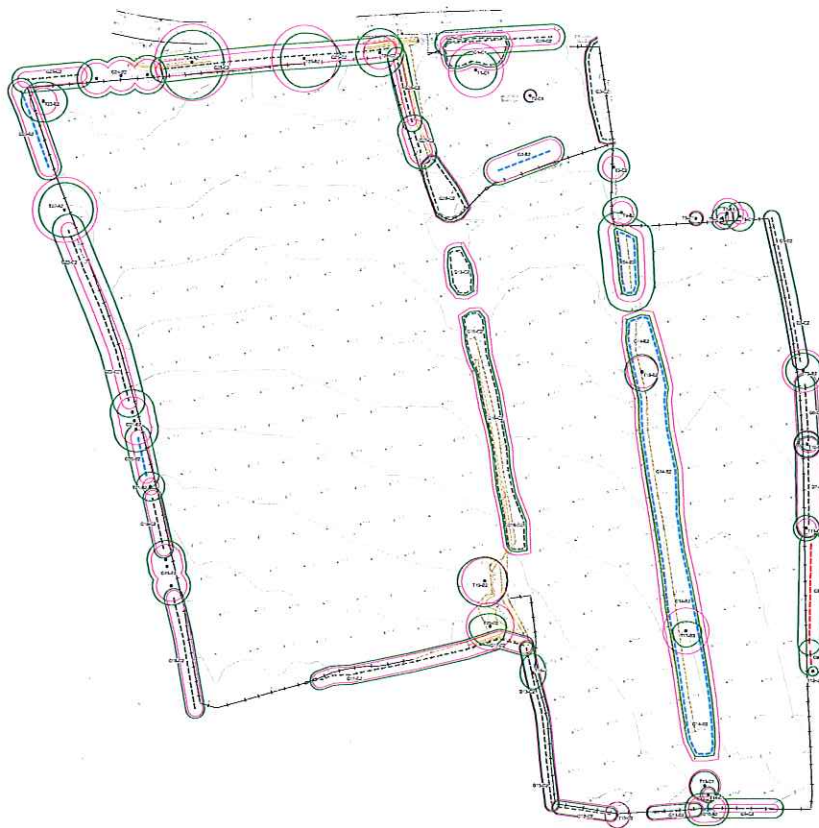
## Appendix 1: Tree Constraints Plan

Tree Constraints Plan  
 showing tree categories  
 and root protection  
 zones.
