Our Ref: P10481/GAL  
Date: 21<sup>st</sup> March 2024

**Re: Gas Addendum Letter Report for Lychgate Lane, Burbage**

**In-Situ Gas Monitoring Results**

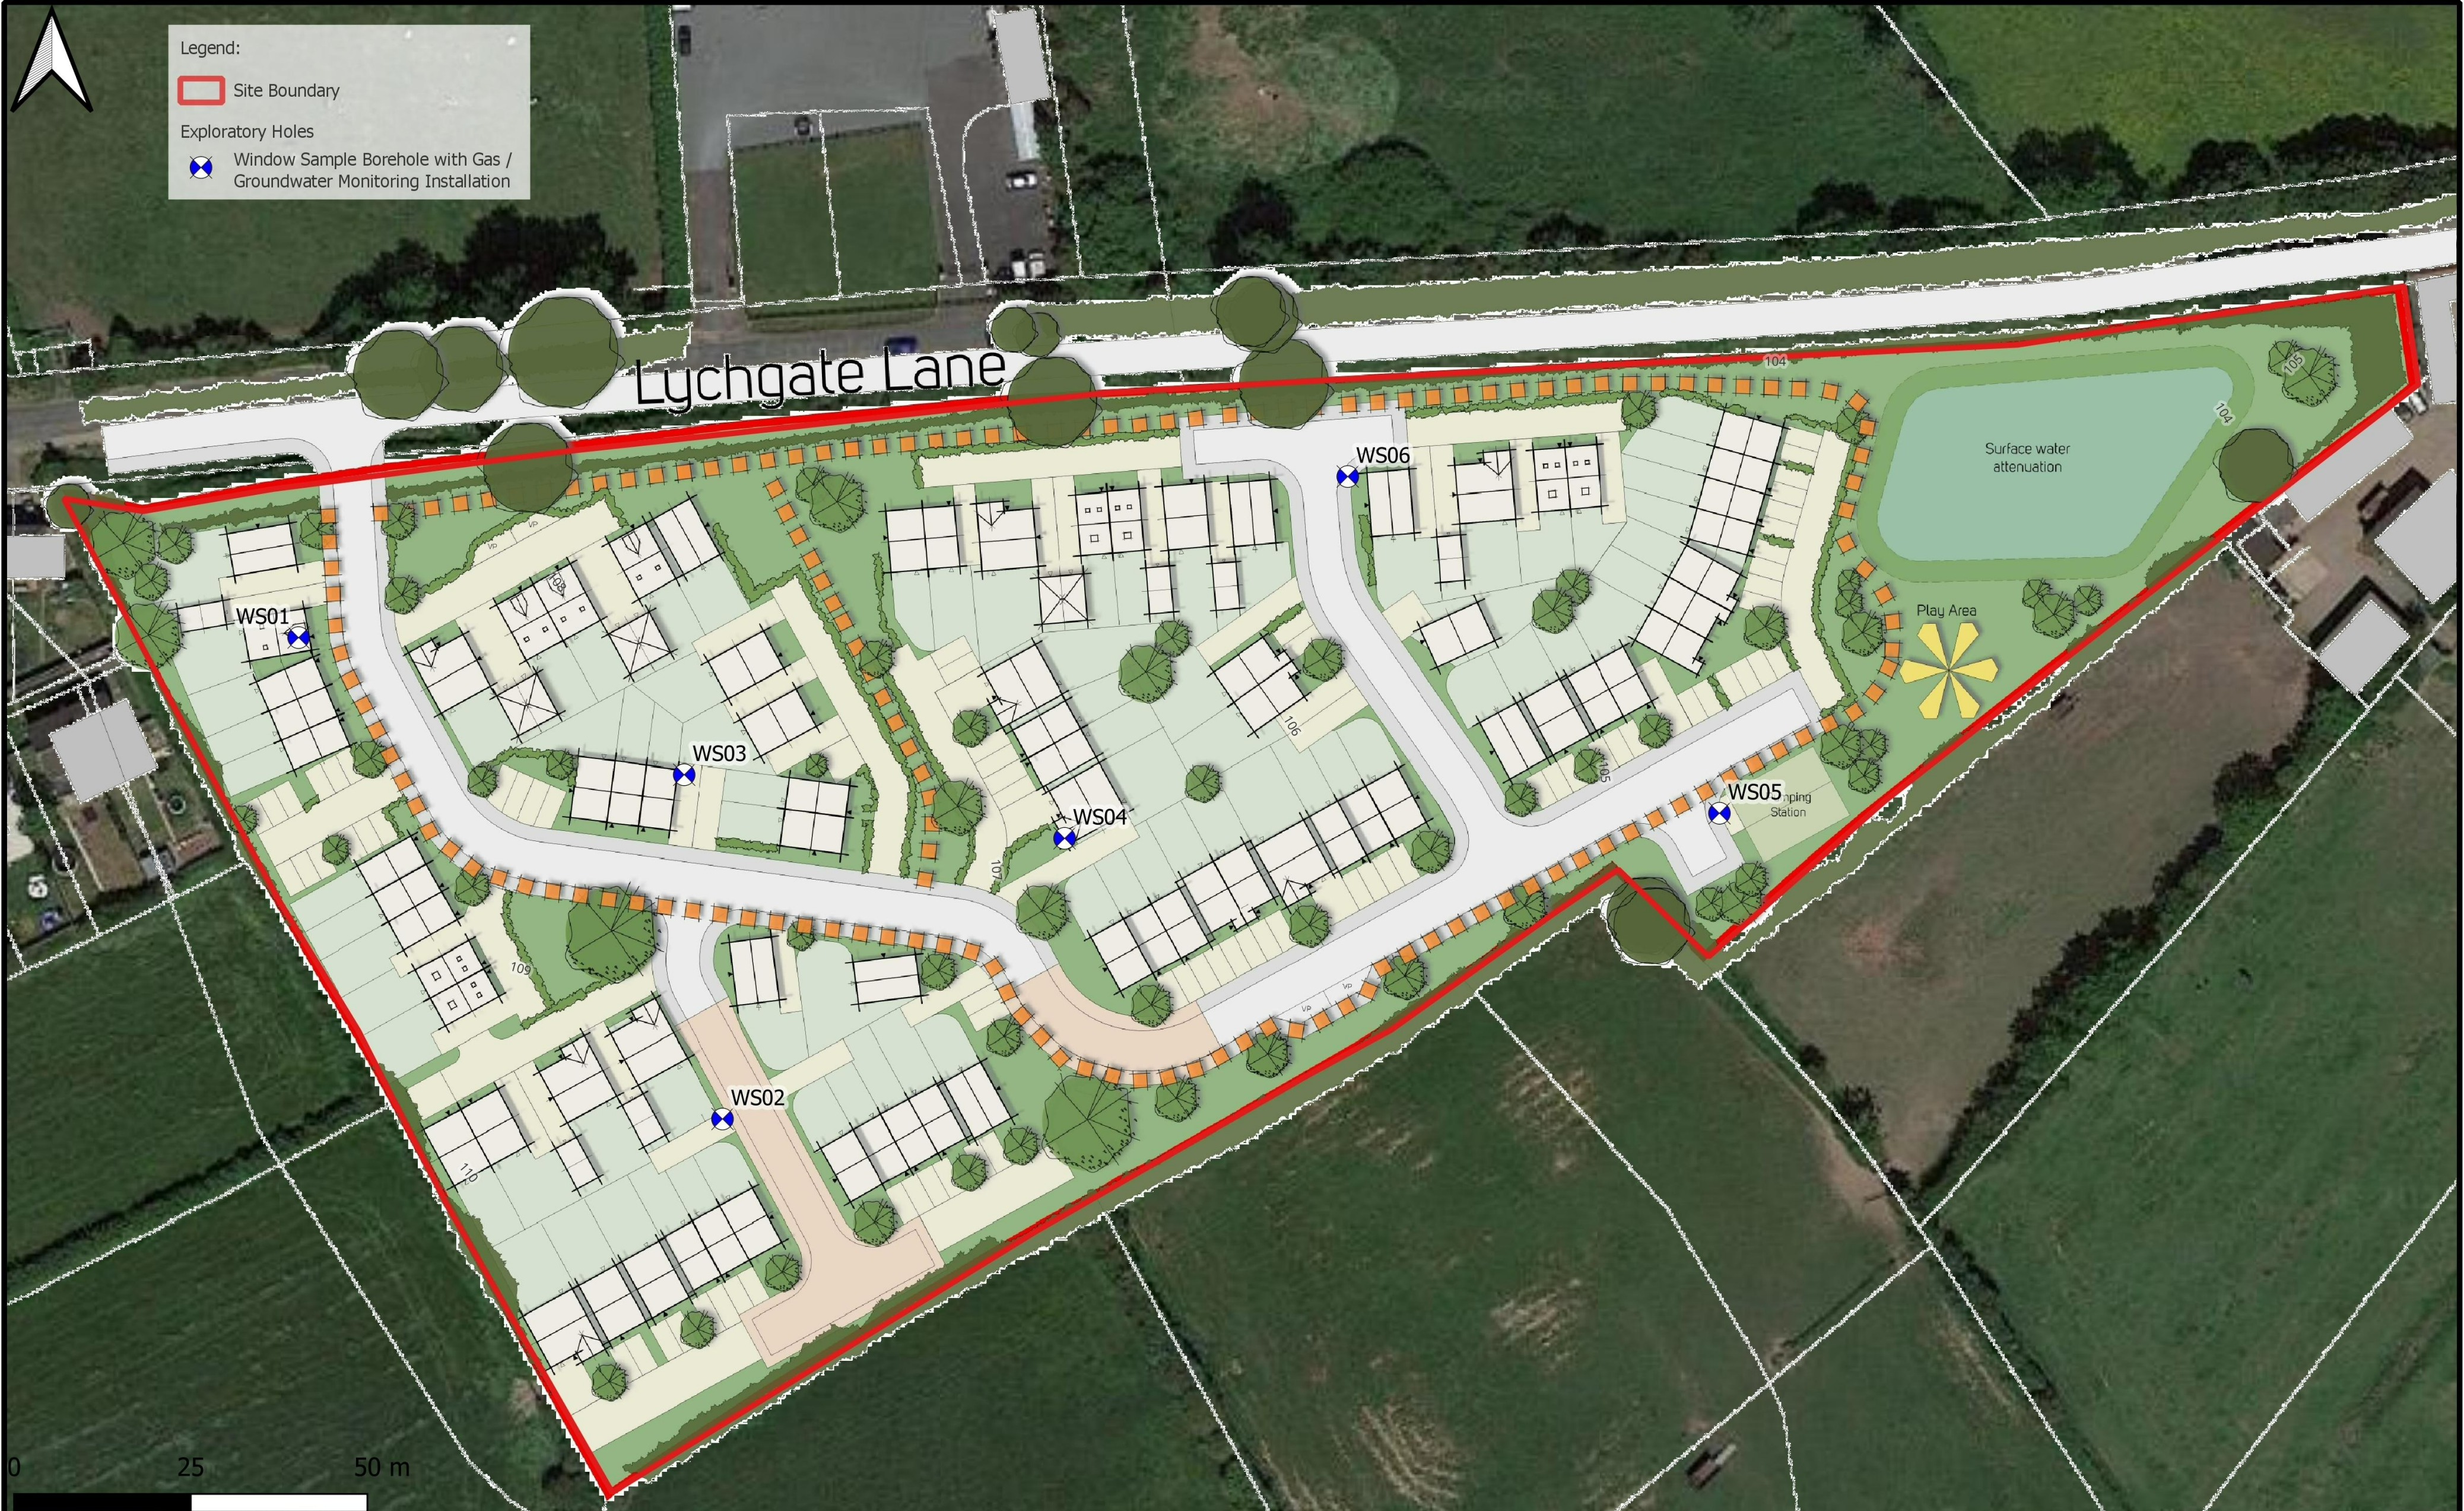
As the proposed end use has been classified as high sensitivity (residential with gardens), six 35mm diameter gas/water monitoring standpipes were installed across the site development area. The standpipes were installed in the window sample boreholes (WS01-WS06 inclusive), with response zones in the natural strata due to the absence of made ground.

A gas monitoring location plan is presented in Appendix A, with the gas monitoring results presented in Appendix B.

⊗ Window Sample Borehole with Gas / Groundwater Monitoring Installation

| | TITLE:<br>Gas Monitoring Plan | © GRM Development Solutions Ltd © Crown Copyright. AL 100014100 | | | |
