Our Ref: P9700 / Let.Rep

**Re: Ground Investigation at 87 High Street, Barwell.**

Vexford Homes Ltd has instructed GRM to undertake a geo-environmental assessment at 87 High Street, Barwell to assess for potential contamination beneath the former residential structure, associated gardens and outbuildings. Current proposals are for the site to be re-developed with new build, terraced housing incorporating private gardens and areas of hardstanding; accordingly, the Client has also instructed that an initial assessment of the soils geotechnical characteristics is made.

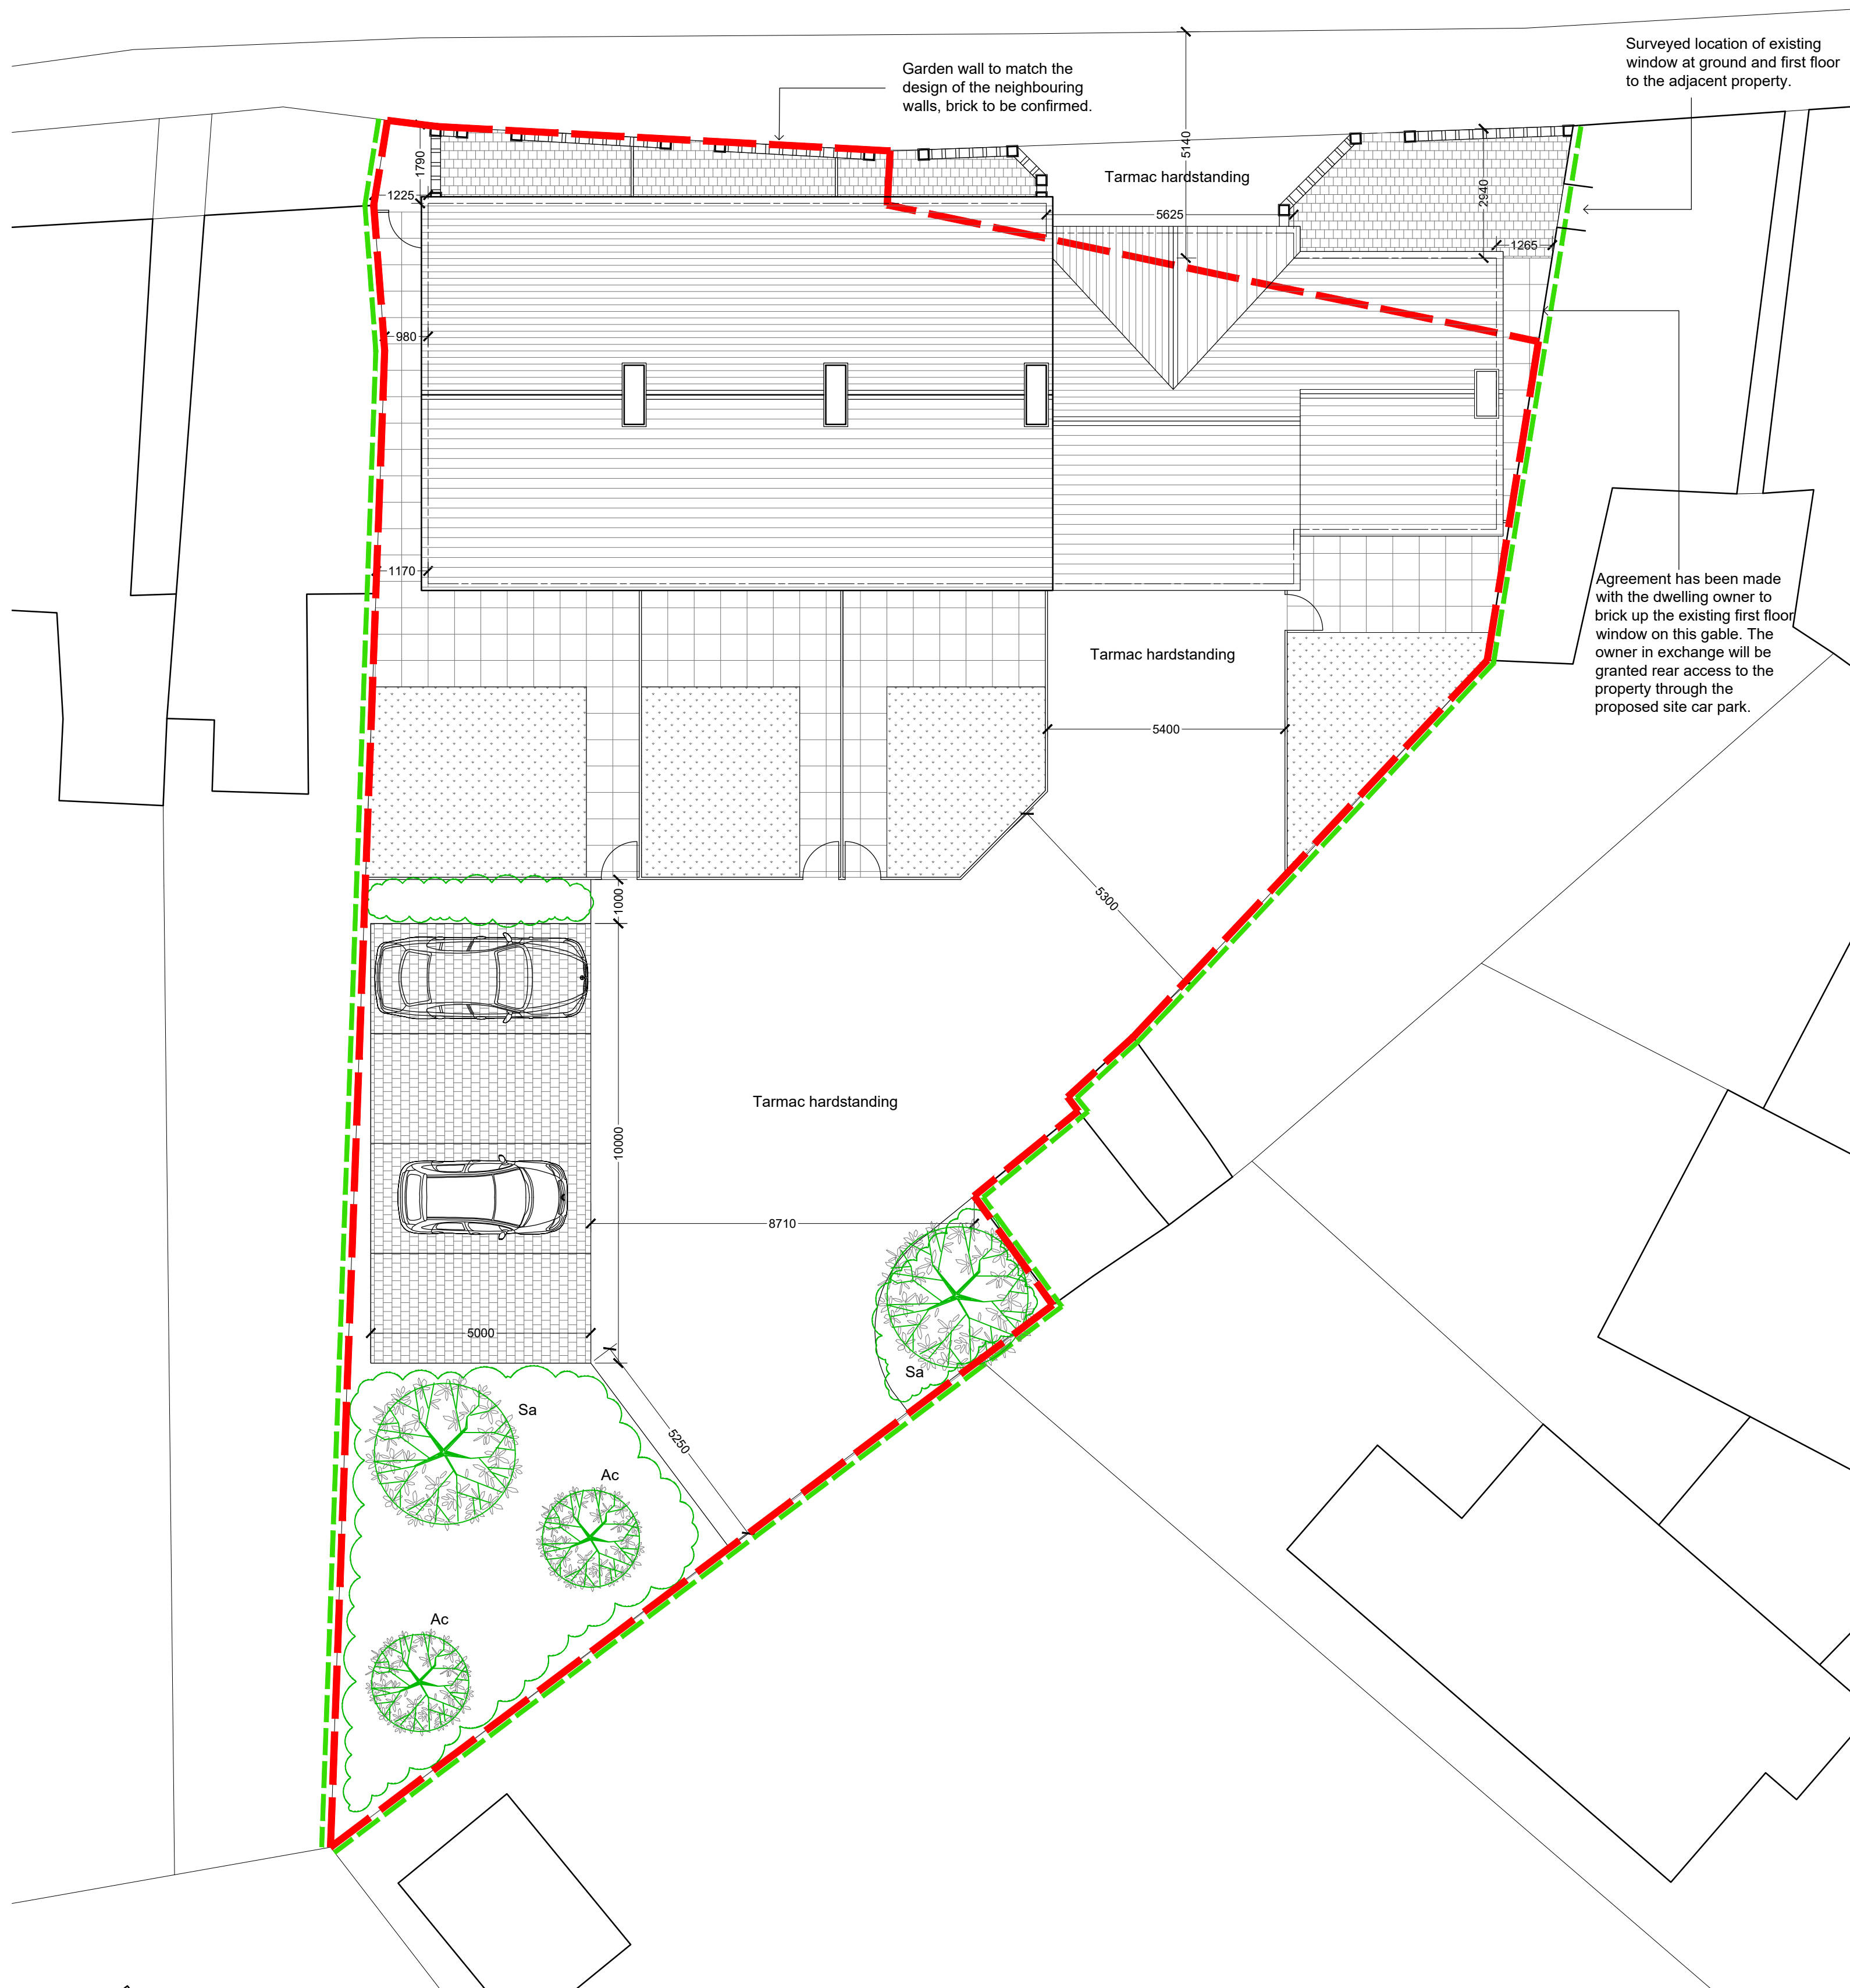
A copy of GRM's standards and limitations of reporting are presented in Appendix A and a Proposed Development Plan is presented in Appendix B.

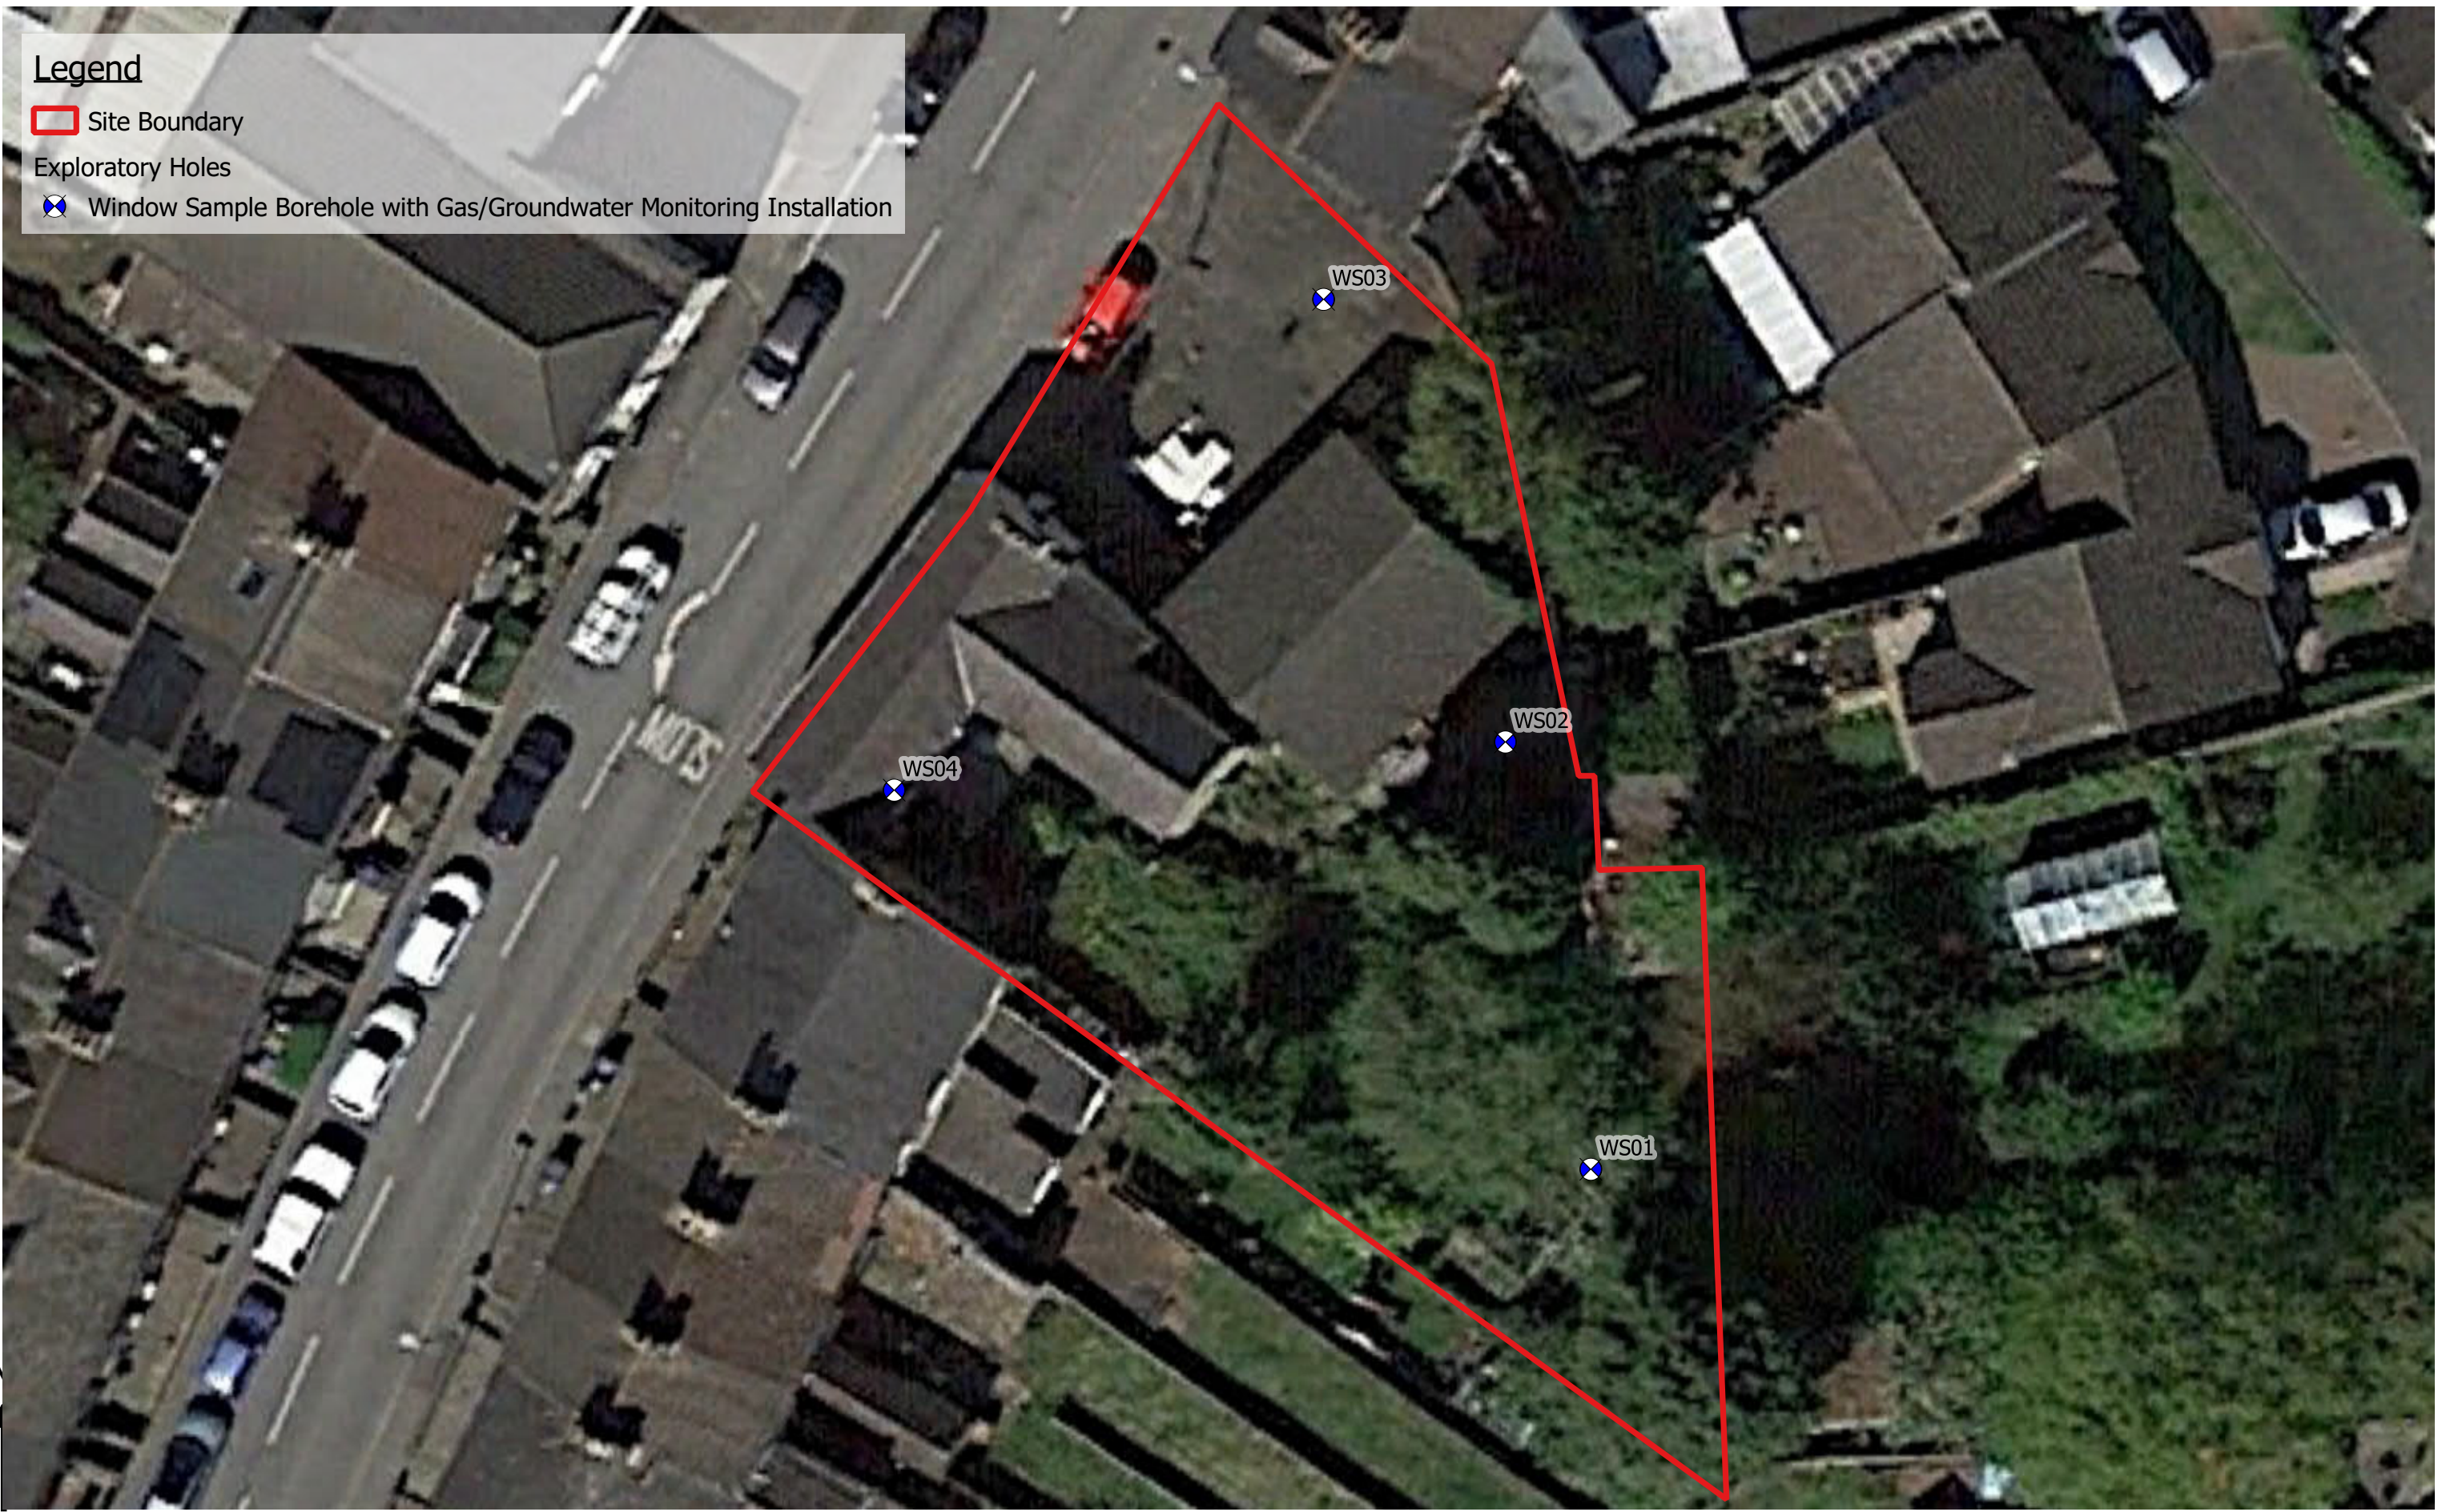
WS01 and WS02 were positioned beneath the recently demolished residential structure, WS03 in the area of a former outbuilding noted to have possessed asbestos cement sheeting roofing and WS04 in the vicinity of the former pond. An Exploratory Hole Location Plan is presented in Appendix C and the Exploratory Hole Logs in Appendix D.
