**Bat and Nesting Bird Method Statement for,  
Mr. and Mrs. Taylor.  
Building at,  
Dovecott Barn,  
Ravenstone Farm,  
Main Street,  
HIGHAM ON THE HILL,  
Leicestershire,  
CV13 6AH.**

**Map Ref SP 3814 9541  
2<sup>nd</sup> March 2026.**

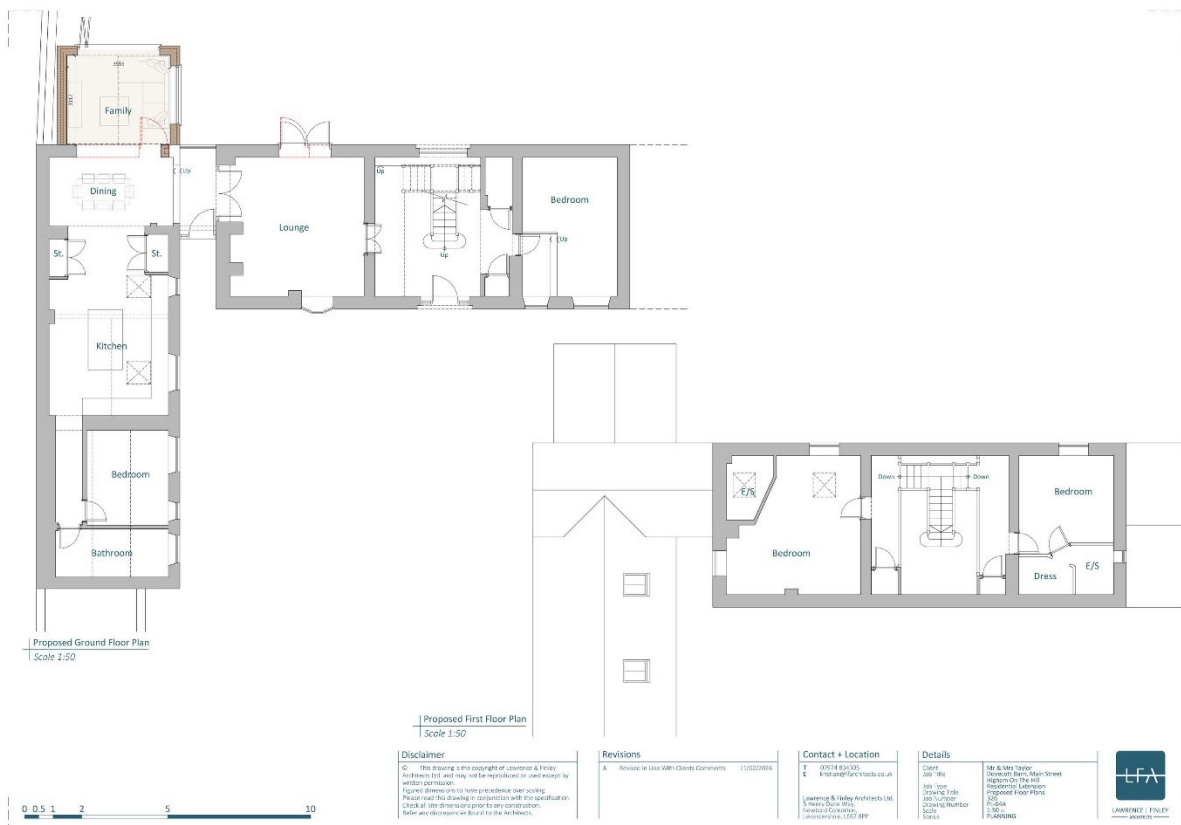
there are no nesting opportunities where the roof lights will be installed. The roof light installation between the beginning of September and the end of February in any year will have no impact birds.

The roof lights must not be installed between the beginning of May and the end of August in any year to ensure that there is no chance of disturbing the Maternity roost of Common pipistrelle bats.

This will require the alteration of the roof lights to match the new internal layout. There are no bat roosting opportunities where the roof lights are to be altered. When the roof tiles and existing roof lights are removed if the area is left open overnight from the beginning of March to the end of April or from the beginning of September to the end of October in any year there is a chance that bats could find and use the newly created openings as a place of shelter. Each roof light is to be replaced within a single day therefore so that no new roosting sites are created. Work between the beginning of November and the end of February in any year will have likelihood of bats using the areas if they are left open over night.

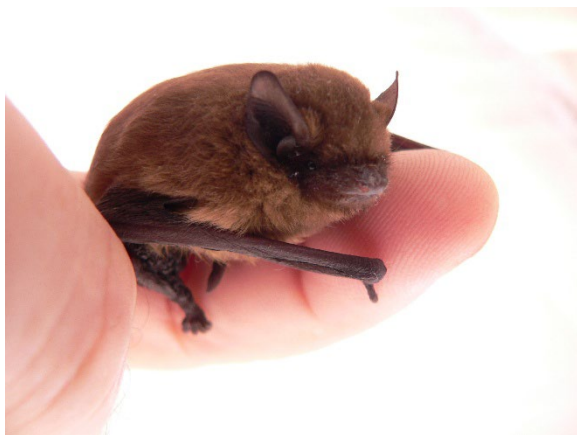
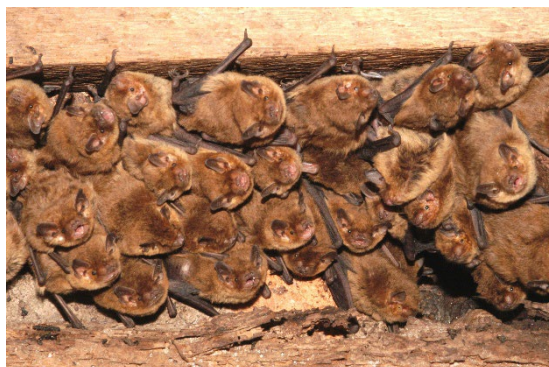
It is common to find bat droppings in places used by bats. These are small and often confused with mouse droppings. It is possible to distinguish between them as mouse droppings are hard whereas bat droppings, being only insect remains, crumble when rubbed between the fingers.

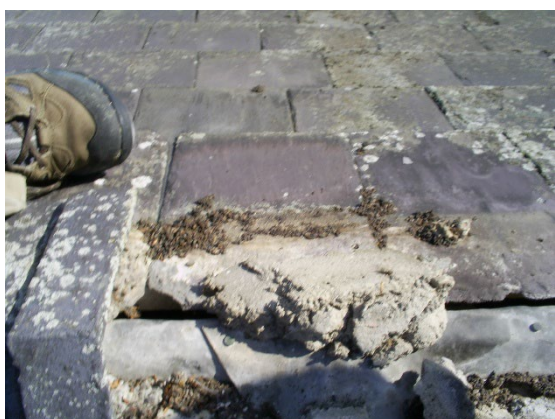
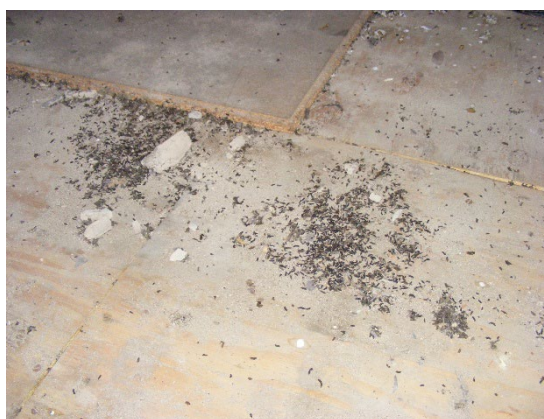
The roof strip works for the installation of the new roof lights is to be undertaken outside of the bat maternity season, beginning of May to the end of August, so that there will be no disturbance of roosting bats in the area 1.2m to the side of where the roof lights are to be installed. The roof tile removal where the new roof lights are to be installed must follow the details below. The Access Points for the Maternity Roost shown above, are to remain untouched during all works.
